The Jockey Club CPS Limited

Central Police Station Conservation  
and Revitalisation Project:  
*Third Monthly EM&A Report*  
*(1 January to 31 January 2012)*

Issue Date: February 2012

Reference 0095646

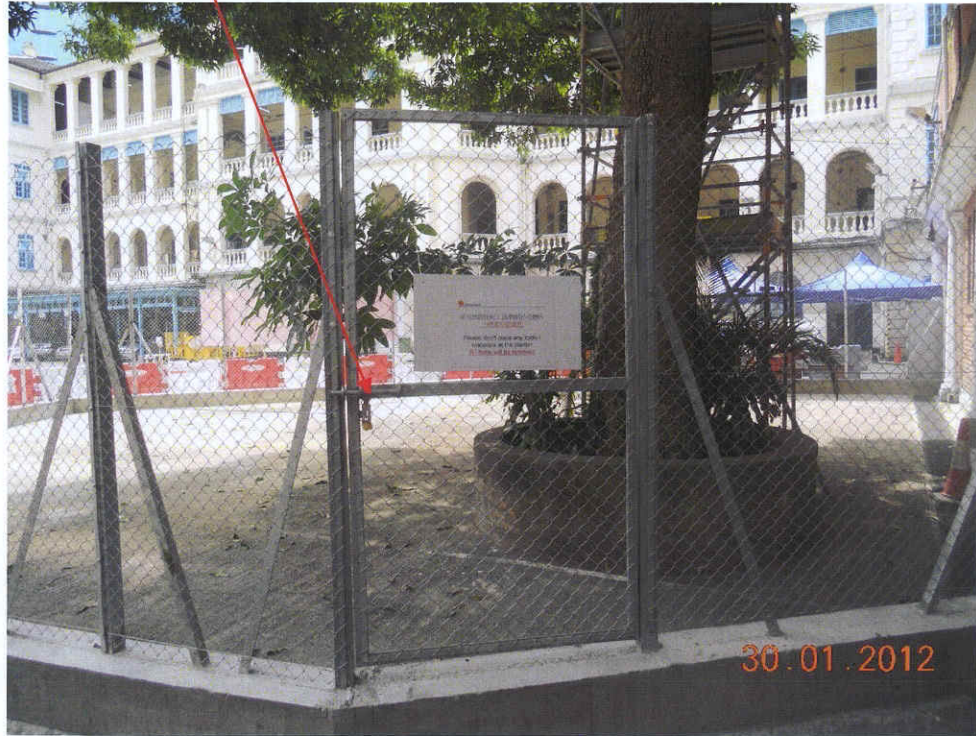
1. Overall health condition of the tree is good.
2. A scaffold is too close to the tree, it will damage the bark easily.
3. The door has been locked and restricts admittance to the zone.
4. The sign of "Tree Protection Zone" has disappeared at site.
5. The site appears clean and tidy.

Fig. 5 The sign of "Tree Protection Zone" has disappeared at the time of inspection.

1. To keep the scaffold a reasonable distance from the tree.
2. Re-displaying of the sign "Tree Protection Zone" in front of the wire-netted fence.

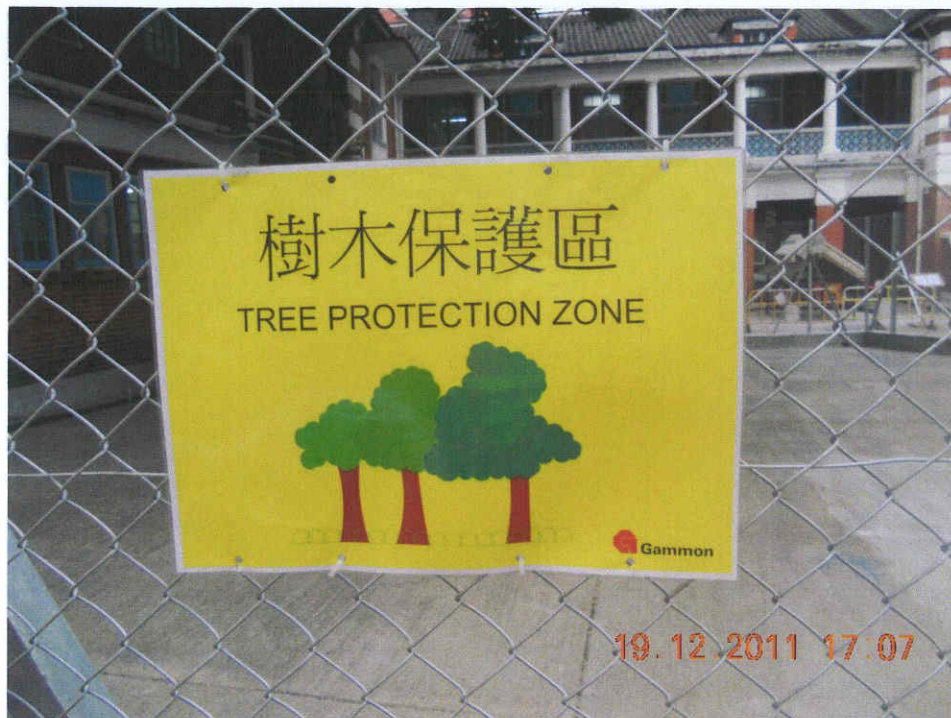
Fig. 6 Recommend to re-display the sign in front of protection zone.

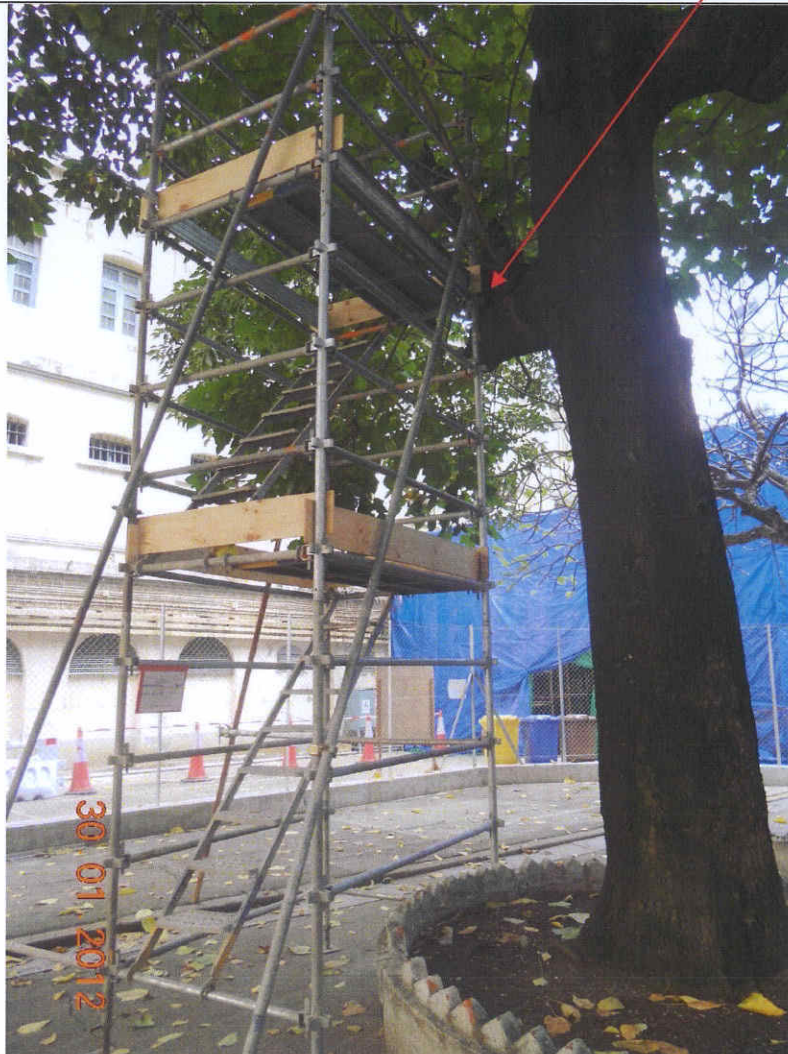
- 2). Tree-6 – Tree-9 :-
  - i). A scaffold is too close to Tree-7 , it will damage the bark easily.  
We recommend to keep the scaffold a reasonable distance from Tree-7.
  - ii).A dead branch is hanging on the lower trunk of Tree-7, removal of this dead branch is recommended.
  - iii). The barbed wire has been cut and removed from Tree-9 prior to inspection.
  - iv). All planters are clean and tidy. The site and nearby environment are in order.

Fig. 5 A scaffold is too close to the tree, it will damage the bark easily .

1. To keep the scaffold a reasonable distance from Tree-7.
2. To remove the hanging dead branch from the tree.

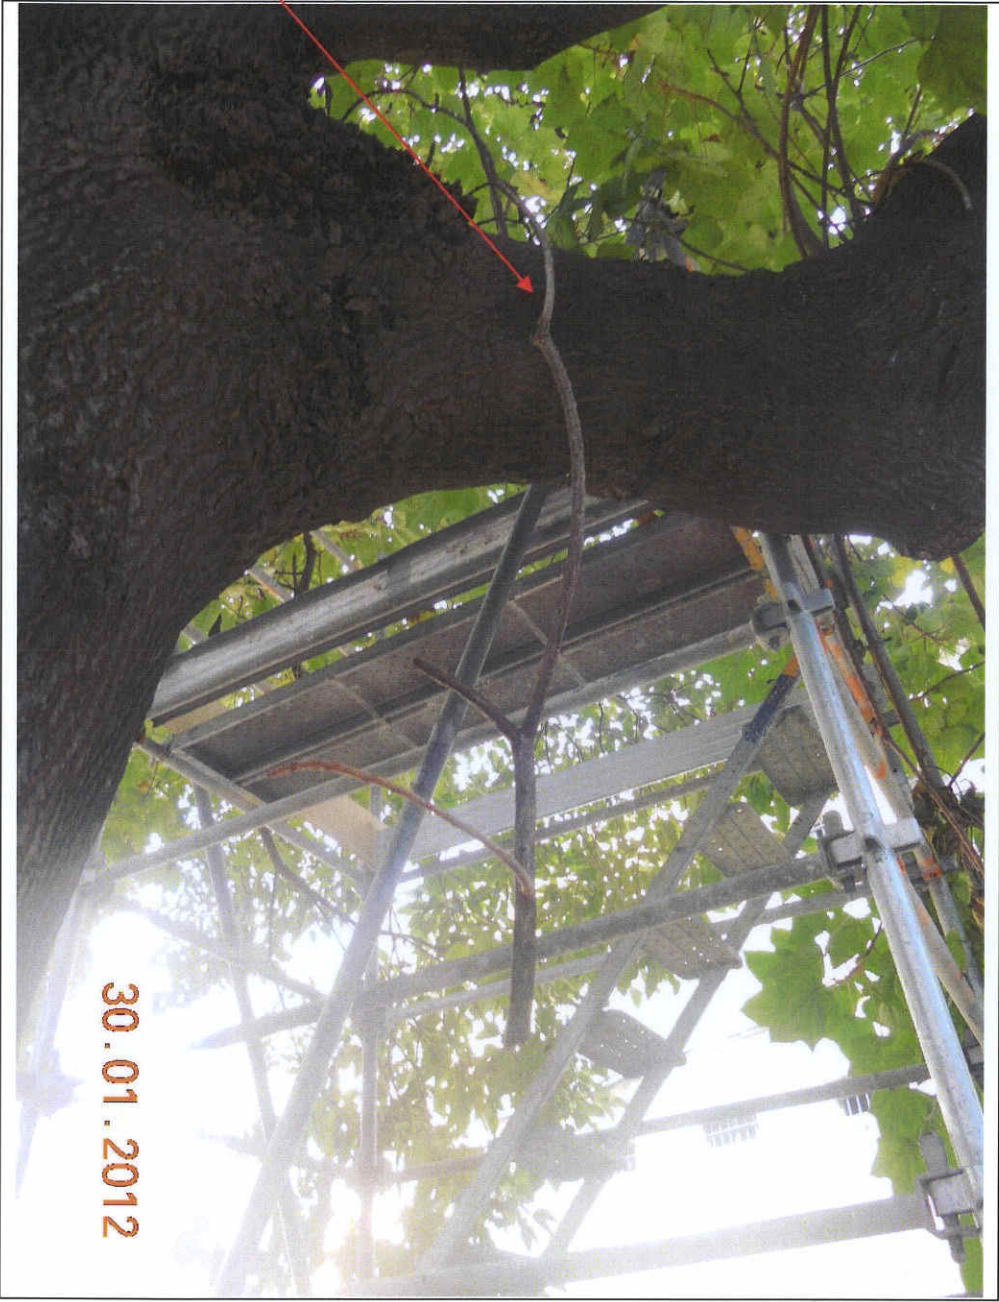
Fig. 6 A dead branch found hanging on the tree.

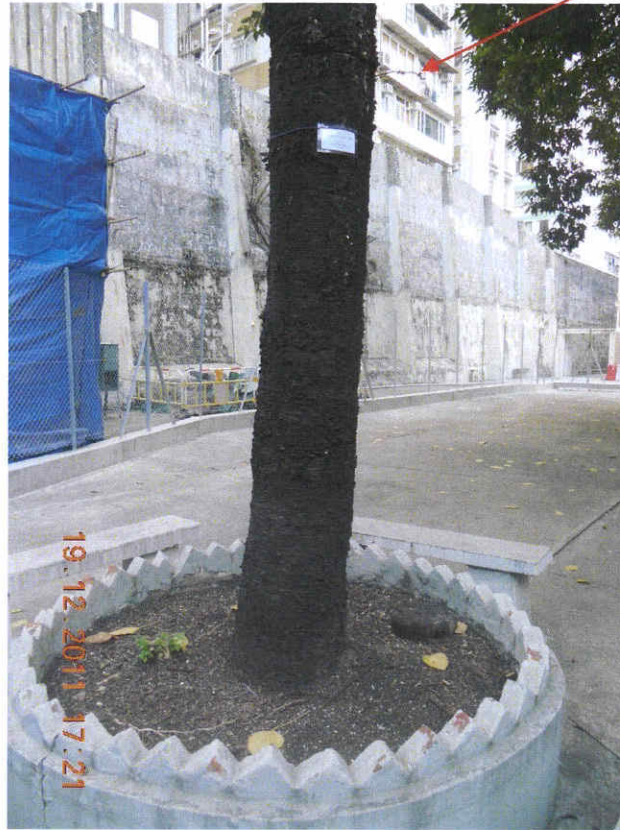
Fig. 4 During the last inspection on 19<sup>th</sup> Dec. 2011, a barbed wire (about 30cm L) was found on the mid trunk.

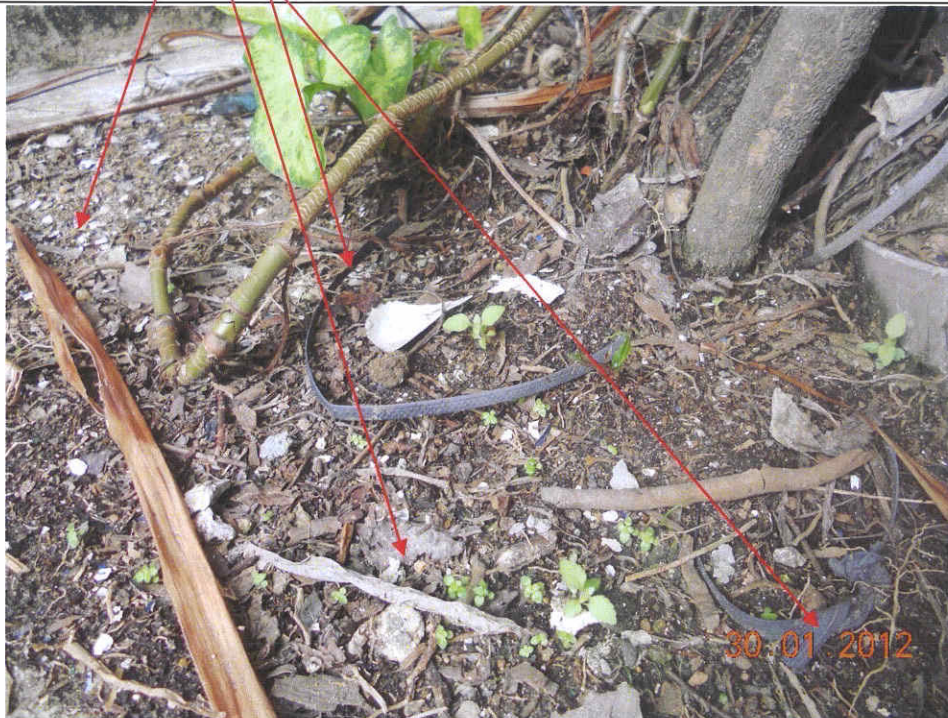
- 3). Tree-11 :-
  - i). Door of the building is locked and the temporary fence has been removed prior to inspection.
  - ii).A few rubbish has been found at the planter.
  - iii). Top soil at the planter appears rather dry, regular watering (preferable twice a week) is recommended.

Fig. 3 Top soil of the planter is rather dry. Regular watering, preferable twice a week, is recommended.  
A few rubbish has been found at the planter.

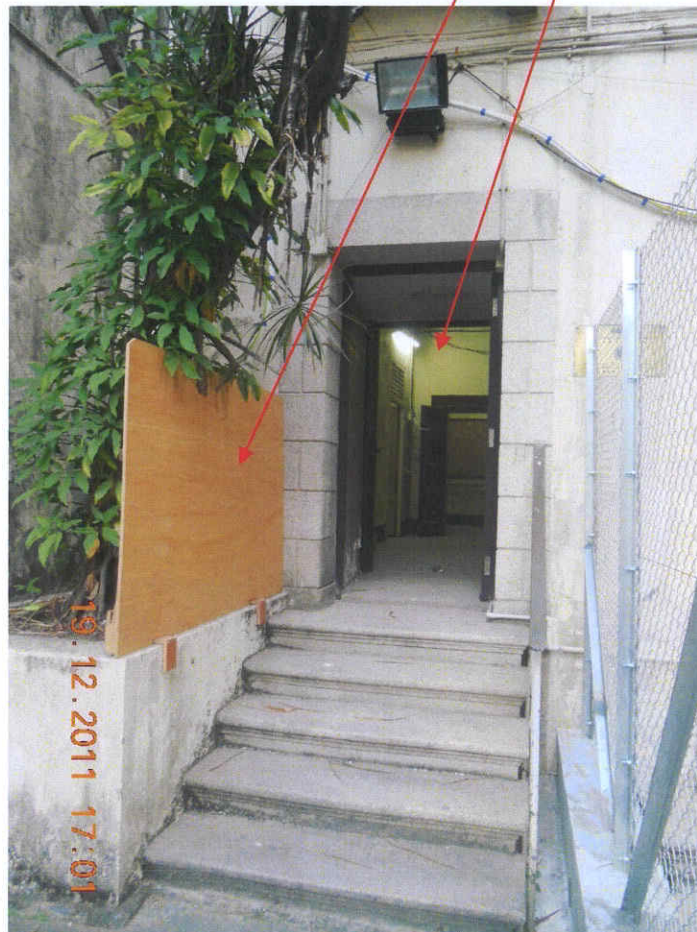
Fig. 5 During the last inspection on 19.12.2011, the door of the building was unlocked and opened. The temporary fence was erected at the planter. Removal of the temporary fence was recommended.
