Central Police Station Conservation
and Revitalisation Project:
75th Monthly EM&A Report
(1 January to 31 January 2018)

Issue Date: February 2018

Reference 0095646

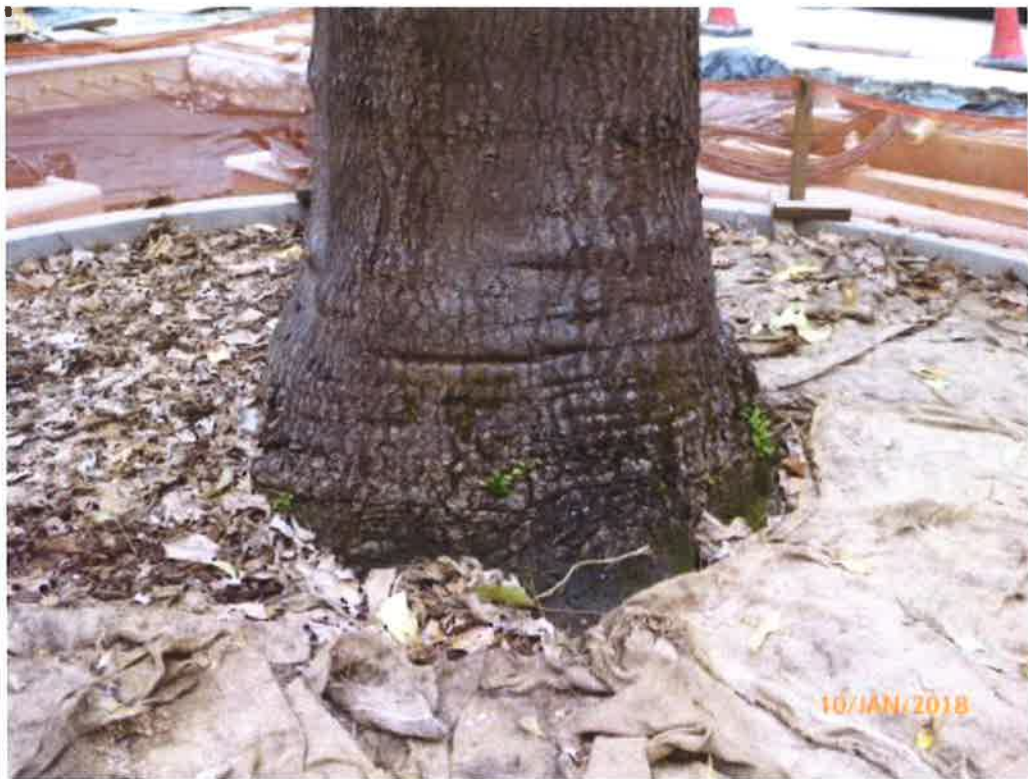
Fig 3. Health condition of the lower trunk is fair.

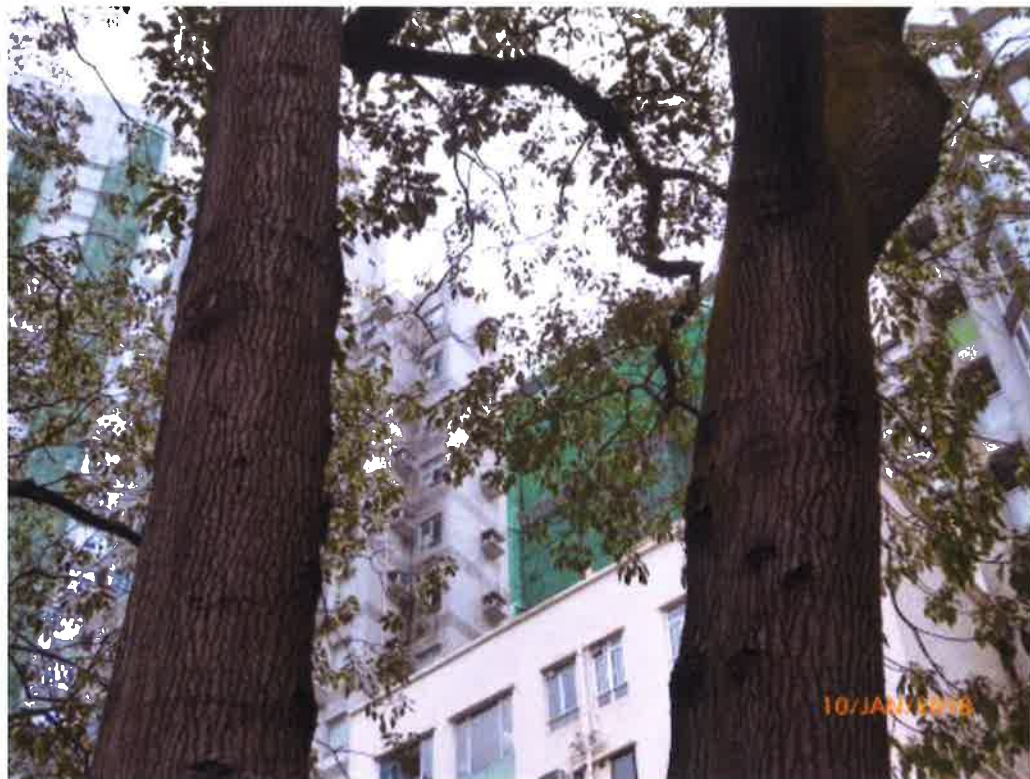
Fig. 6 Leaves on the crown are rather sparse.

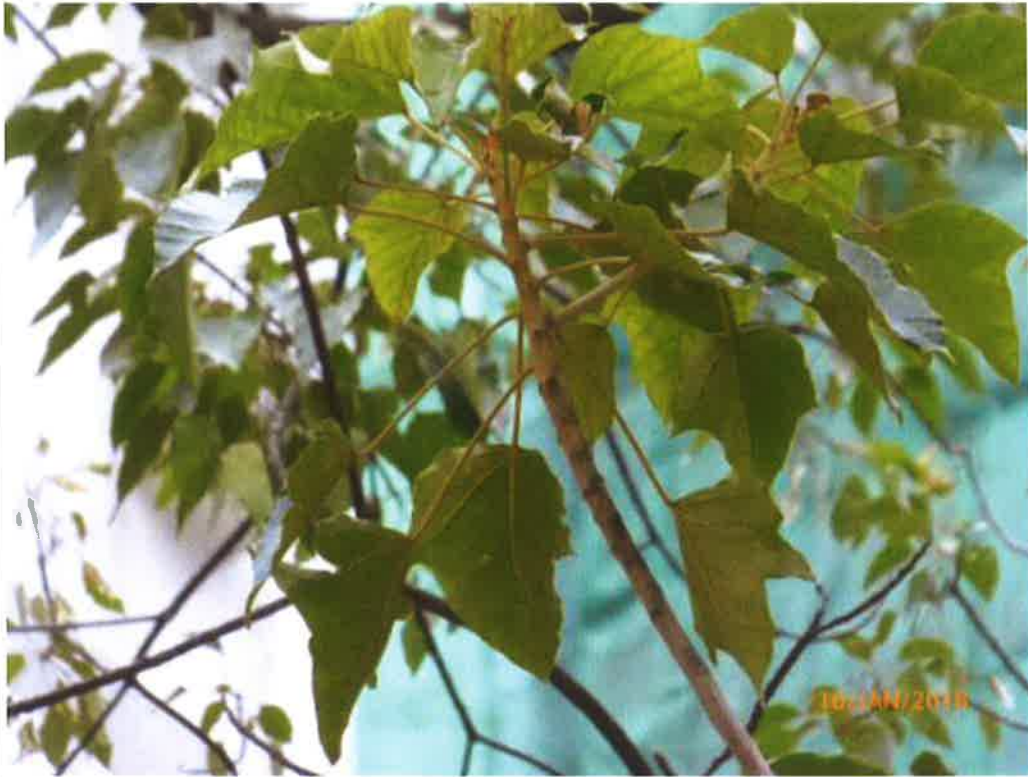
Fig. 9 As dry season has come, some leaves on the tree become faded.

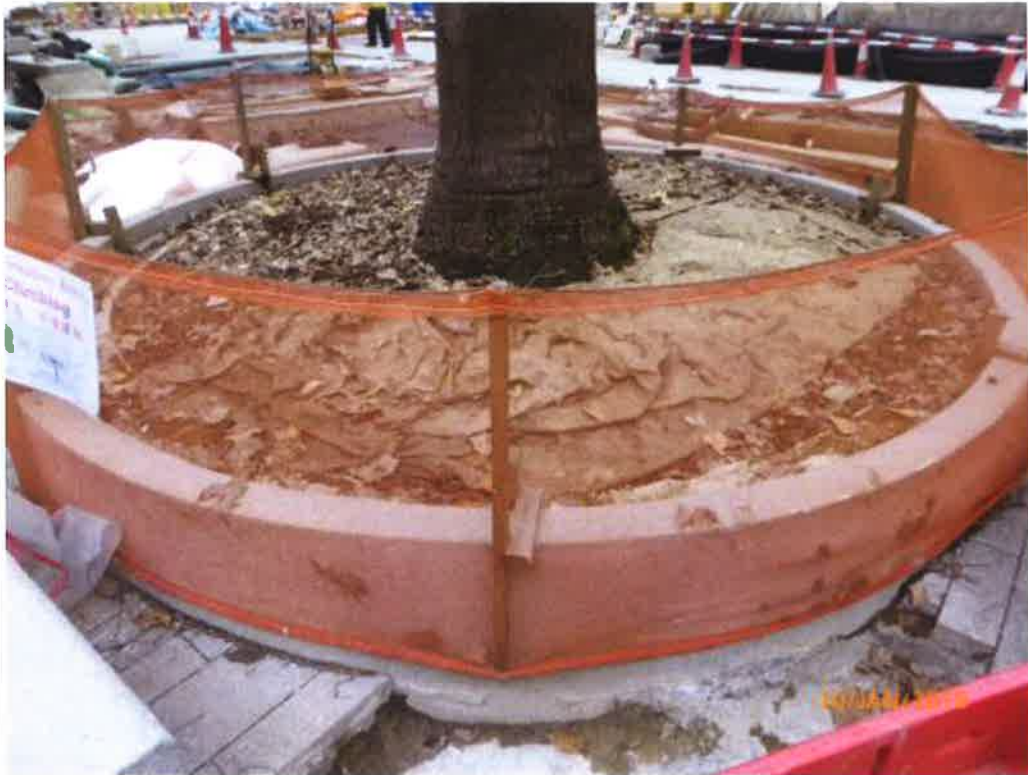
Fig. 11 The site near Tree-6 seems to be re-constructed.

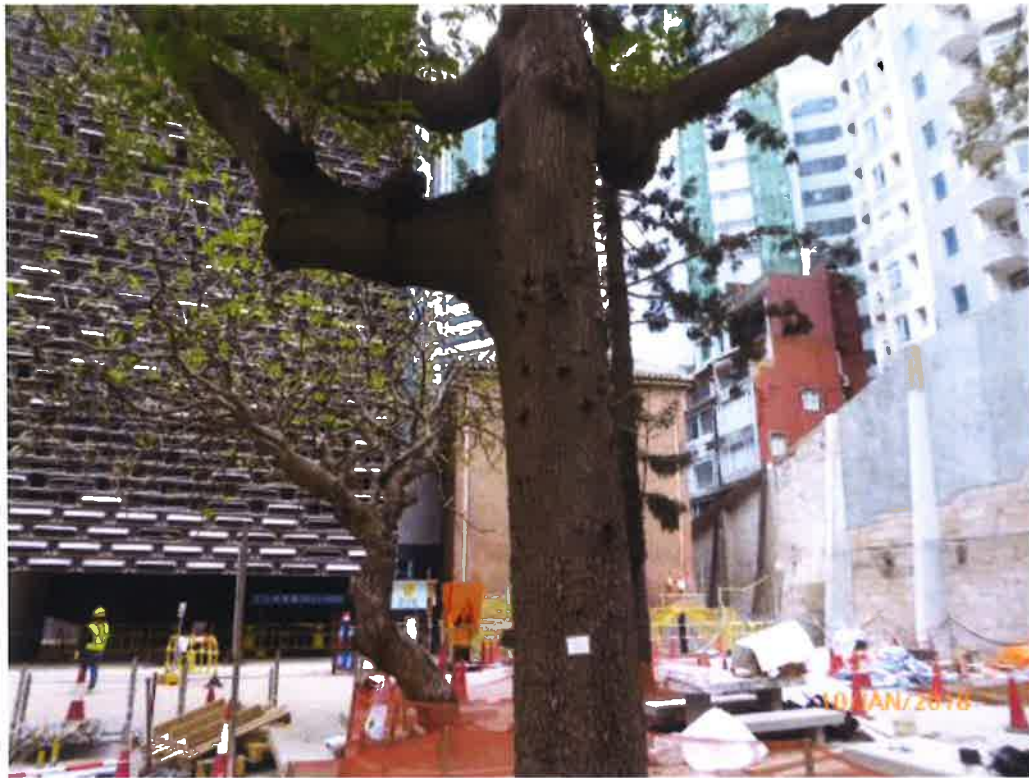
Fig. 5 Leaves on the crown are rather sparse.

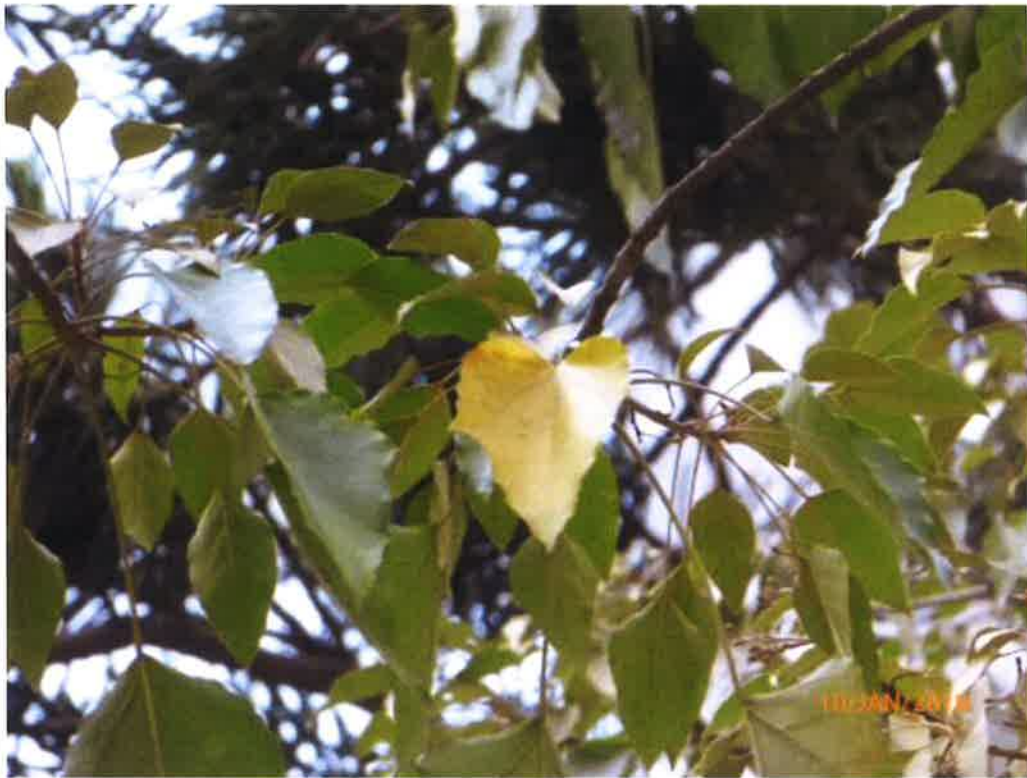
Fig. 8 As dry season has come, some leaves on the tree become faded.

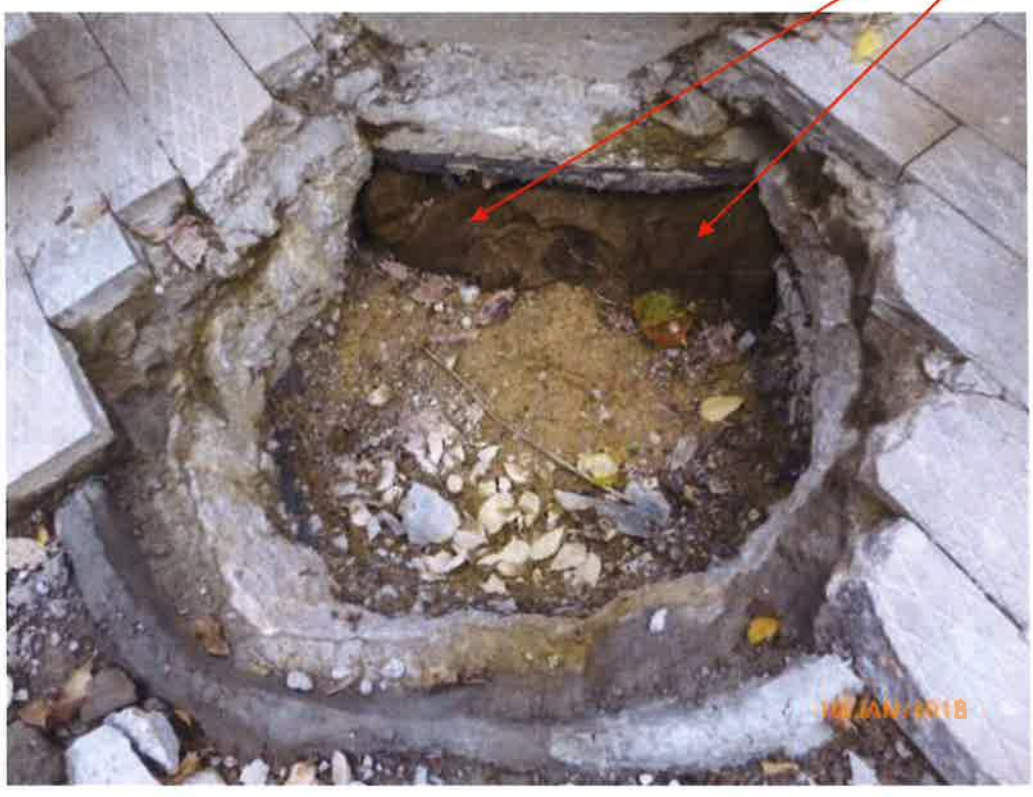
Fig. 10 The bare roots at the pits have been wrapped with hessian clothes.

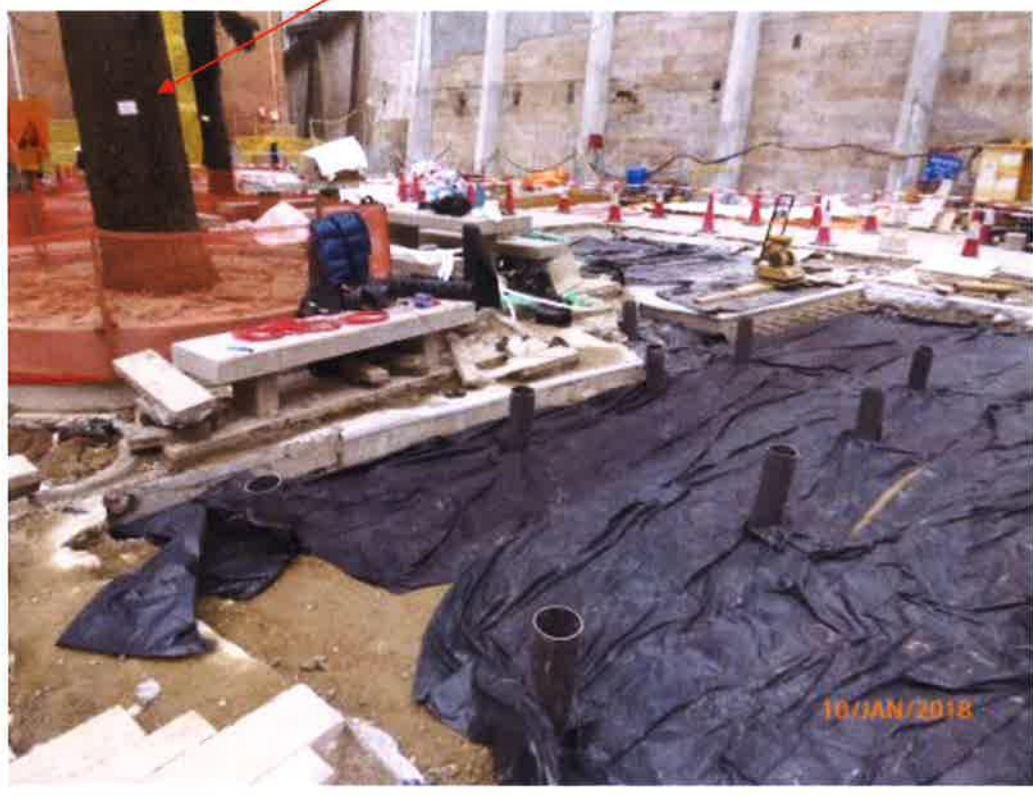
Fig. 11 The site near Tree-7 seems to be re-constructed.

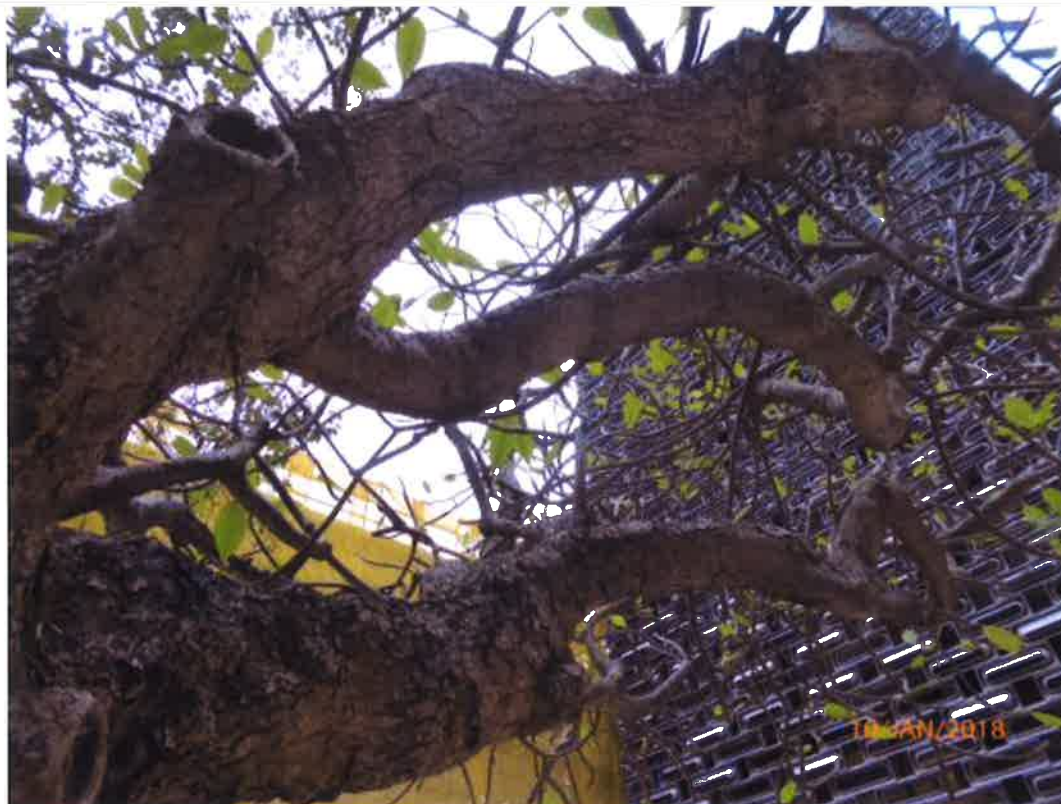
Fig. 6 As dry season has come, leaves on the tree become sparse.

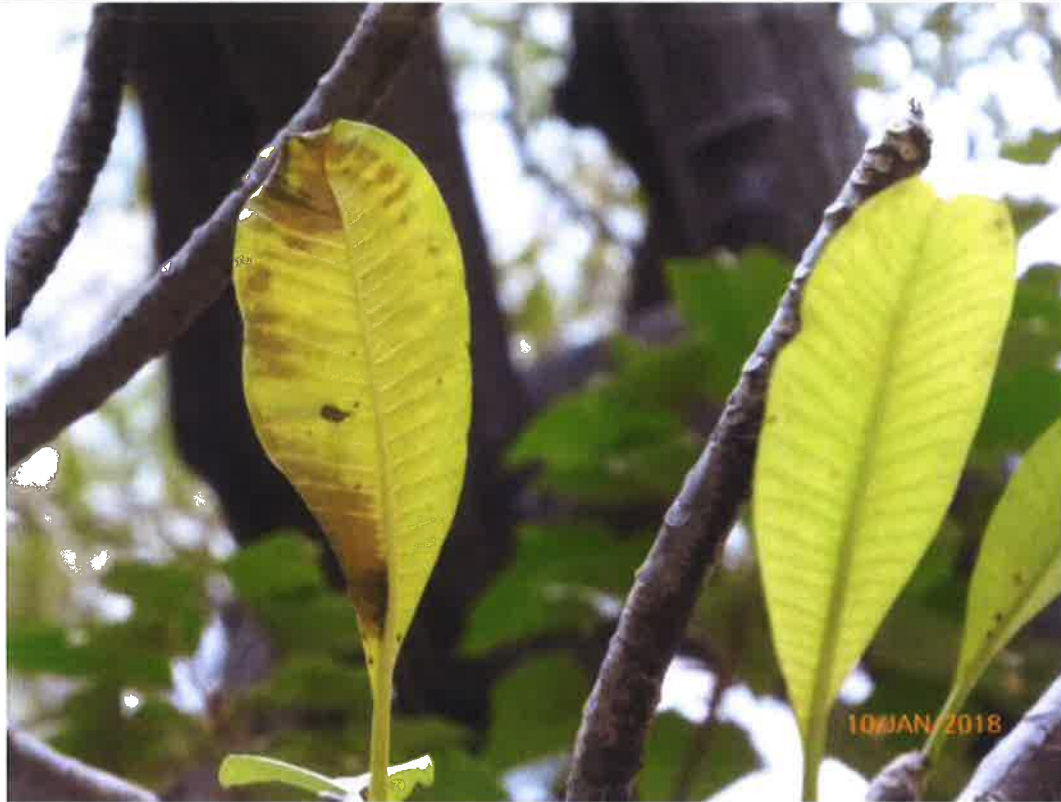
Fig. 8 Some leaves on the crown become faded.

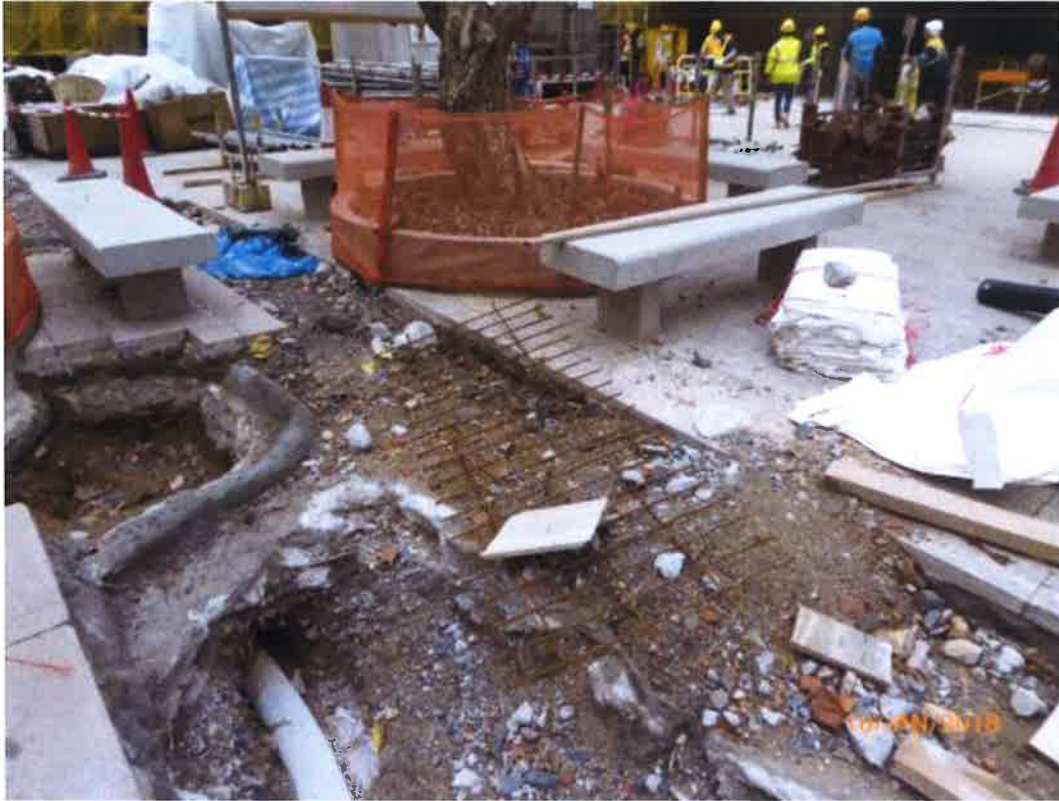
Fig. 10 The site near the planter seems to be re-constructed.

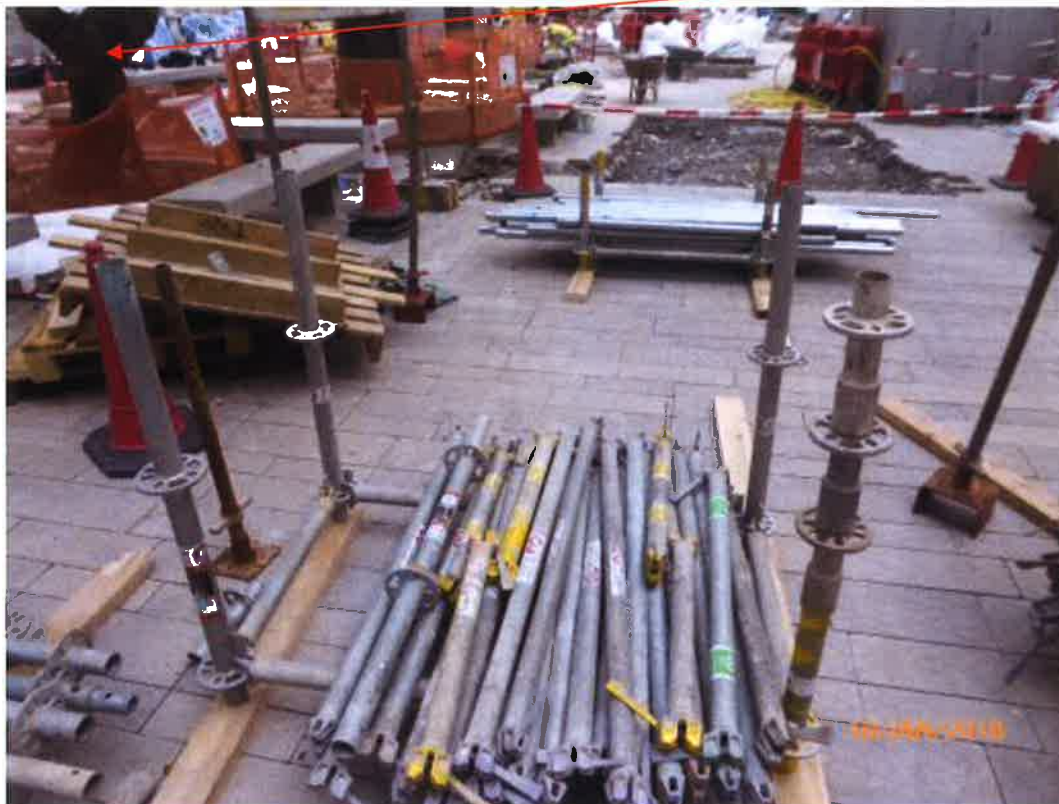
Fig. 11 Many construction equipment are placed near Tree-8.

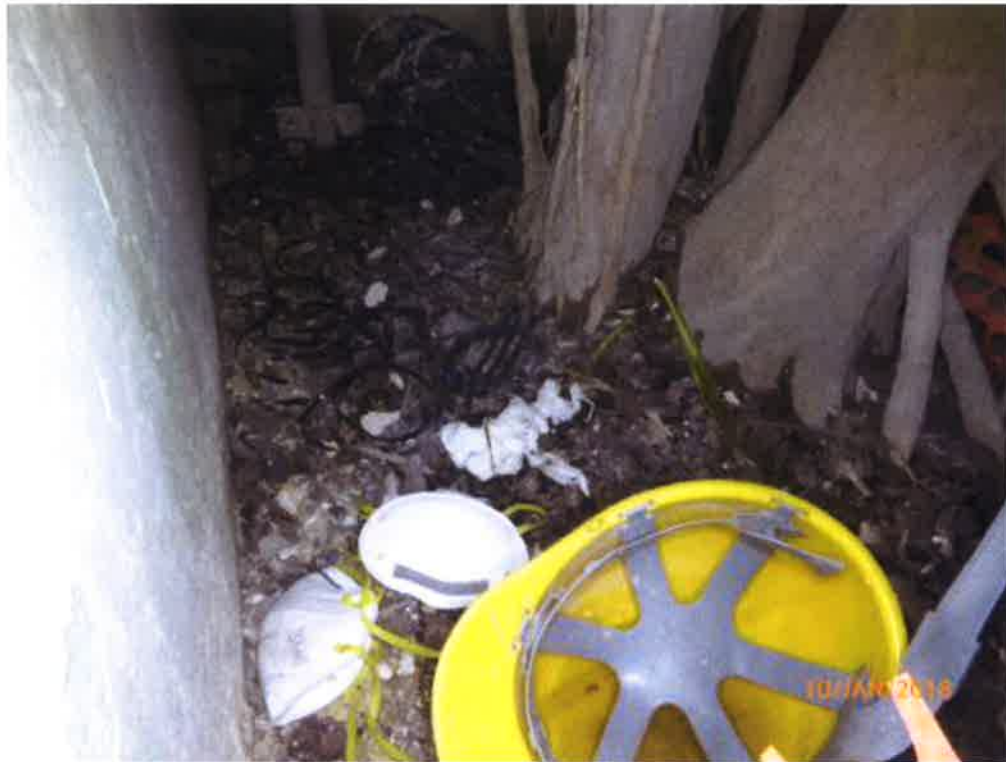
Tree No.	Botanical Name	Overall Health Condition	Arborist's Observations / Recommendations
			<ul style="list-style-type: none"> Some construction debris was observed at the planter. The Contractor was reminded to remove the construction debris from the planter.

Fig. 2 Root collar is normal. A few construction debris remain at the planter.
