The Jockey Club CPS Limited

Central Police Station Conservation
and Revitalisation Project:
69th Monthly EM&A Report
(1 July to 31 July 2017)

Issue Date: August 2017

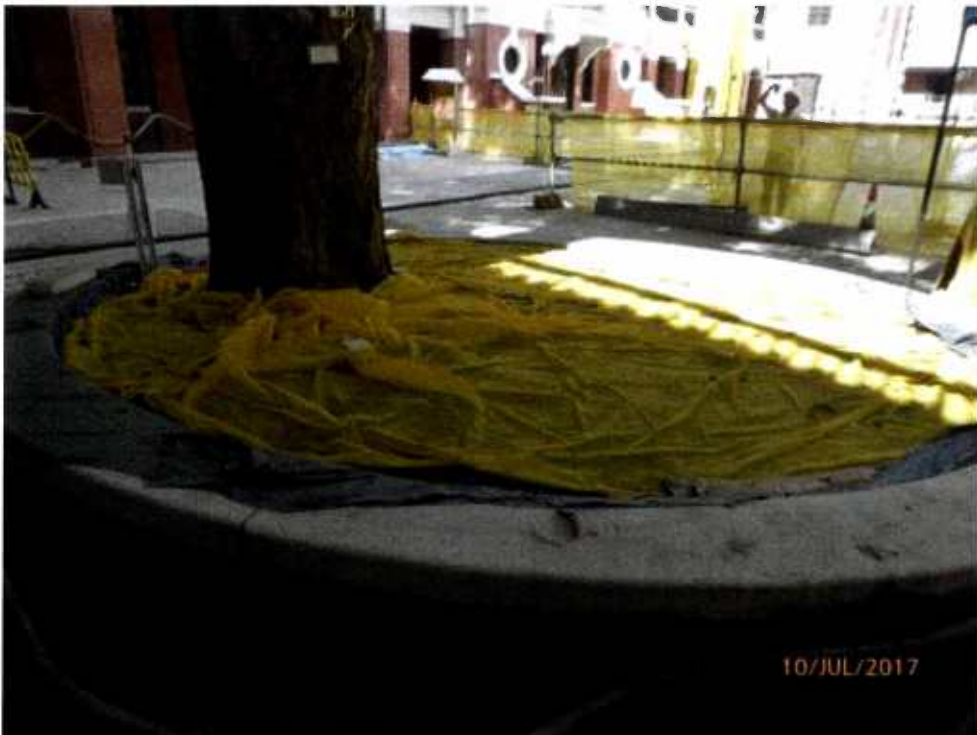
Fig. 9 The newly-built planter is covered with some netting sheets.

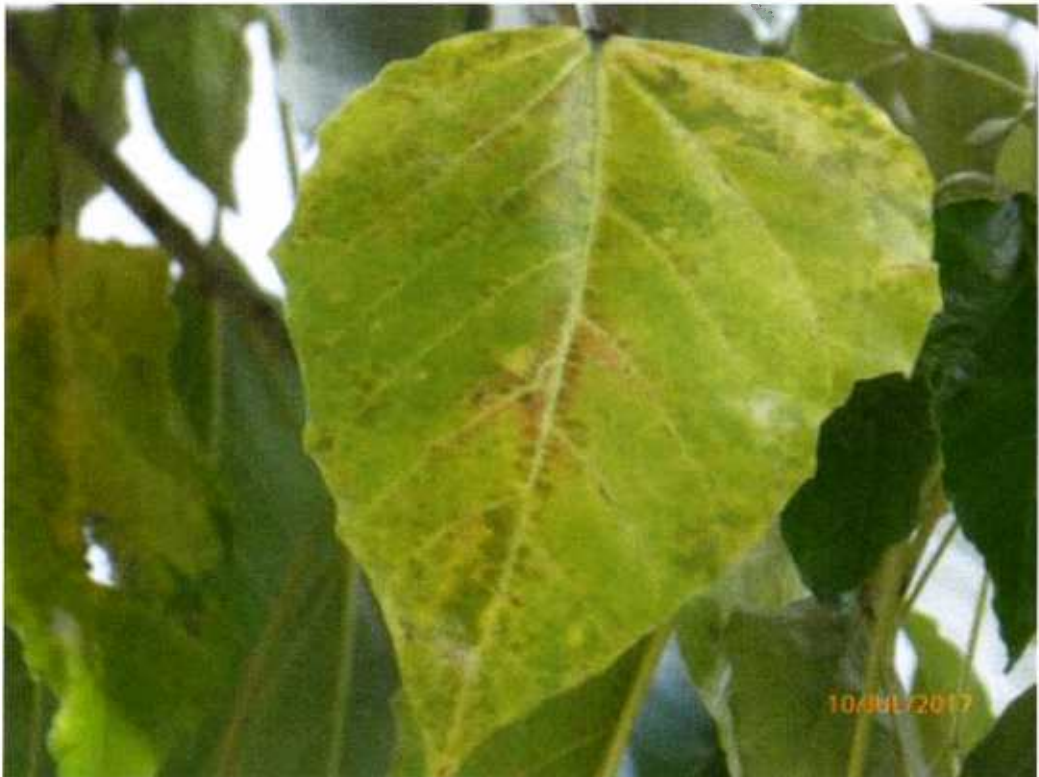
Fig. 9 Signs of Pest “白粉蝨 (*Trialeurodes vaporariorum*)” have been observed on the faded leaves.

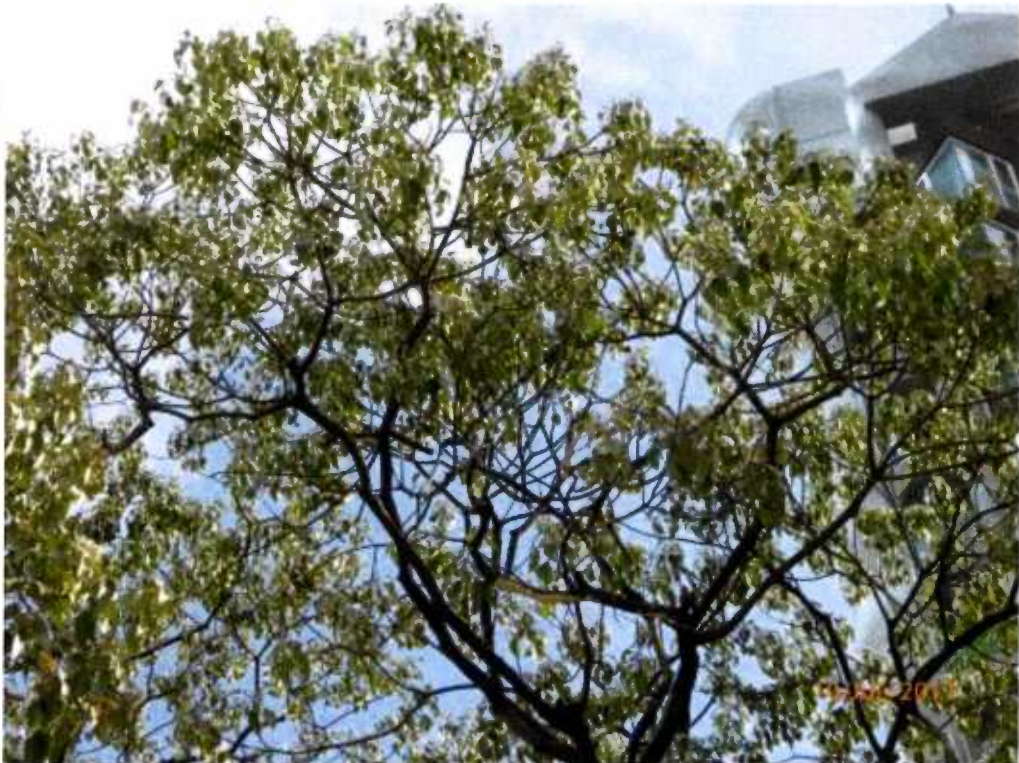
Fig. 7 Leaves on the crown are rather sparse.

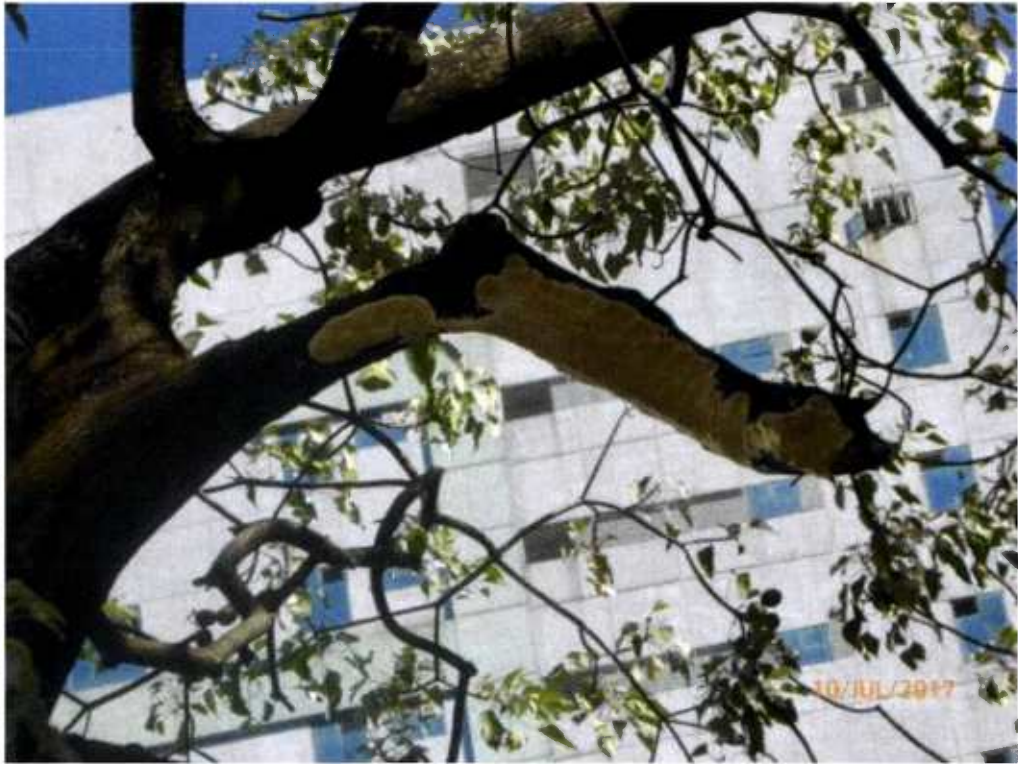
Fig. 8 A large decayed log has been found on the upper branches.

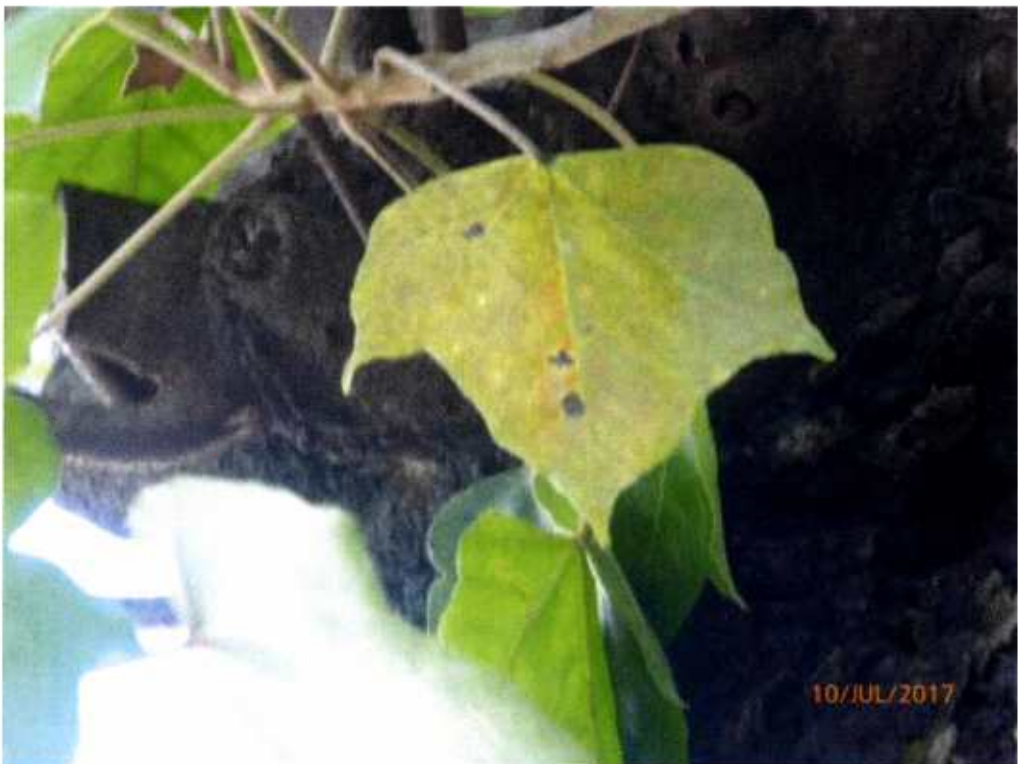
Fig. 9 Signs of Pest “白粉蝨” have been observed on the faded leaves.

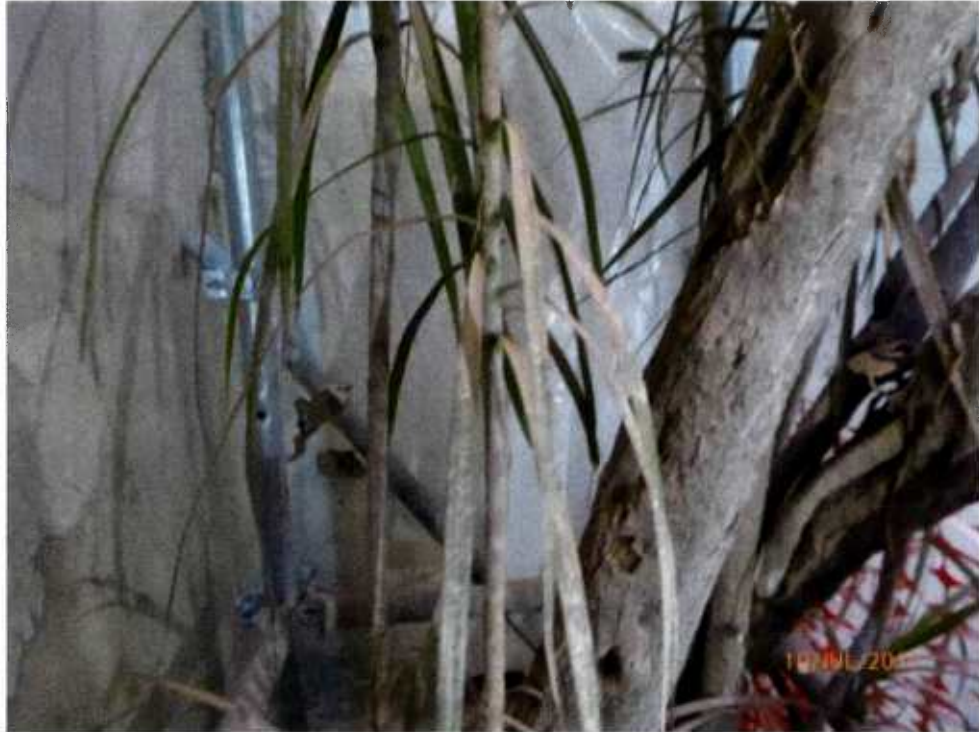
Fig. 4 The lower part of the tree has also been polluted by construction dust.

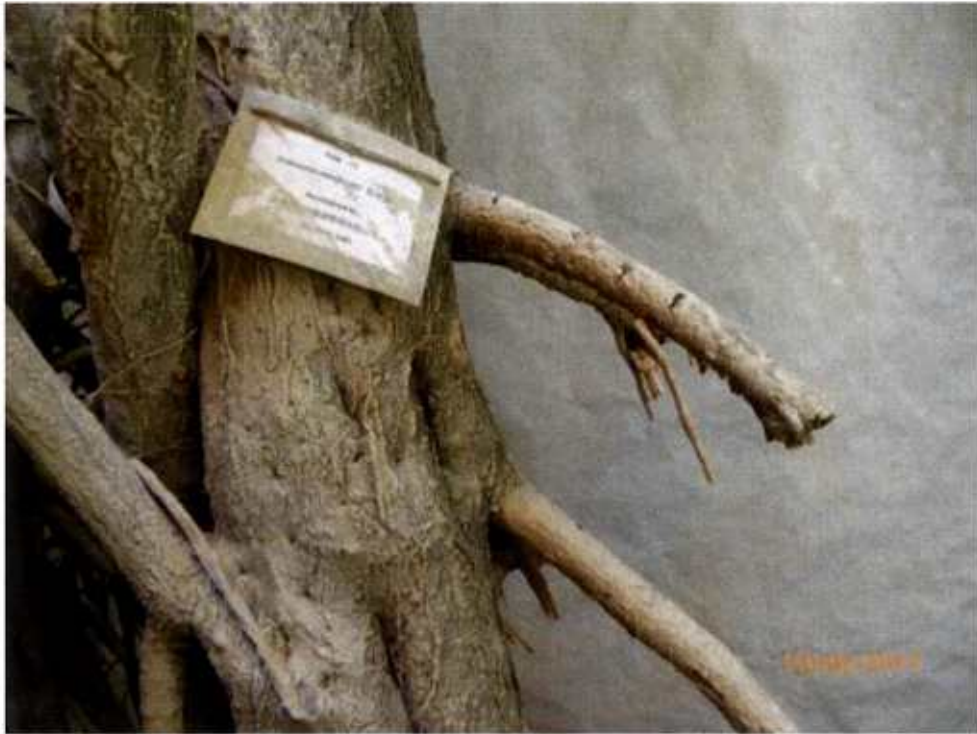
Fig. 6 Health condition of the mid trunk is fair. But the trunk is covered with much construction dust.
