Central Police Station Conservation
and Revitalisation Project:
61st Monthly EM&A Report
(1 November to 30 November 2016)

Issue Date: December 2016

Environmental Resources Management

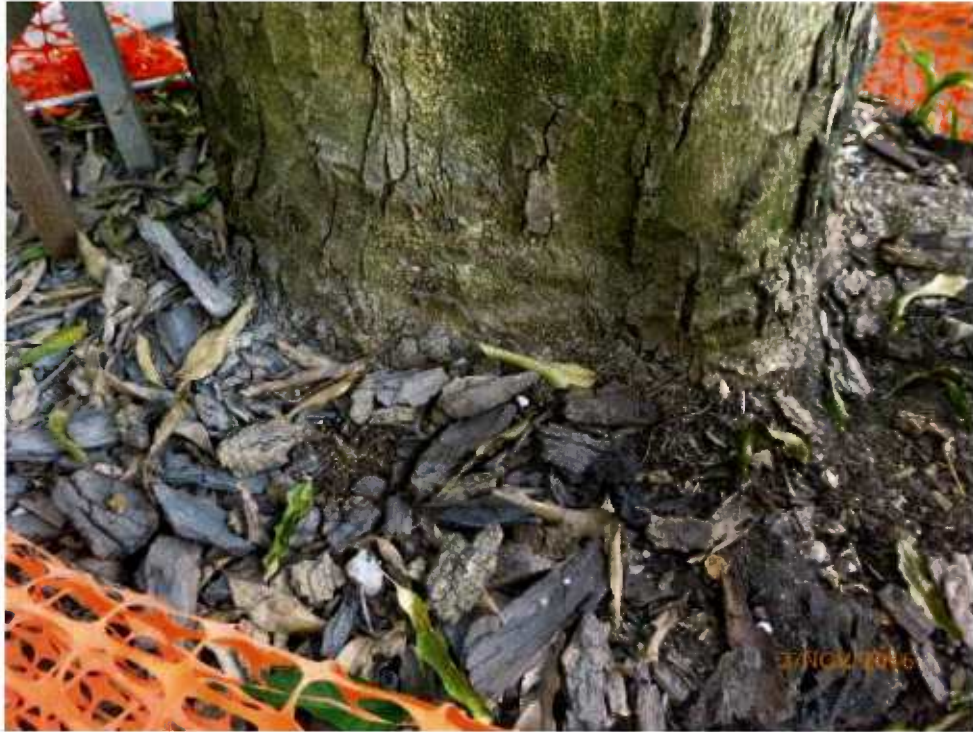
Fig. 3 Health condition of the lower trunk is fair.

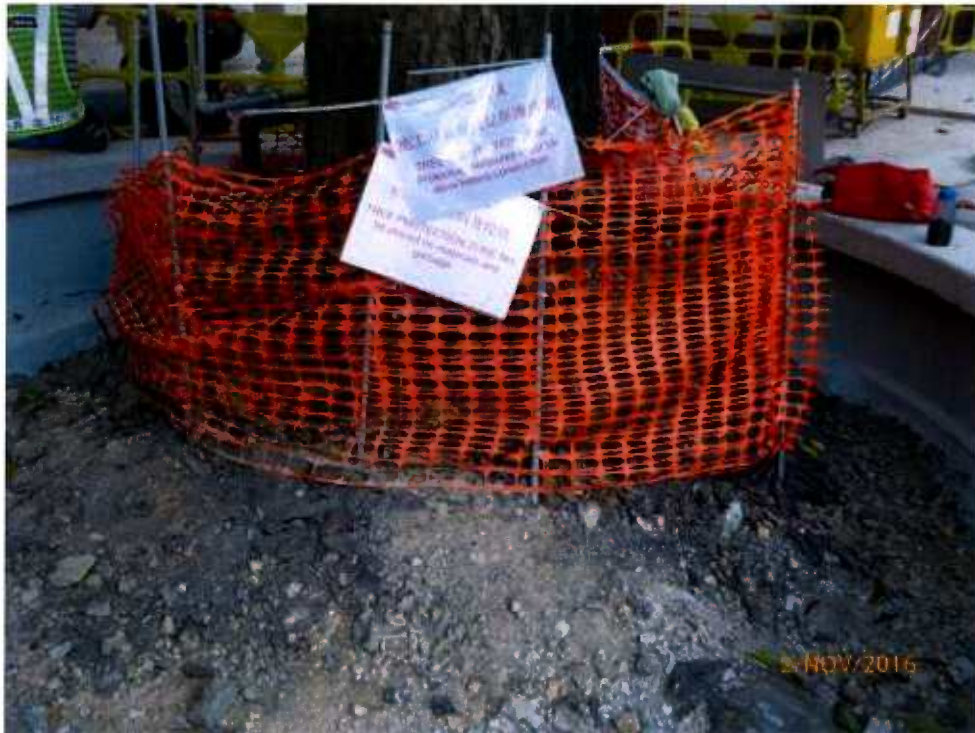
Fig. 10 The newly-built planter still vacated and pending for backfilling of topsoil.

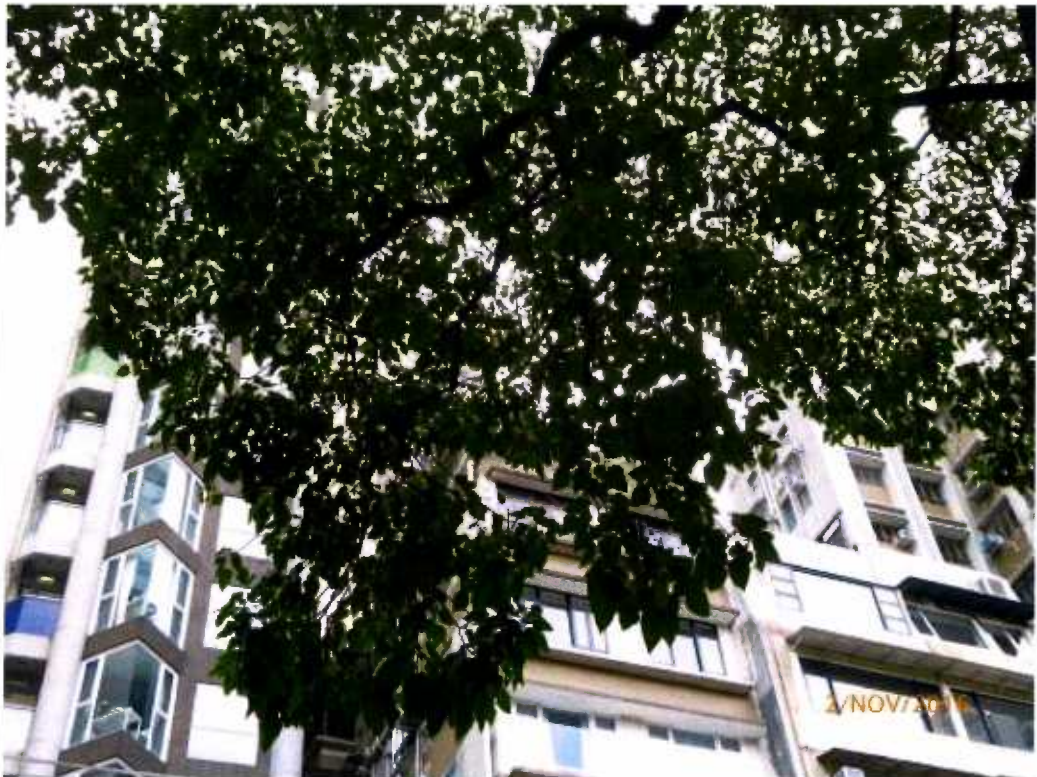
Fig. 8 Signs of Pest (Mealy Bugs 粉狀介殼蟲) are rarely found on the tree due to Pest Control Operation on 25th April 2016.

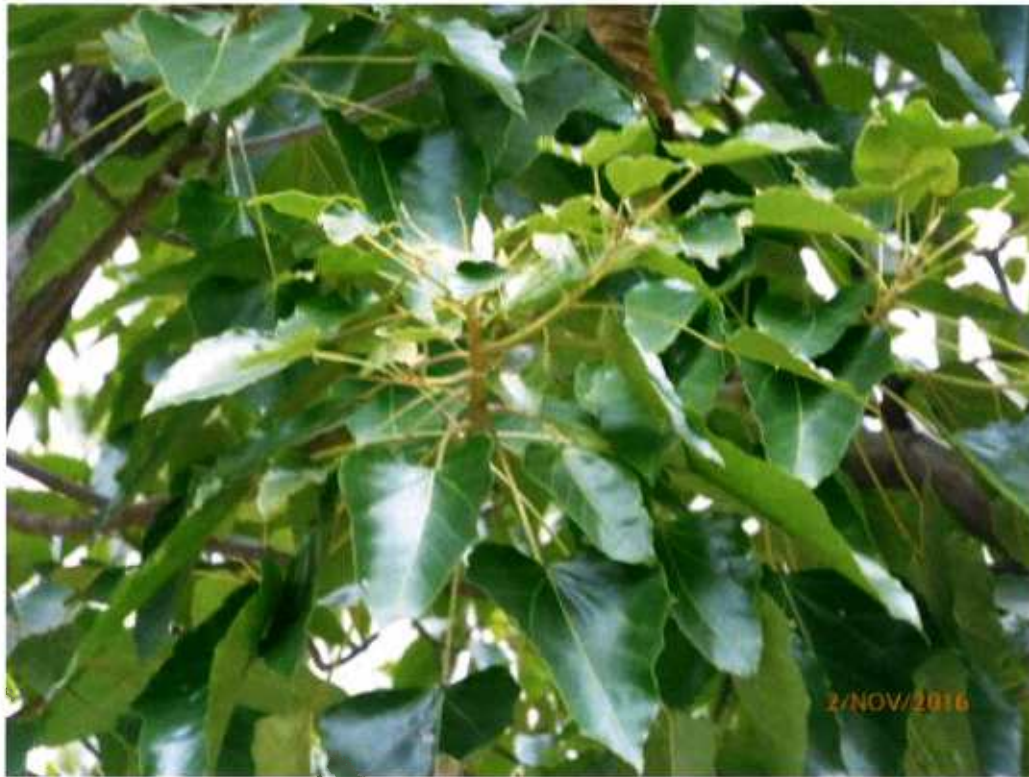
Fig. 9 As dry season has come, some leaves on the tree become faded.

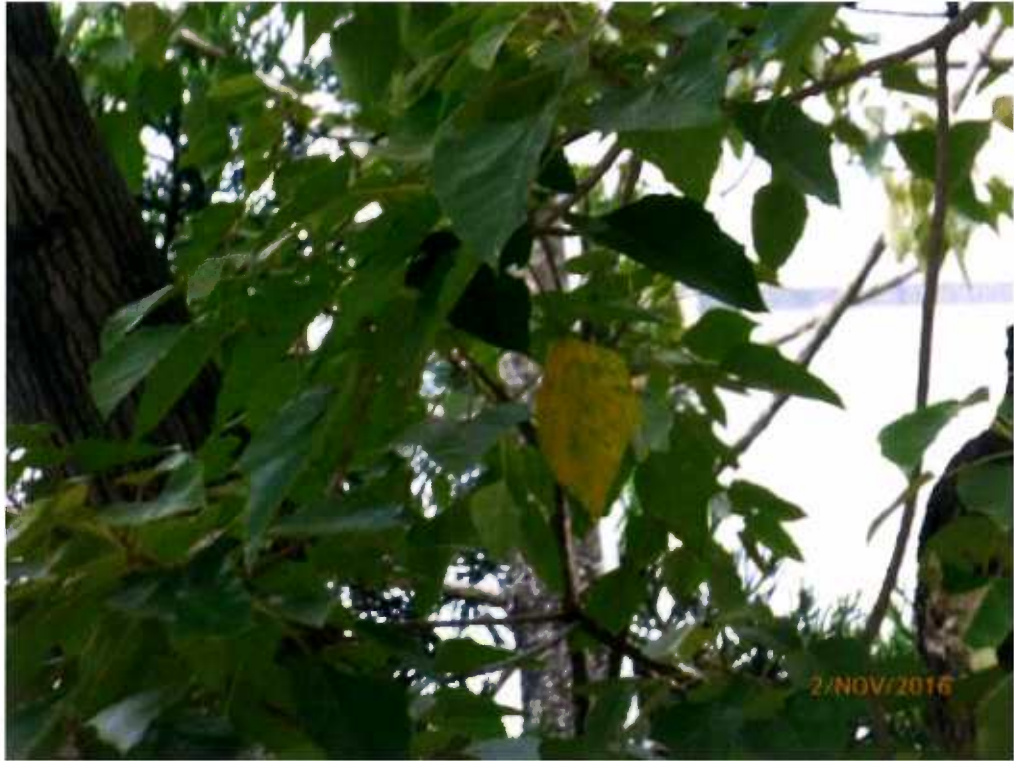
Fig. 8 As dry season has come, some leaves on the tree become faded.

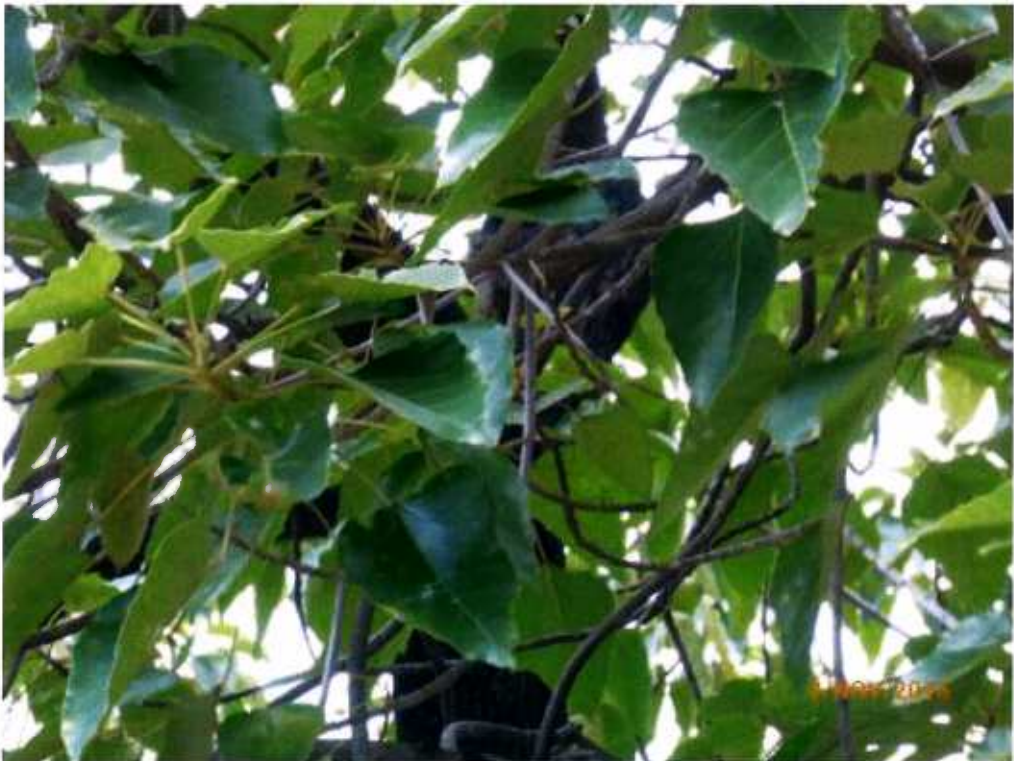
Fig. 9 Signs of Pest (Mealy Bugs 粉狀介殼蟲) are rarely found on Tree-7 due to Pest Control Operation on 25th April 2016.

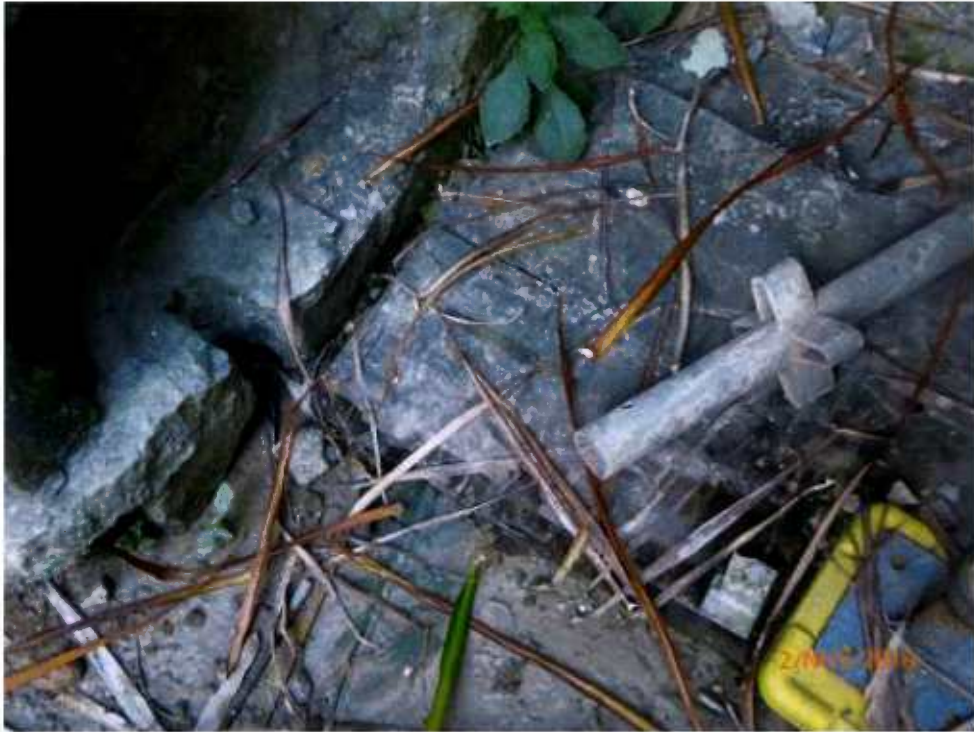
Tree-11	<i>Dracaena marginata</i>	Fair	<ul style="list-style-type: none"> Some withered leaves were observed on the tree and at the planter; Renovation works were observed being carried out near the tree; To provide further protection measures (e.g. erect temporary shelter) to the tree during the nearby renovation works.

Fig. 9 We worry that the nearby renovation works have affected the health of Tree-11.

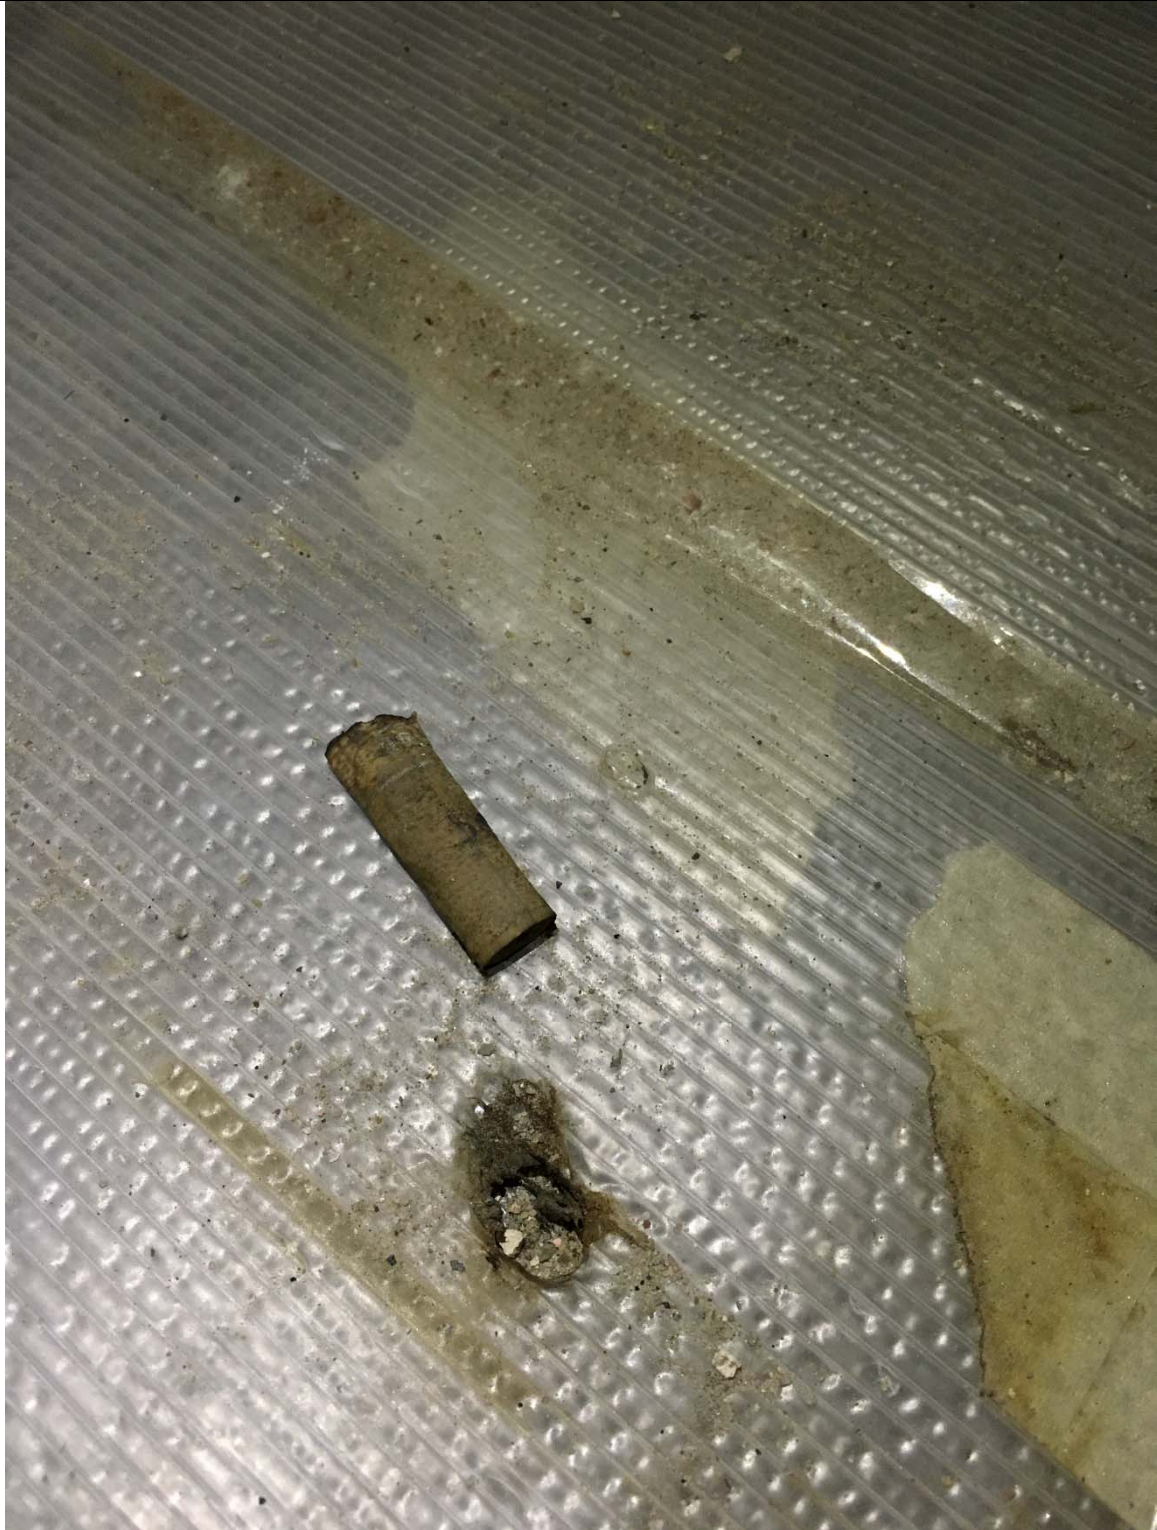
Above, photograph taken on 4th November 2016, showing the damage by cigarette to the protection and the timber floorboards in room 03/F/22.

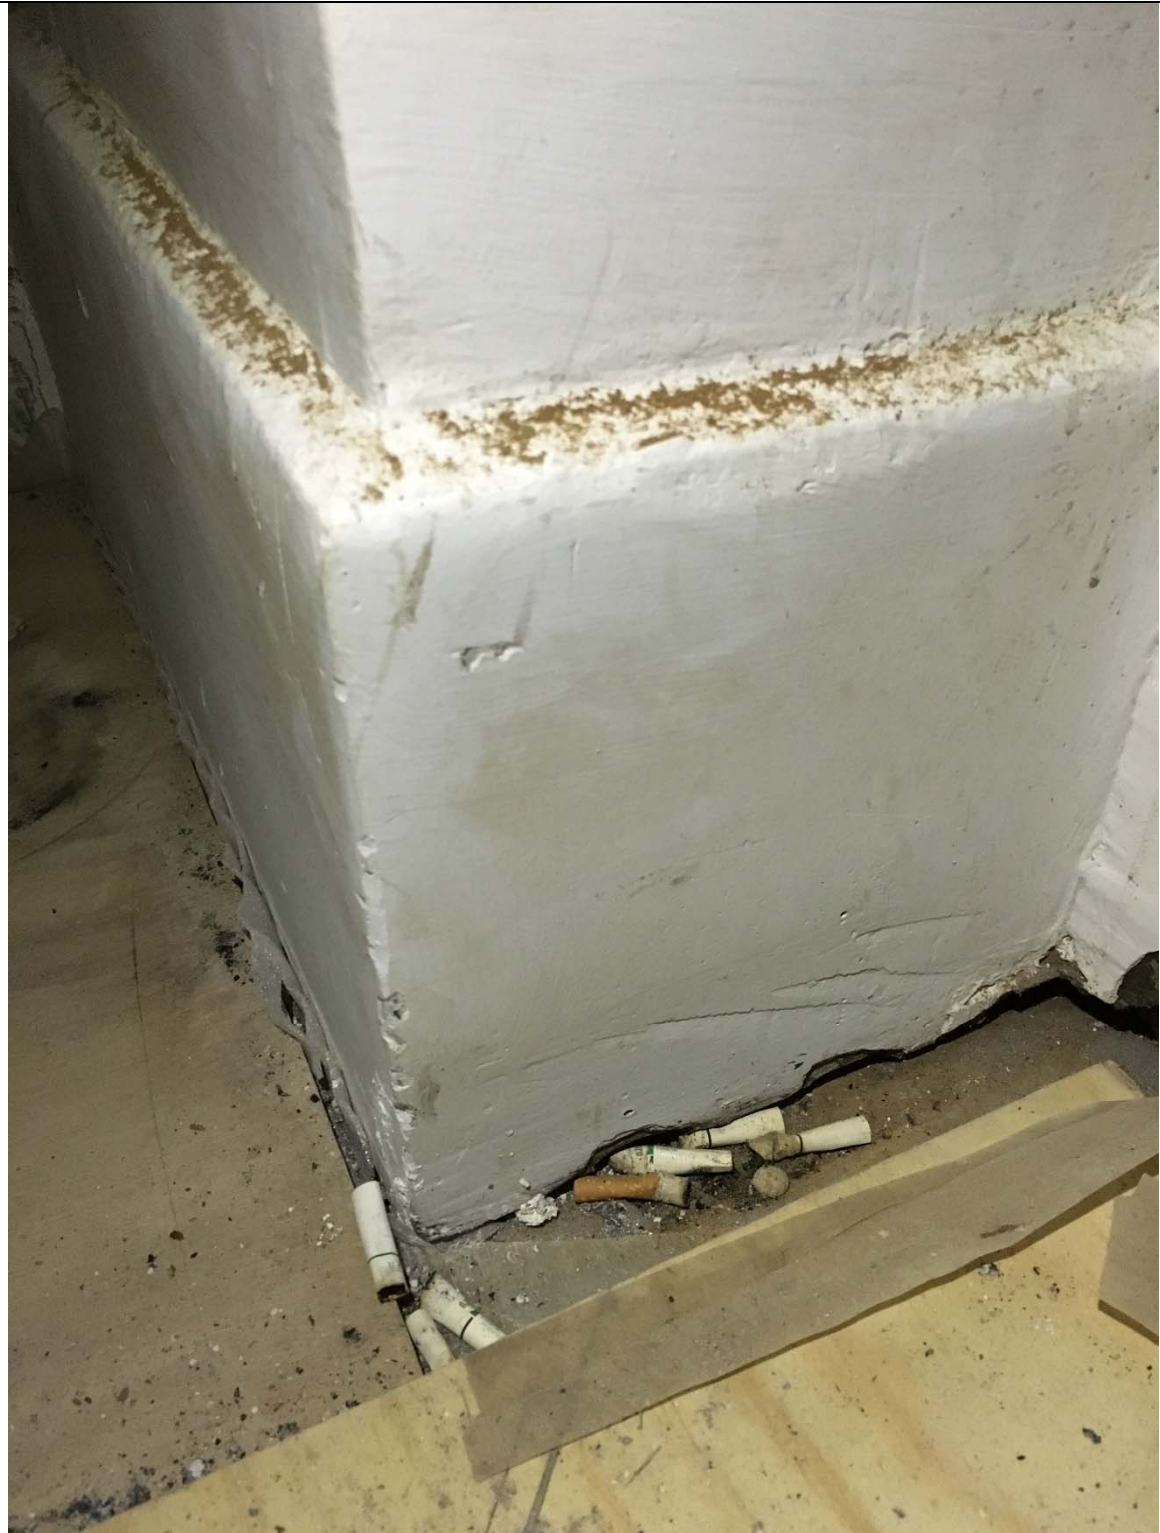
Above, photograph taken on 4th November 2016, showing the plenty of cigarette butts found in room 03/F/22.

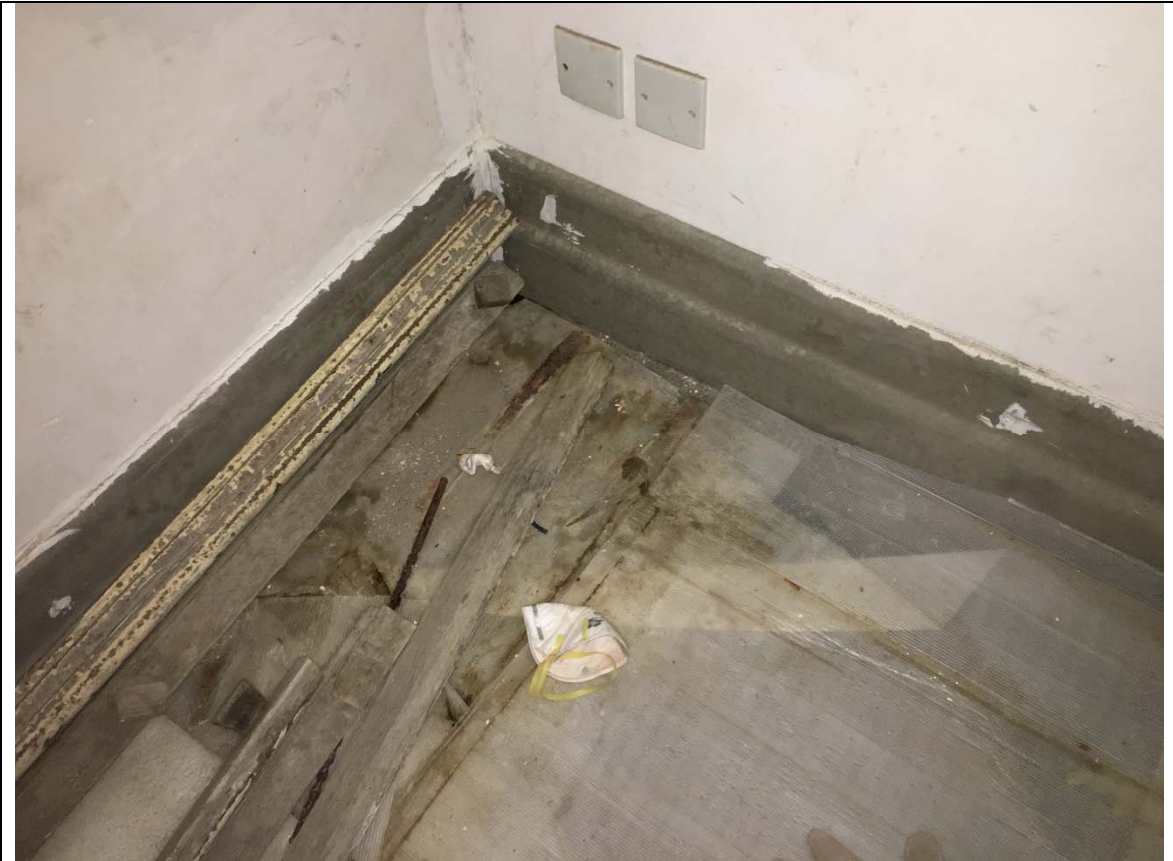
Above, photograph taken on 4th November 2016, showing sign of urinating in room 03/F/01.
