Central Police Station Conservation
and Revitalisation Project:
72nd Monthly EM&A Report
(1 October to 31 October 2017)

Issue Date: November 2017

Environmental Resources Management

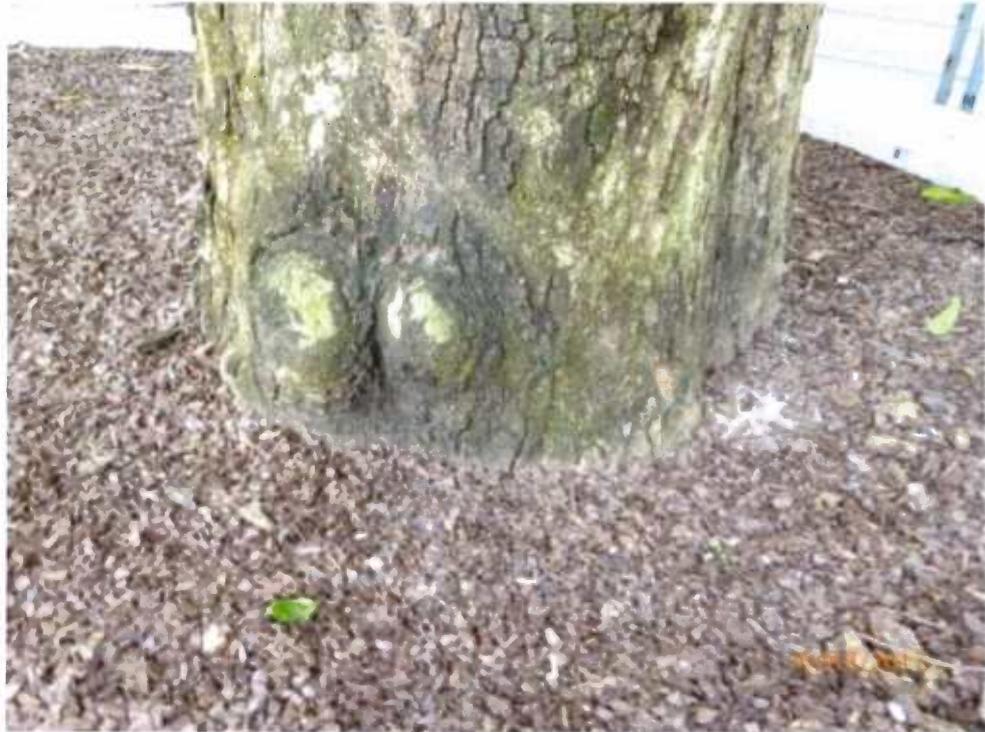
Fig 2. The root collar is normal. The planter is covered with small pieces of pine bark.

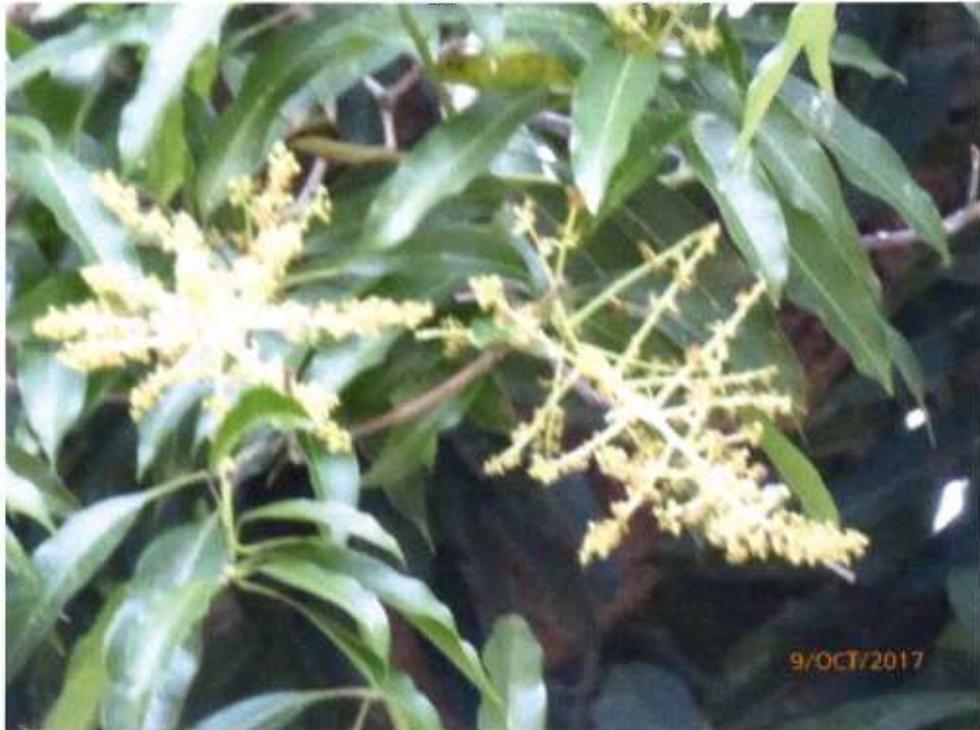
Fig. 9 Signs of Pest (Mealy Bugs 粉狀介殼蟲) are rarely found on the tree due to Pest Control Operation on 26th September 2017.

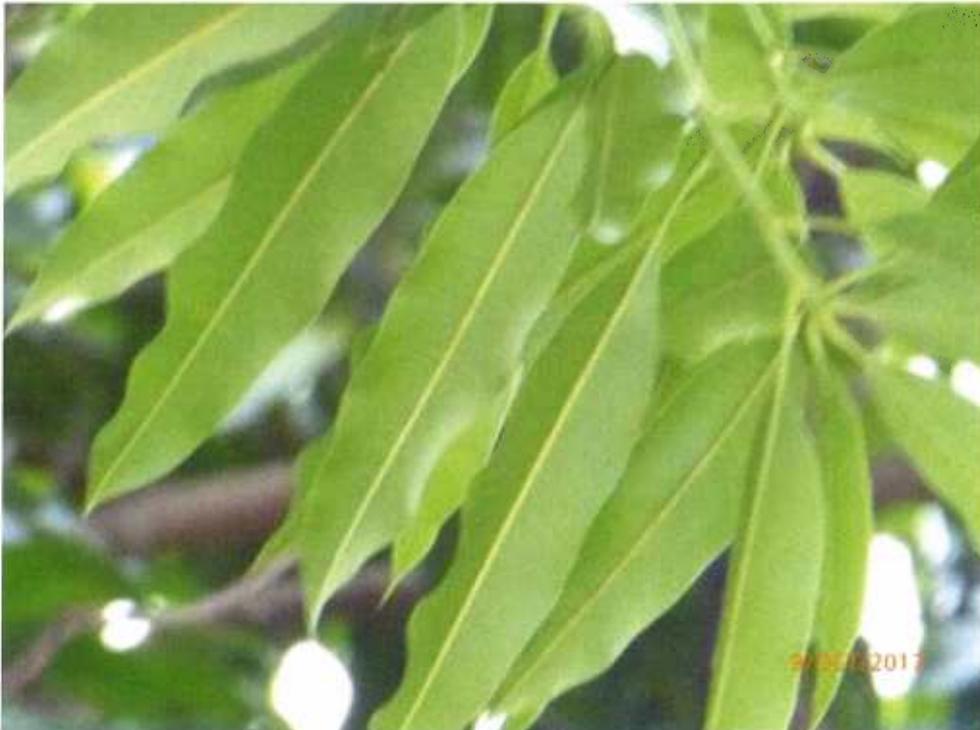
Fig. 10 The overgrown branches have been pruned on 26th Sept. 2017.

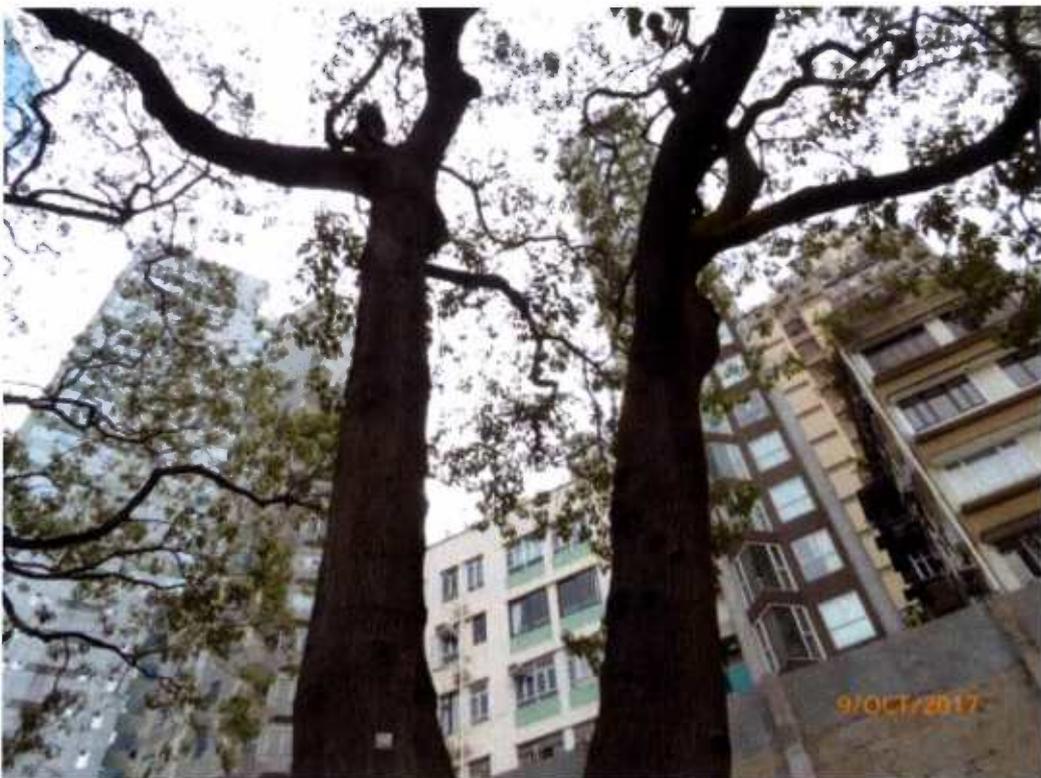
Fig. 6 Leaves on the crown are rather sparse.

1. Keep close monitoring on the growth of the tree.

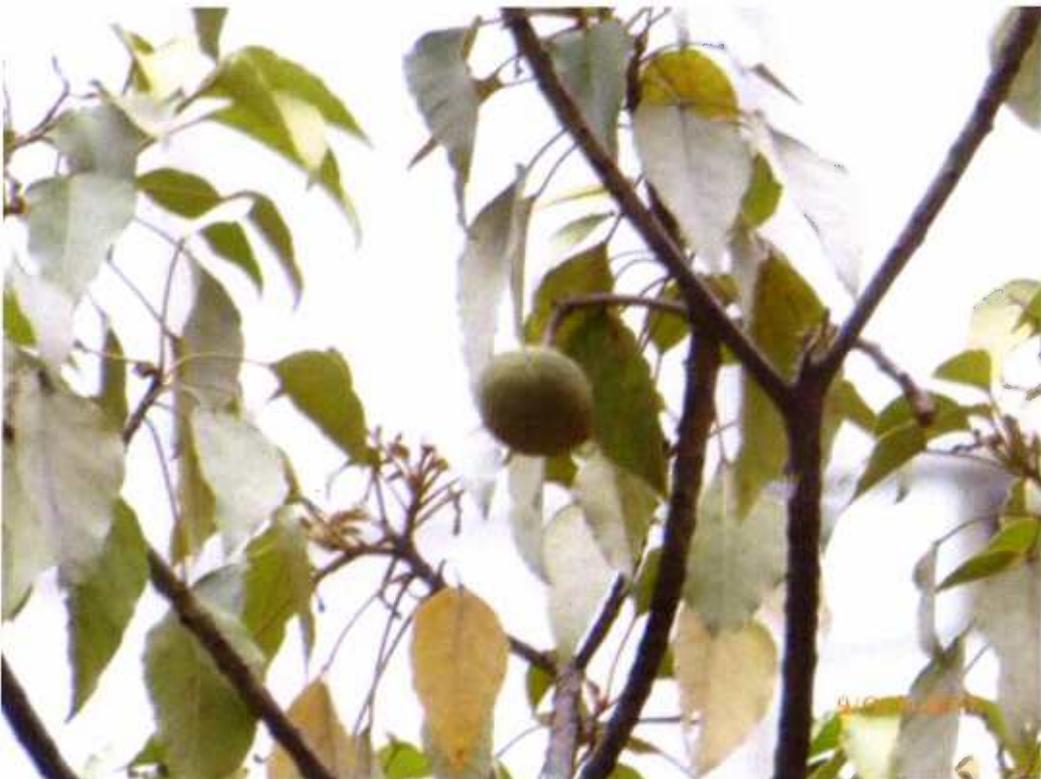
Fig. 10 Signs of Pest “白粉蝨 (*Trialeurodes vaporariorum*)” are rarely found on the leaves due to Pest Control Operation on 3rd & 4th Aug. 2017.

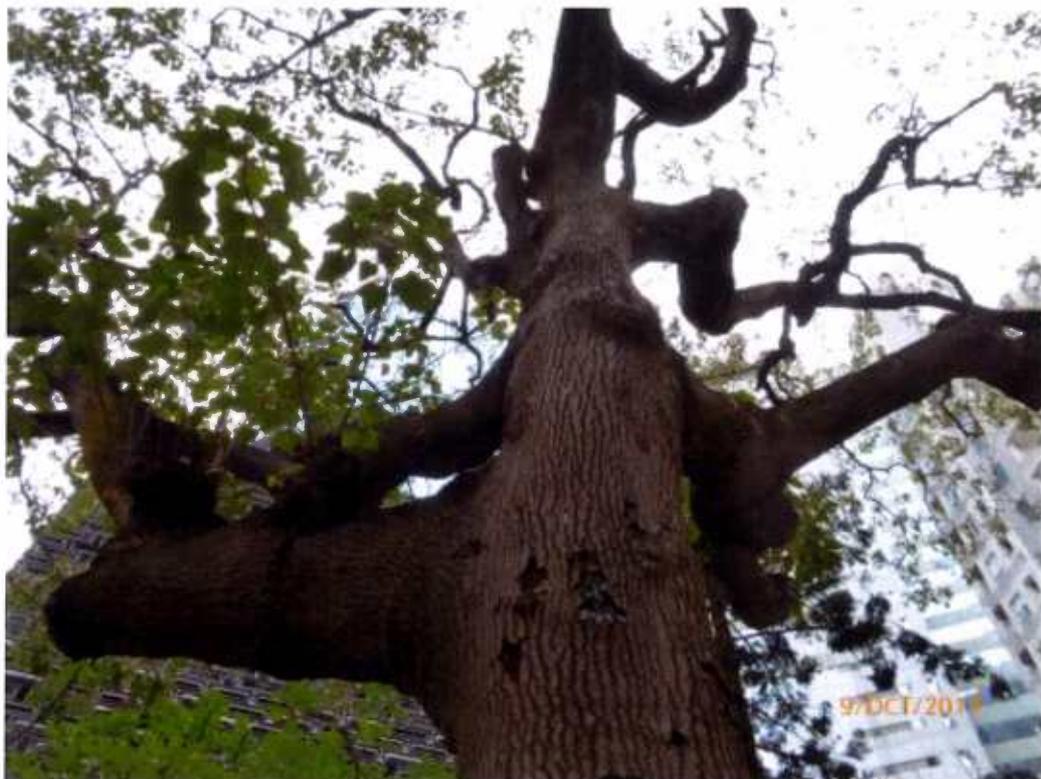
Fig. 6 Leaves on the crown are rather sparse.

1. Keep close monitoring on the growth of the tree.

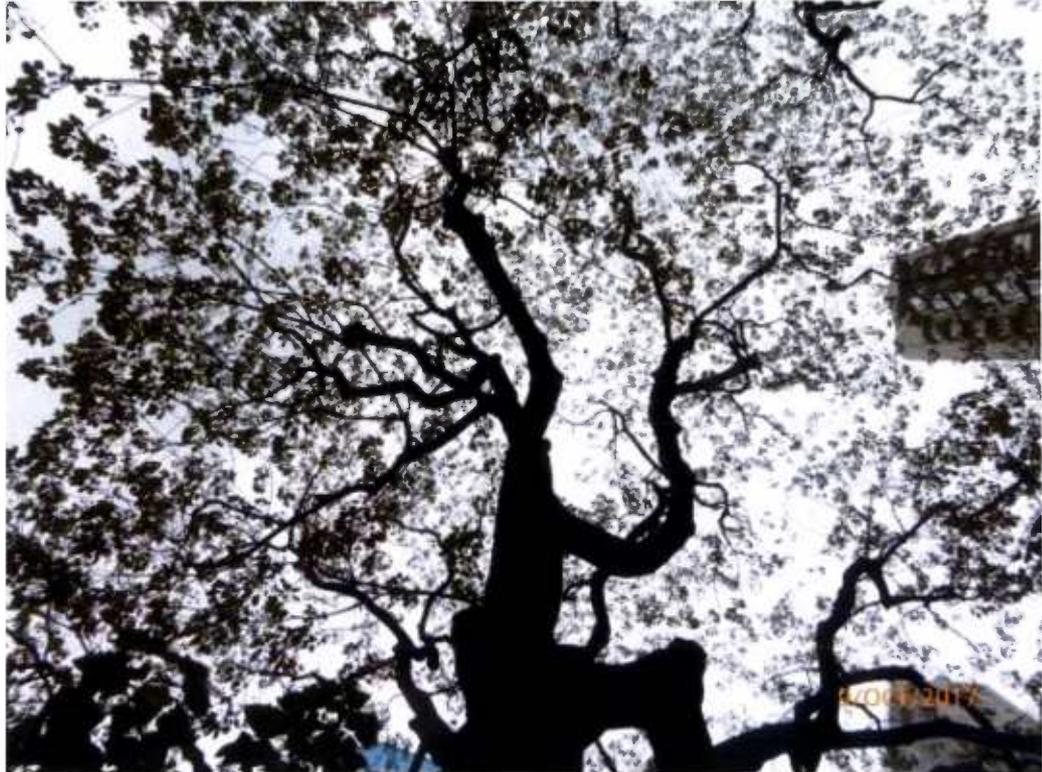
Fig. 7 Signs of Pest “白粉蝨 (*Trialeurodes vaporariorum*)” have apparently reduced due to Pest Control Operation on 3rd & 4th Aug. 2017.

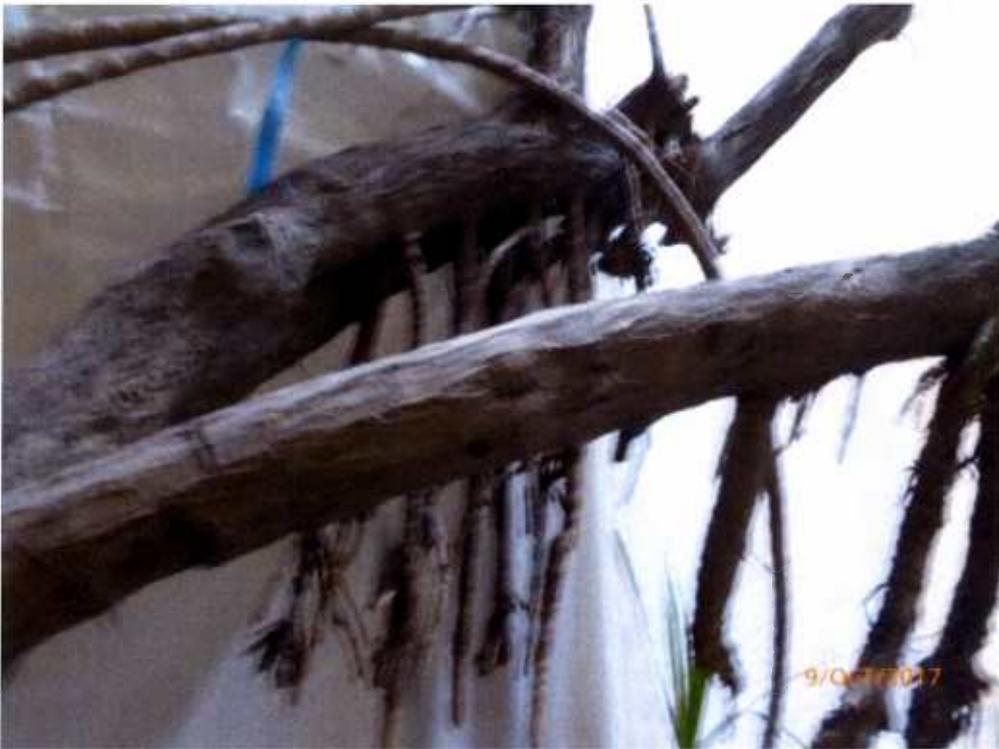
Fig. 6 A few withered leaves still remain on the tree.

1. Keep close monitoring on the growth of Tree-11 especially during the nearby renovation works are in progress.
