Central Police Station Conservation
and Revitalisation Project:
78th Monthly EM&A Report
(1 April to 30 April 2018)

Issue Date: May 2018

Environmental Resources Management

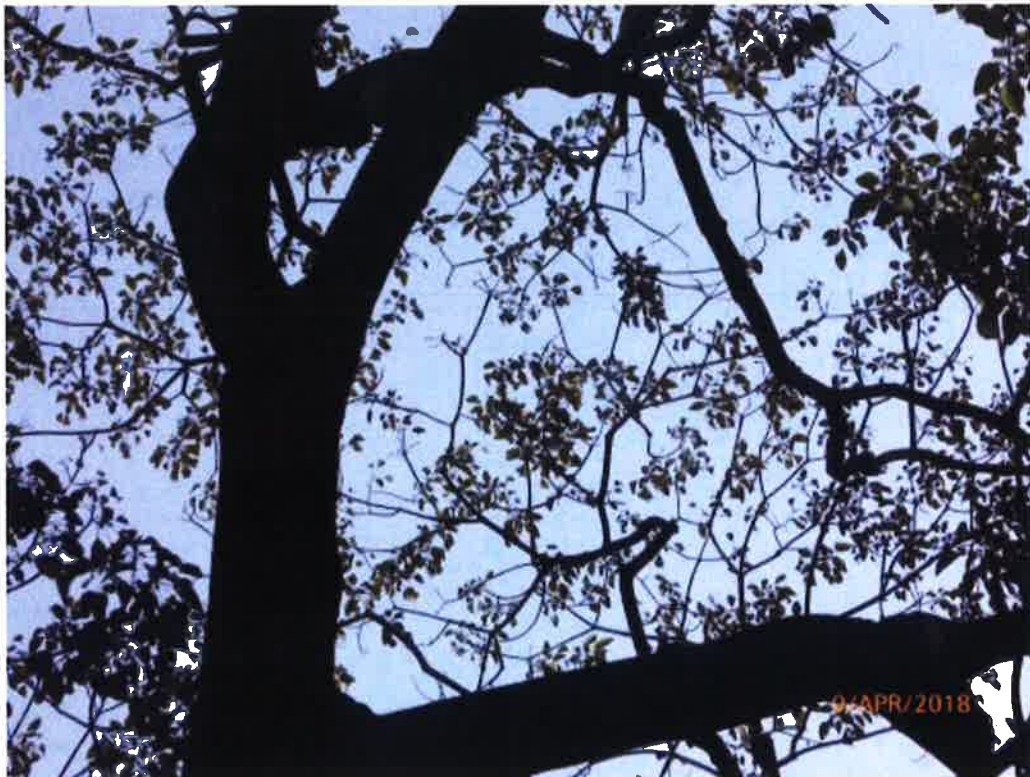
Fig. 7 Leaves on the crown are rather sparse.

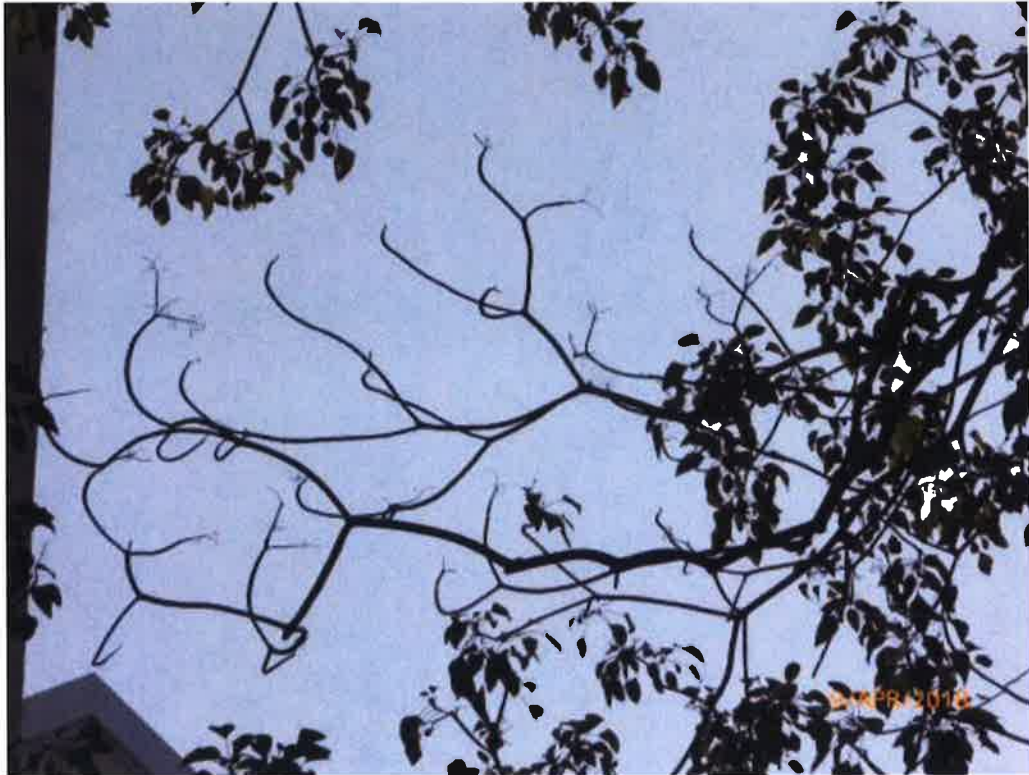
Fig. 10 A few dead twigs remain on the upper branches.

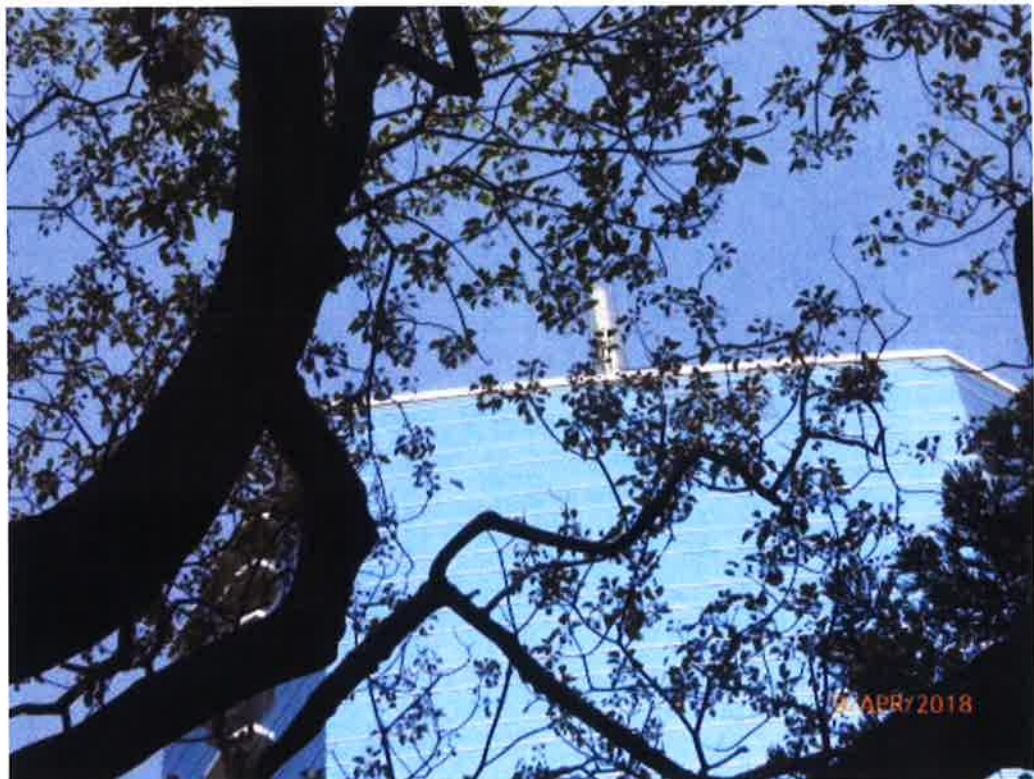
Fig. 7 Leaves on the crown are rather sparse.

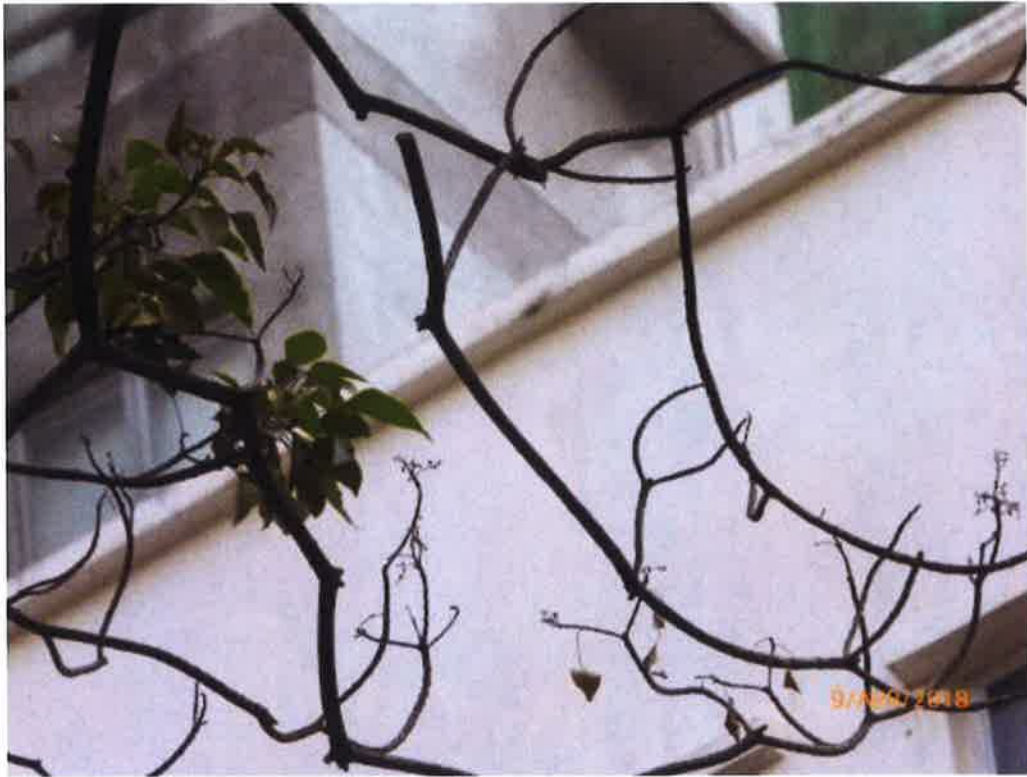
Fig. 10 A few dead twigs remain on the upper branches.

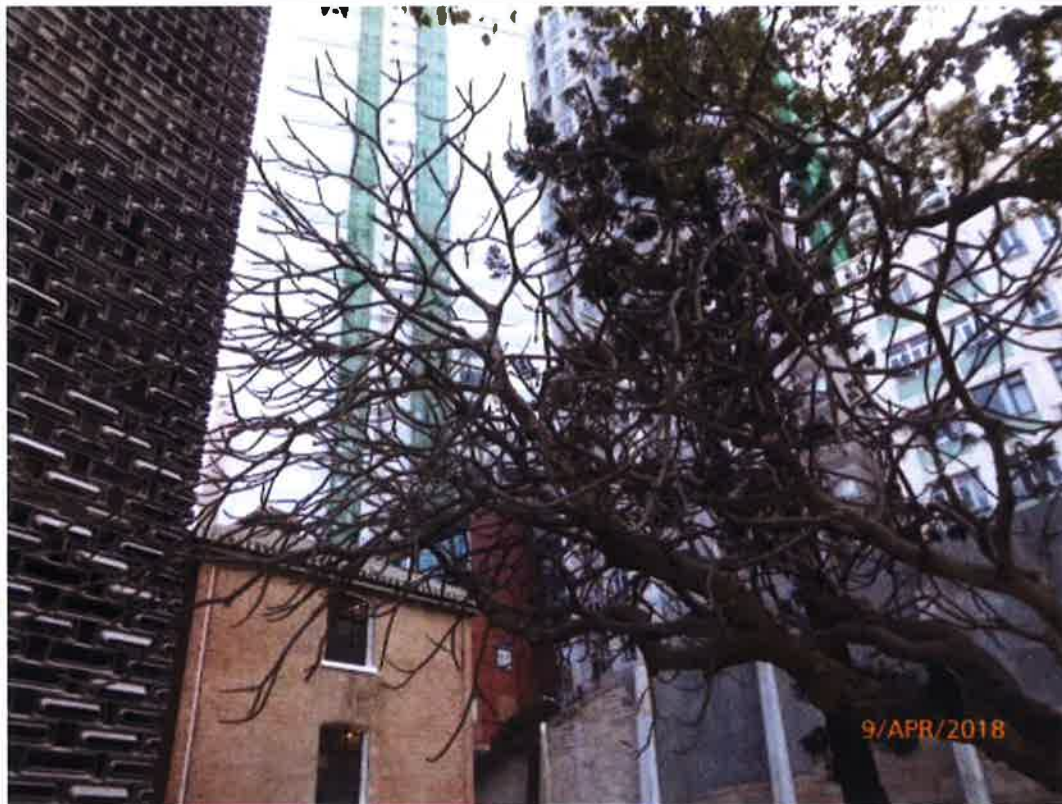
Fig. 7 As dry season has come, leaves on the crown are sparse.

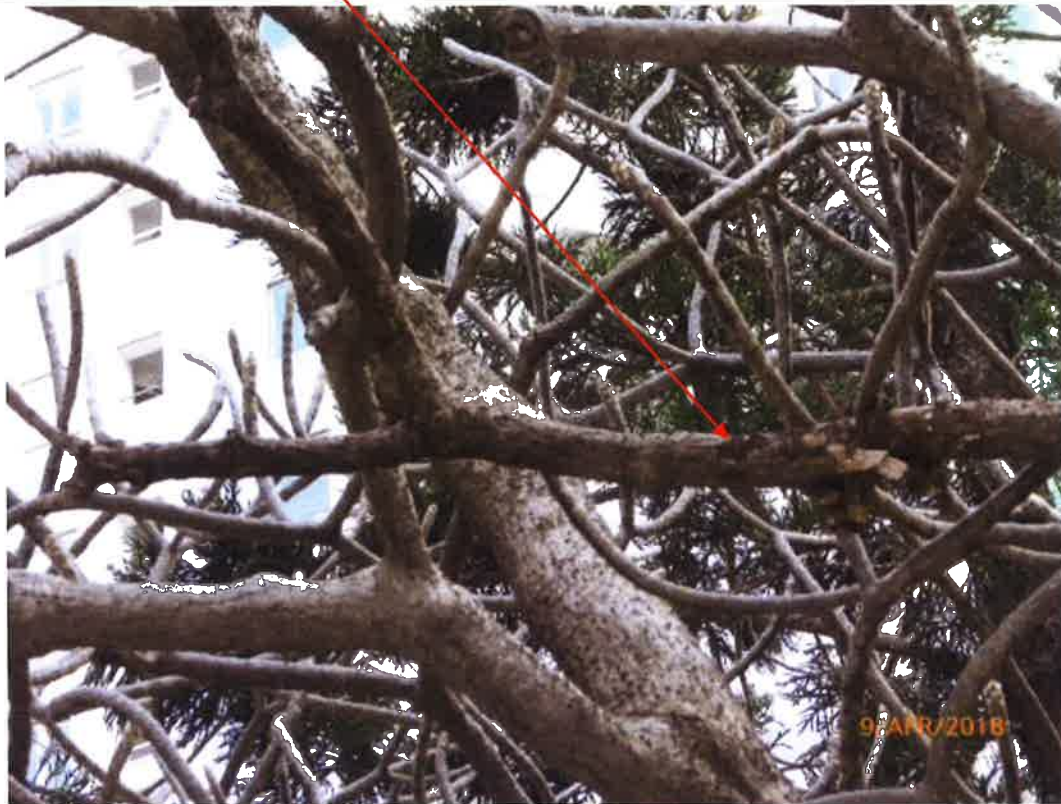
Fig. 10 A few dead branches remain on the tree.

1. Remove the dead branches away from the tree.

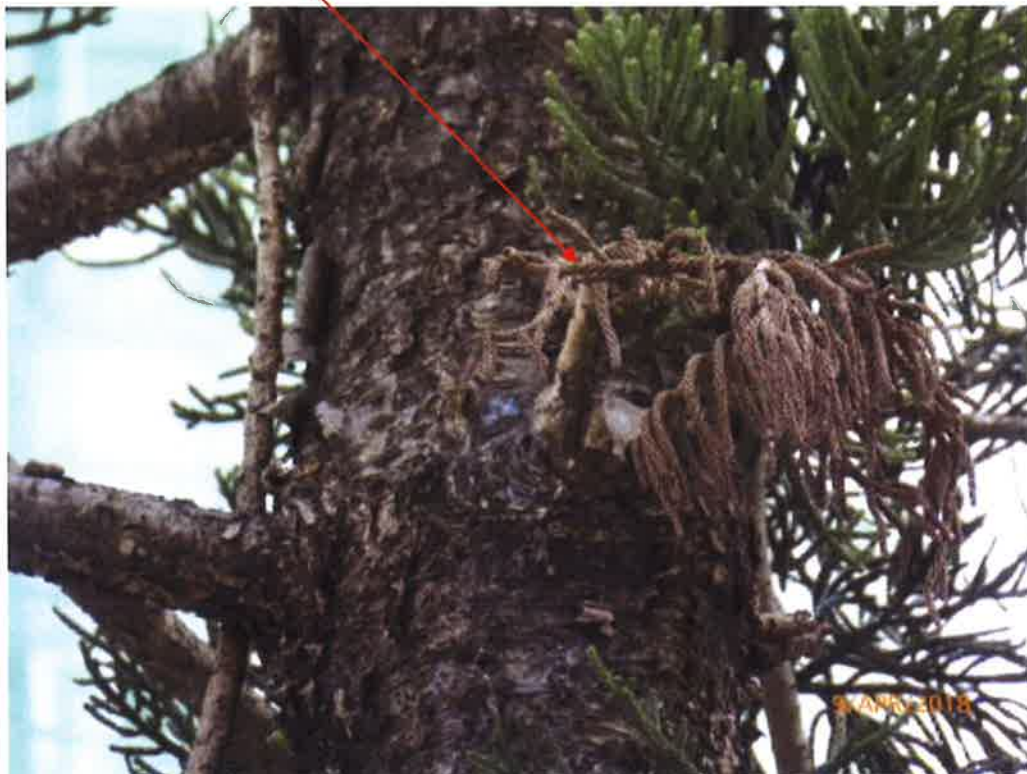
Fig. 10 A few dead twigs remain on the upper branches.

1. Remove the dead twigs away from the tree.

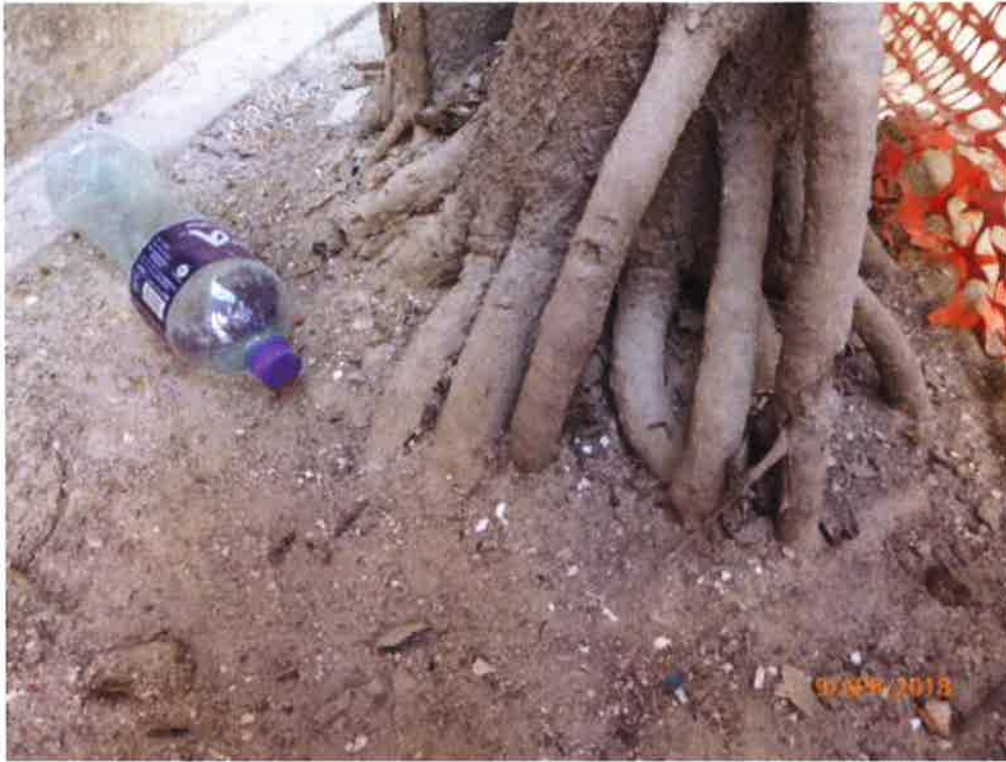
Fig. 2 Root collar is normal. A few litter remains at the planter.

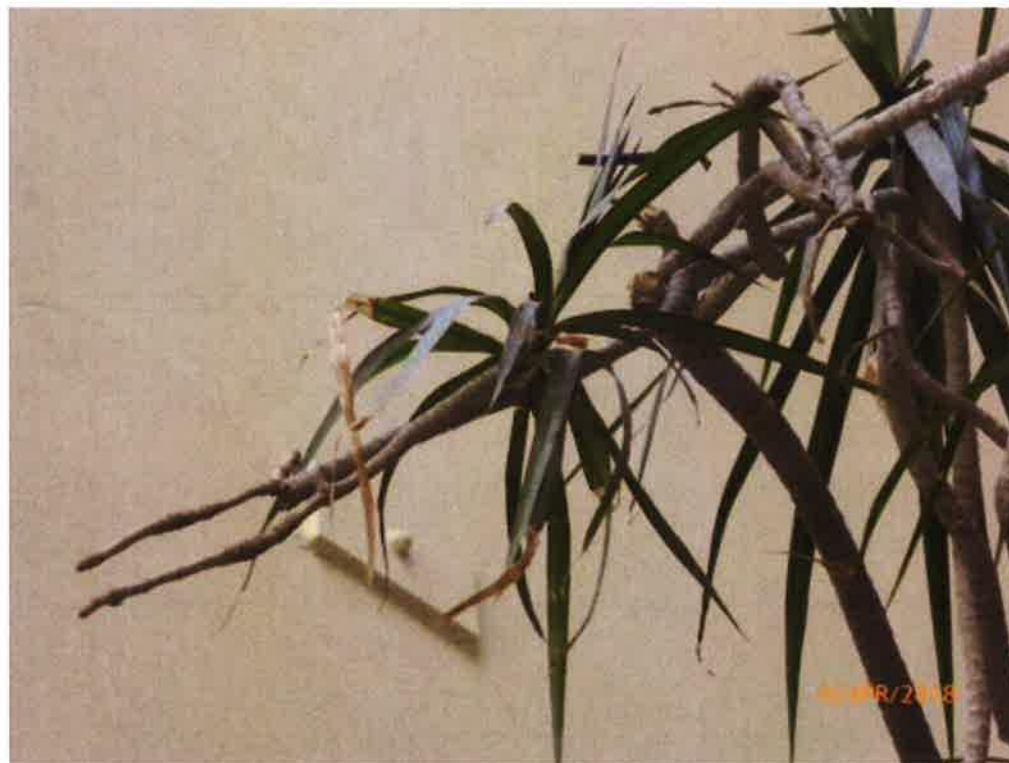
Fig. 7 Some withered leaves also appear on the lower branches.

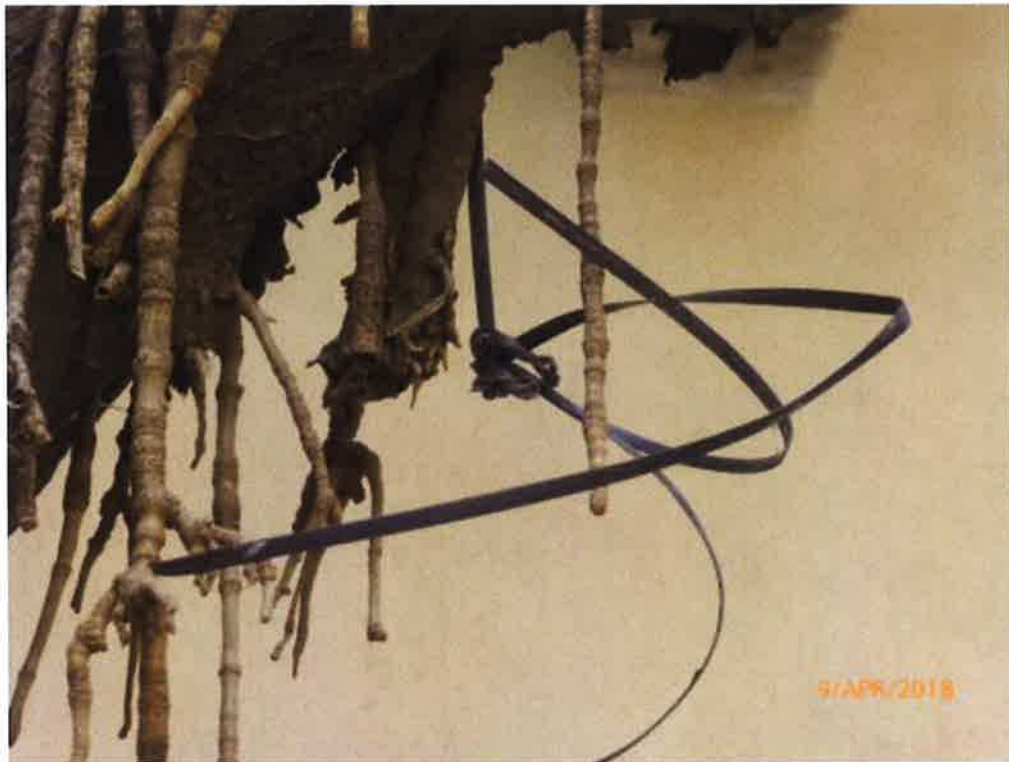
Fig. 8 A few construction debris remains on the tree.

Tree-11	<i>Dracaena marginata</i>	Fair	<ul style="list-style-type: none"> Some construction debris was observed on the tree; the Contractor was reminded to remove it.

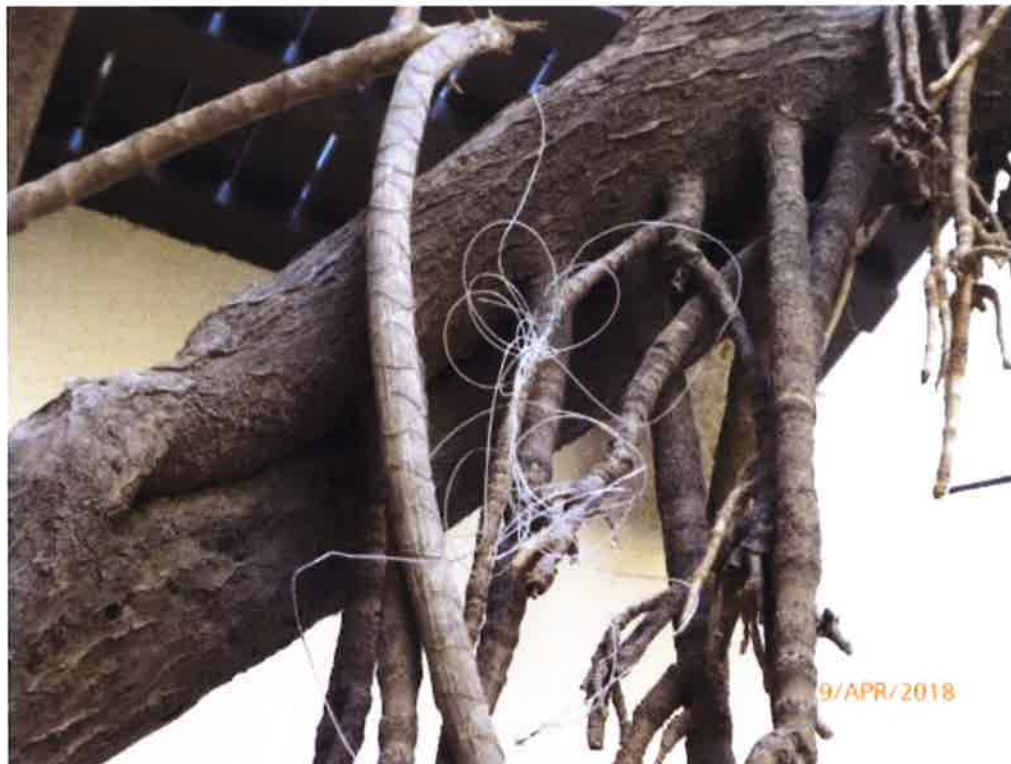
Fig. 9 Some construction debris also remain on the upper trunk.
