Central Police Station Conservation
and Revitalisation Project:
74th Monthly EM&A Report
(1 December to 31 December 2017)

Issue Date: January 2018

Environmental Resources Management

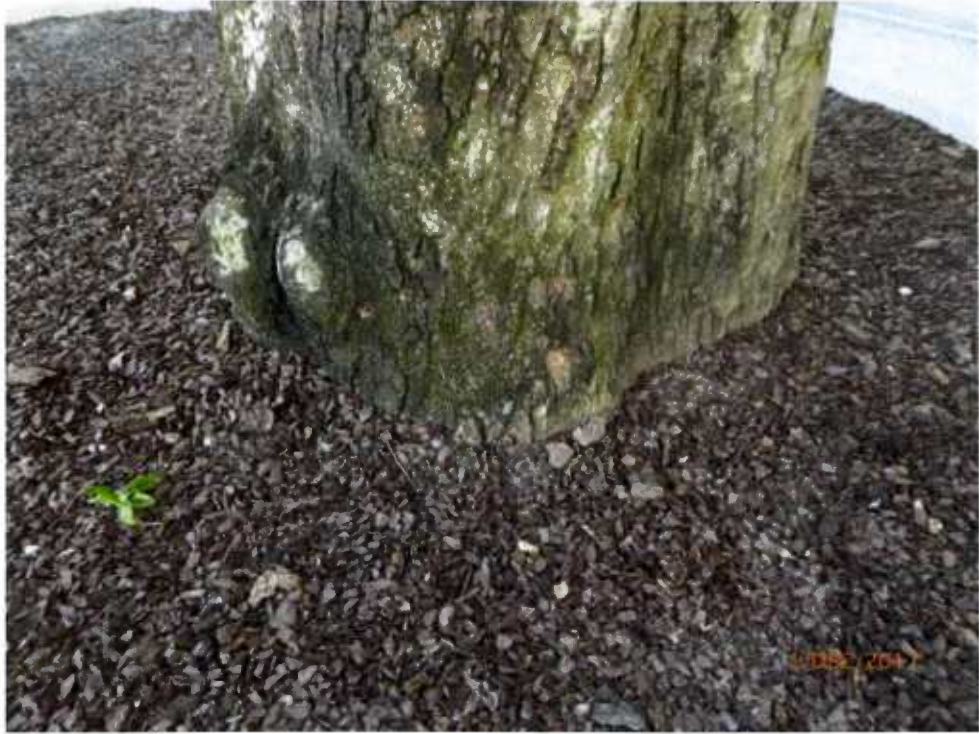
Fig 2. The root collar is normal. The planter is covered with small pieces of pine bark.

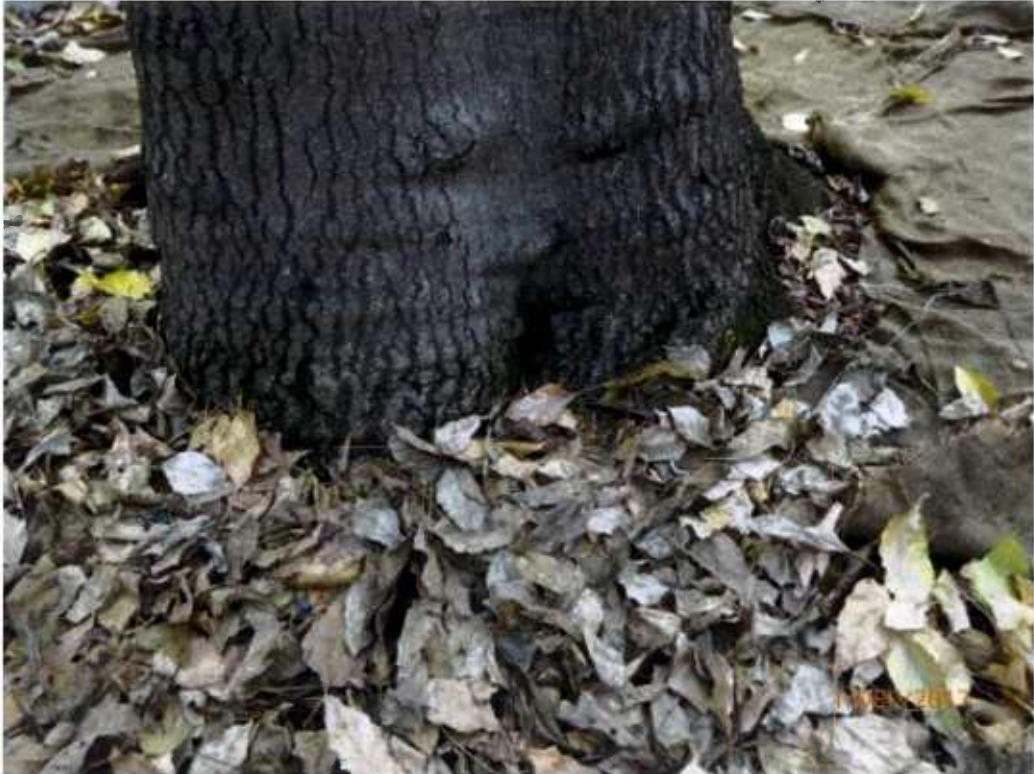
Fig 2. Root collar is normal. The planter is covered with mulch and dry leaves.

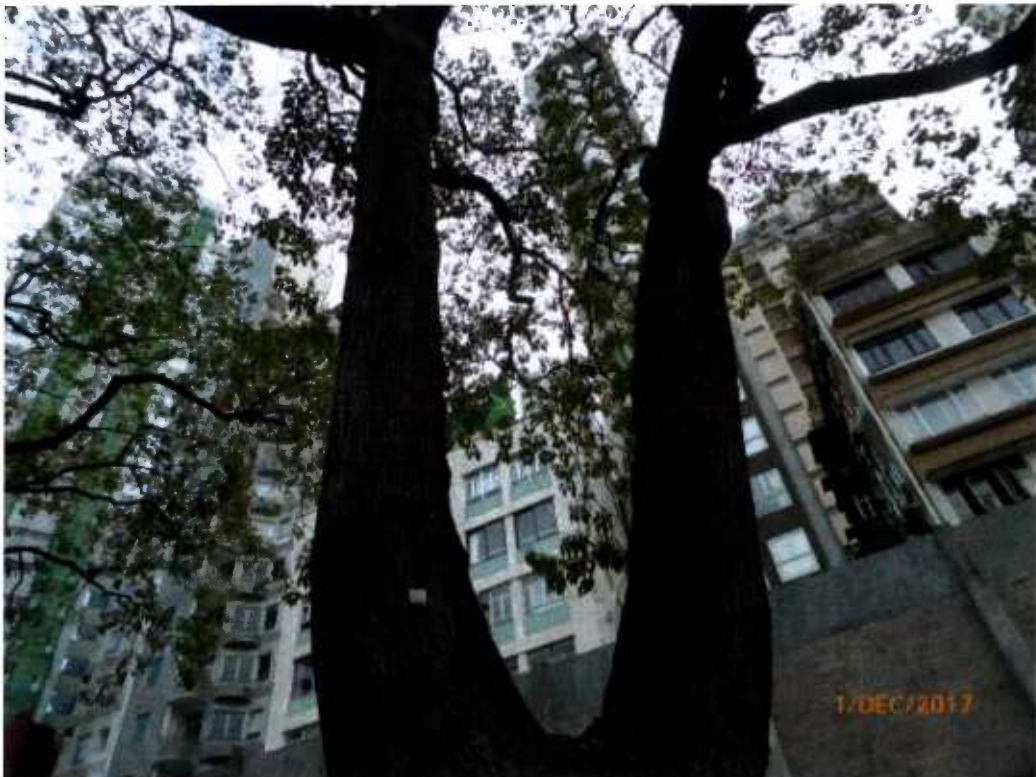
Fig. 6 Leaves on the crown are rather sparse.

1. **Keep close monitoring on the growth of the tree.**

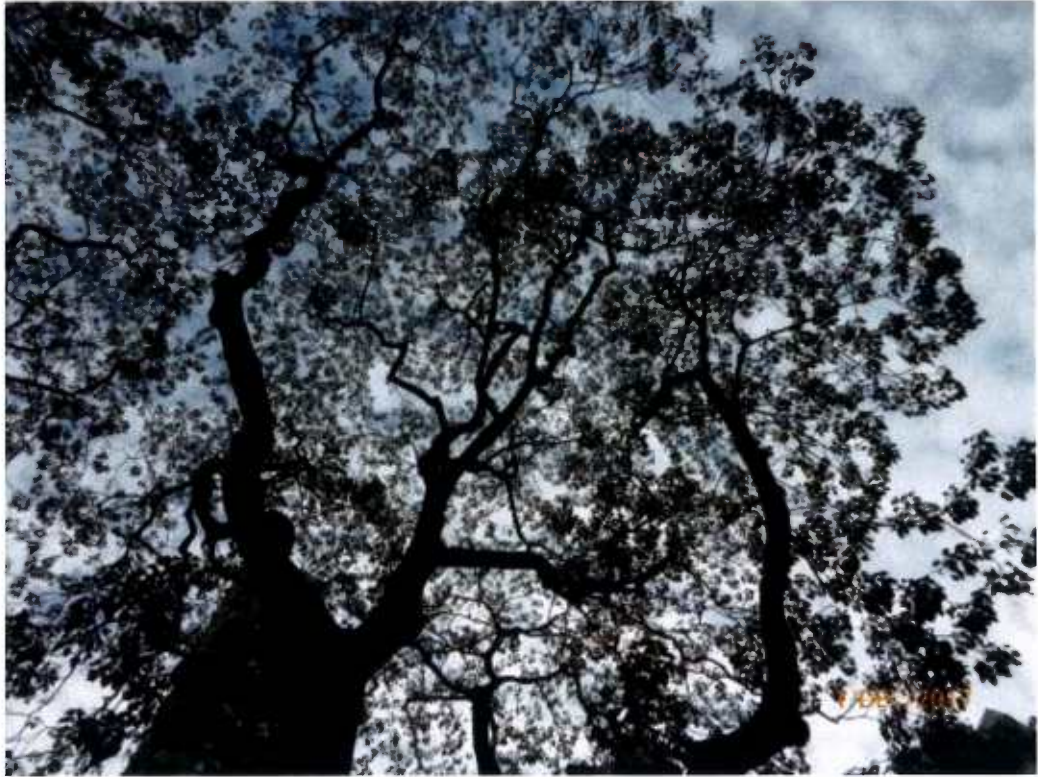
Fig. 7 Leaves on the lower branches are normal.

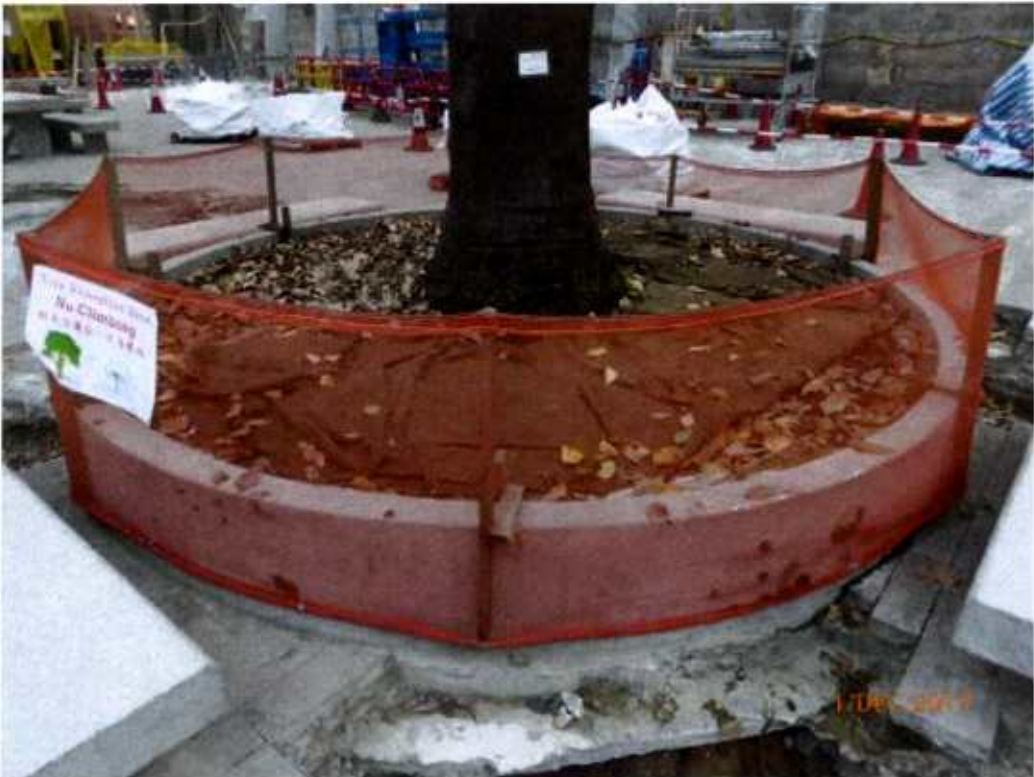
Fig. 10 The bare roots at the pits have been wrapped with hessian clothes.

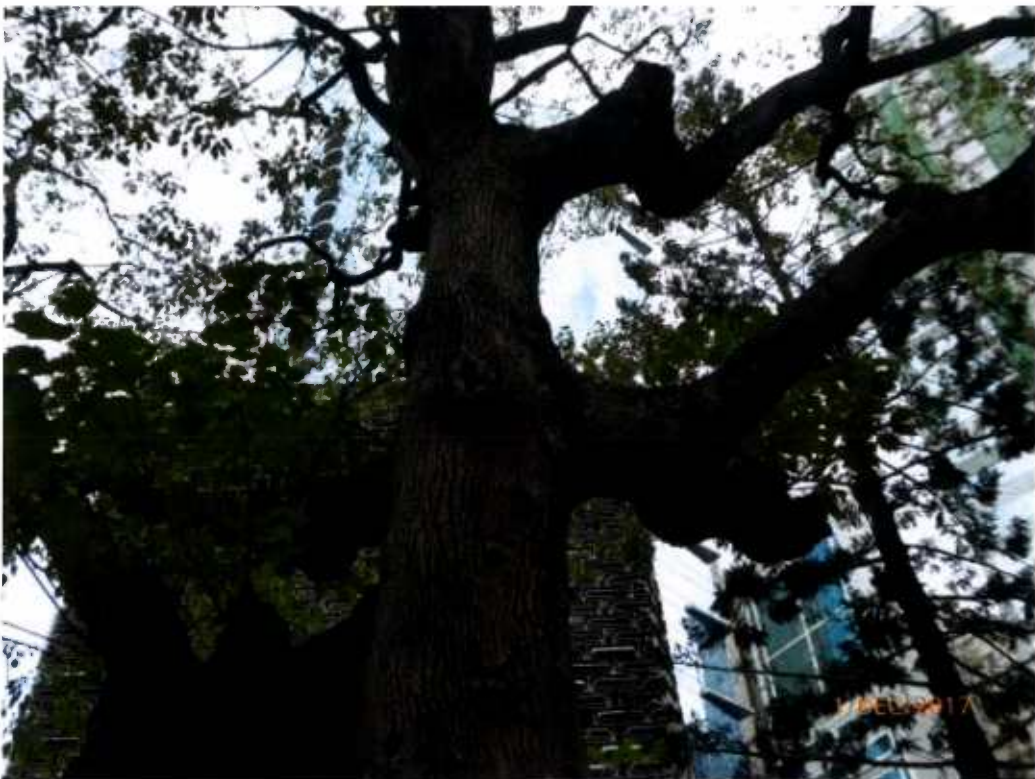
Fig. 6 Leaves on the crown are rather sparse.

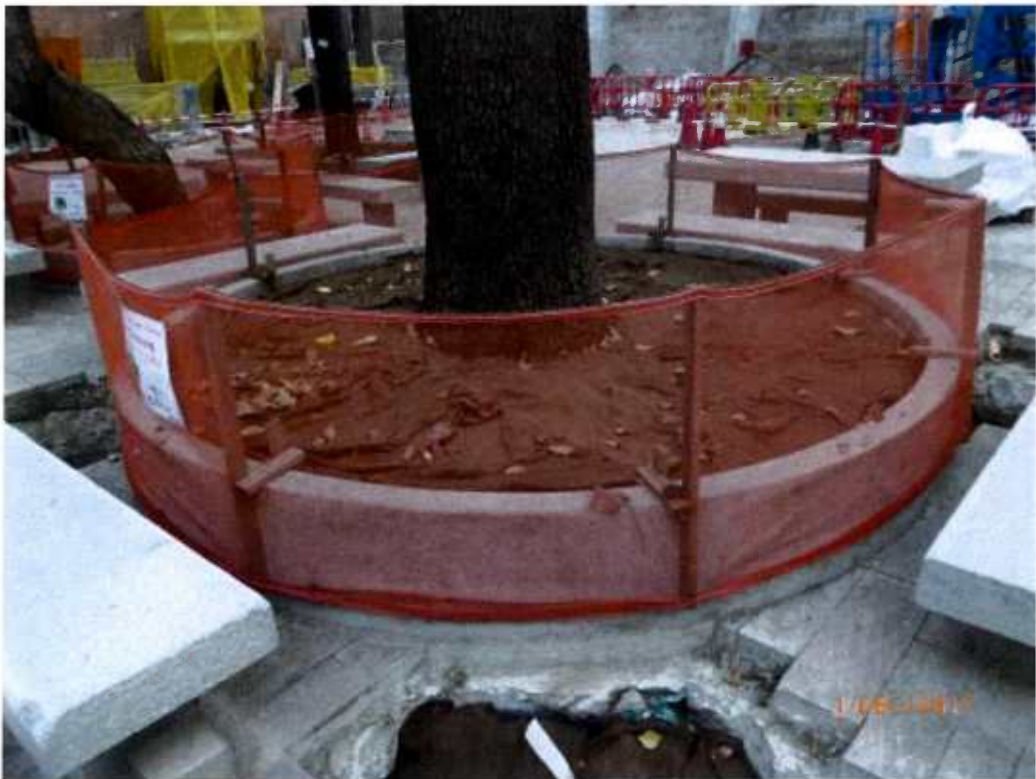
Fig. 10 The bare roots at the pits have been wrapped with hessian clothes.

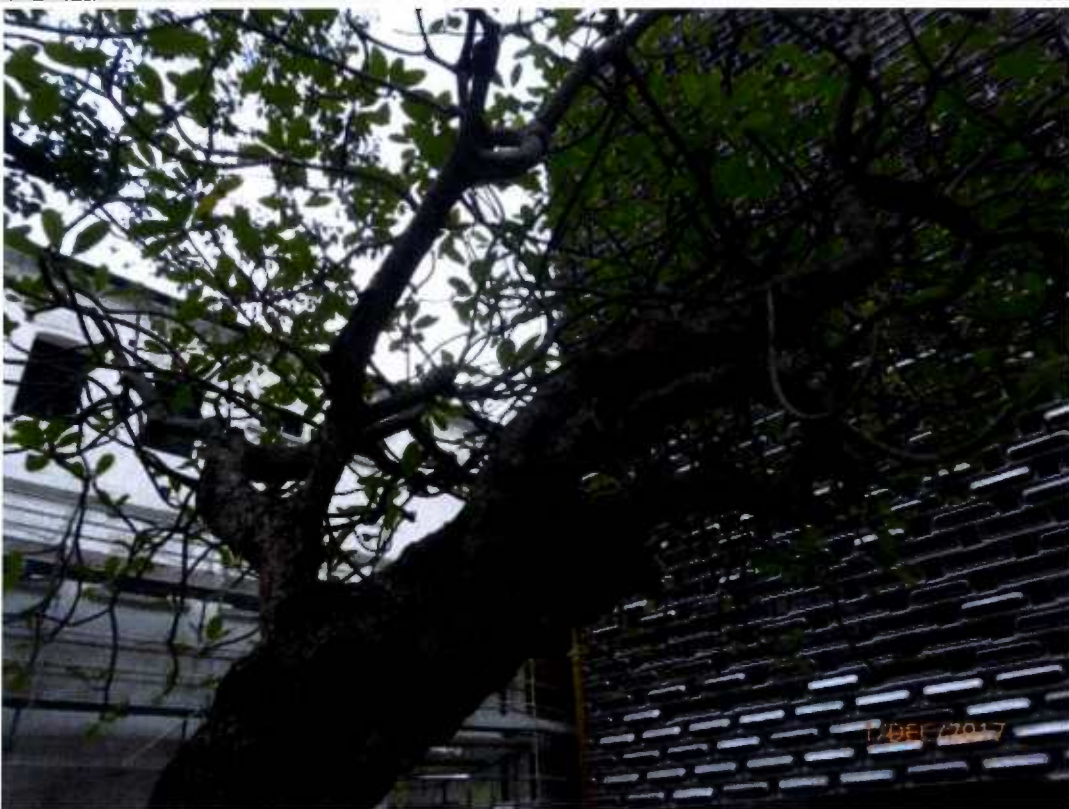
Fig. 6 As dry season is drawing near, leaves on the tree become sparse.

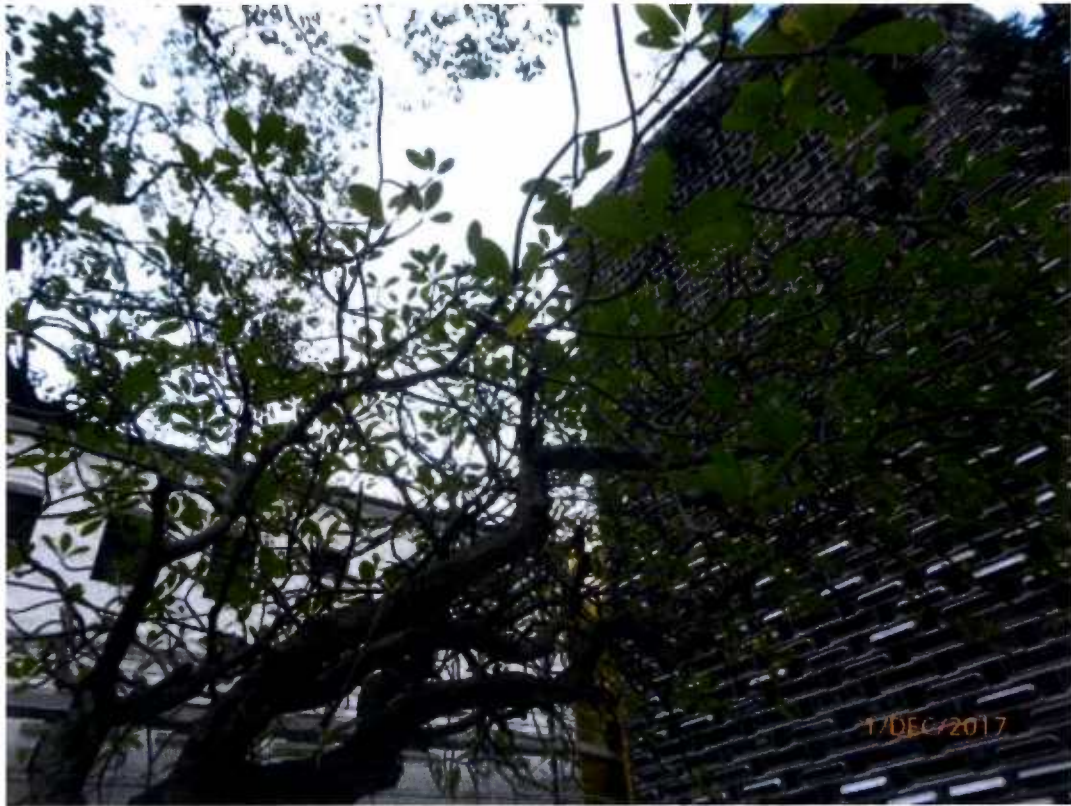
Fig. 7 Sparse leaves also appear on the lower branches.

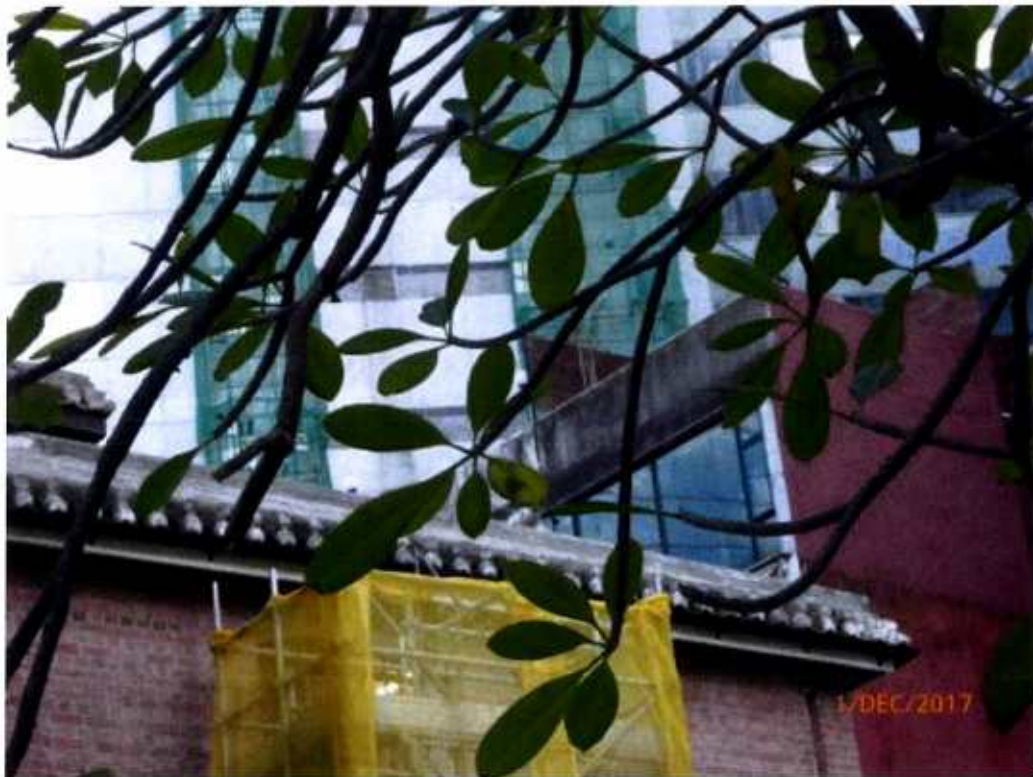
Fig. 8 Some leaves on the crown become faded.

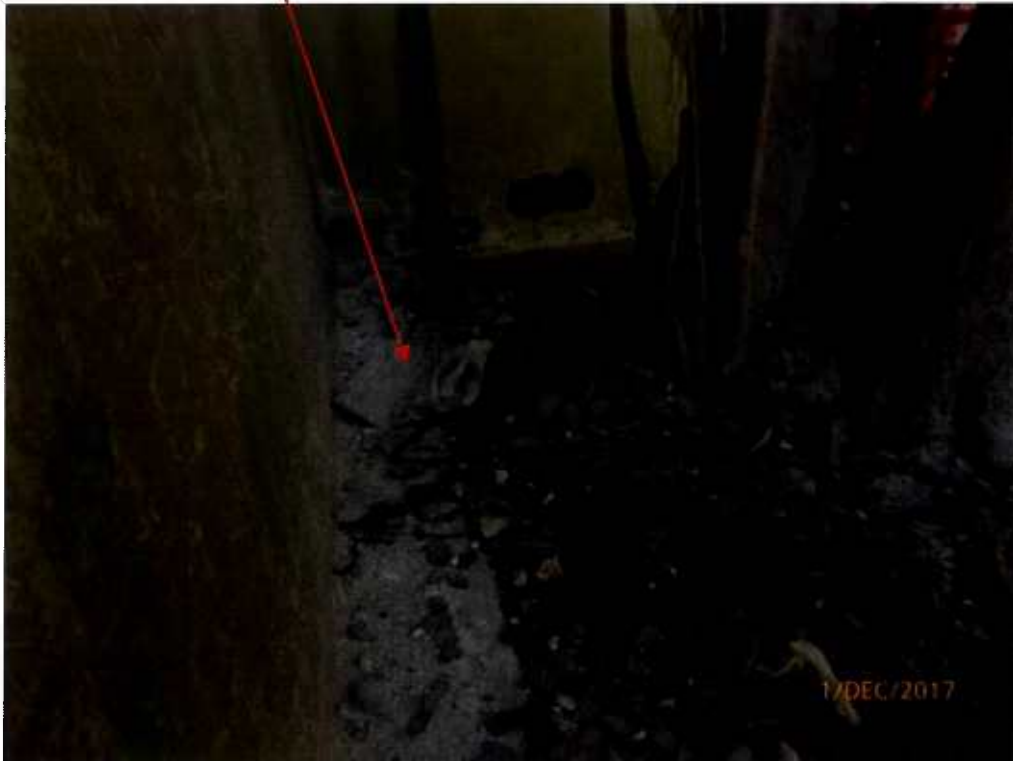
Fig. 3 A few litter remain at the edge of the planter.

Tree No.	Botanical Name	Overall Health Condition	Arborist's Observations / Recommendations
			<p>monitor the growth of the tree especially during the nearby renovation works are in progress.</p> <ul style="list-style-type: none"> Some litter was observed at the planter. The Contractor was reminded to remove the litter from the planter.

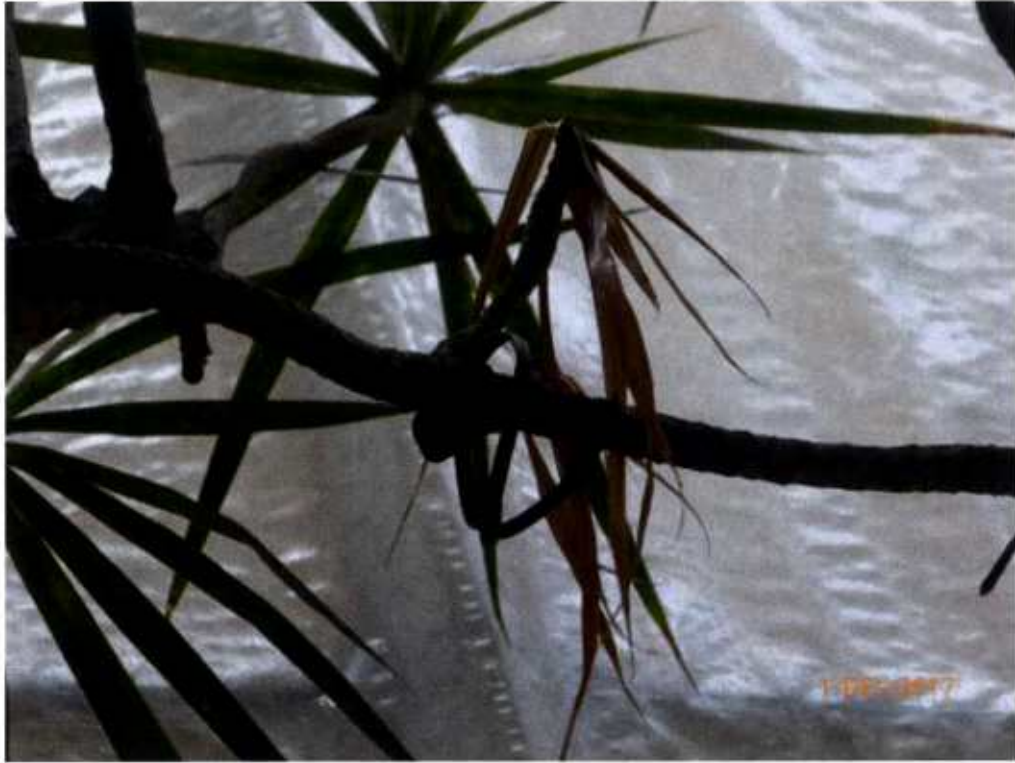
Fig. 8 Withered leaves also appear on the lower branches.

Tree-11	<i>Dracaena marginata</i>	Fair	<ul style="list-style-type: none"> • Withered leaves were observed on the tree. • The Contractor should closely

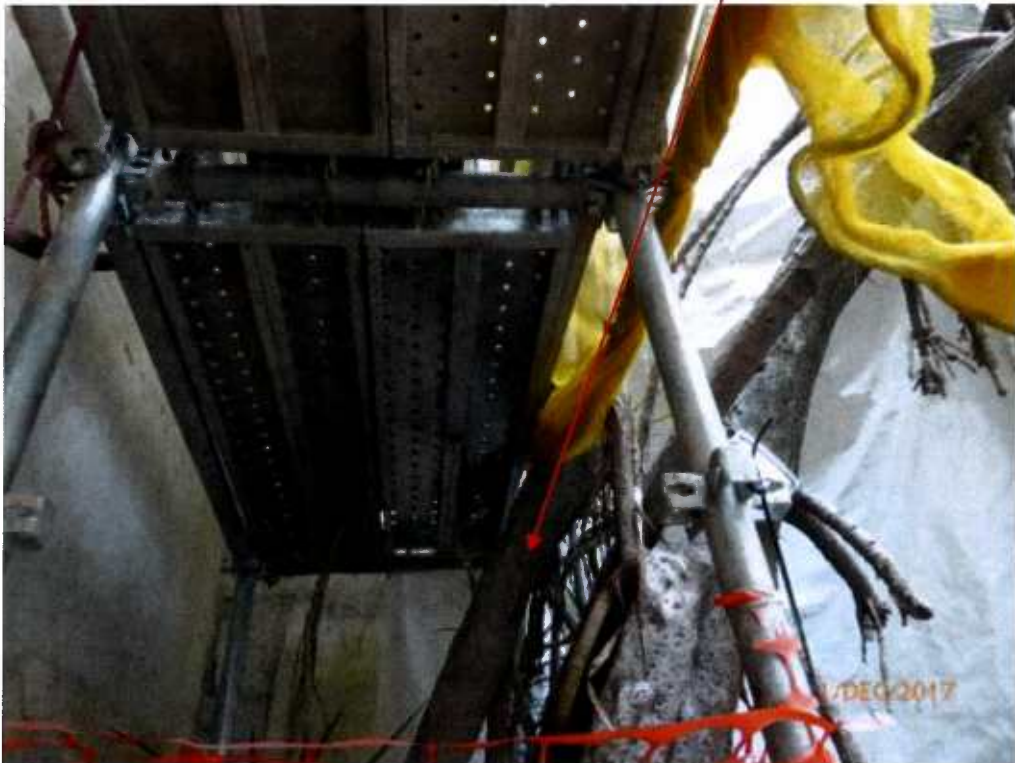
Fig. 9 A large working platform is set up close to Tree-11.

Landscape and visual monitoring has commenced since October 2011 on a monthly basis. The tree inspection was conducted on 1 December 2017 by the arborist during the reporting period. Leaves on Tree 6 and Tree 7 were observed to be rather sparse. Four pits near each of the planter of Tree 6 and Tree 7 were created for ventilation purpose for the trees. The exposed roots of Tree 6 and Tree 7 observed in the last inspection have been wrapped with hessian clothes for protection from sunlight. The Contractor was reminded to keep close monitoring of the growth of Tree 6 and Tree 7. The Contractor has provided a temporary shelter for the protection of Tree 11 during the nearby renovation works. Withered leaves were observed on Tree 11. Some litter were also observed at the planter of Tree 11 and the Contractor was reminded to remove the litter. The Contractor should closely monitor the growth of Tree 11 especially during the nearby renovation works are in progress.
