The Jockey Club CPS Limited

Central Police Station Conservation  
and Revitalisation Project:  
*Eleventh Quarterly EM&A Report*  
*(1 May 2014 to 31 July 2014)*

Issue Date: September 2014

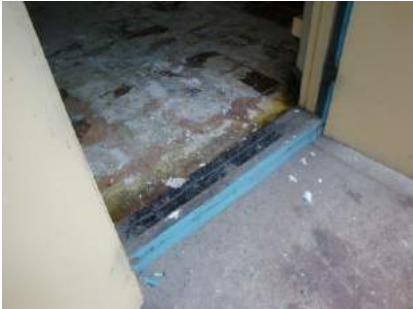
Adverse	Replace with hardwood floor boards	Not applicable	High
07.011	Timber thresholds at external doors and internal doors between main corridor and individual rooms

Low	Remove to enable level access	Splice extensions to door jambs, extend width of bottom rail of doors to match existing	Low

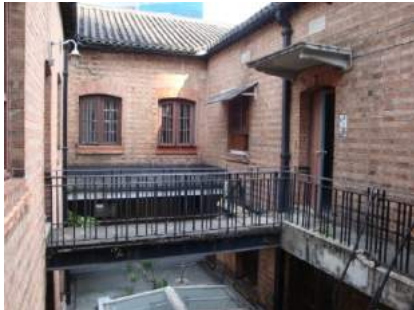
Moderate	Replace with larger sizes/closer spacing to improve performance	Use cast iron to match original pattern Make good all redundant fixing holes	High
09.013	Metal walkways across lightwell

Adverse	Remove walkways and make good brickwork at abutments	Not applicable	High

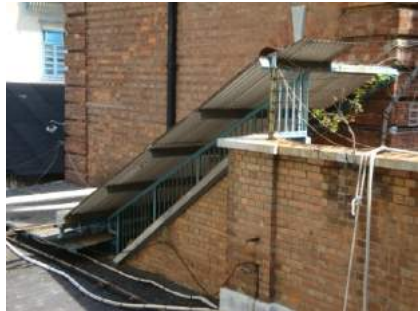
Adverse	Repair or renew as necessary existing frames to match original patterns	Not applicable	High
09.015	Sloping canopy over external stair on west side

Adverse	Remove canopy and supporting structure	Not applicable	Moderate

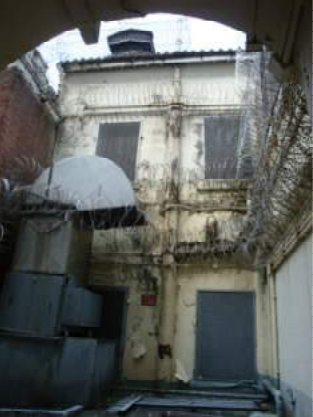
Adverse	Repair or renew as necessary existing frames to match original patterns	Not applicable	High
10.009	External airconditioning units and other external services

Adverse	Remove and make good brickwork	Not applicable	High

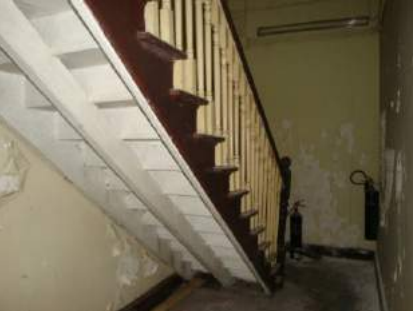
Moderate	Repair as necessary and retain	Avoid intrusive alteration. Retain open appearance/	Low
10.019	Timber stair

Moderate	Underline with fire-resisting lining	Repair as necessary and retain.	Low

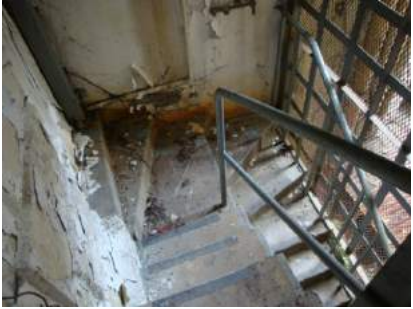
Moderate	Open up window opening to full extent.	Record existing condition on measured survey drawings. Add further detail during demolition works.	Low
14.008	External granite stair from Lower Ground to Ground Floor level

Moderate	Remove stair to make way for new stair in similar position	Review design proposals to see whether existing stair can be retained.	Low

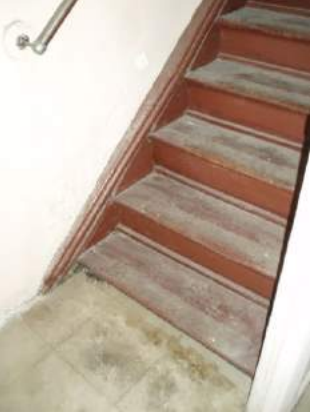
High	Repair and retain insitu	Not applicable	Neutral
19.012	Timber stair

Moderate	Remove	Record on measured surveys drawings	Low
