Central Police Station Conservation  
and Revitalisation Project:  
*Seventeenth Monthly EM&A Report*  
*(1 March to 31 March 2013)*

Issue Date: April 2013

Central Police Station Conservation  
and Revitalisation Project:  
*Seventeenth Monthly EM&A Report*  
*(From 1 March to 31 March 2013)*

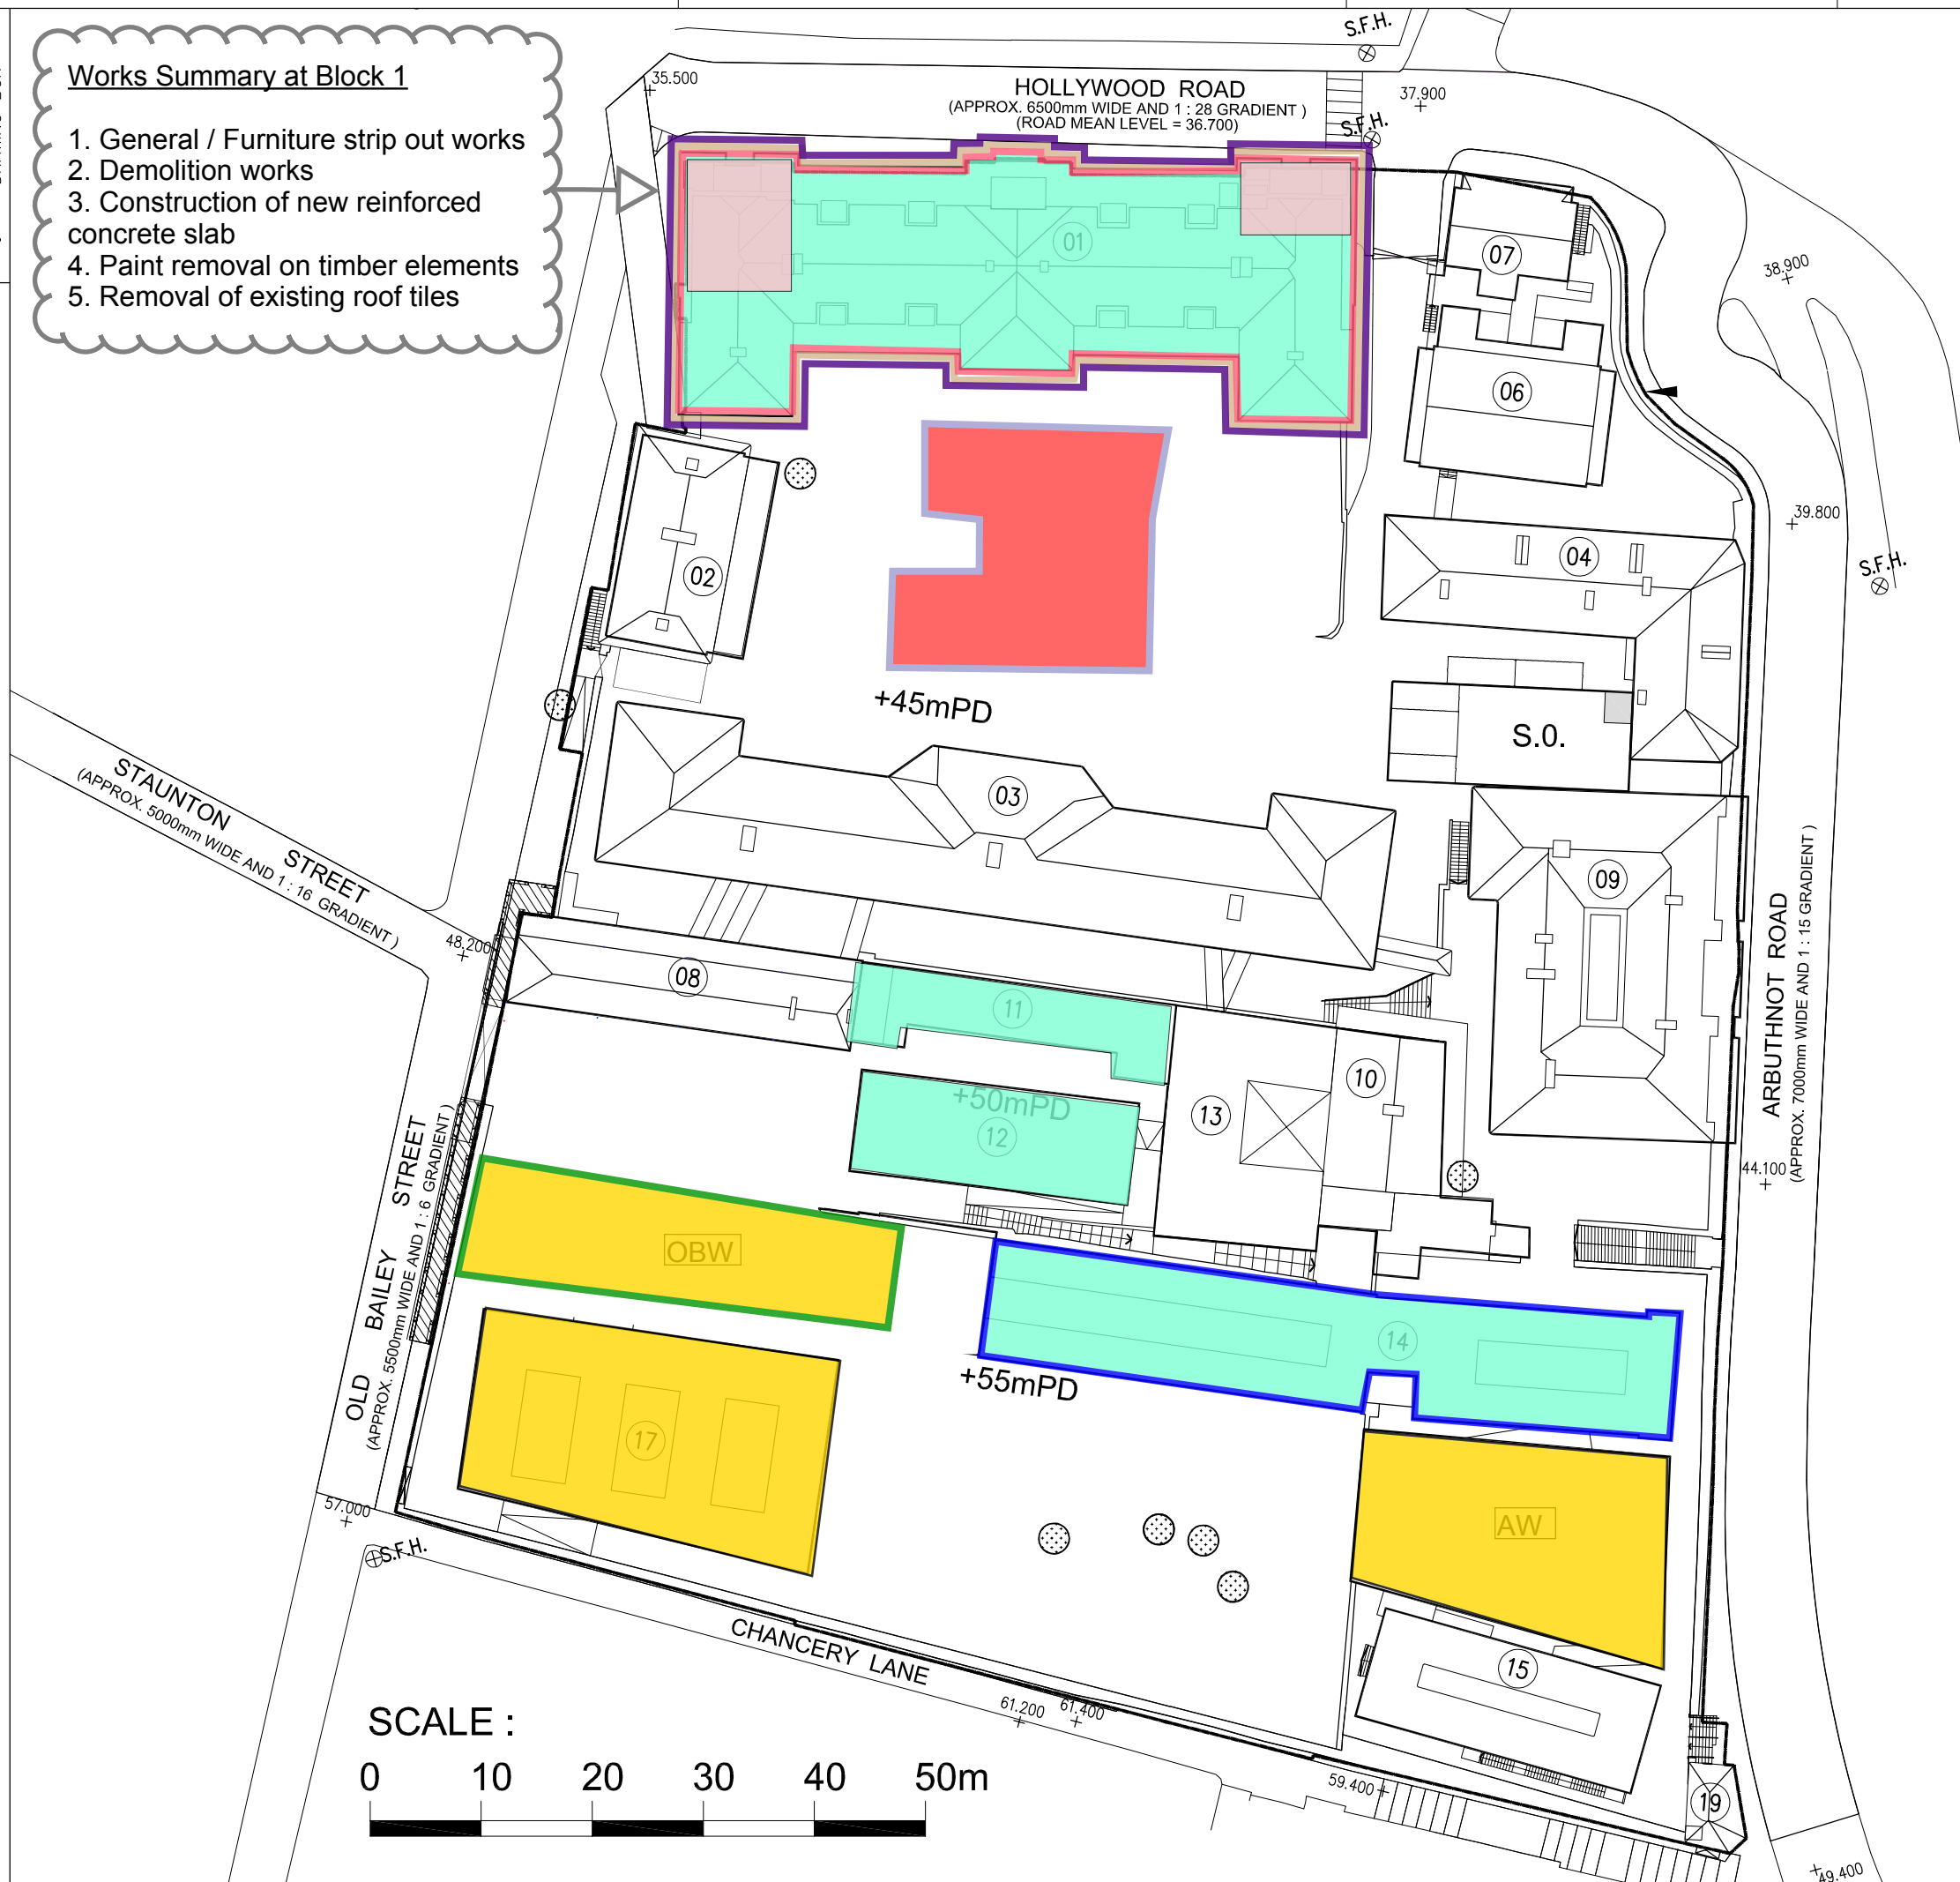
**Works Summary at Block 1**

1. General / Furniture strip out works
2. Demolition works
3. Construction of new reinforced concrete slab
4. Paint removal on timber elements
5. Removal of existing roof tiles

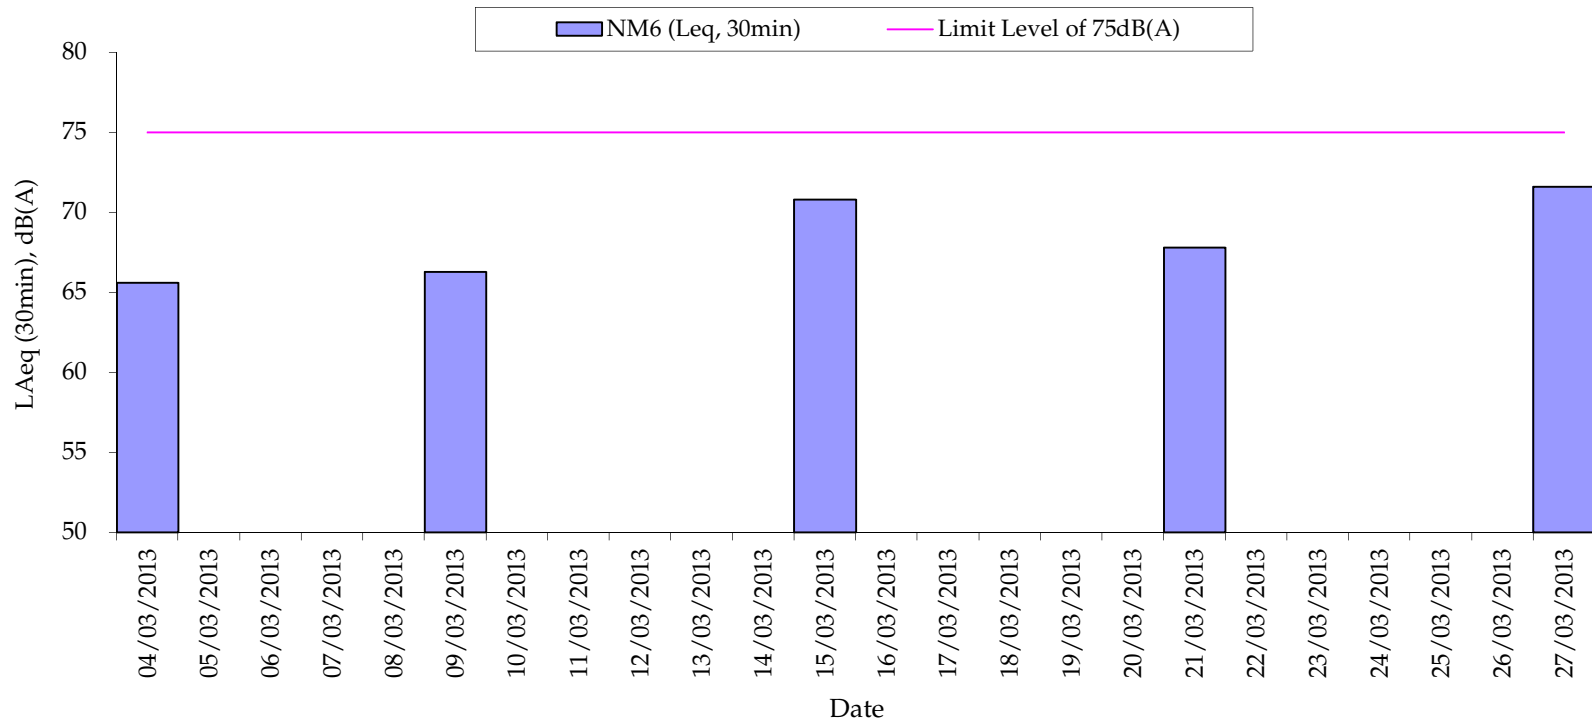
Normal Weekdays Noise Monitoring Results at NM6 - Chancery Mansion (Leq, 30min)

- 75dB(A) was adopted as the Limit Level during normal weekdays in the reporting period

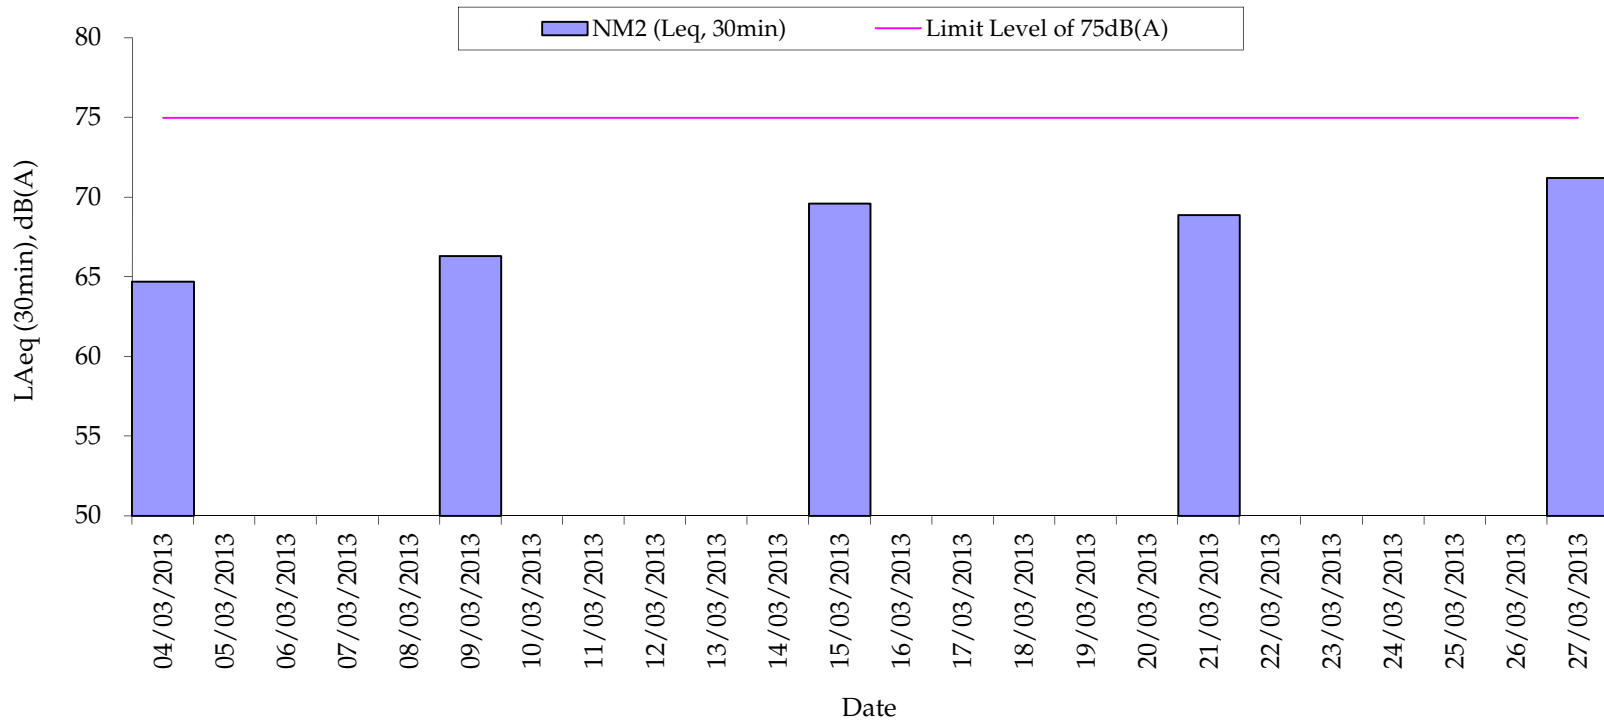
Normal Weekdays Noise Monitoring Results at NM2 - Ho Fook Building (Leq, 30min)

- 75dB(A) was adopted as the Limit Level during normal weekdays in the reporting period

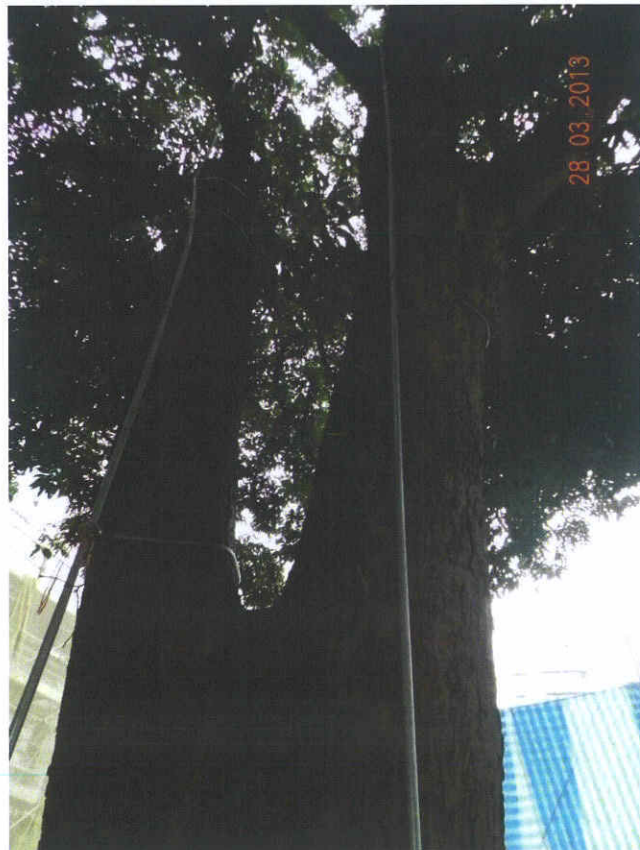
Fig. 5 Two pipes lead water to tree top for irrigation.

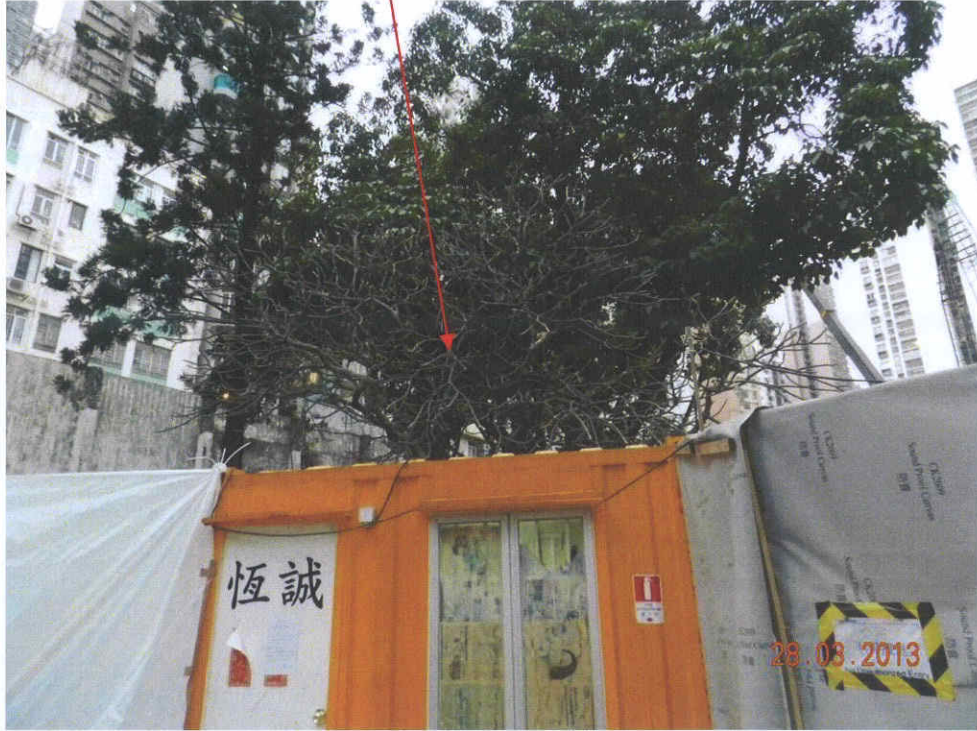
Fig. 4 Most leaves of Tree-8 have fallen at the time of inspection.

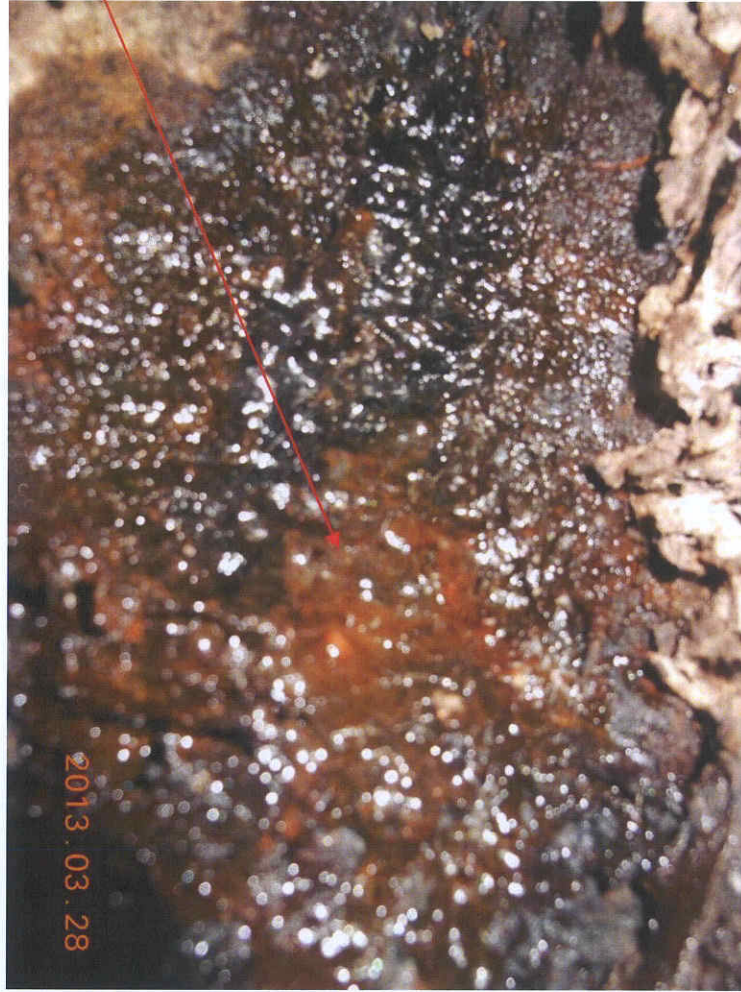
Fig. 4 Sap flow still appears on the mid trunk, close monitoring at regular intervals is required.

Landscape and visual monitoring has commenced since October 2011 on a monthly basis. Tree inspection was conducted on 28 March 2013 by the arborist during the reporting period. Sap flow was still observed on the mid-trunk of Tree-9 and close monitoring by the Contractor was recommended.

1. Keep close monitoring on the sap flow at regular intervals.

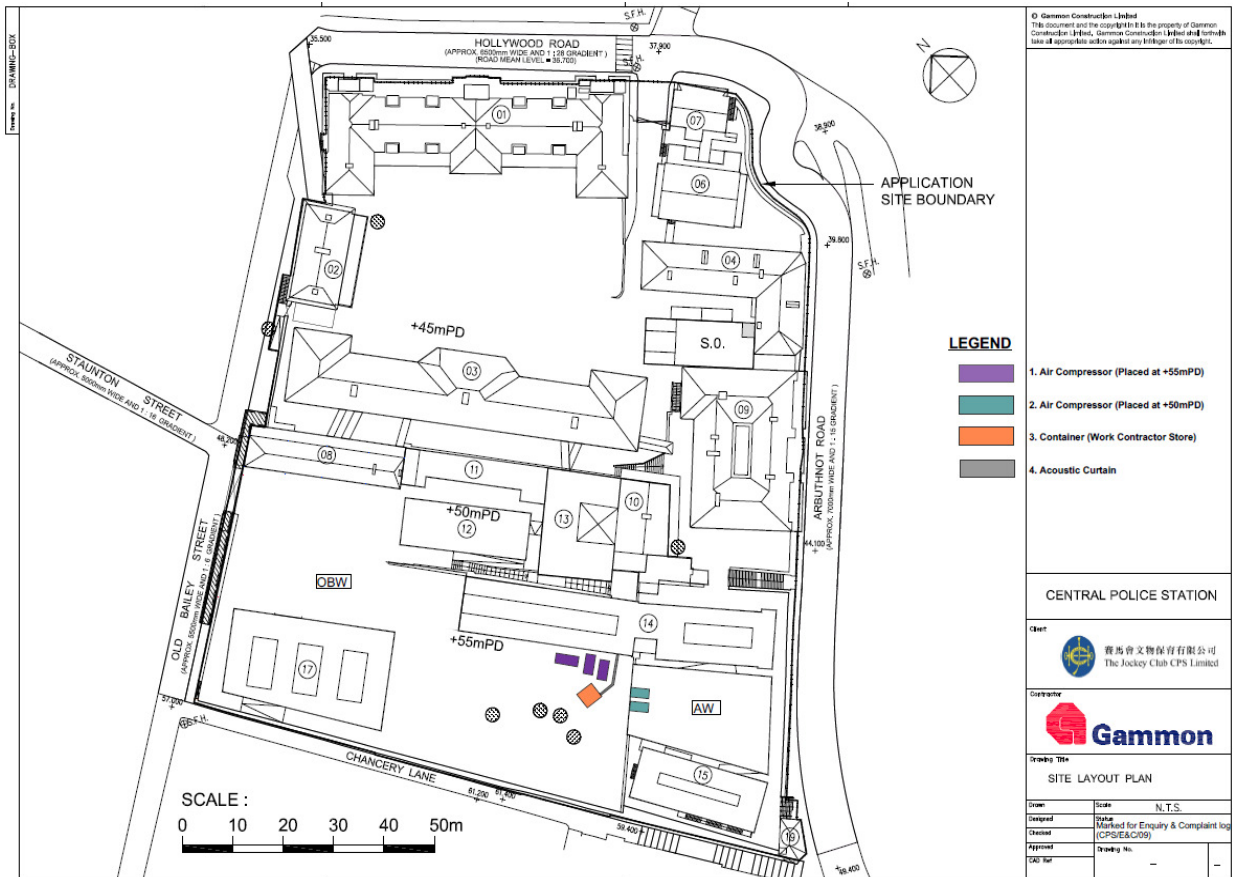
1. Air compressors were observed from a photo of the CPS construction site taken by the EPD from the location of complainant. Three air compressors near Block 14 and two air compressors at Arbuthnot Wing (AW) (Figure 1) could be the potential source of the mentioned noise nuisance.
2. According to the information provided by the Contractor, the air compressors were only operating during daytime and the air compressor in the open area near Block 14 was provided with noise barriers on the side (Figure 2).
3. Recent noise monitoring was conducted at the rooftop of Chancery Mansion along the Chancery Lane on 27 March 2013 during which the air compressors were operating. The noise levels at the monitoring location complied with the construction noise standards.

Figure 1 – Site layout plan showing locations of air compressors and noise barrier

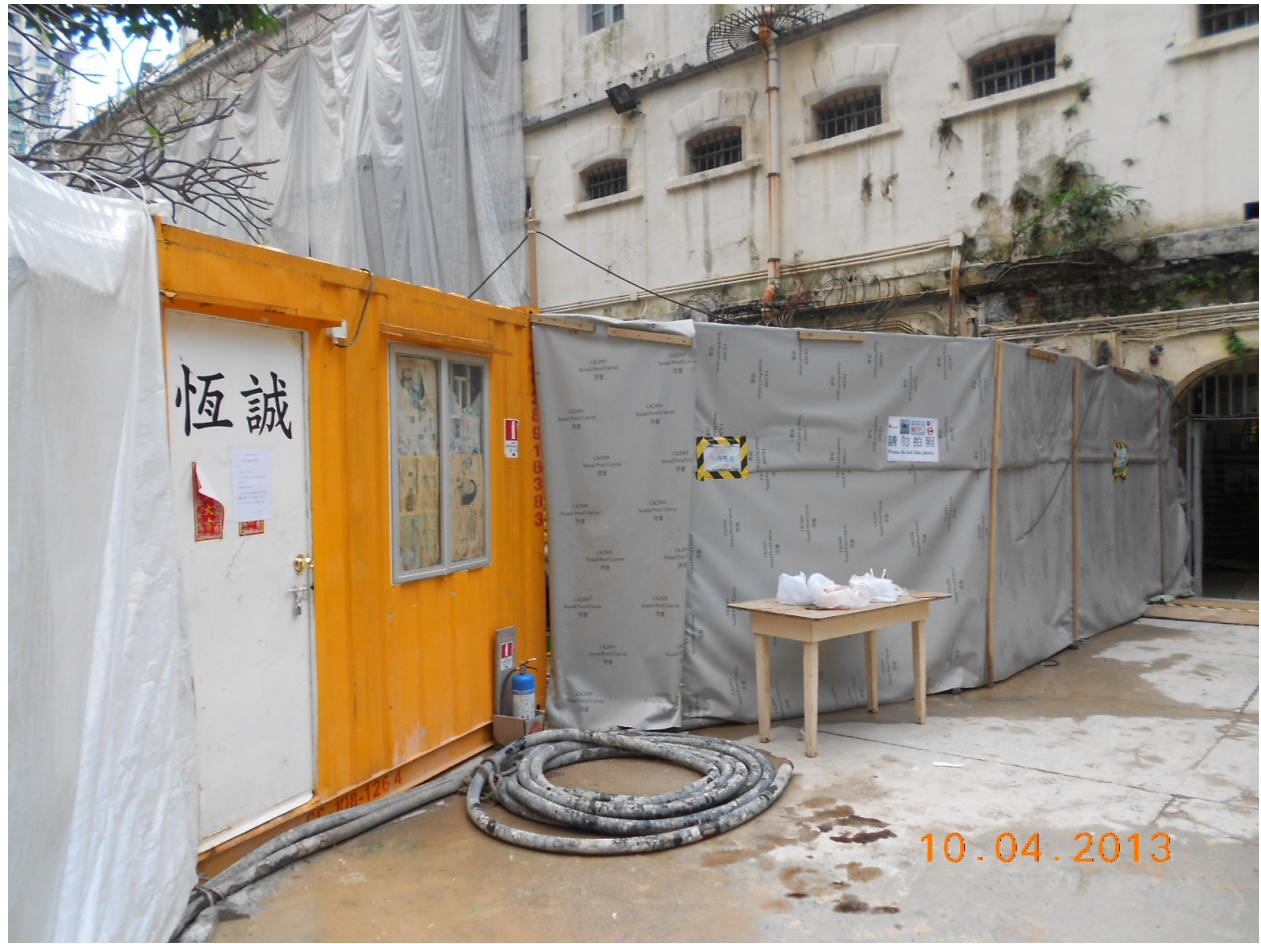
*Figure 2 – Noise barrier for air compressors near Block 14*

The Contractor should follow all relevant noise requirements specified in EIA, EM&A Manual, EMP, Method Statements, General and Particular Specifications of this Project. The Contractor was recommended to conduct regular inspection of the air compressors and other machineries to ensure that they are well-maintained and operating in normal condition without generating any abnormal or excessive noise. The Contractor was also reminded that machines and plants that may be in intermittent use should be shut down if not in use or throttled down to a minimum.
