The Jockey Club CPS Limited

Central Police Station Conservation  
and Revitalisation Project:  
*Sixth Quarterly EM&A Report*  
*(1 February 2013 to 30 April 2013)*

Issue Date: May 2013

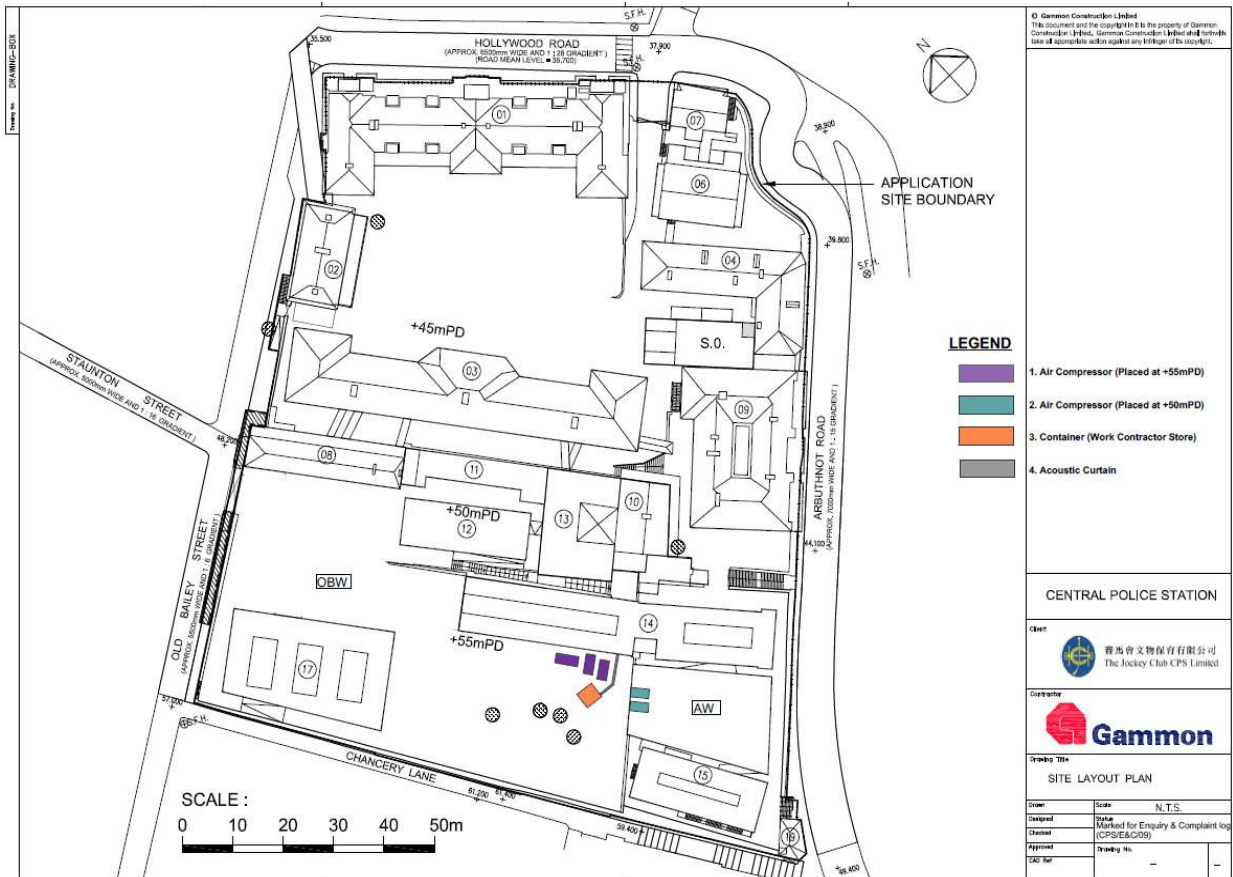
Figure 1 – Site layout plan showing locations of air compressors and noise barrier

1. Air compressors were observed from a photo of the CPS construction site taken by the EPD from the location of complainant. Three air compressors near Block 14 and two air compressors at Arbuthnot Wing (AW) (Figure 1) could be the potential source of the mentioned noise nuisance.
2. According to the information provided by the Contractor, the air compressors were only operating during daytime and the air compressor in the open area near Block 14 was provided with noise barriers on the side (Figure 2).
3. Recent noise monitoring was conducted at the rooftop of Chancery Mansion along the Chancery Lane on 27 March 2013 during which the air compressors were operating. The noise levels at the monitoring location complied with the construction noise standards.

The Contractor should follow all relevant noise requirements specified in EIA, EM&A Manual, EMP, Method Statements, General and Particular Specifications of this Project. The Contractor was recommended to conduct regular inspection of the air compressors and other machineries to ensure that they are well-maintained and operating in normal condition without generating any abnormal or excessive noise. The Contractor was also reminded that machines and plants that may be in intermittent use should be shut down if not in use or throttled down to a minimum.

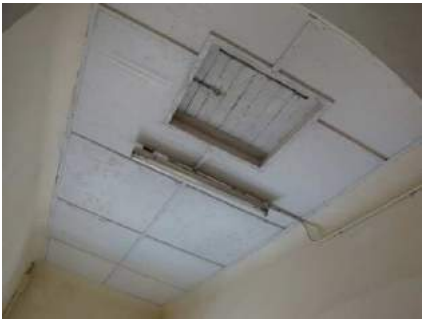
Element no.	Description	Photo ref	Significance	Proposal	Mitigation	Impact
01.001	Flat plywood ceiling lining with plain rectangular cover battens

Adverse	Replace with T&G boarding to match existing	Not applicable	High
01.002	Plaster coving at abutments of walls and ceilings

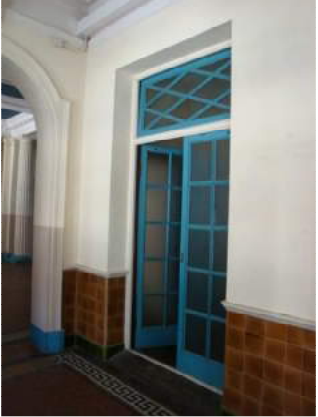
Moderate	Remove in exceptional cases eg. where adjacent new lift shafts	Cut back neatly to a square edge and ensure remaining section is secure.	Moderate
01.006	Panelled doors

Moderate	Replace where necessary to achieve fire resistance to comply with Code	Re-use where possible. Record design on survey drawings where element cannot be re-used.	Moderate

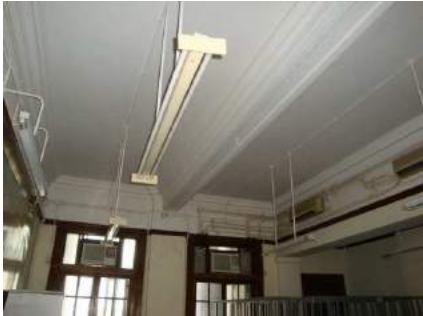
Element no.	Description	Photo ref	Significance	Proposal	Mitigation	Impact
01.009	Plaster ceilings on GF and LG1

Moderate	Install cloud ceilings to accommodate new services	Install fixed grid to minimise damage to ceiling	High
01.010	Timber door frames and architraves

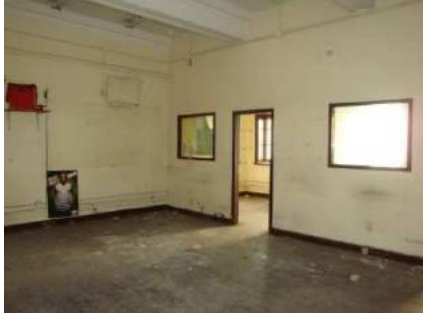
Element no.	Description	Photo ref	Significance	Proposal	Mitigation	Impact
01.011	Concrete floor

Low	Replace where new kitchens and plant rooms to be installed	Carefully remove and retain existing floorboards for re-use. Ensure controlled demolition of concrete structure and removal of debris from building to avoid damage to adjacent surfaces. Protect or carefully remove and set aside adjacent elements such as skirting boards	Low

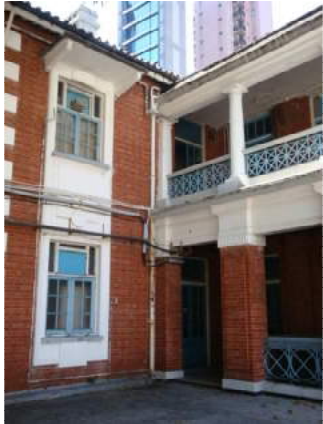
Element no.	Description	Photo ref	Significance	Proposal	Mitigation	Impact
01.012	Rainwater goods

Adverse	Replace with cast iron in pattern to match original and in correct locations	Not applicable	High

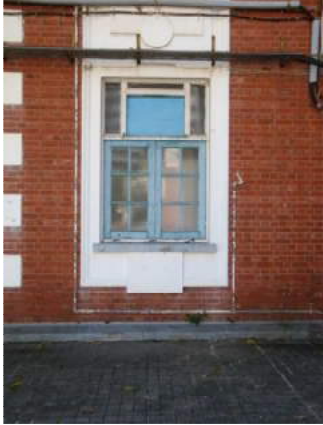
Element no.	Description	Photo ref	Significance	Proposal	Mitigation	Impact
01.016	Altered doors and windows

Adverse	Repair or renew as necessary existing frames to match original patterns	Not applicable	High
01.017	Mezzanine floor in room 01/LG1/13

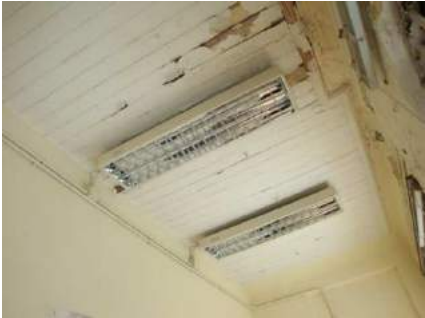
Low	Remove	Record on measured drawings and photographs	Low
01.028	Tongued and grooved flat and sloped timber boarded ceilings

Moderate	Repair where necessary and reinstate where missing	Not applicable	Moderate

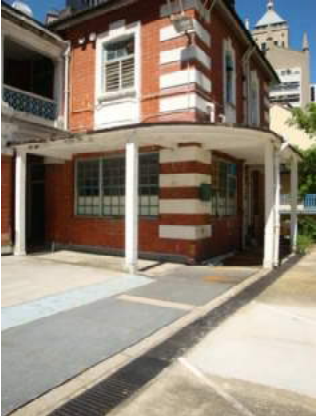
Element no.	Description	Photo ref	Significance	Proposal	Mitigation	Impact
01.031	Reinforced concrete canopy and sash windows

Moderate	Remove canopy and replace sash windows with new windows to match original	Make good brickwork where canopy removed, Reinstate rendered architraves around new window to match similar window facing on West wing	Moderate
01.032	Arched opening in brick wall above ceiling line

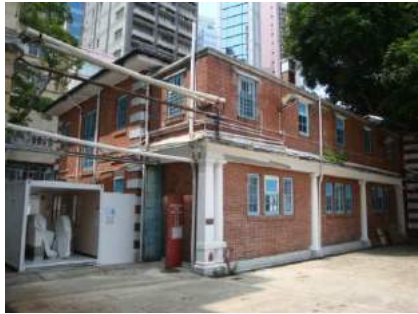
Element no.	Description	Photo ref.	Significance	Proposal	Mitigation	Impact
02.007	Rainwater goods

Adverse	Replace with cast iron in pattern to match original and in correct locations	No applicable	High
02.008	Altered doors and windows

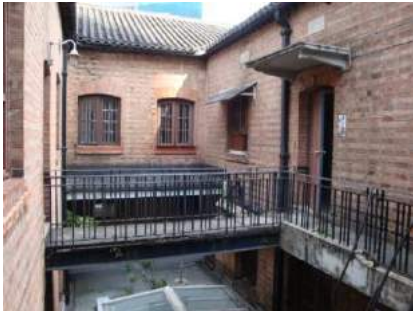
Moderate	Replace with larger sizes/closer spacing to improve performance	Use cast iron to match original pattern Make good all redundant fixing holes	High
09.013	Metal walkways across lightwell

Adverse	Remove walkways and make good brickwork at abutments	Not applicable	High

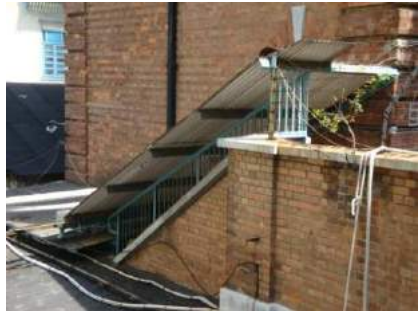
Adverse	Repair or renew as necessary existing frames to match original patterns	Not applicable	High
09.015	Sloping canopy over external stair on west side

Adverse	Remove canopy and supporting structure	Not applicable	Moderate
