Central Police Station Conservation
and Revitalisation Project:
17th Quarterly EM&A Report
(1 November 2015 to 31 January
2016)

Issue Date: November 2016

Annex N	<i>A Summary of Condition of Character Defining Elements, Historic Buildings and Structures</i>

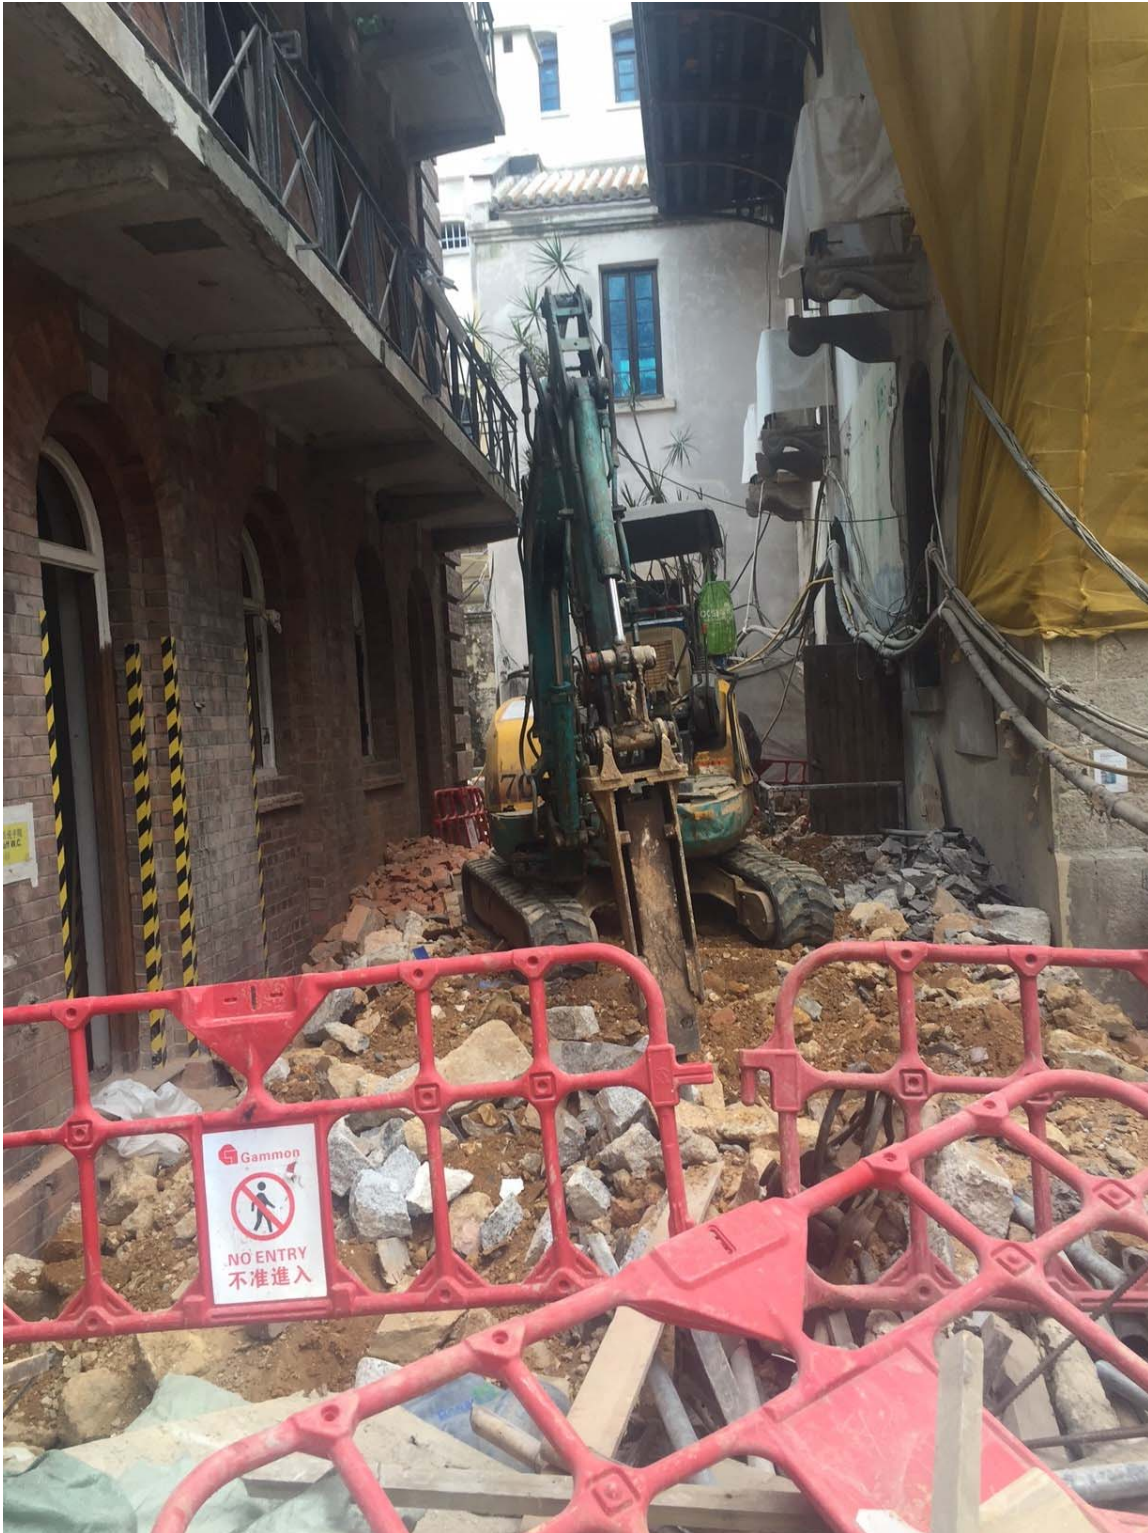
Above, photo taken on 5th November 2015, showing site works on the Magistracy Terrace (West). No protection was provided to the granite steps nor the masonry walls.

- It was observed that granite steps at the Magistracy Terrace (West) were damaged during excavation. The Contractor was informed to follow up.

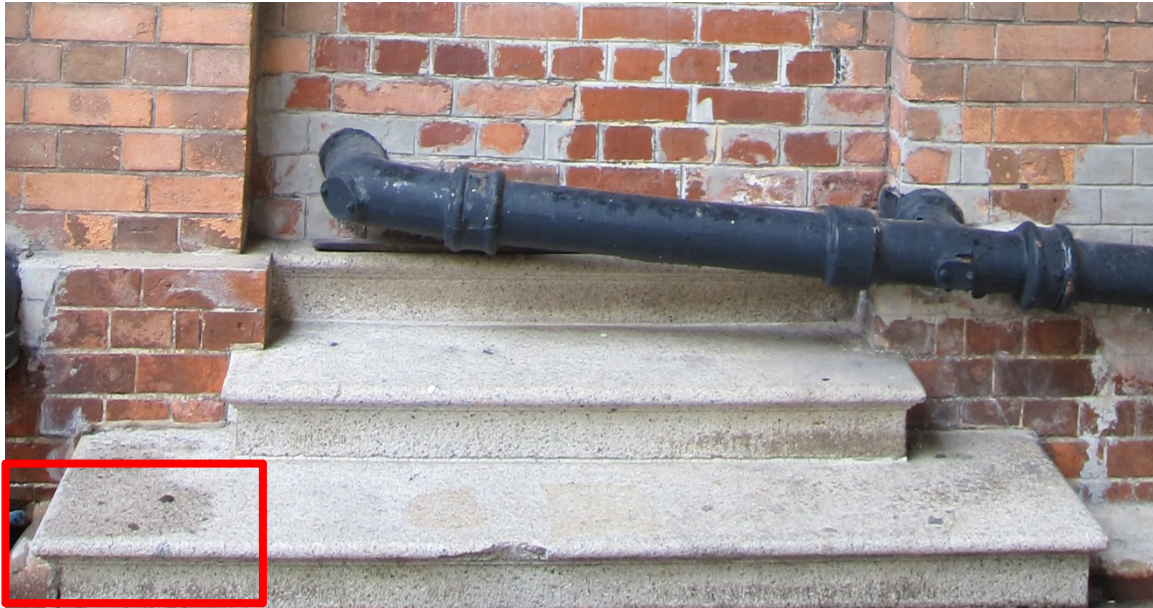
Above, photograph taken on 26th April 2011, showing granite steps at 09/WG/04. The highlighted area was damaged during site works.

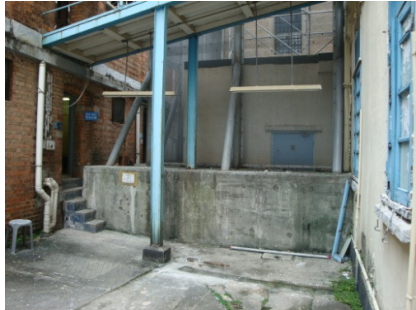
High	Open up selected openings to form new fire escape doors	Retain any salvageable material for possible re-use elsewhere. Retain existing window jambs intact. Cut away masonry to form door openings along same line as window jamb; do not re-bind cut brickwork. Record existing condition on measured survey drawings.	Low
03.023	Single storey outbuildings on south side

Adverse	Demolish	Check for evidence of early route from Magistracy to Prison.	Low
