The Jockey Club CPS Limited

Central Police Station Conservation
and Revitalisation Project:
Twelfth Quarterly EM&A Report
(1 August 2014 to 31 October 2014)

Issue Date: November 2014

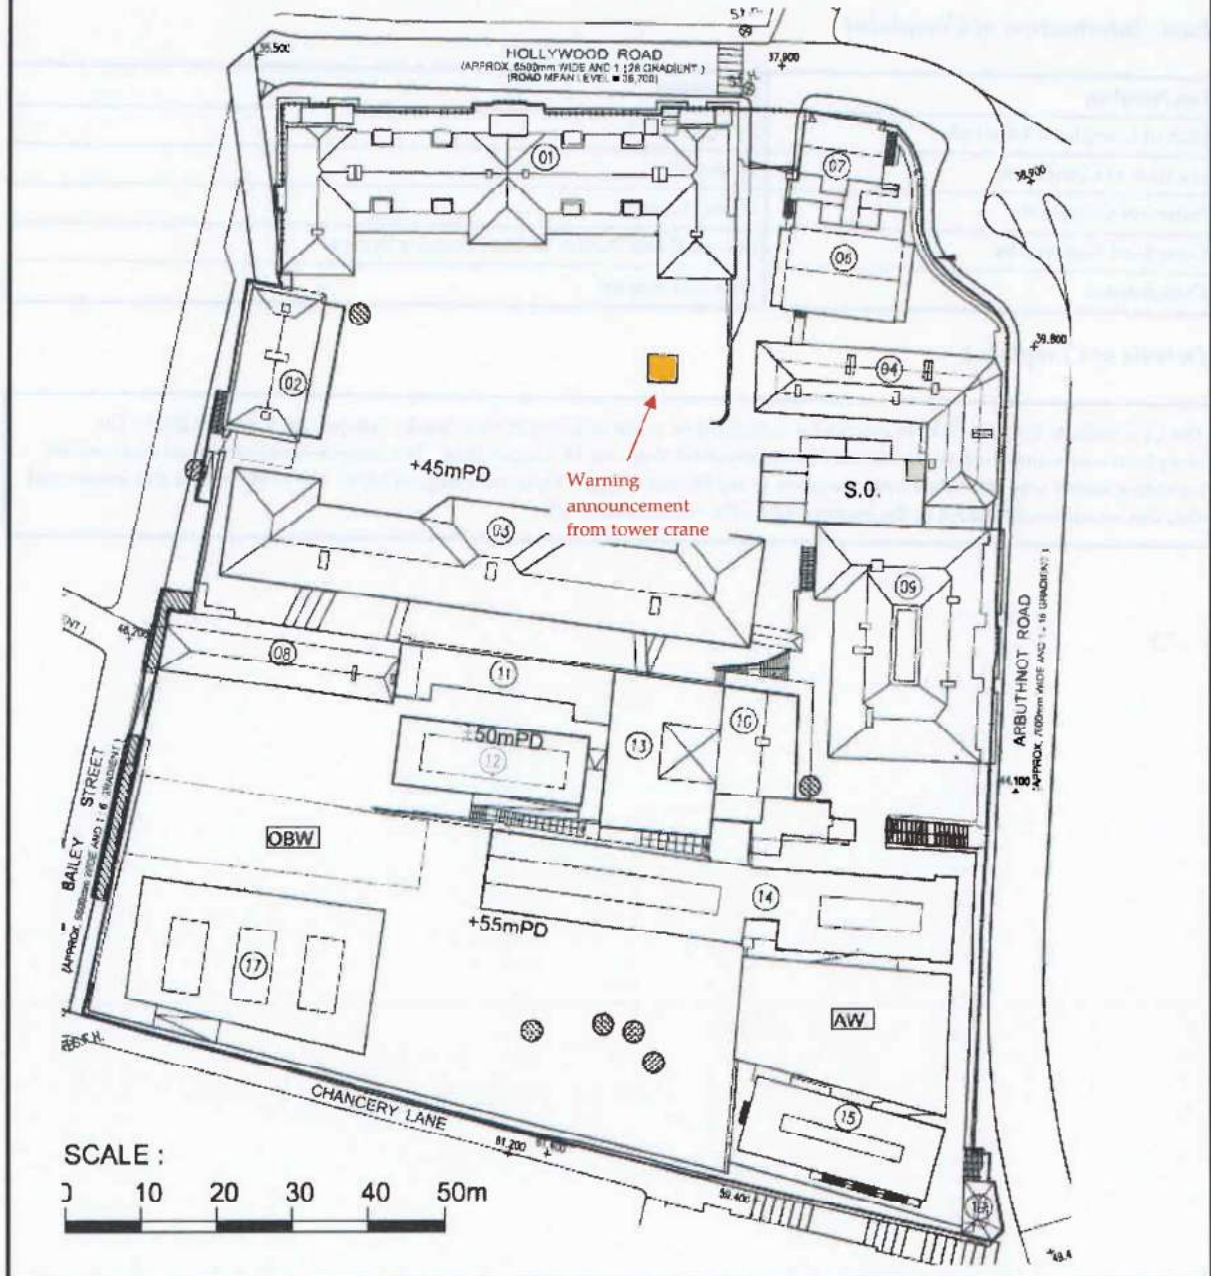
1. According to the Contractor, the noise was originated from a device on the hook of the tower crane that provides warning announcement to the workers working underneath the lifting operation. The location of the warning announcement from tower crane is shown in the figure below.
2. The warning announcement is designed to be activated by a remote control operated by the banksman of the tower crane. The Contractor confirmed that the device was accidentally activated on 5 August 2014 in the evening.

Mitigation Measures and Follow-up Actions Recommended to Contractor

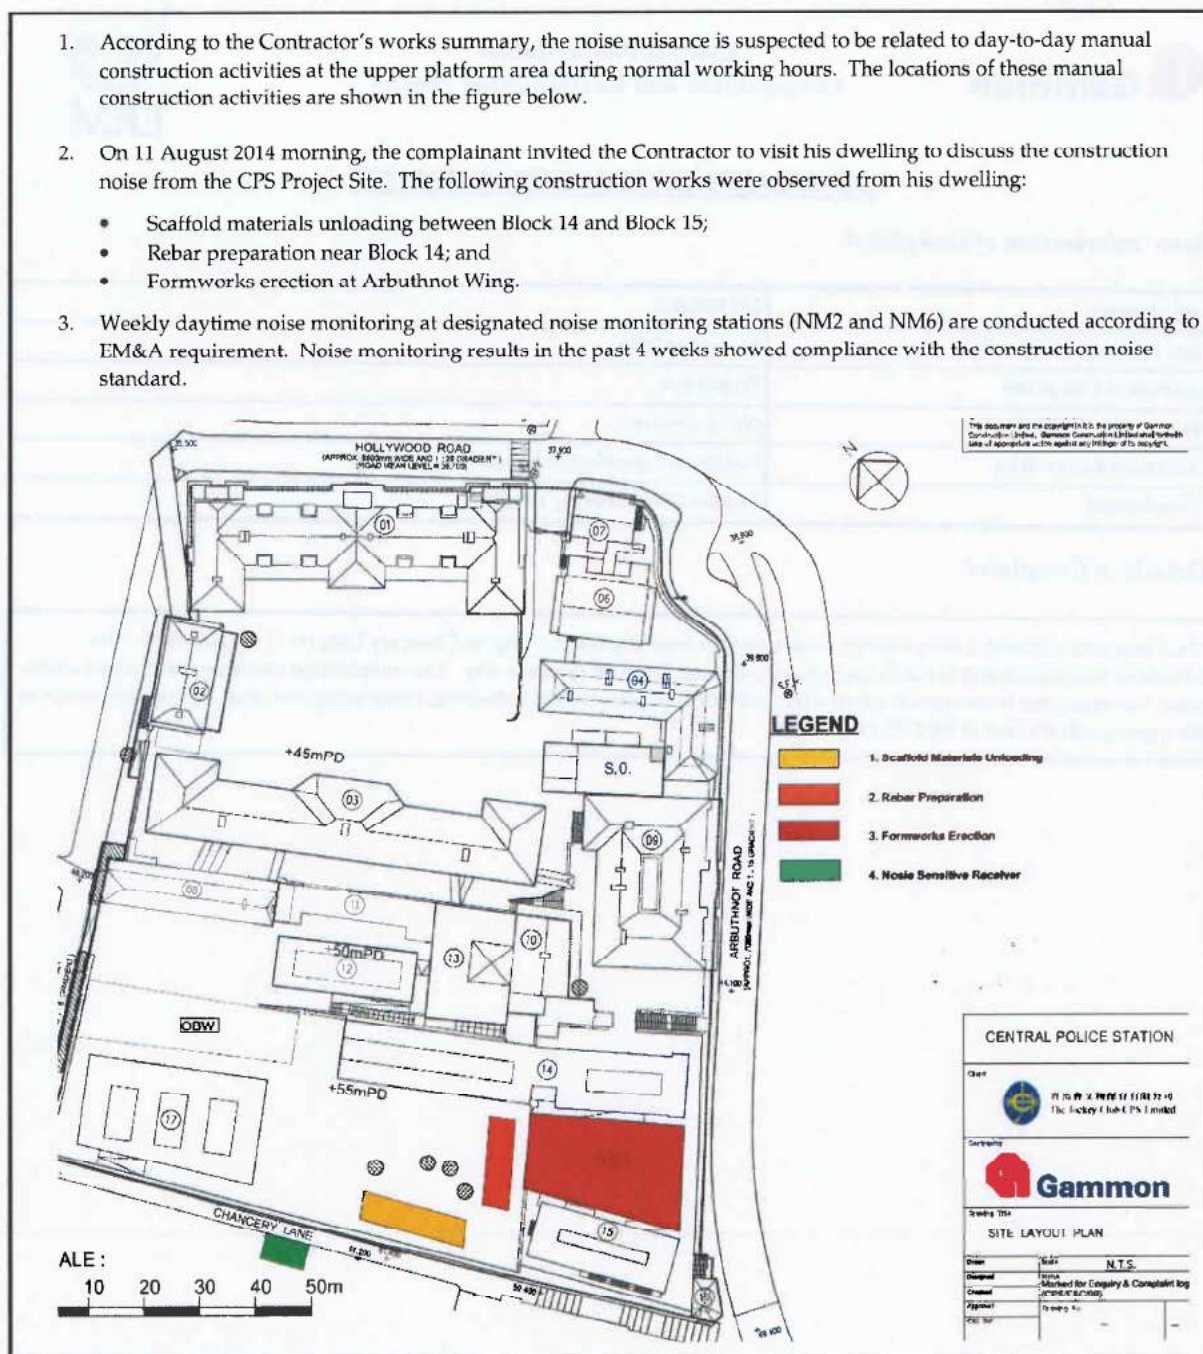
1. According to the Contractor's works summary, the noise nuisance is suspected to be related to day-to-day manual construction activities at the upper platform area during normal working hours. The locations of these manual construction activities are shown in the figure below.
2. On 11 August 2014 morning, the complainant invited the Contractor to visit his dwelling to discuss the construction noise from the CPS Project Site. The following construction works were observed from his dwelling:
 - Scaffold materials unloading between Block 14 and Block 15;
 - Rebar preparation near Block 14; and
 - Formworks erection at Arbuthnot Wing.
3. Weekly daytime noise monitoring at designated noise monitoring stations (NM2 and NM6) are conducted according to EM&A requirement. Noise monitoring results in the past 4 weeks showed compliance with the construction noise standard.

Mitigation Measures and Follow-up Actions Recommended to Contractor

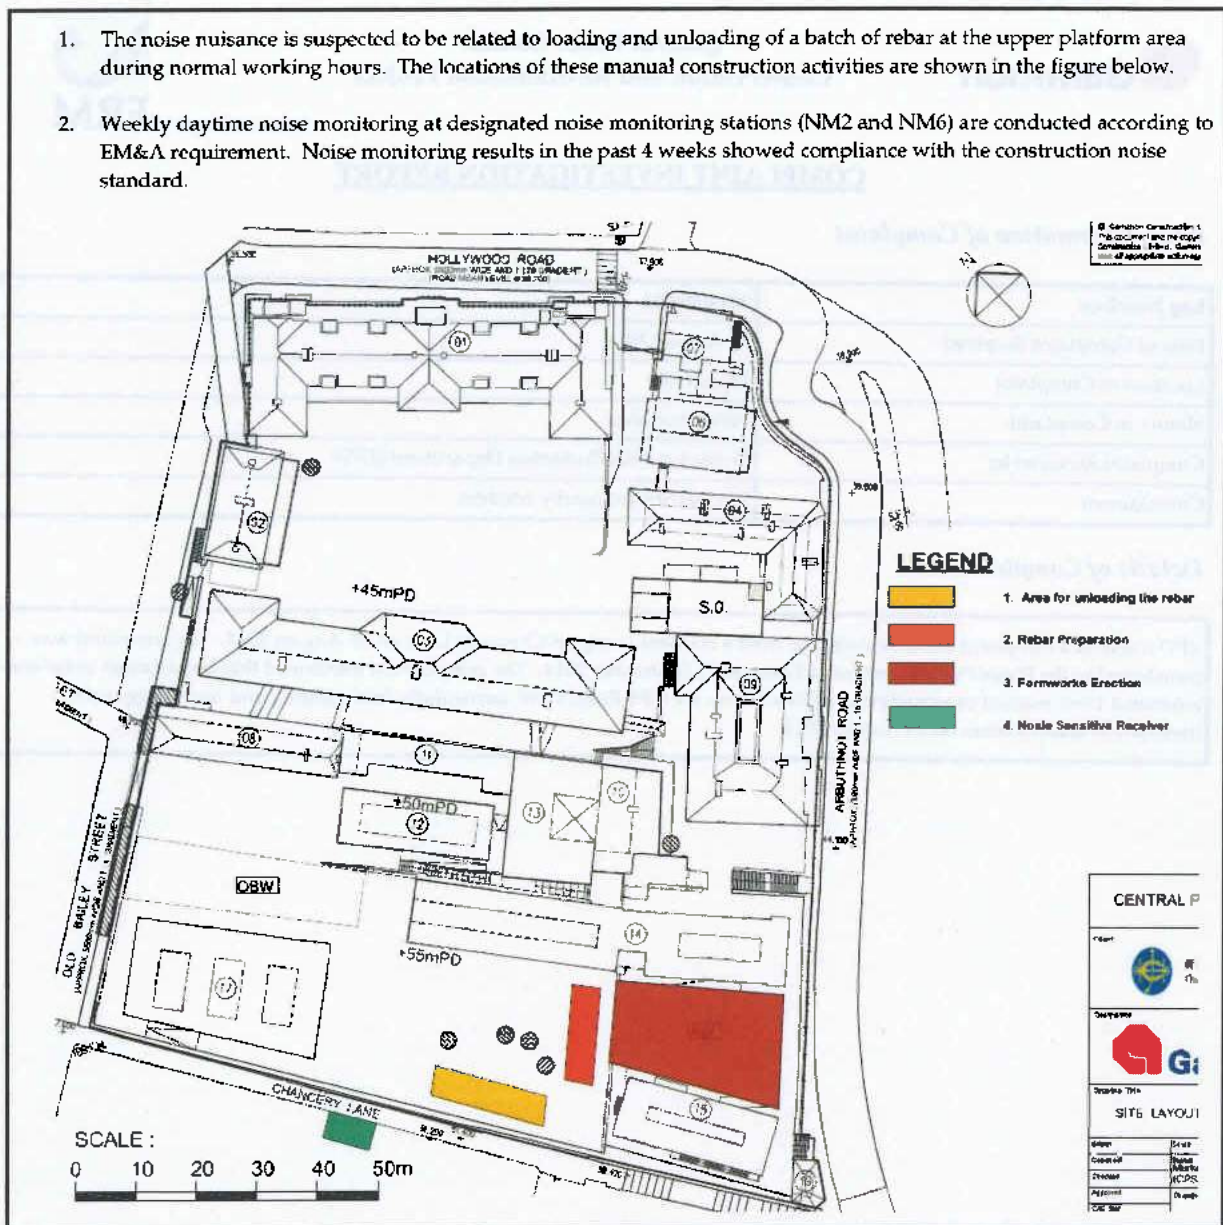
1. The noise nuisance is suspected to be related to loading and unloading of a batch of rebar at the upper platform area during normal working hours. The locations of these manual construction activities are shown in the figure below.
2. Weekly daytime noise monitoring at designated noise monitoring stations (NM2 and NM6) are conducted according to EM&A requirement. Noise monitoring results in the past 4 weeks showed compliance with the construction noise standard.

Mitigation Measures and Follow-up Actions Recommended to Contractor

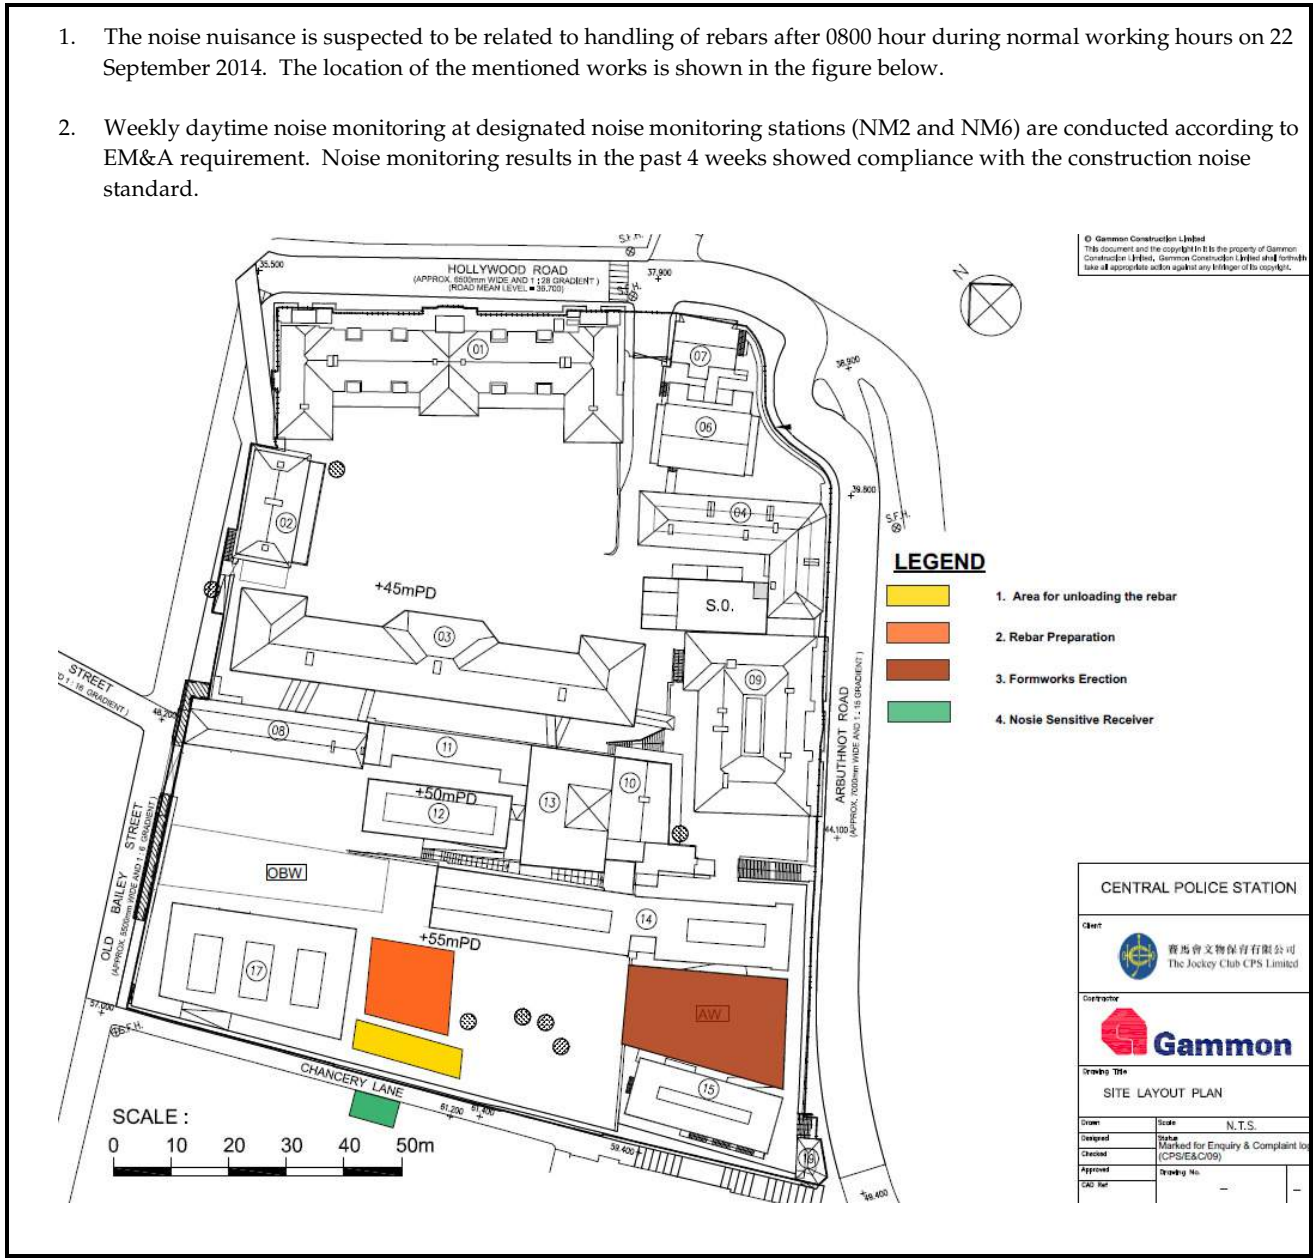
1. The noise nuisance is suspected to be related to handling of rebars after 0800 hour during normal working hours on 22 September 2014. The location of the mentioned works is shown in the figure below.
2. Weekly daytime noise monitoring at designated noise monitoring stations (NM2 and NM6) are conducted according to EM&A requirement. Noise monitoring results in the past 4 weeks showed compliance with the construction noise standard.

Mitigation Measures and Follow-up Actions Recommended to Contractor

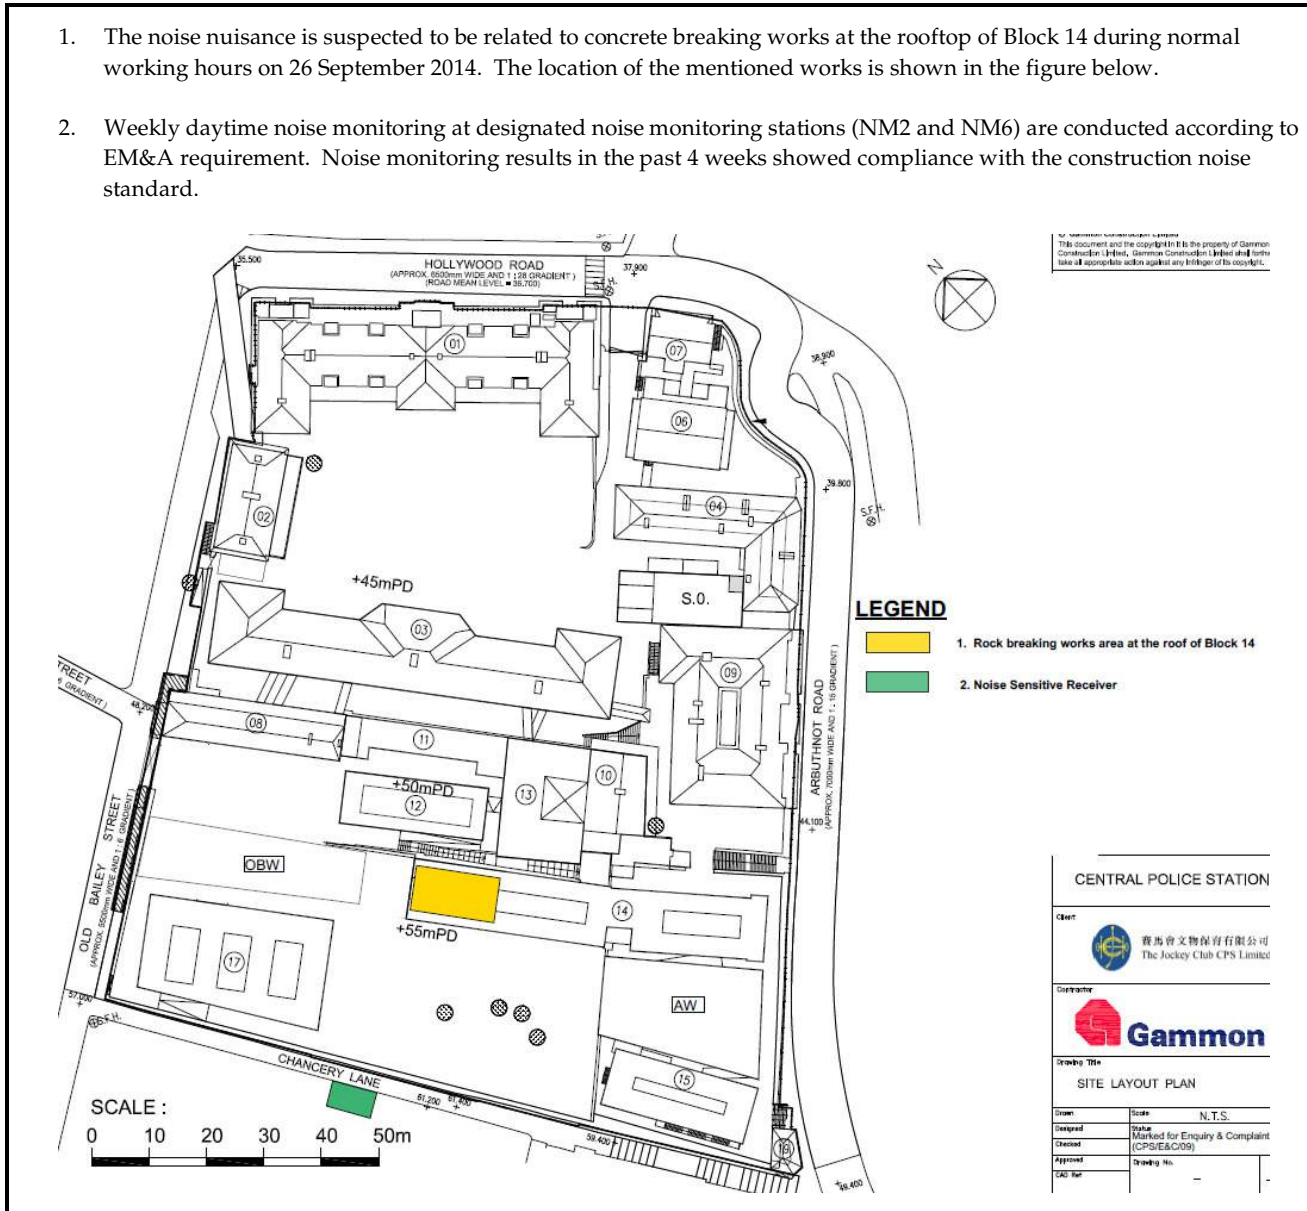
1. The noise nuisance is suspected to be related to concrete breaking works at the rooftop of Block 14 during normal working hours on 26 September 2014. The location of the mentioned works is shown in the figure below.
2. Weekly daytime noise monitoring at designated noise monitoring stations (NM2 and NM6) are conducted according to EM&A requirement. Noise monitoring results in the past 4 weeks showed compliance with the construction noise standard.

Mitigation Measures and Follow-up Actions Recommended to Contractor

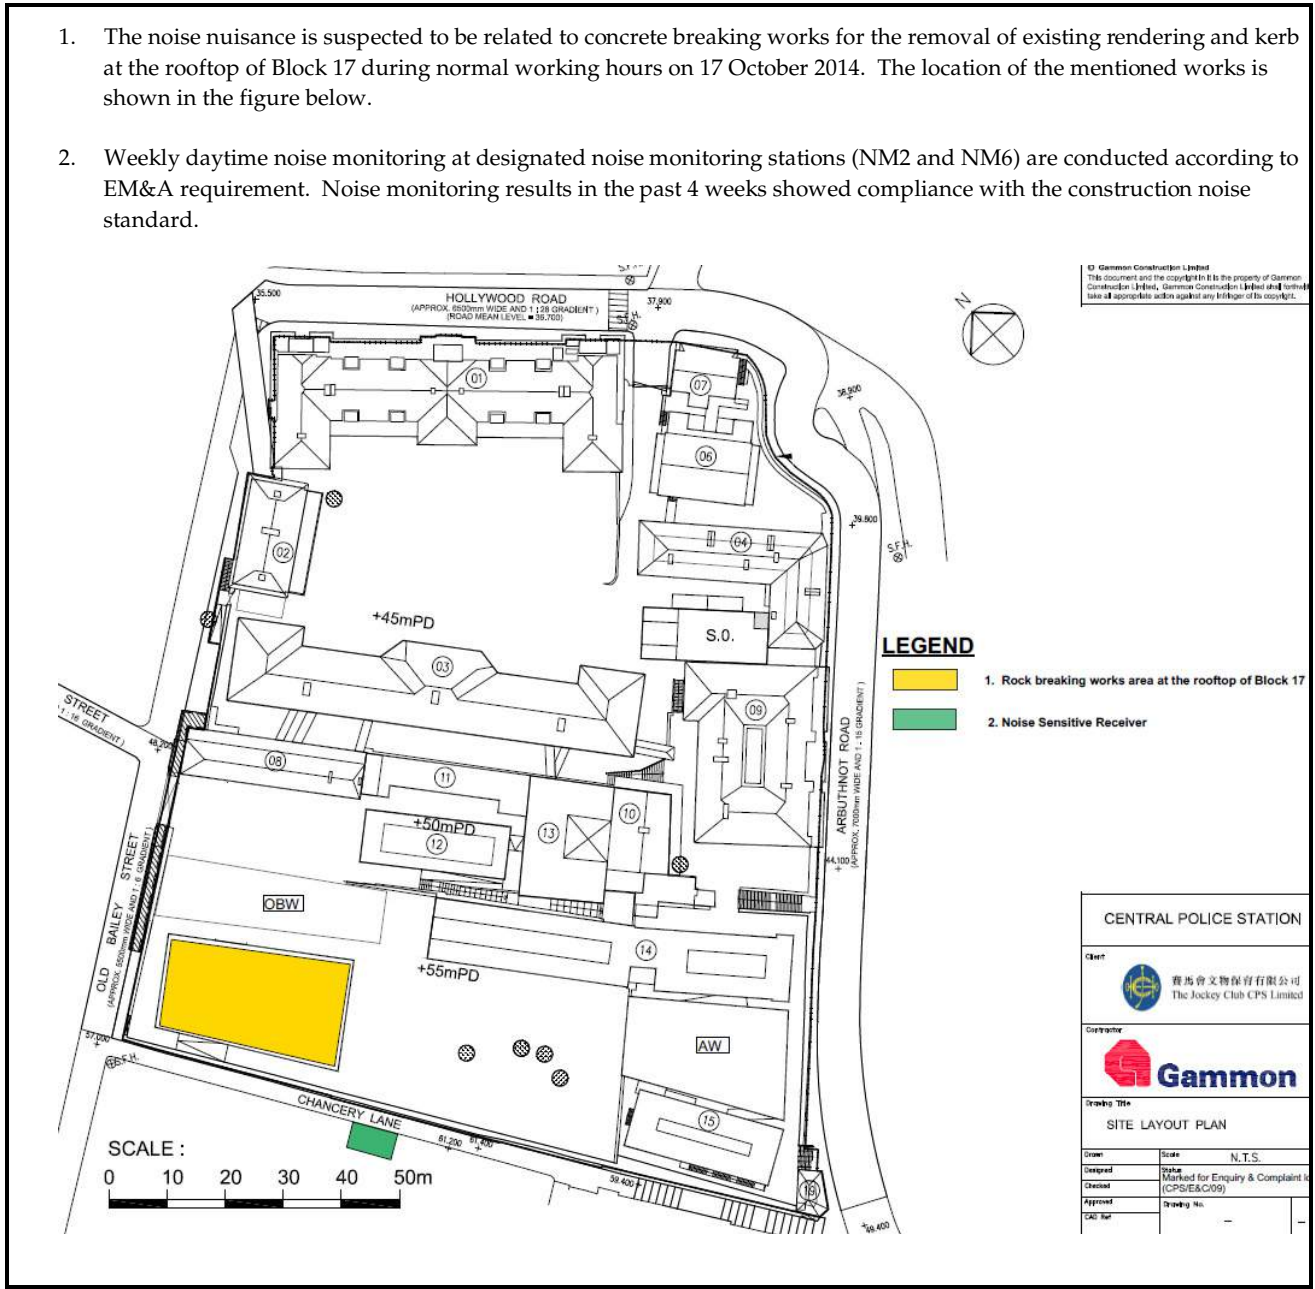
1. The noise nuisance is suspected to be related to concrete breaking works for the removal of existing rendering and kerb at the rooftop of Block 17 during normal working hours on 17 October 2014. The location of the mentioned works is shown in the figure below.
2. Weekly daytime noise monitoring at designated noise monitoring stations (NM2 and NM6) are conducted according to EM&A requirement. Noise monitoring results in the past 4 weeks showed compliance with the construction noise standard.

Mitigation Measures and Follow-up Actions Recommended to Contractor

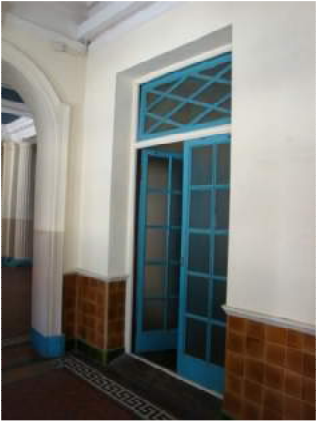
Moderate	Remove in exceptional cases eg. where adjacent new lift shafts	Cut back neatly to a square edge and ensure remaining section is secure.	Moderate
01.006	Panelled doors

Moderate	Replace where necessary to achieve fire resistance to comply with Code	Re-use where possible. Record design on survey drawings where element cannot be re-used.	Moderate

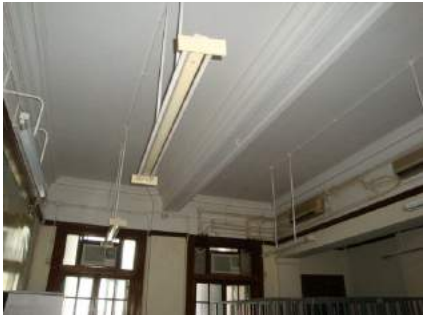
Element no.	Description	Photo ref	Significance	Proposal	Mitigation	Impact
01.009	Plaster ceilings on GF and LG1

Moderate	Install cloud ceilings to accommodate new services	Install fixed grid to minimise damage to ceiling	High
01.010	Timber door frames and architraves
