The Jockey Club CPS Limited

Central Police Station Conservation  
and Revitalisation Project:  
*Second Quarterly EM&A Report*  
*(1 February 2012 to 30 April 2012)*

Issue Date: June 2012

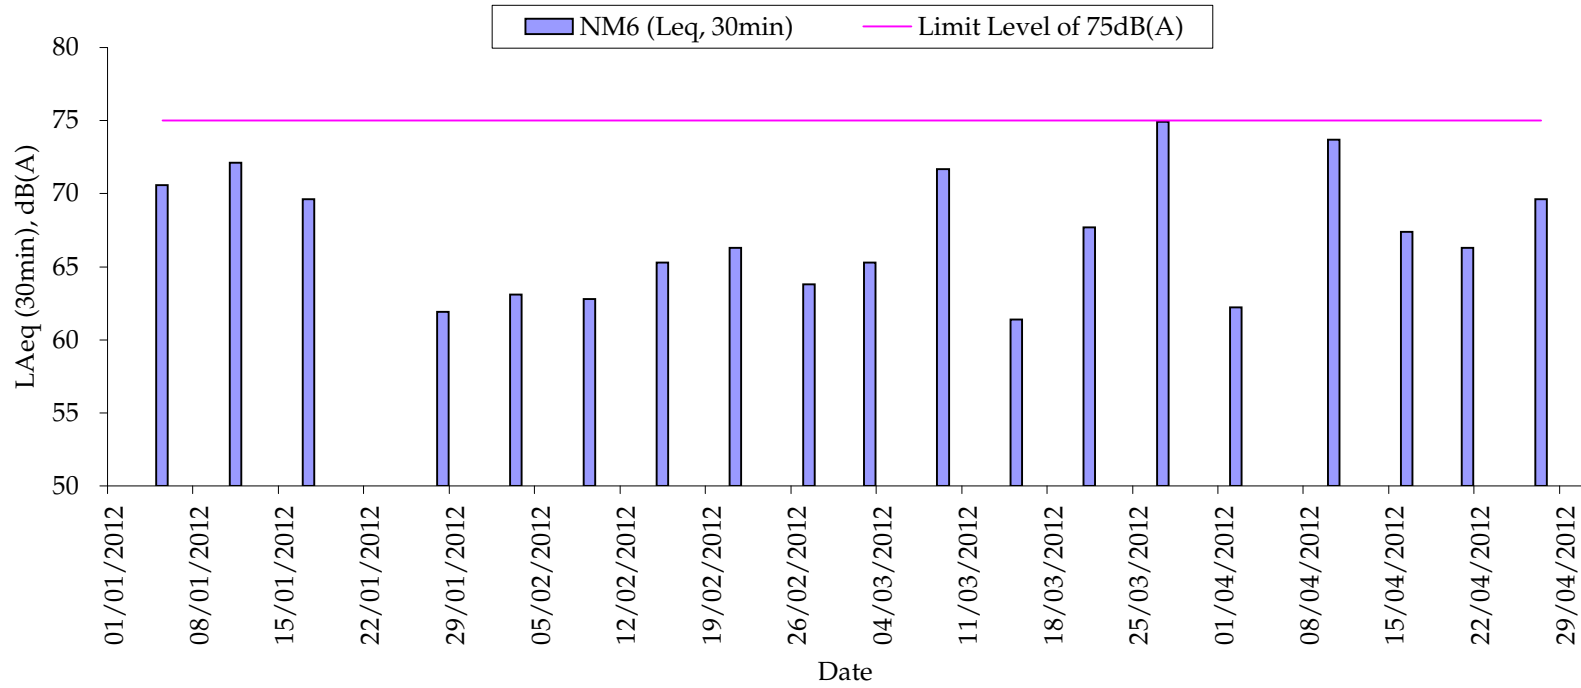
Normal Weekdays Noise Monitoring Results at NM6 - Chancery Mansion (Leq, 30min)

- 75dB(A) was adopted as the Limit Level during normal weekdays in the reporting period

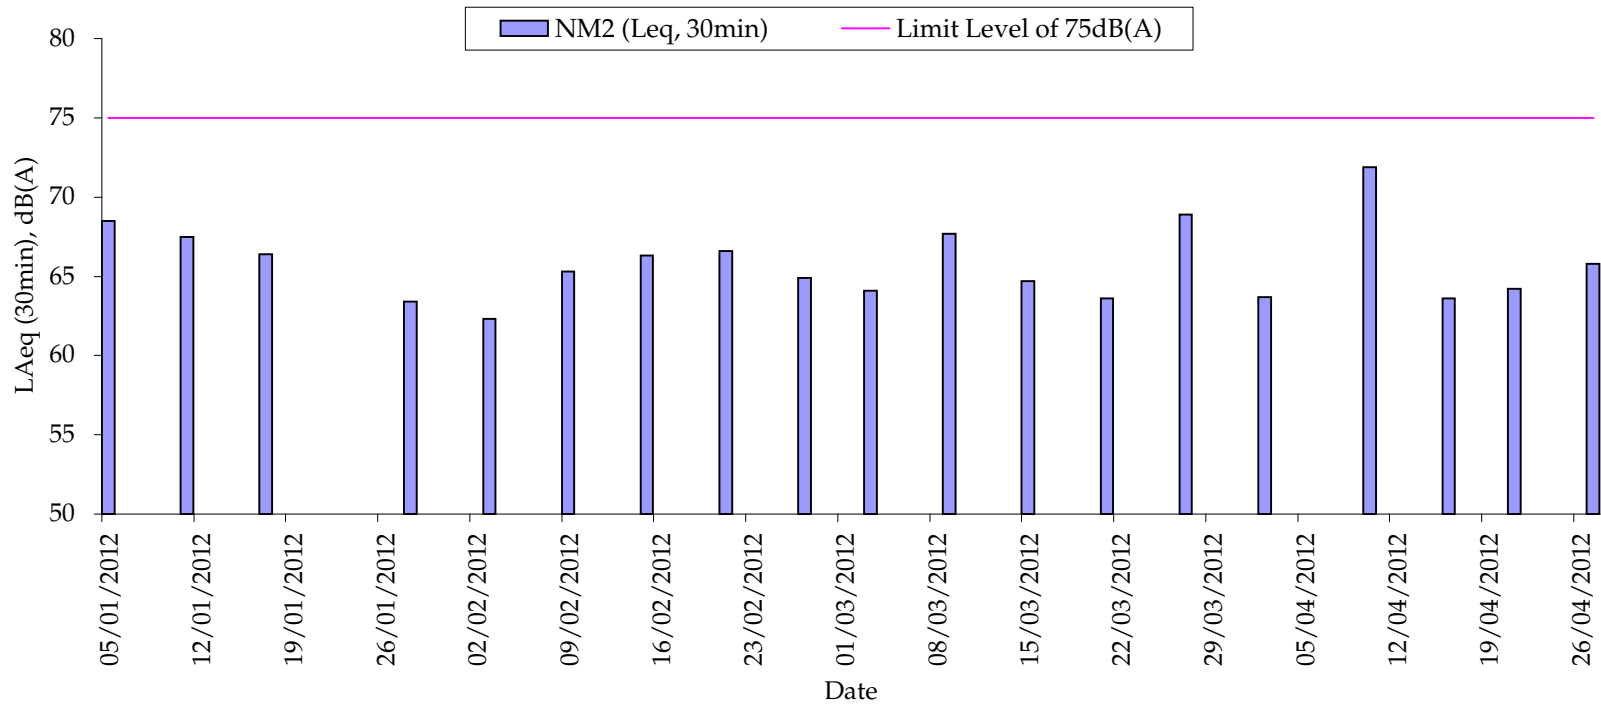
Normal Weekdays Noise Monitoring Results at NM2 - Ho Fook Building (Leq, 30min)

- 75dB(A) was adopted as the Limit Level during normal weekdays in the reporting period

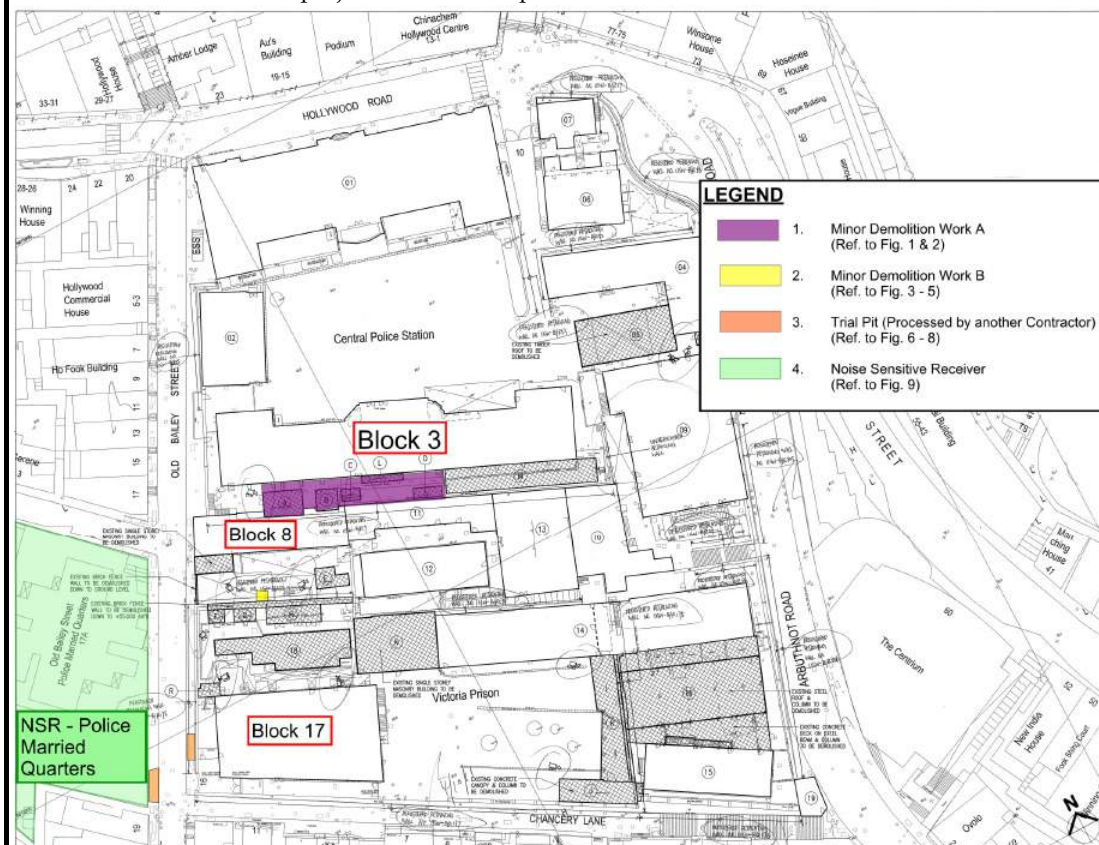
1. According to the works summary provided by the Contractor, construction work conducted included demolition works between Block 3 and Block 8, and nearby Block 8 and gantry entrance; and asbestos abatement work at Block 16. It was also noted that trial pit work for WSD’s project was conducted by another contractor at Old Bailey Street.
2. It was noted that the location of the trial pit work is nearer to the residence of the complainant compared to the construction works of the project (see the figure below). Both the construction works by another contractor at Old Bailey Street and within the project site could be possible sources of noise nuisance.

Based on the above investigation, the following mitigation measures are proposed to the Contractor to further minimize the nuisance to the adjacent users:

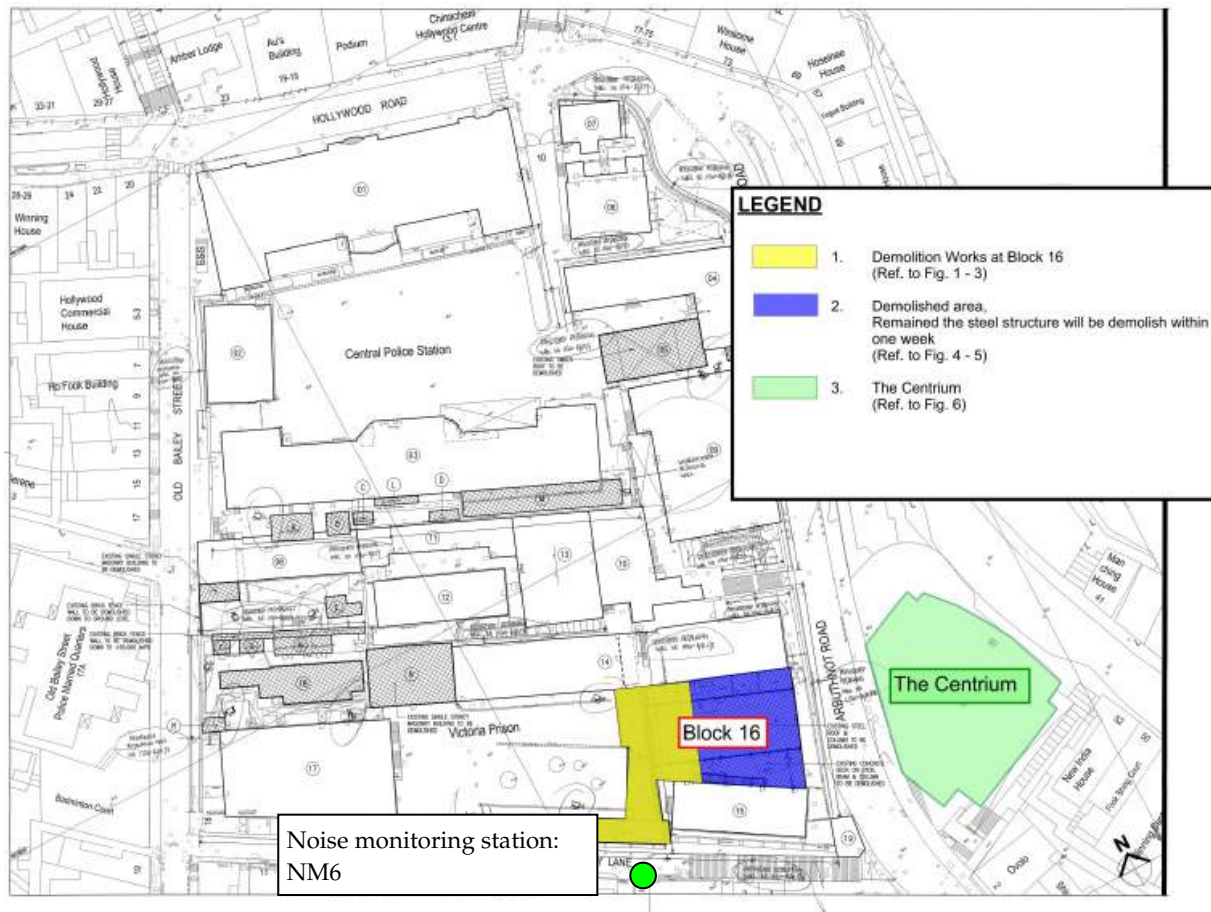
1. According to the works summary provided by the Contractor, construction work conducted during the week included demolition works at Block 16 which is located opposite the Centrum (see the figure below).

2. It was noted that the location of the demolition works at Building 16 is the nearest to the complainant. The construction noise from the demolition works at Building 16 could be possible sources of noise nuisance noted by the complainant.

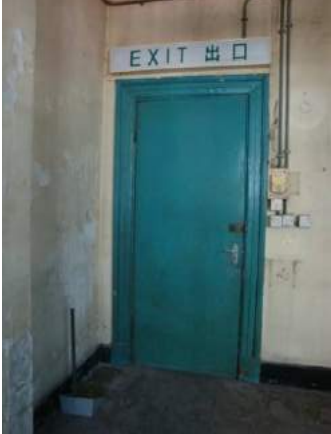
A photograph of a teal-colored door set in a wall. Above the door is a white sign with the word "EXIT" and a square symbol. The wall is light-colored and shows some wear.	Moderate
06.013	Form new door openings
