Central Police Station Conservation
and Revitalisation Project:
14th Quarterly EM&A Report
(1 February 2015 to 30 April 2015)

Issue Date: July 2015

Annex N	<i>A Summary of Current Condition of Character Defining Elements</i>

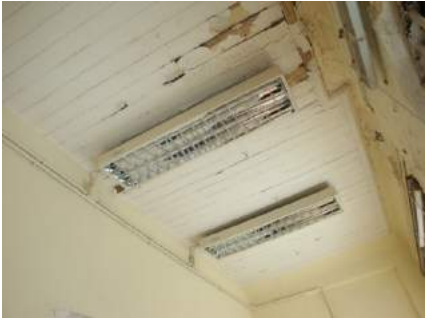
Low	Remove	Record on measured drawings and photographs	Low
01.028	Tongued and grooved flat and sloped timber boarded ceilings

Moderate	Repair where necessary and reinstate where missing	Not applicable	Moderate

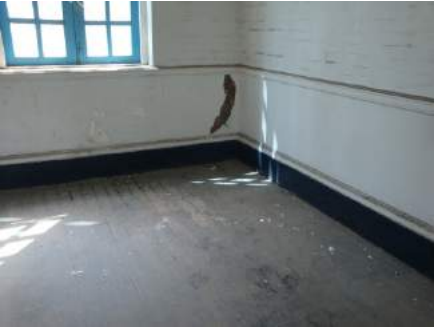
Low	Conceal in exceptional cases eg. where adjacent new lift shaft	Retain frame and spandrel panel where possible. Remove only where necessary in connection with re-planning of interiors. Record on measured survey drawings.	Low
03.006	Timber floors

High	Replace where new kitchens and plant rooms to be installed	Limit extent of removal as much as possible. Carefully remove and retain existing floorboards for re-use. Ensure controlled dismantling of timber structure and set aside for possible re-use. Protect or carefully remove and set aside adjacent elements such as skirting boards	Medium

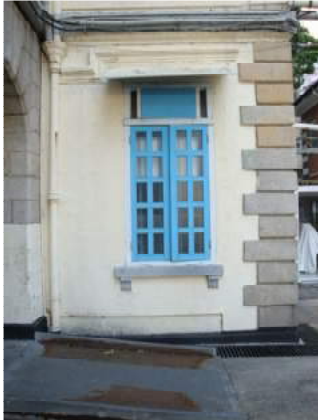
Element no.	Description	Photo ref.	Significance	Proposal	Mitigation	Impact
03.011	Altered doors and windows

Adverse	Repair or renew as necessary existing frames to match original patterns	Not applicable	High
