The Jockey Club CPS Limited

Central Police Station Conservation
and Revitalisation Project:
54th Monthly EM&A Report
(1 April to 30 April 2016)

Issue Date: May 2016

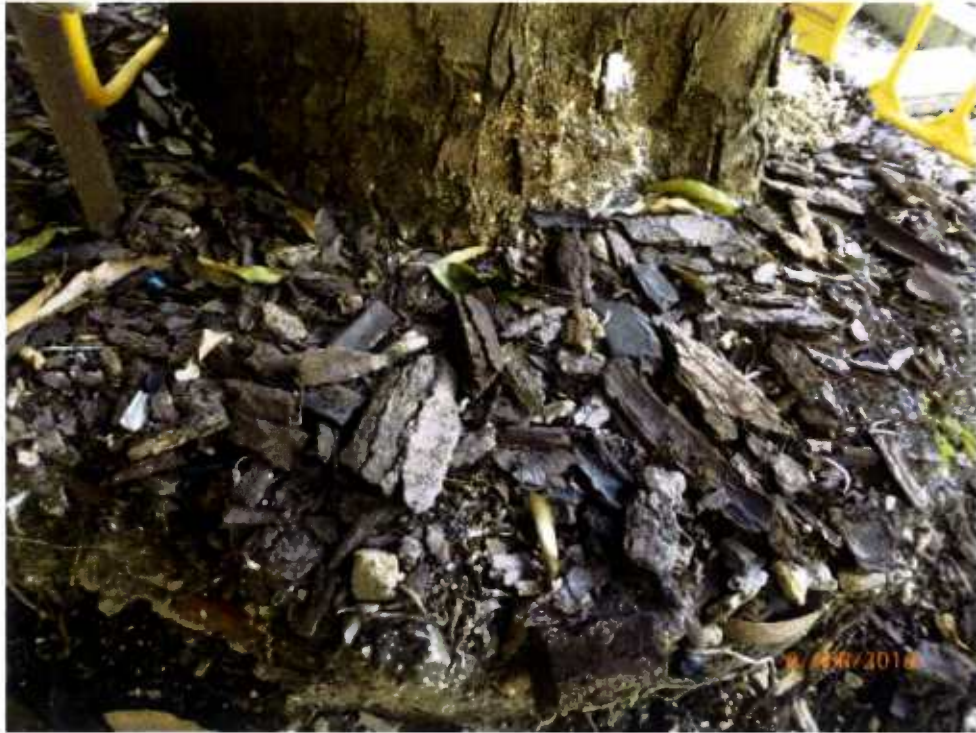
Fig 2. Root collar is normal. The planter is covered with reasonable mulch.

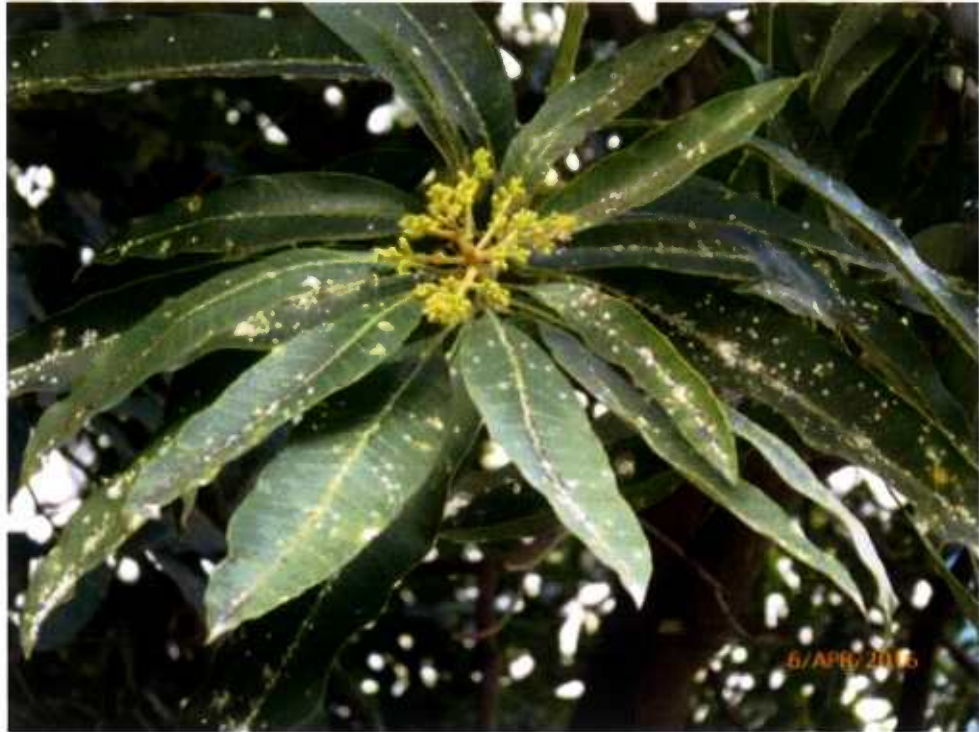
Fig. 8 Signs of Pest (Mealy Bugs 粉狀介殼蟲) have apparently increased at the time of inspection.

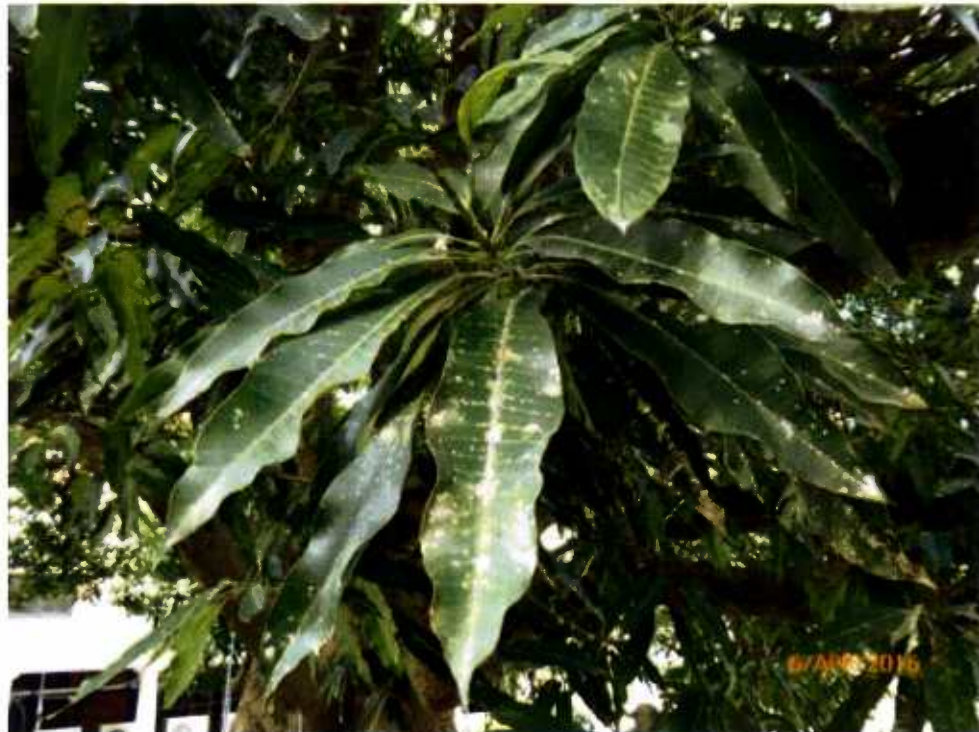
Fig. 9 Signs of Pest (Mealy Bugs 粉狀介殼蟲) are mainly found on the lower branches. Recommend to prune/trim off the affected branches/leaves and to spray pesticide for the tree a.s.a.p.

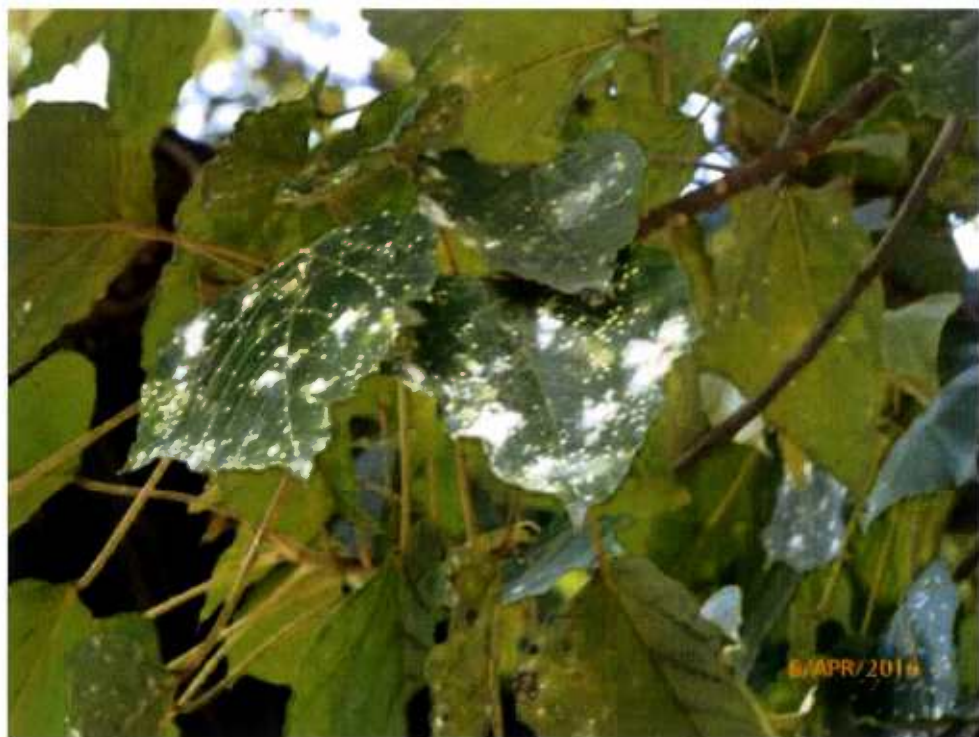
Fig. 7 Signs of Pest (Mealy Bugs 粉狀介殼蟲) are found on the leaves of Tree-6 at the time of inspection.

1. To prune/trim off the affected branches and leaves as soon as possible.
2. To spray pesticide for the tree as soon as possible.

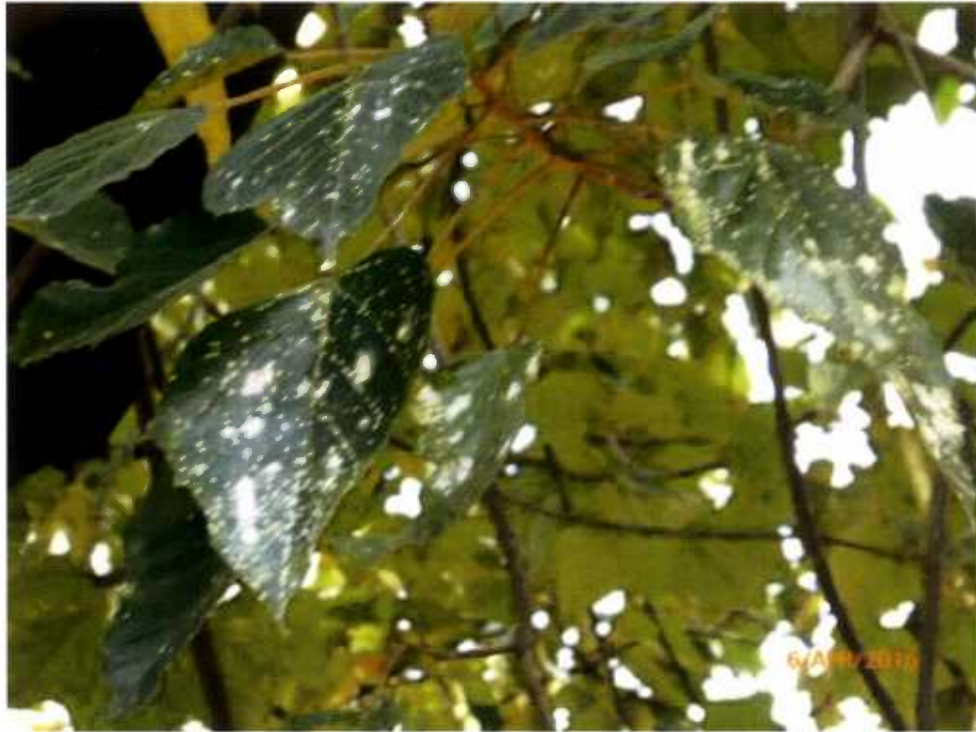
Fig. 8 Signs of Pest (Mealy Bugs 粉狀介殼蟲) are mainly found on the leaves of the lower branches. Recommend to prune/trim off the affected branches/leaves and to spray pesticide for the tree a.s.a.p.

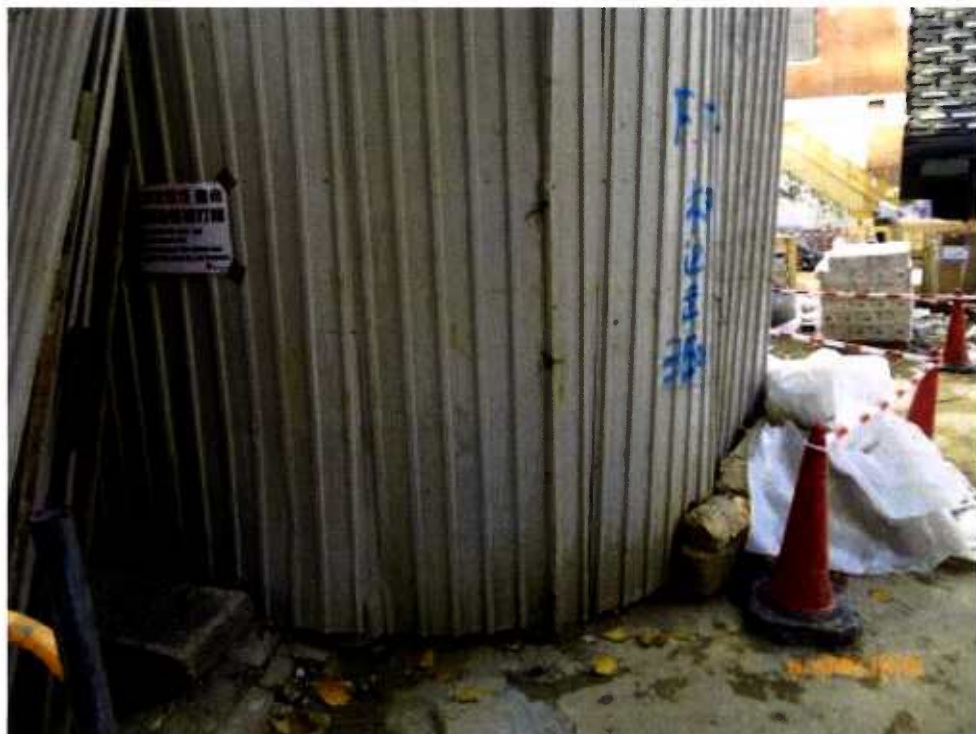
Fig. 9 Several metallic sheets surrounded the planter to act as a cordon zone.

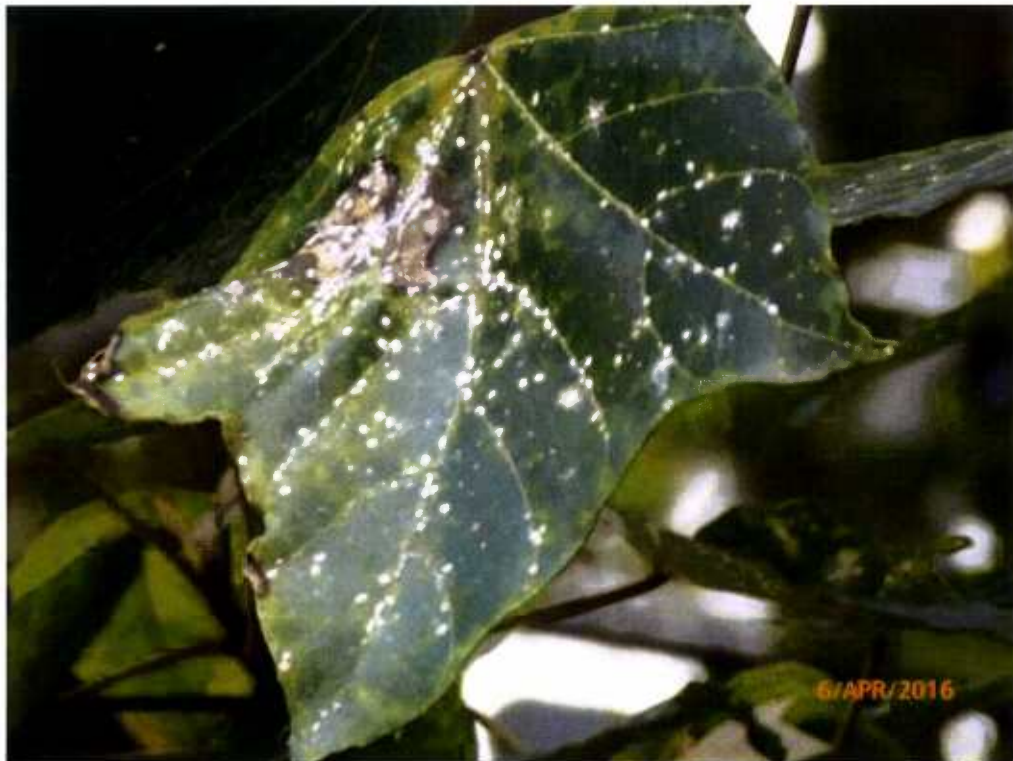
Fig. 7 Signs of Pest (Mealy Bugs 粉狀介殼蟲) are found on the leaves of Tree-7 at the time of inspection.

1. To prune/trim off the affected branches and leaves as soon as possible.
2. To spray pesticide for the tree as soon as possible.

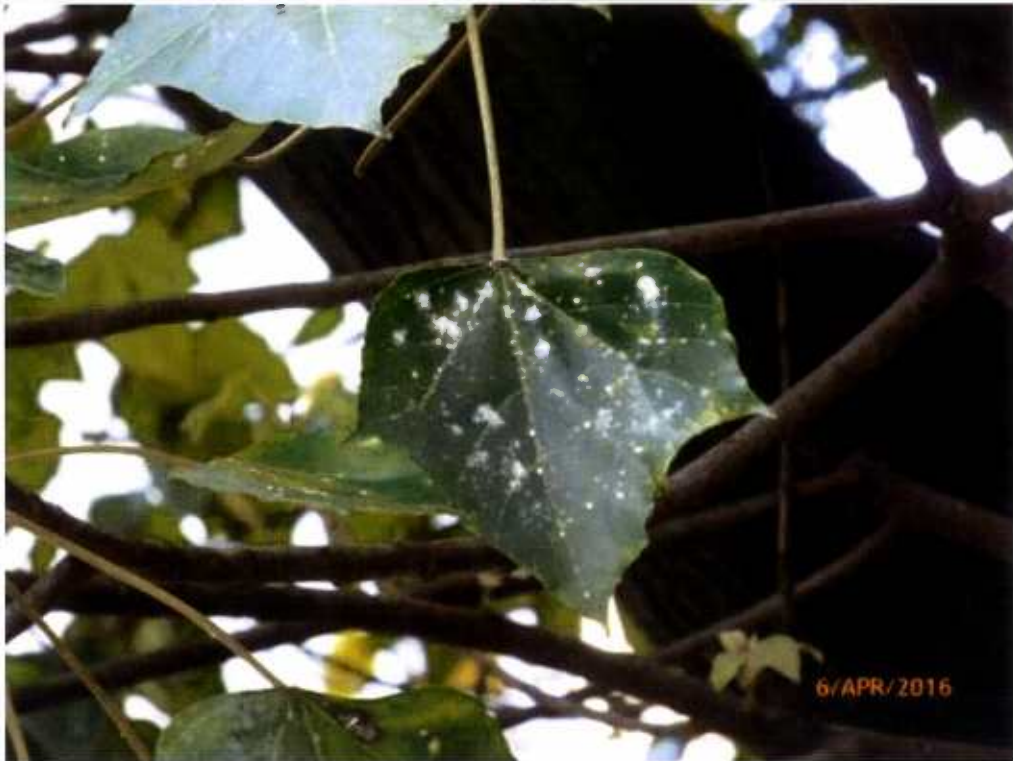
Fig. 8 Signs of Pest (Mealy Bugs 粉狀介殼蟲) are mainly found on the leaves of the lower branches. Recommend to prune/trim off the affected branches/leaves and to spray pesticide for the tree a.s.a.p.

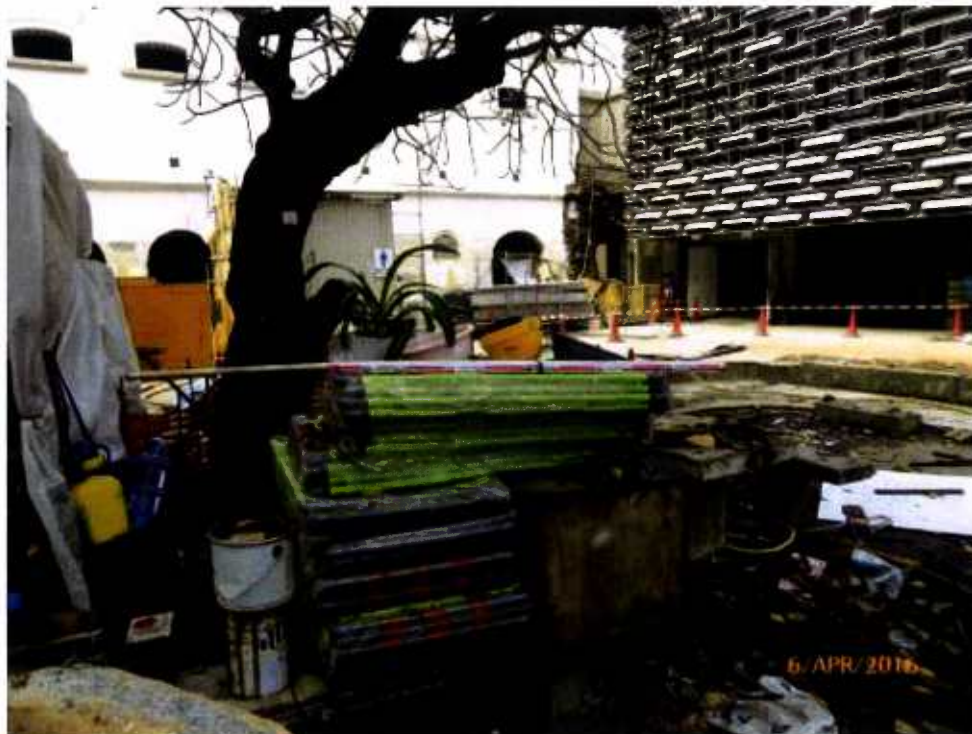
Fig. 7 Many bulky items are placed near the tree.

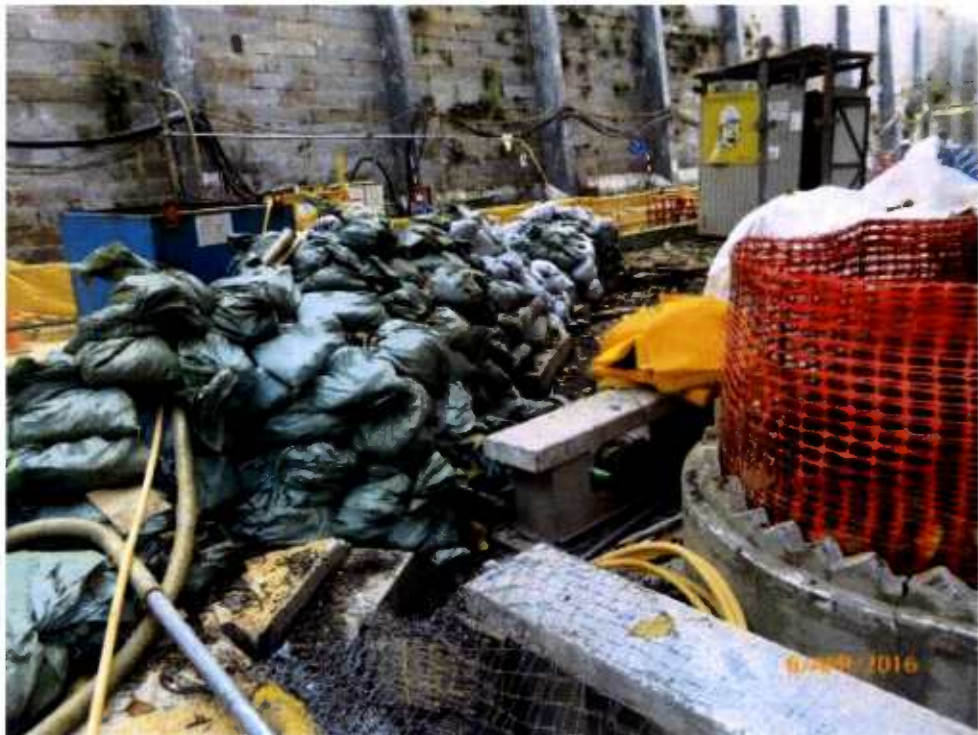
Fig. 9 Many bulky items are placed near the planter.
