Central Police Station Conservation and Revitalisation Project:
Twelfth Monthly EM&A Report (1 October to 31 October 2012)

Issue Date: November 2012

Central Police Station Conservation and Revitalisation Project:
Twelfth Monthly EM&A Report (From 1 October to 31 October 2012)

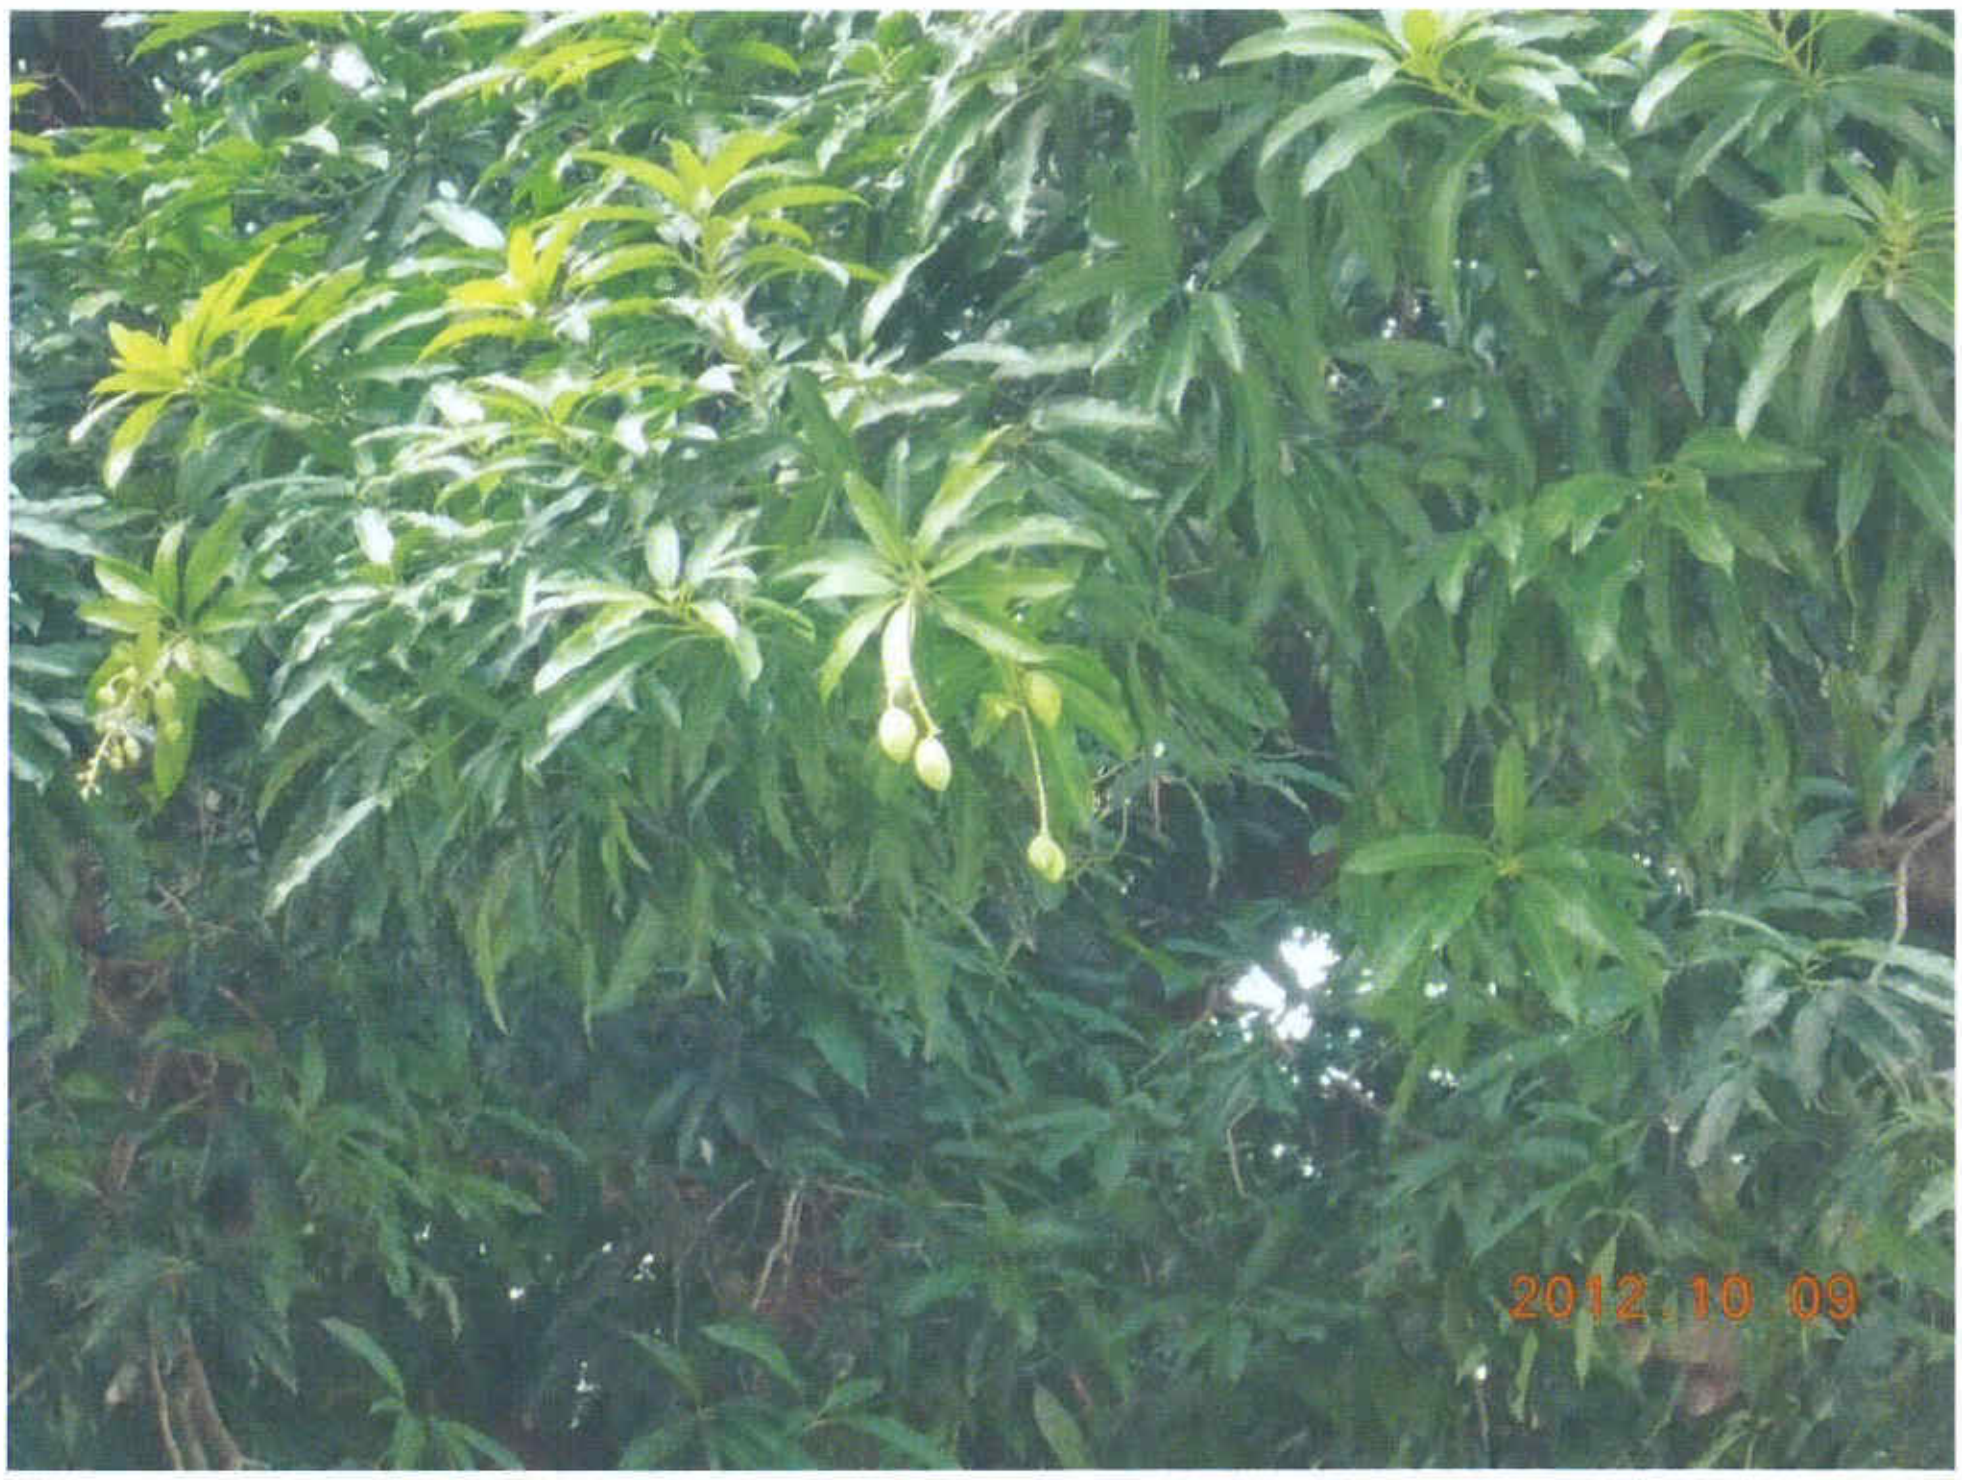
Fig. 8 Overall view of Tree-5 during inspection on 9th October 2012.

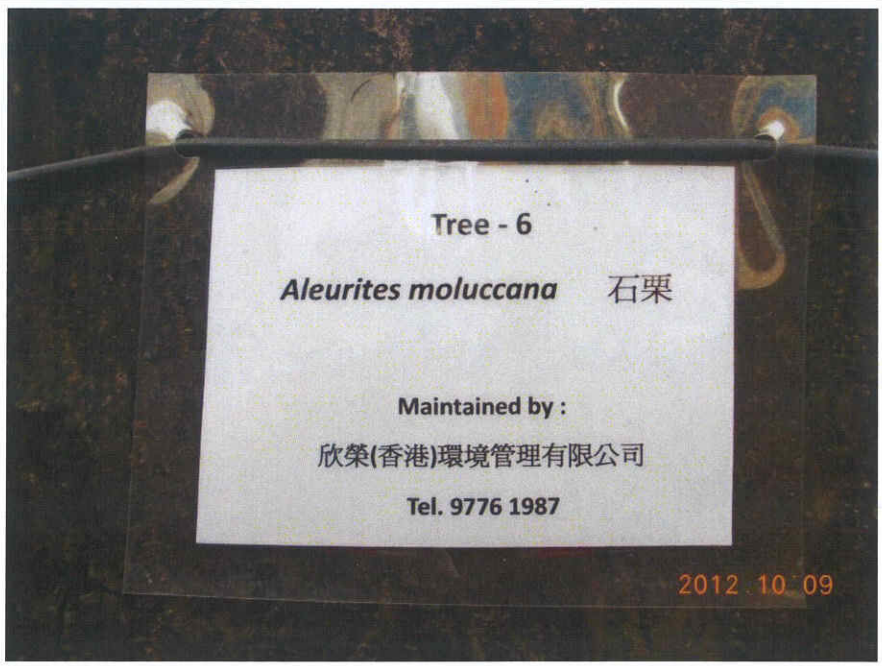
Fig 1. Tree number

Fig 2. The planter is clean and tidy during inspection on 9th Oct. 2012.

Fig. 3 Cracks in question are well-repaired. No more new cracks have been detected at the time of inspection.

1. To continue regular inspections on the cracks every week.
2. To remove the decayed branches as well as the drooping branches/leaves.

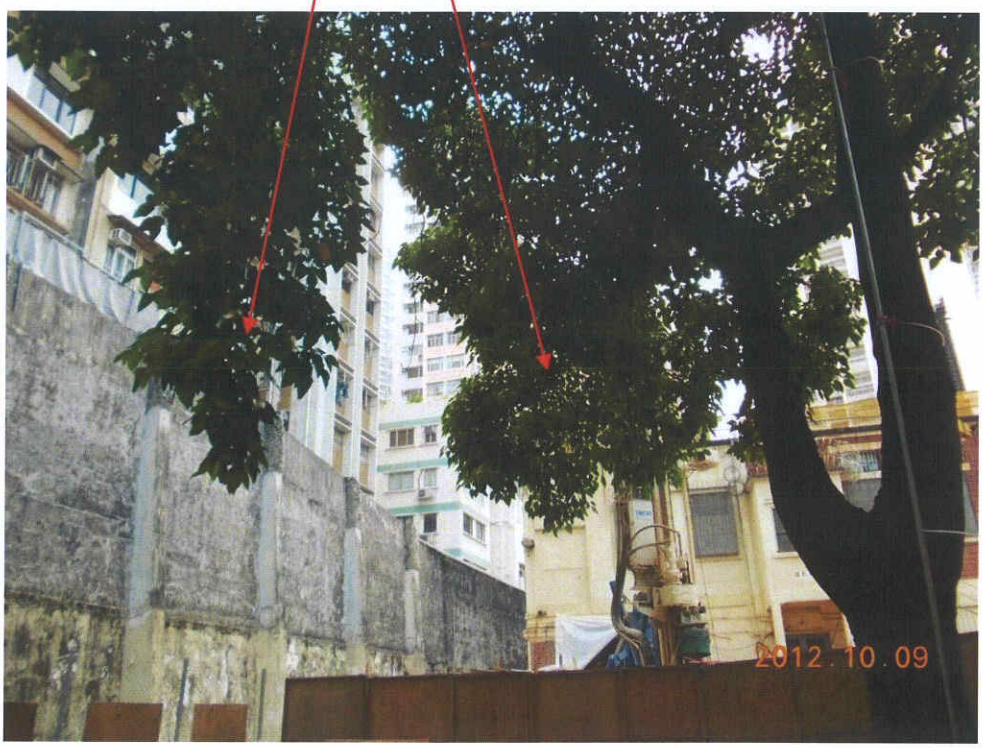
Fig. 5 Many drooping branches/leaves appear on the tree. Removal of such branches/leaves are recommended.

Fig. 6 Some decayed branches have been found on the tree top. Such decayed branches should be removed a.s.a.p.

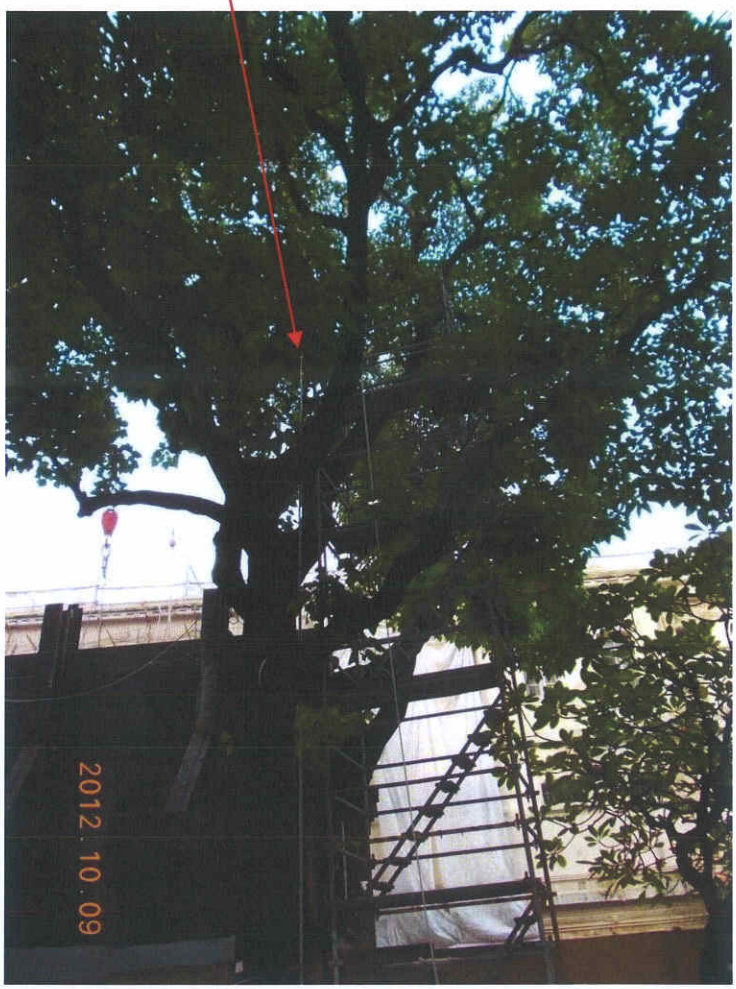
Fig. 4 A scaffold is being set up near the tree for repairing of the broken water pipe.

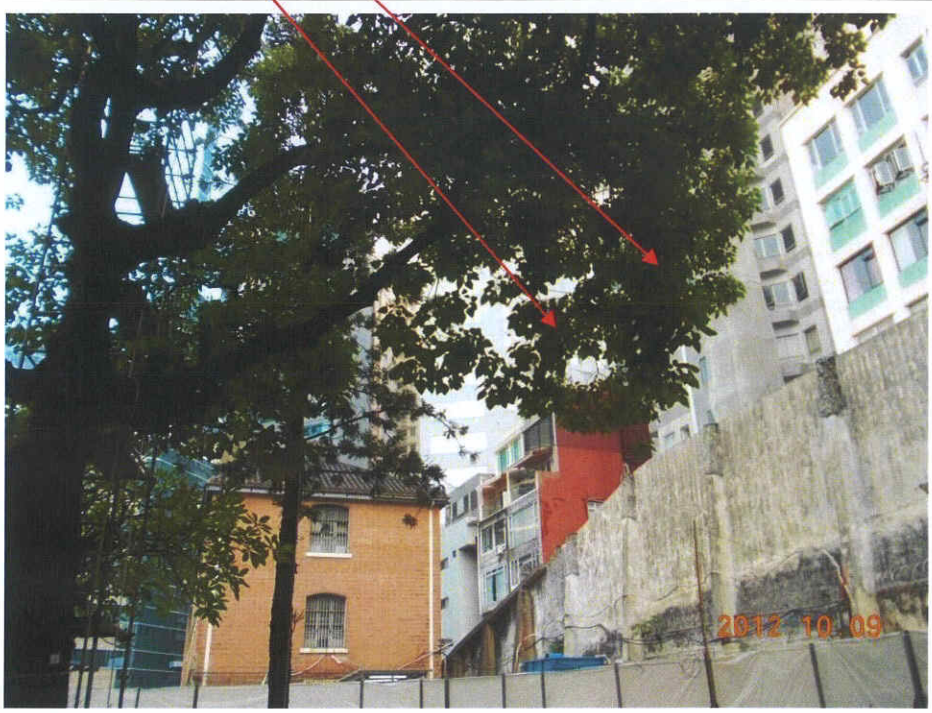
Fig. 5 Some drooping branches/leaves appear on the tree. Removal of such branches/leaves are recommended.

Fig. 6 Many bulky items are still placed near Tree-7.

1. To continue regular inspections on the cracks every week.
2. To remove the drooping branches/leave from the tree.

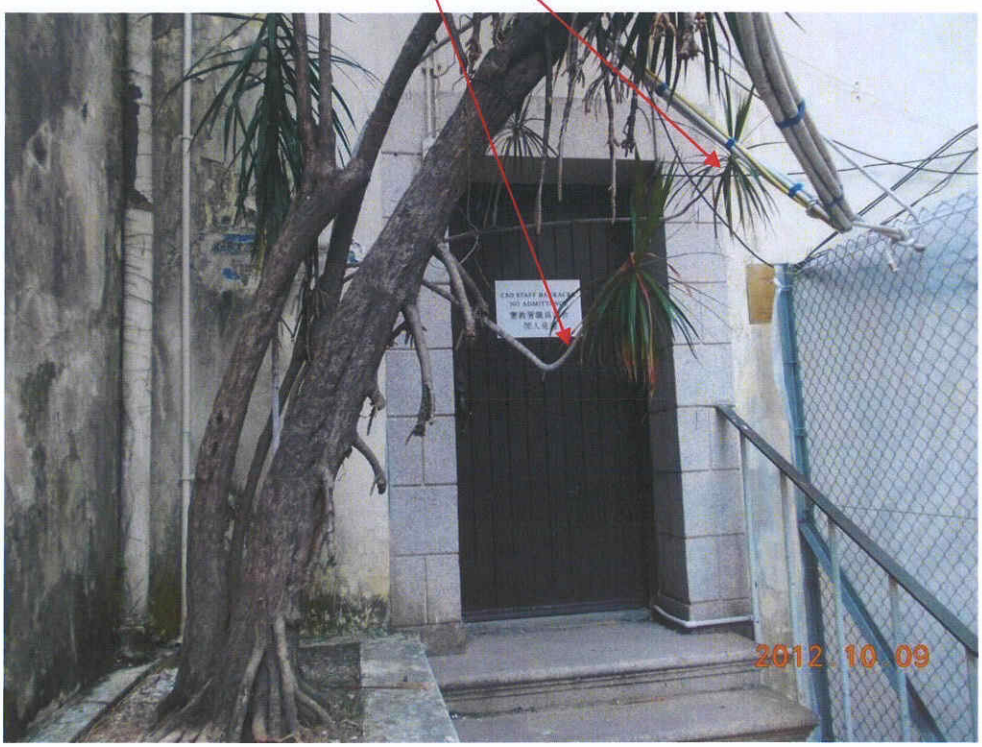
Fig. 5 Some overgrown branches have obstructed the access, we recommend to keep them close to the tree by nylon ropes.
