Central Police Station Conservation and Revitalisation Project:
Fifteenth Monthly EM&A Report (1 January to 31 January 2013)

Central Police Station Conservation and Revitalisation Project:
Fifteenth Monthly EM&A Report (From 1 January to 31 January 2013)

Issue Date: February 2013

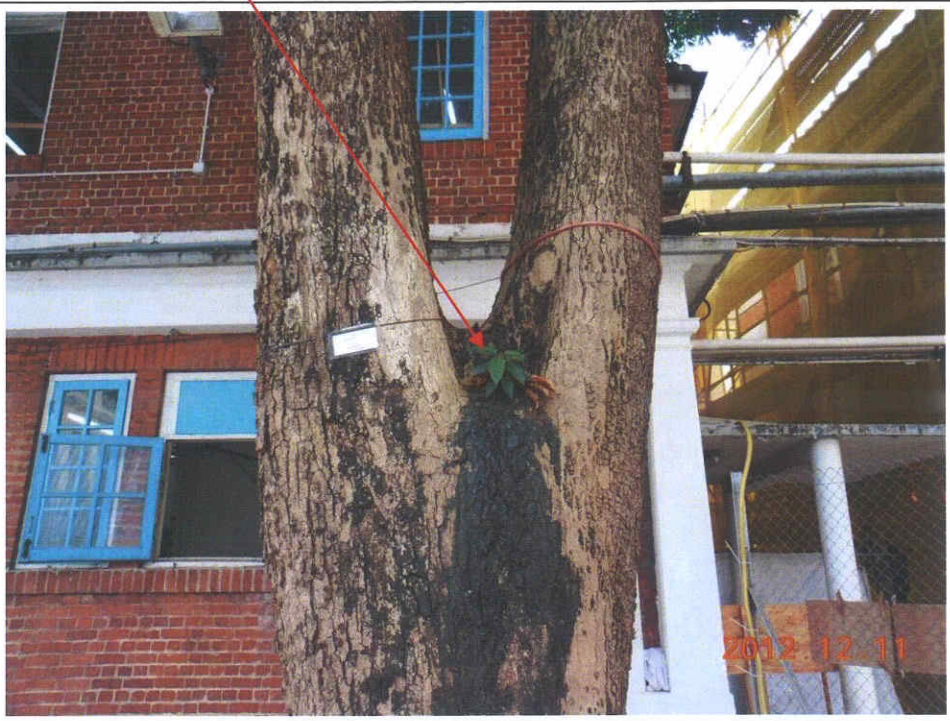
Fig. 4 Parasitic plant appeared on Tree-5 during inspection on 11.12.2012.

Fig. 5 The plant has been removed prior to inspection on 30.1.2013.

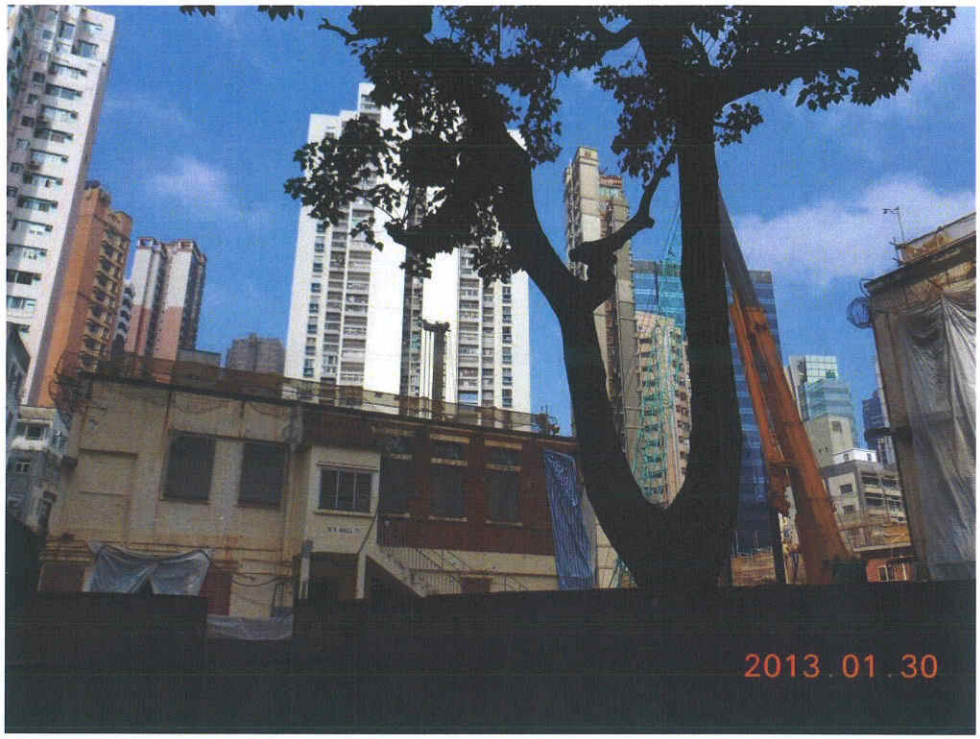
Fig. 3 Bulky items were placed near Tree-6 during inspection on 11.12.2012.

Fig. 4 Bulky items have been removed during inspection on 30.1.2013.

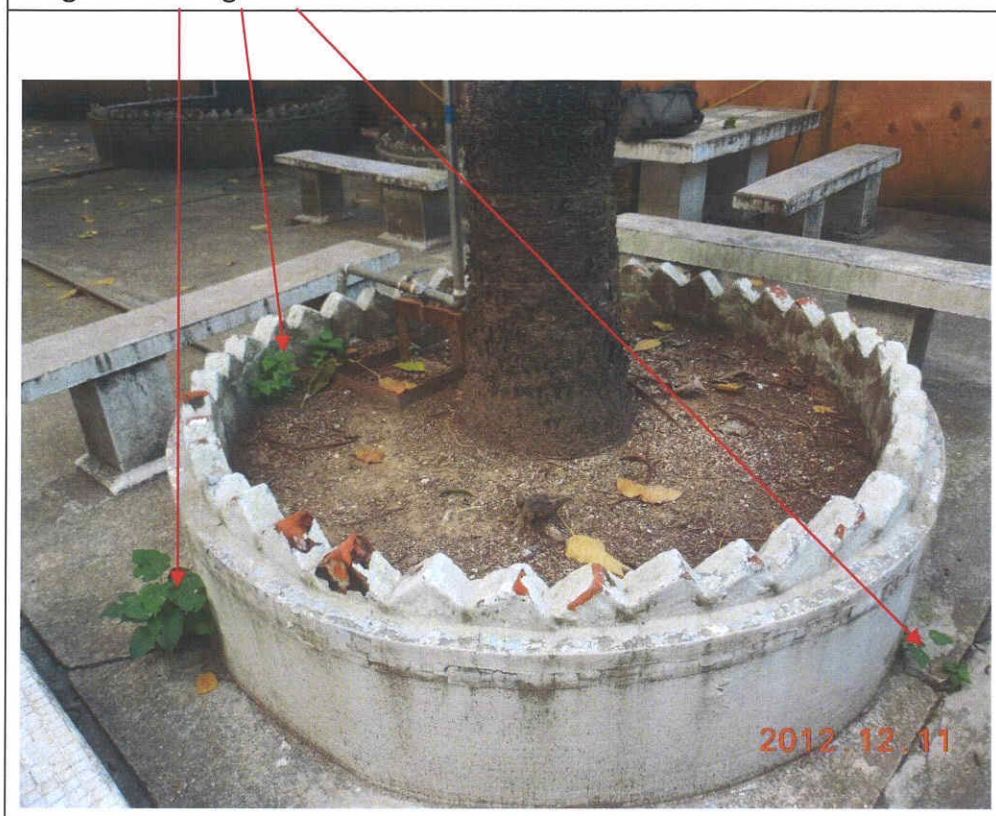
Fig 2. Undergrowth had been found near Tree-9 on 11.12.2012.

Fig. 3 All undergrowth have been removed prior to inspection.
