Central Police Station Conservation
and Revitalisation Project:
75th Monthly EM&A Report
(1 January to 31 January 2018)

Issue Date: February 2018

Reference 0095646

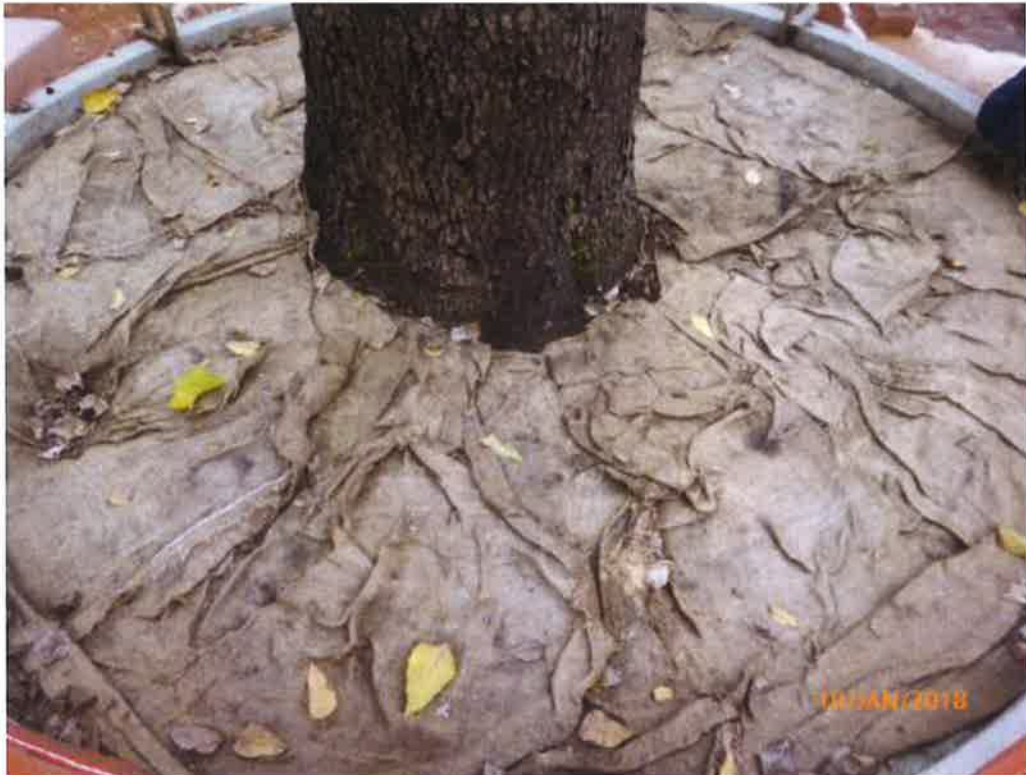
Fig 3. Health condition of the lower trunk is fair.

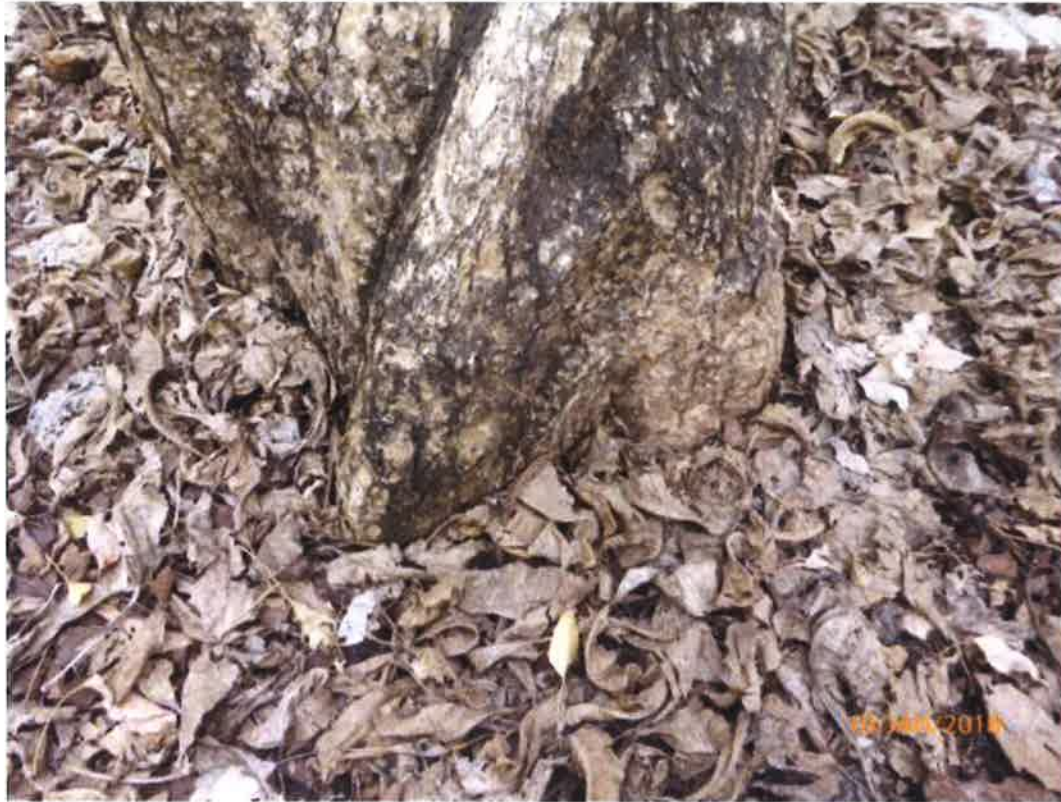
Fig. 3 Health condition of the lower trunk is fair.

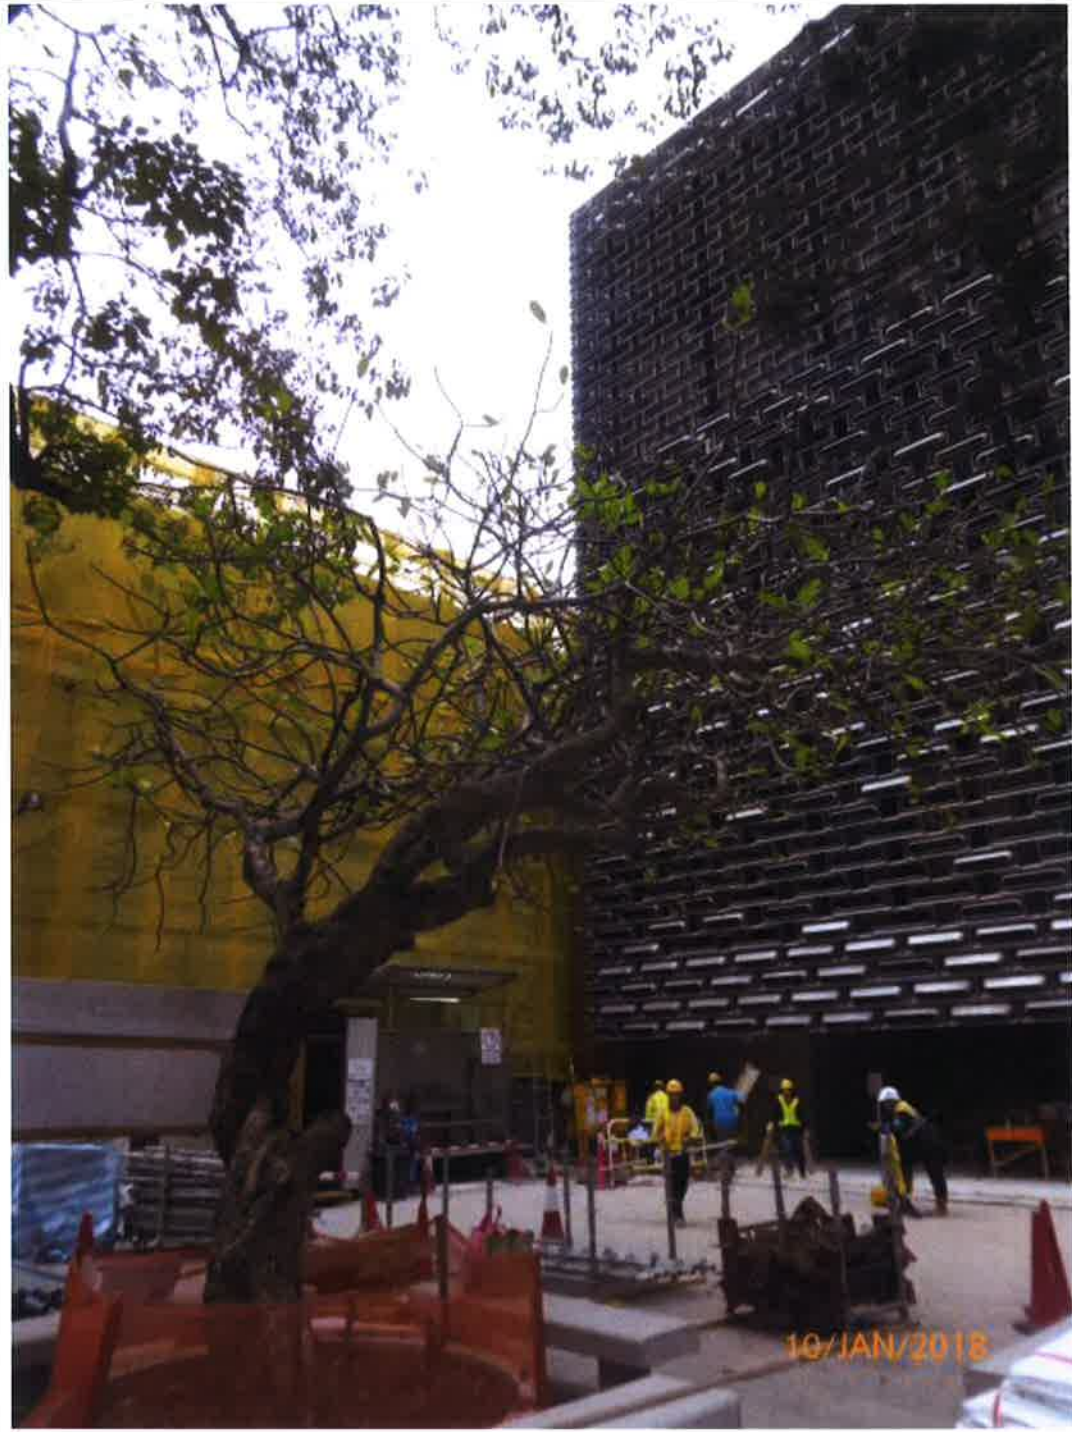
Fig. 12 Overall view of Tree-8 during inspection on 10th January 2018.

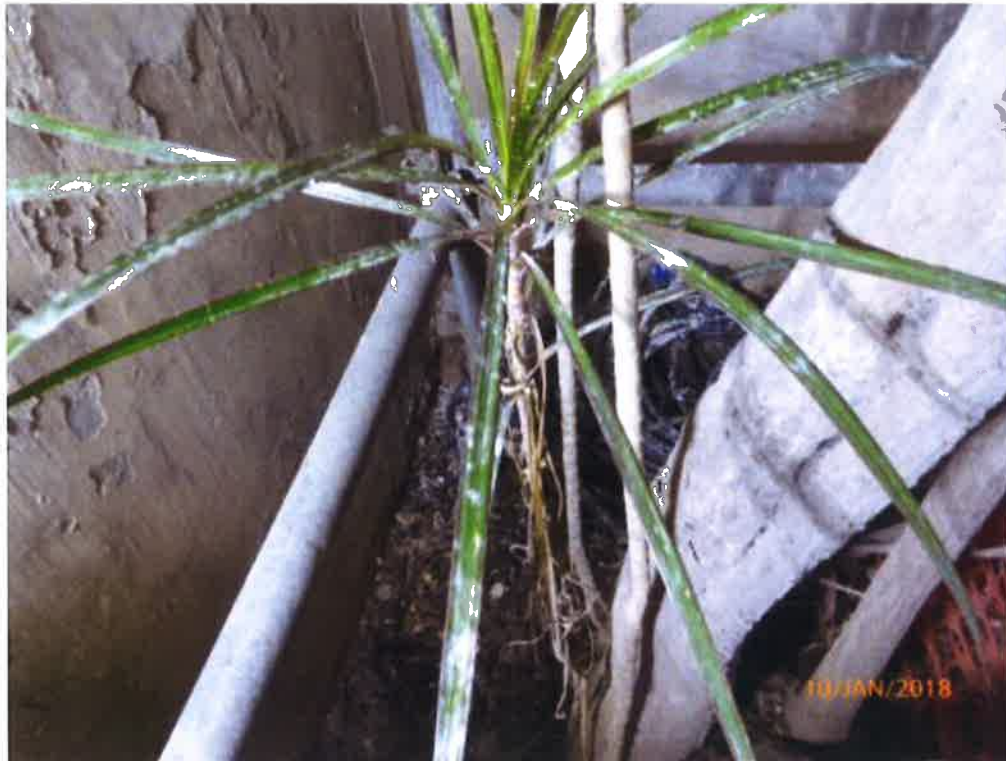
Fig. 7 Withered leaves still appear on the lower branches.

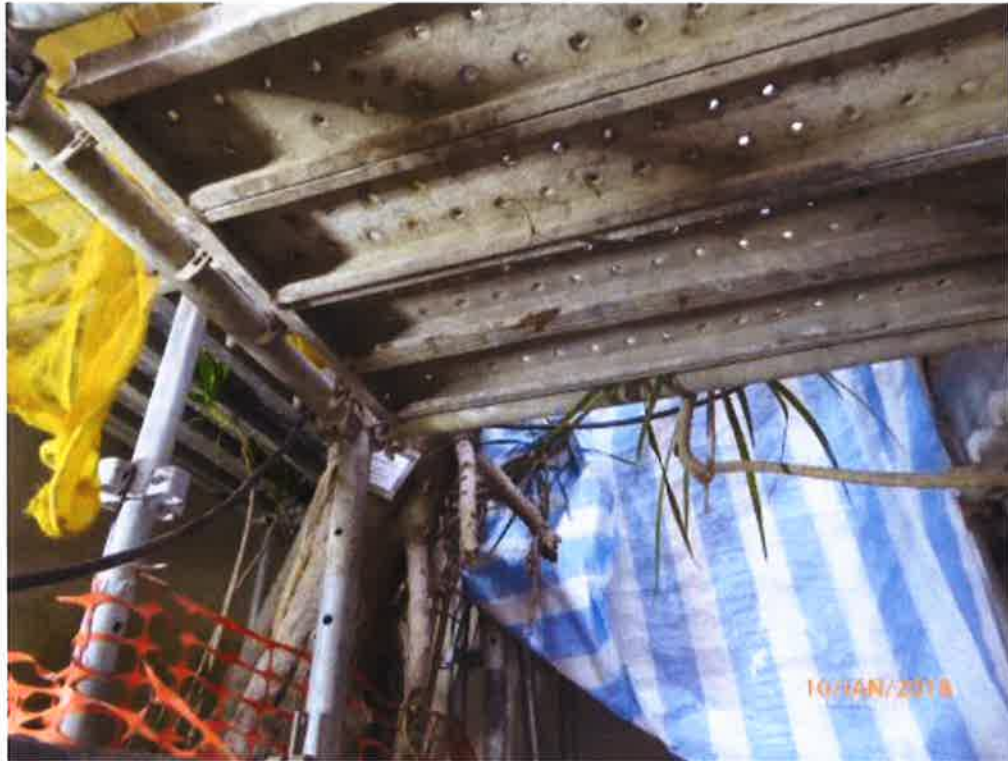
Fig. 11 The tree protection zone is in order.
