The Jockey Club CPS Limited

Central Police Station Conservation
and Revitalisation Project:
69th Monthly EM&A Report
(1 July to 31 July 2017)

Issue Date: August 2017

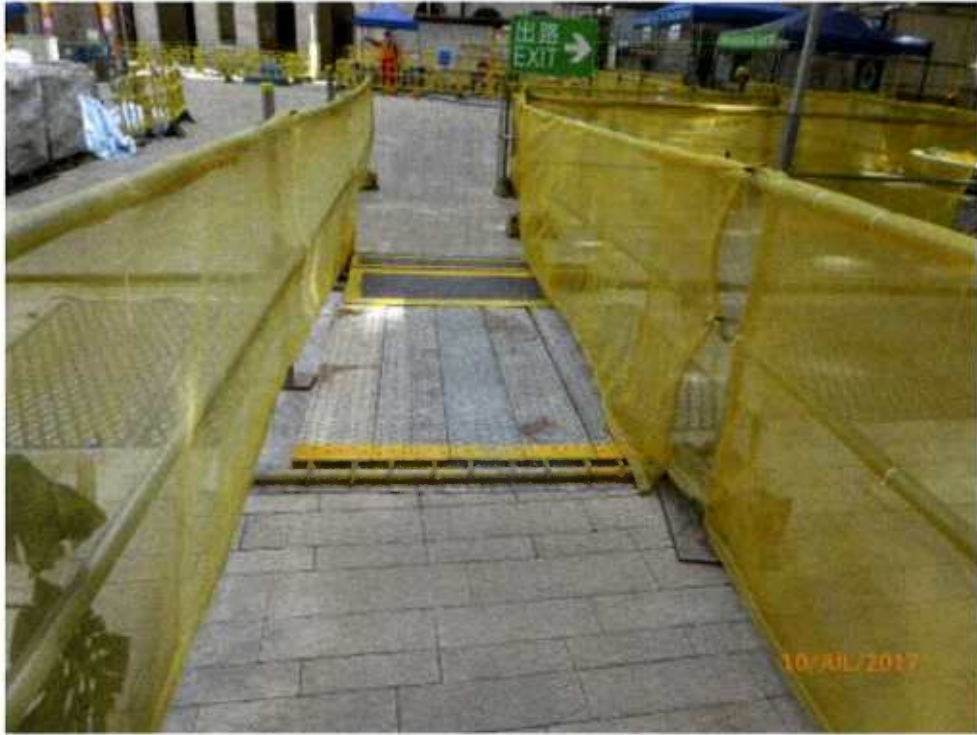
Fig. 10 The access near the planter is clean and tidy.

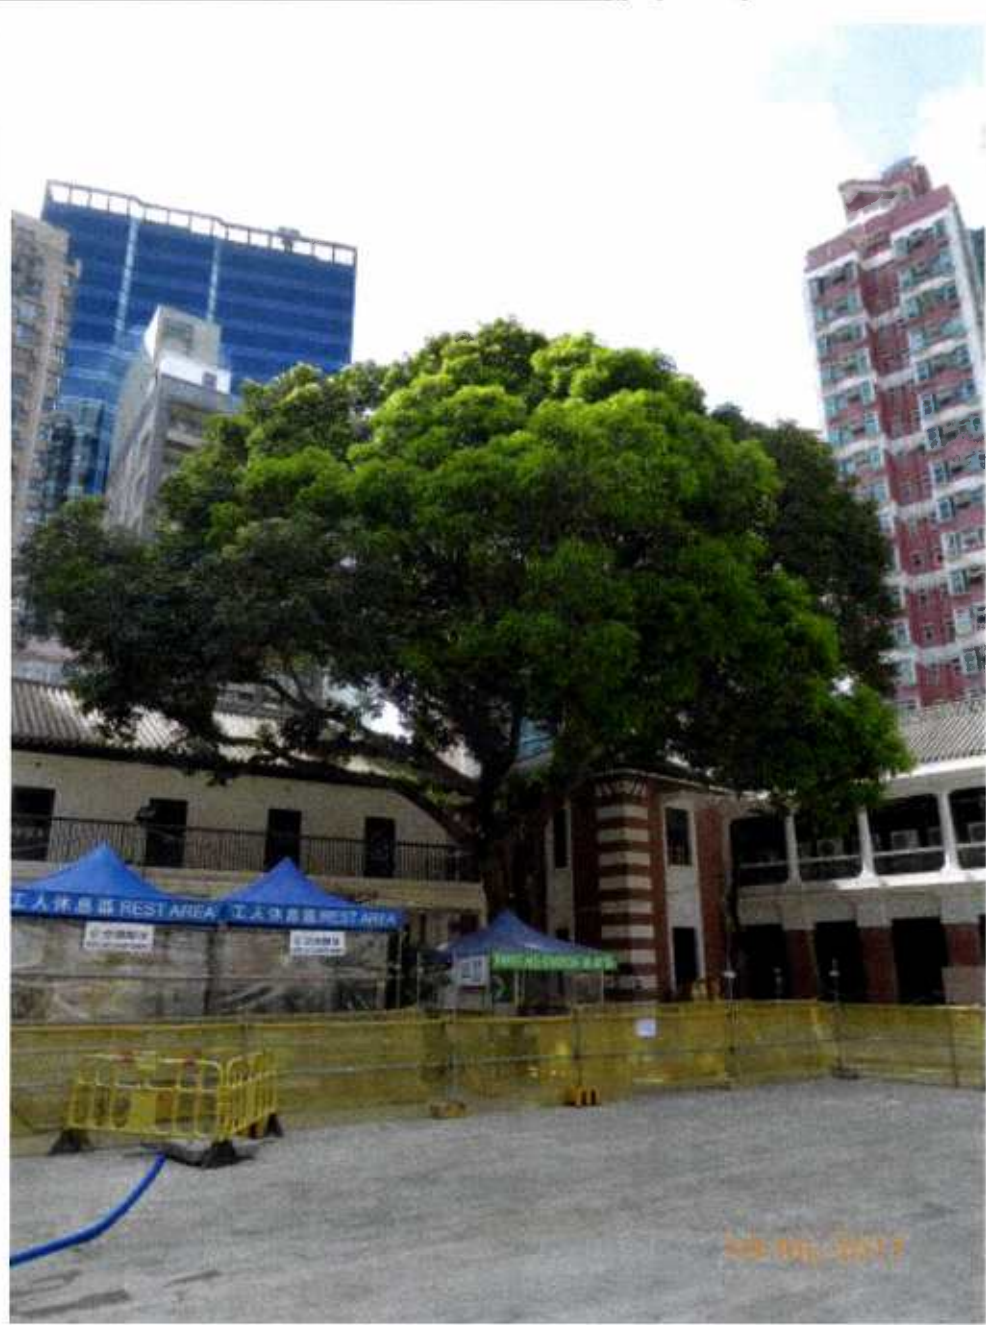
Fig. 12 Overall view of Tree-5 during inspection on 10th Jul. 2017.

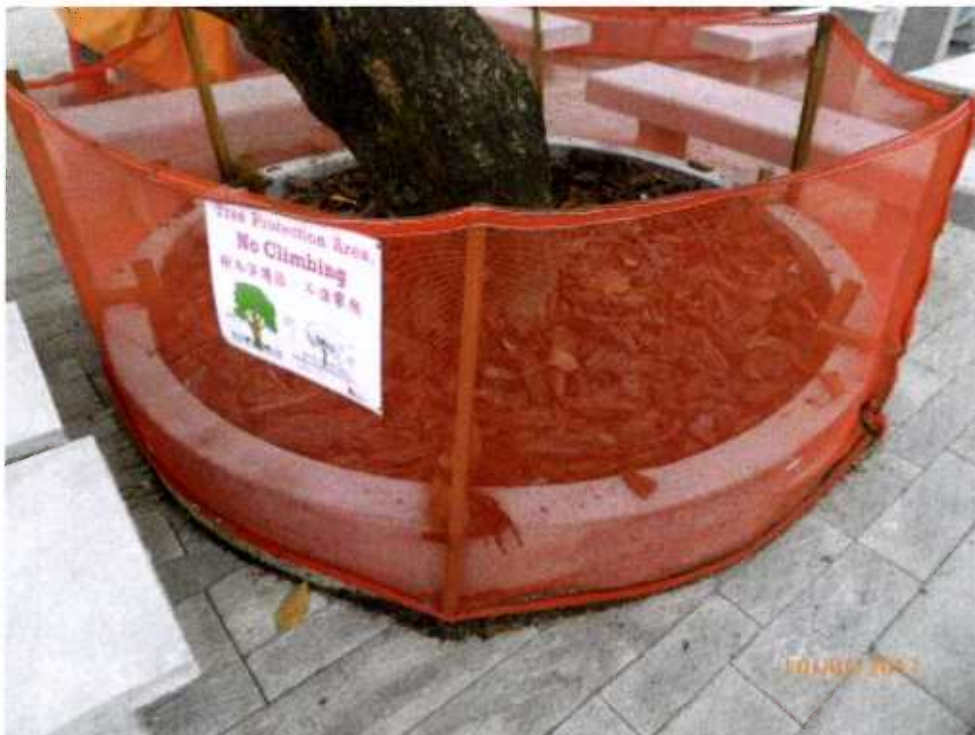
Fig. 10 The site near the planter is clean and tidy.

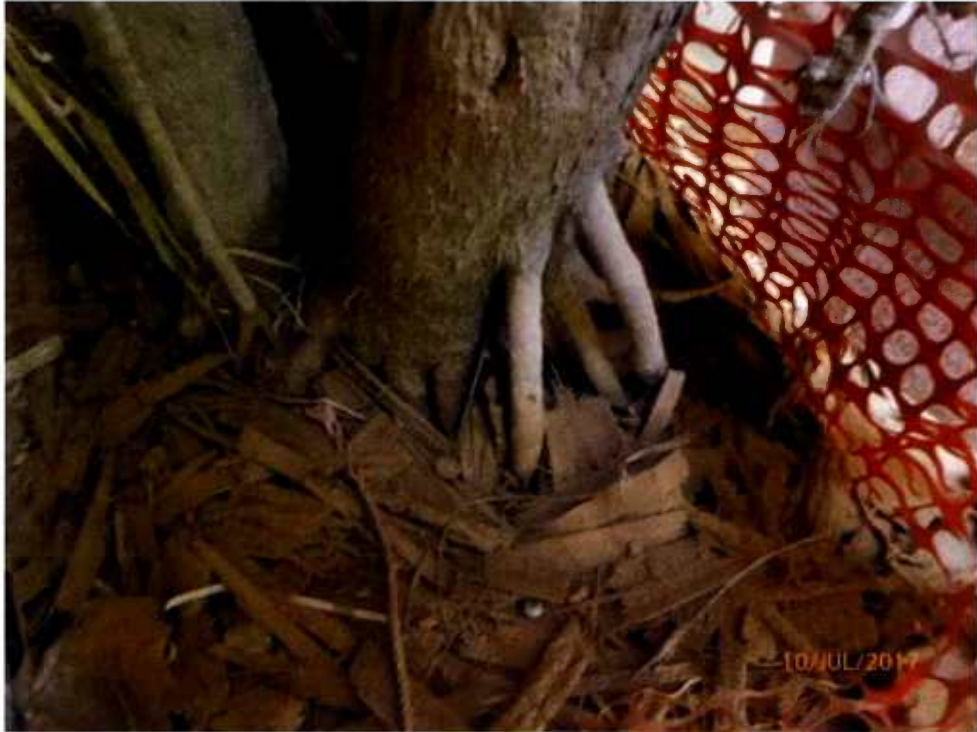
1. Health condition of the tree is fair.
2. Root collar is normal, **The planter is covered with much construction dust.**
3. Withered leaves still appear on the tree.
4. Many construction materials are placed near the tree.

Fig. 2 Root collar is normal. The planter is covered with construction dust.

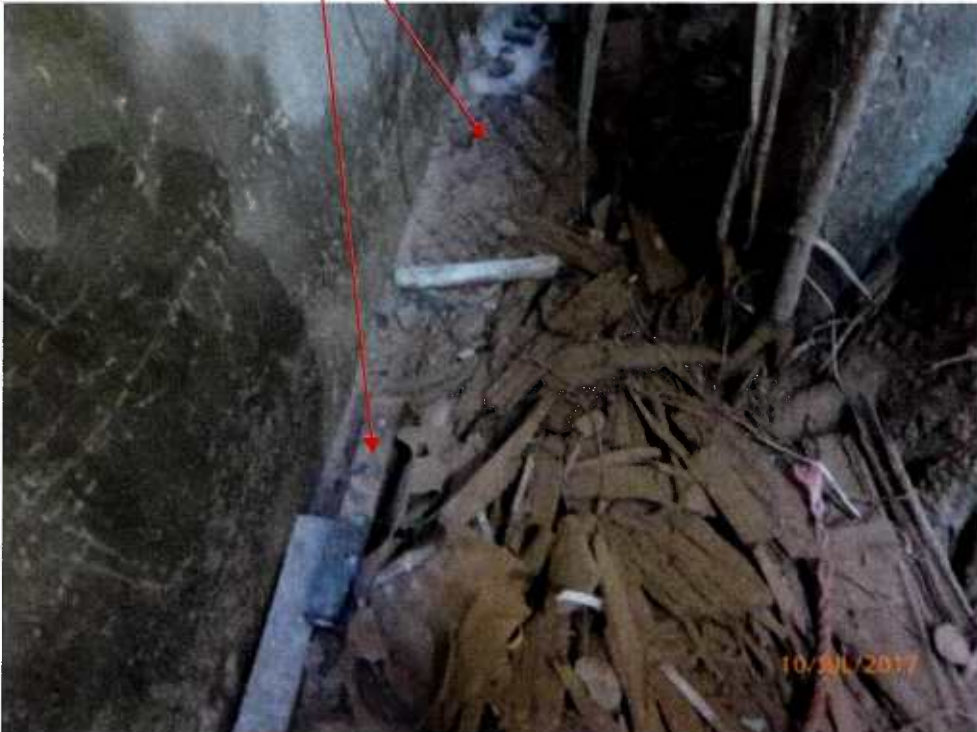
Fig. 3 Lots of construction debris scattered at the corner of the planter.

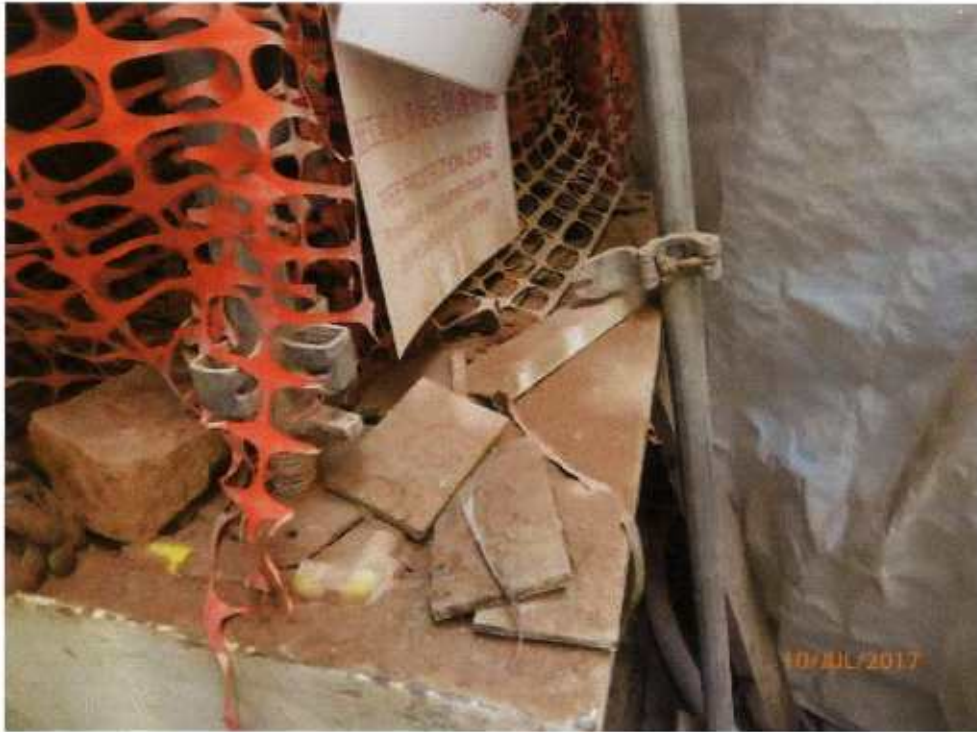
Fig. 10 Many construction materials are placed near the tree.

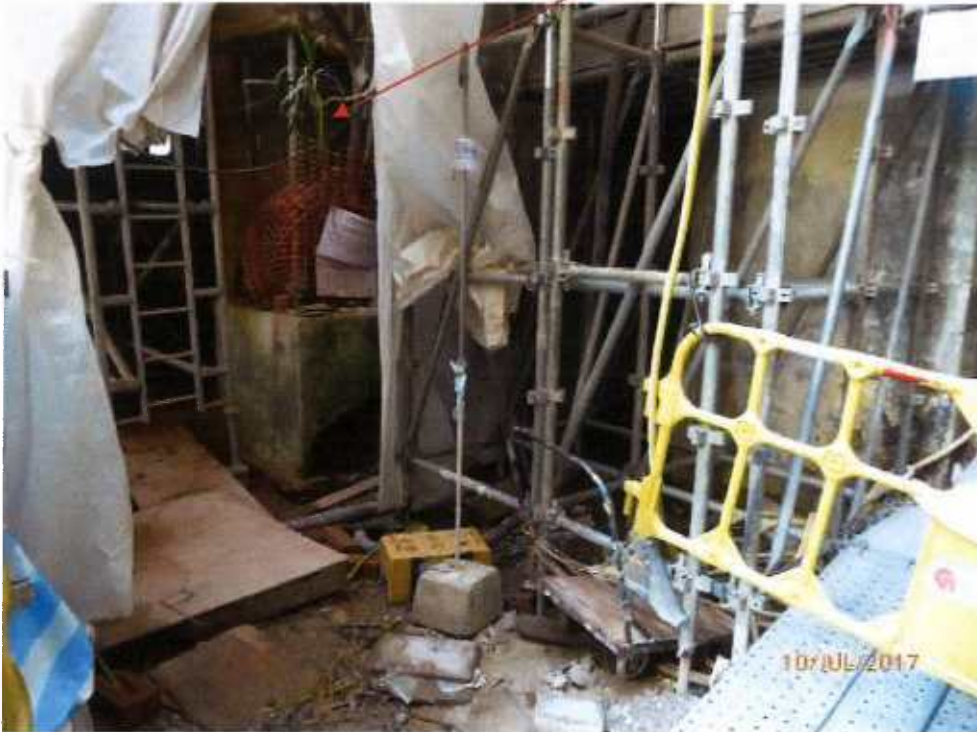
Fig. 11 Renovation works are in progress near Tree-11.
