Central Police Station Conservation
and Revitalisation Project:
61st Monthly EM&A Report
(1 November to 30 November 2016)

Issue Date: December 2016

Environmental Resources Management

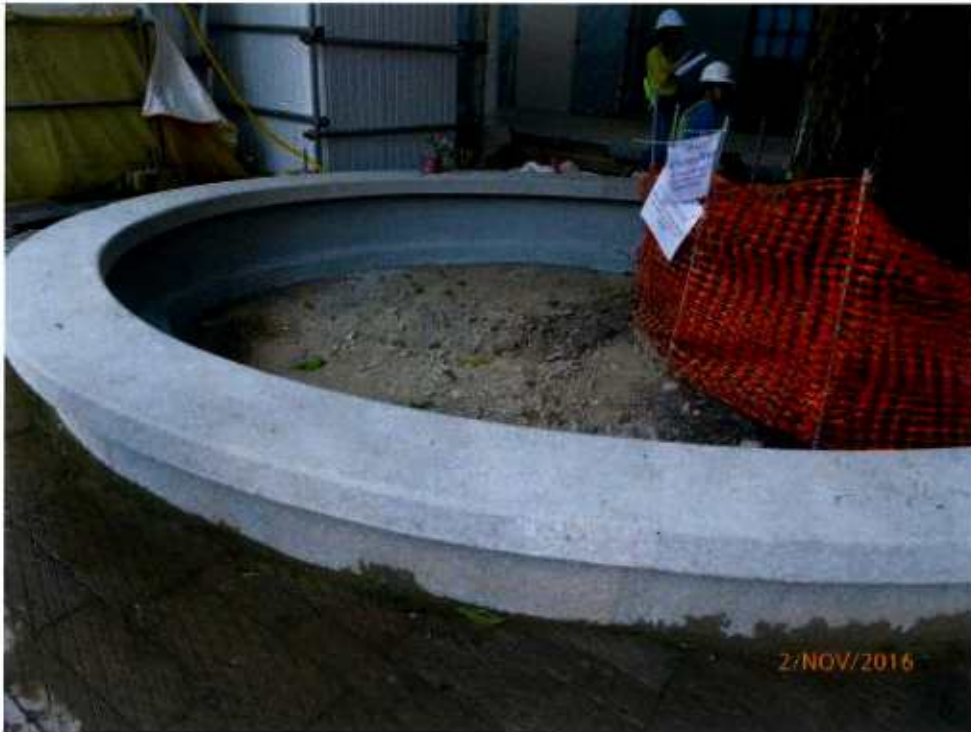
Fig. 11 The site near Tree-5 appears clean and tidy.

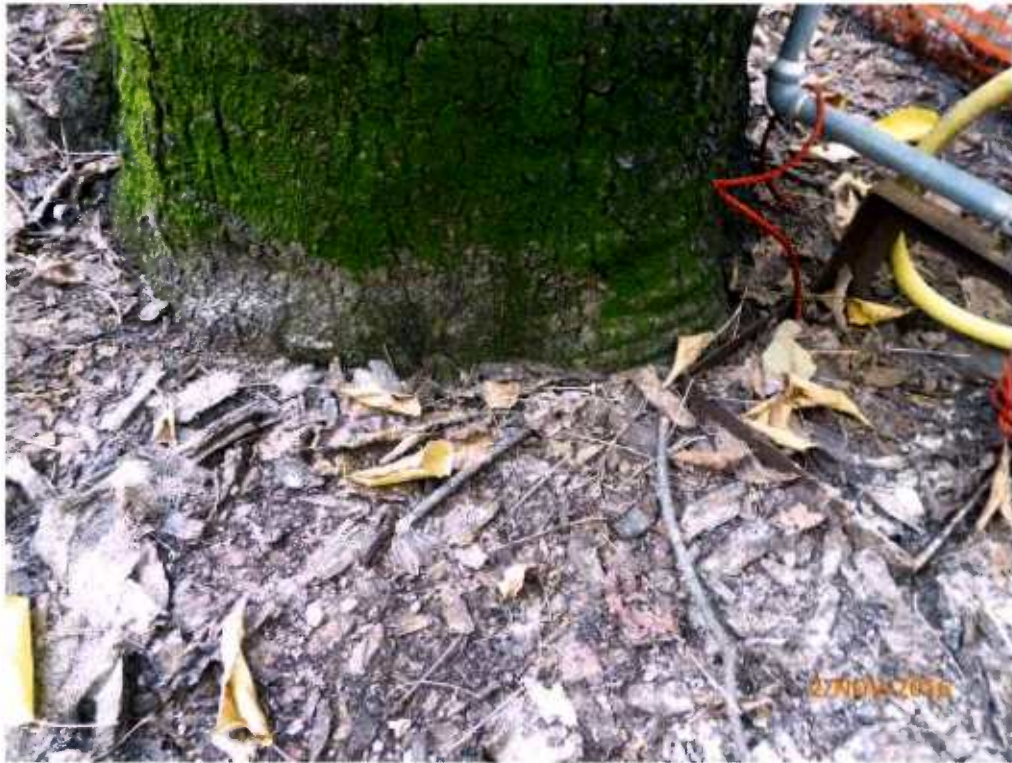
Fig 3. Health condition of the lower trunk is fair.

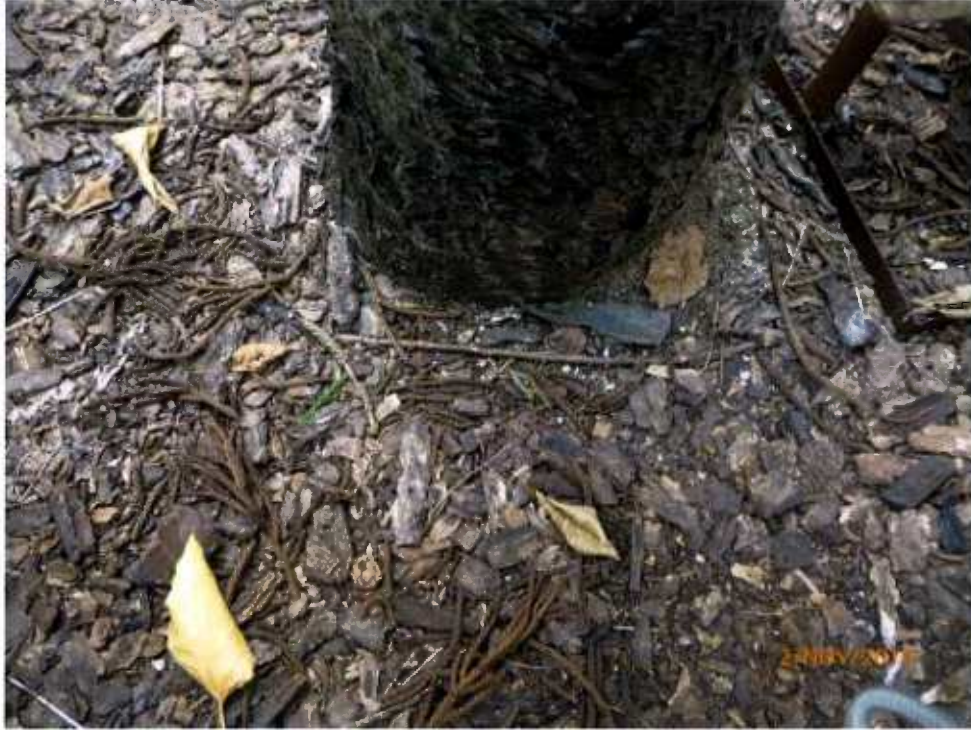
Fig. 3 Health condition of the lower trunk is fair.
