Central Police Station Conservation
and Revitalisation Project:
78th Monthly EM&A Report
(1 April to 30 April 2018)

Issue Date: May 2018

Environmental Resources Management

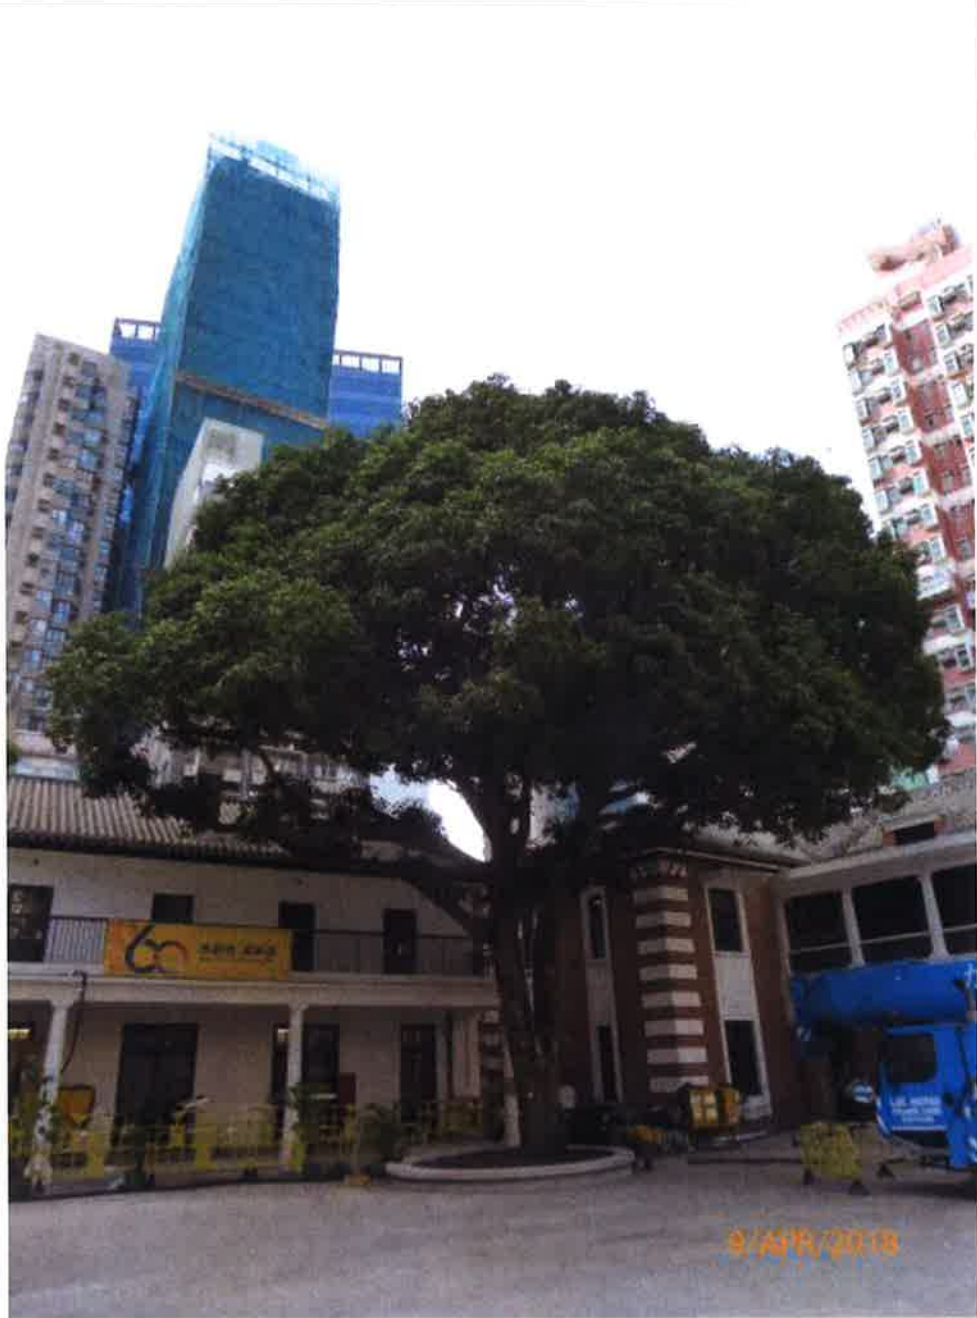
Fig. 12 Overall view of Tree-5 during inspection on 9th April 2018.

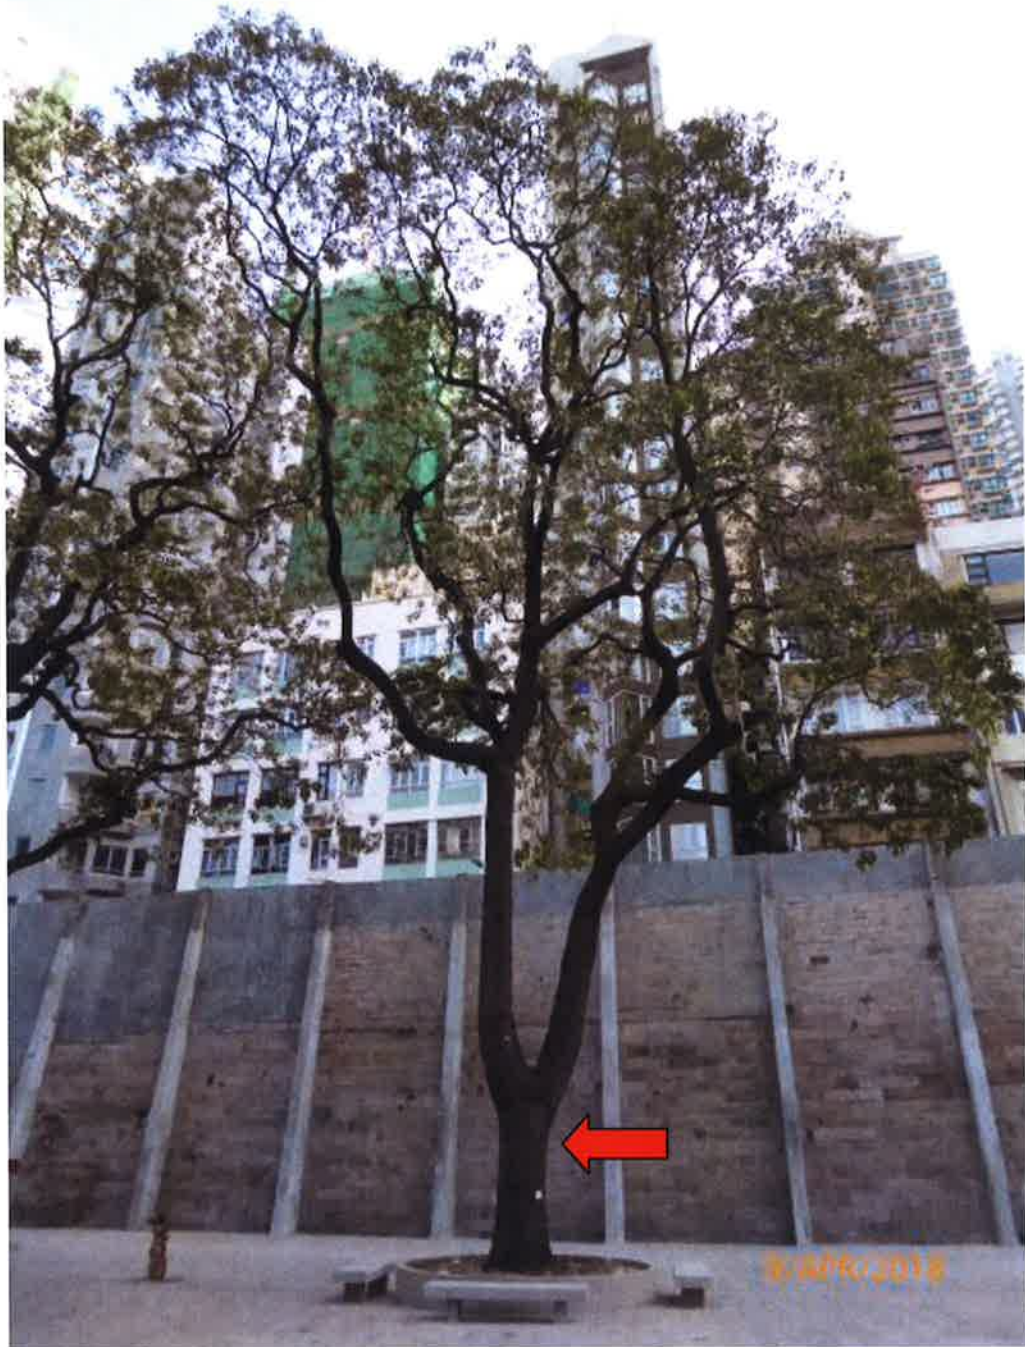
Fig. 12 Overall view of Tree-6 during inspection on 9th April 2018.
