Central Police Station Conservation
and Revitalisation Project:
74th Monthly EM&A Report
(1 December to 31 December 2017)

Issue Date: January 2018

Environmental Resources Management

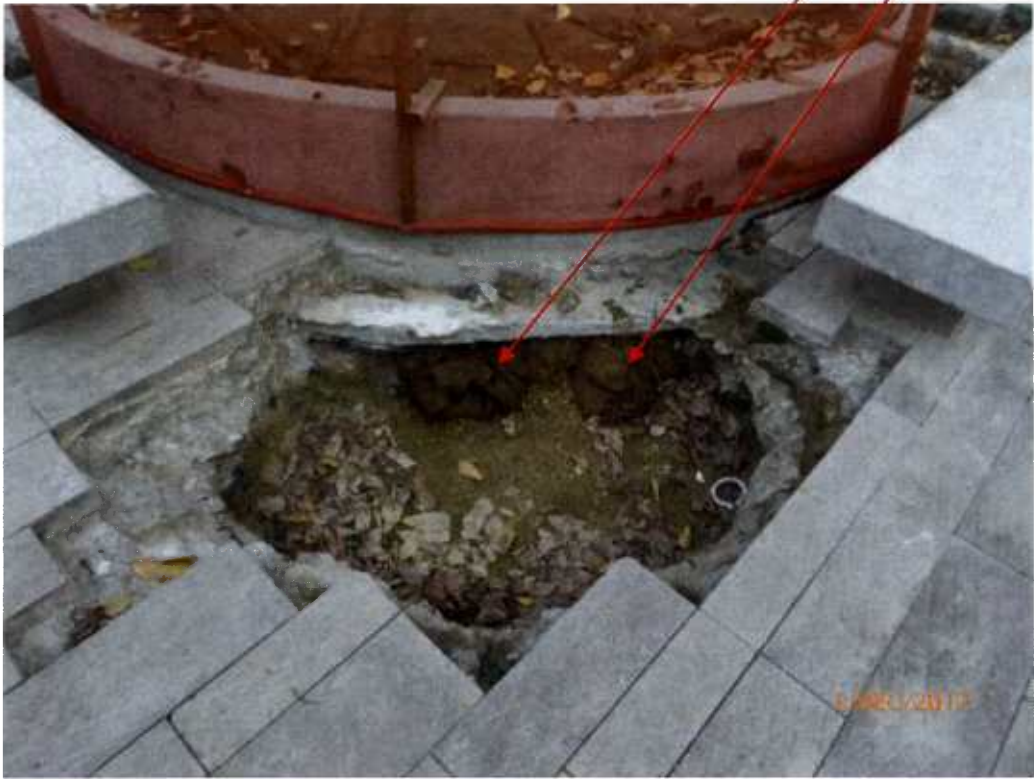
Fig. 11 The site near Tree-6 is clean and tidy.

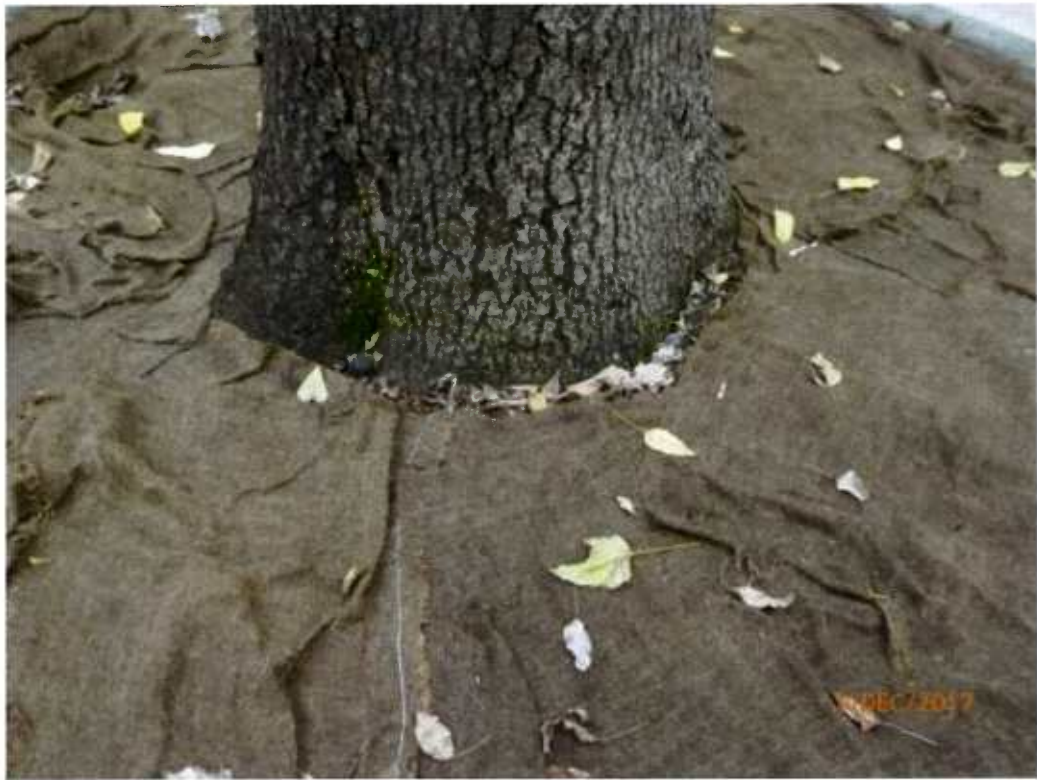
Fig 3. Health condition of the lower trunk is fair.

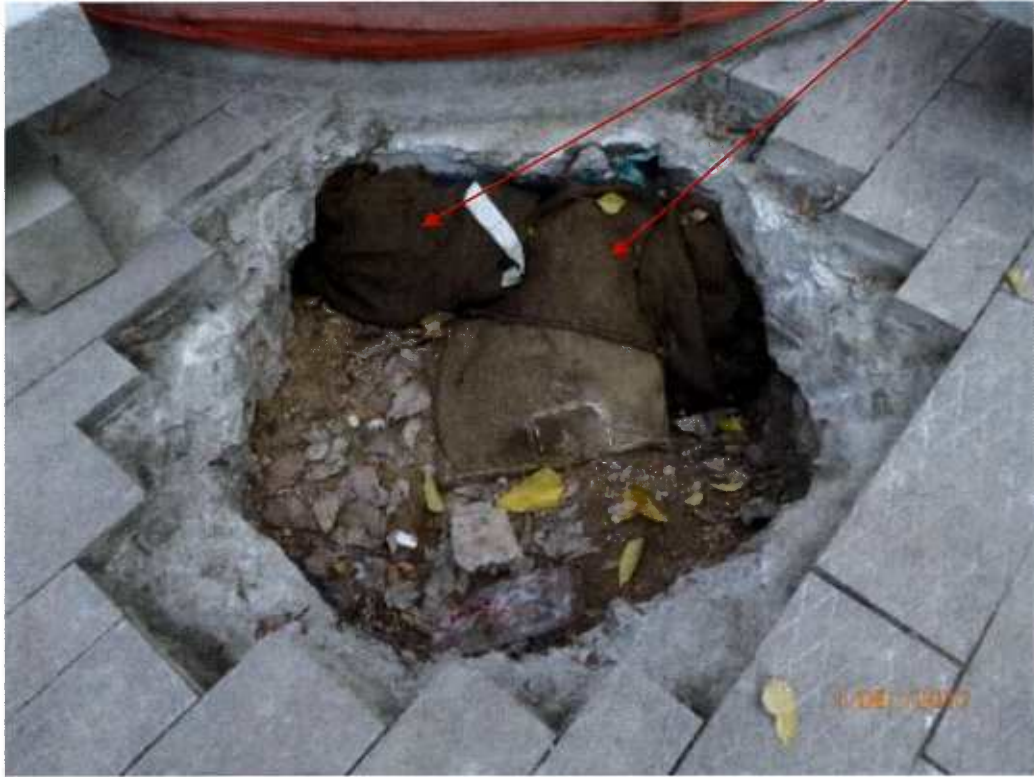
Fig. 11 The site near Tree-7 is clean and tidy.

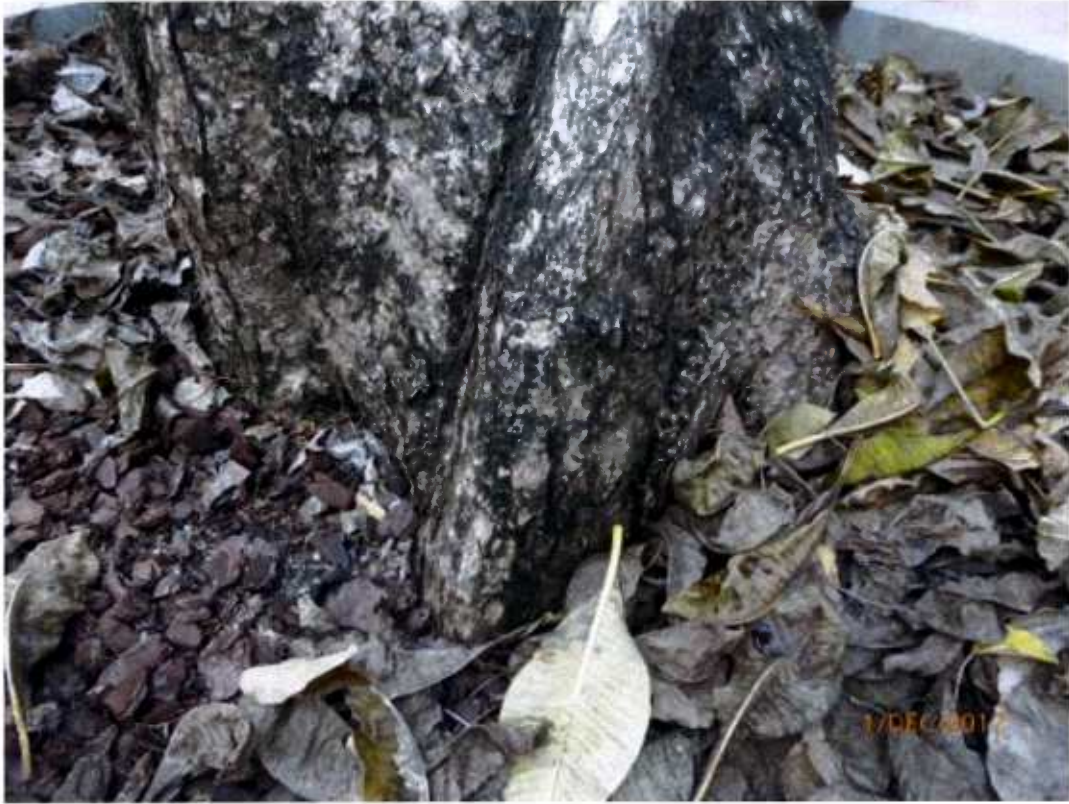
Fig. 3 Health condition of the lower trunk is fair.

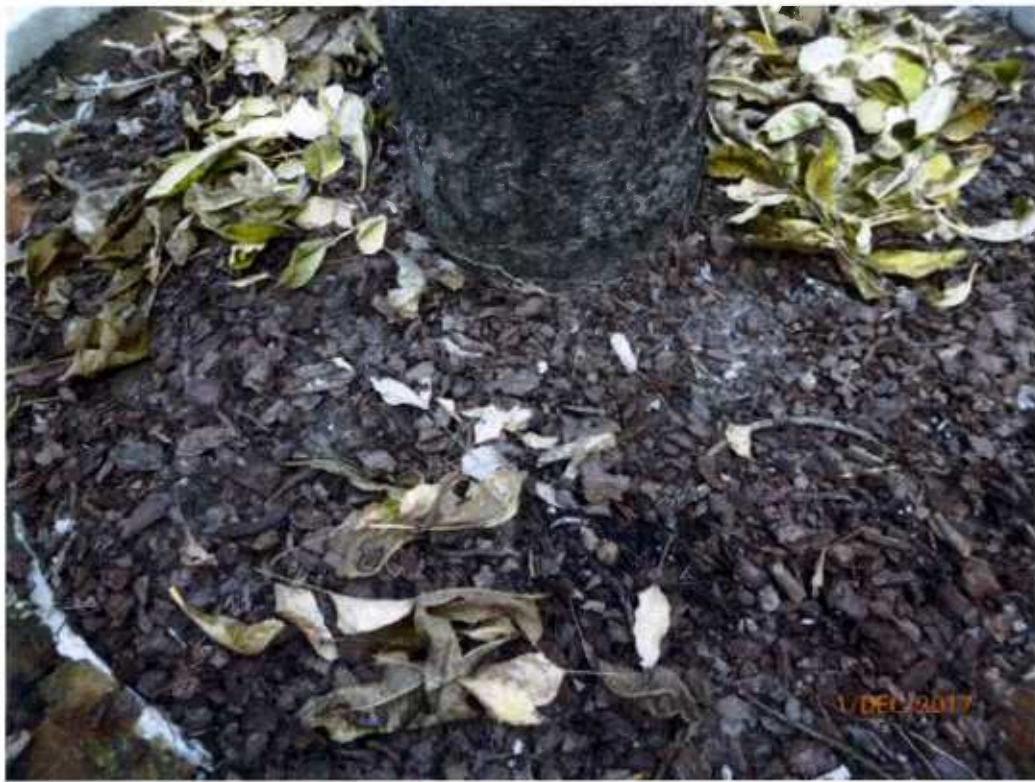
Fig. 3 Health condition of the lower trunk is fair.

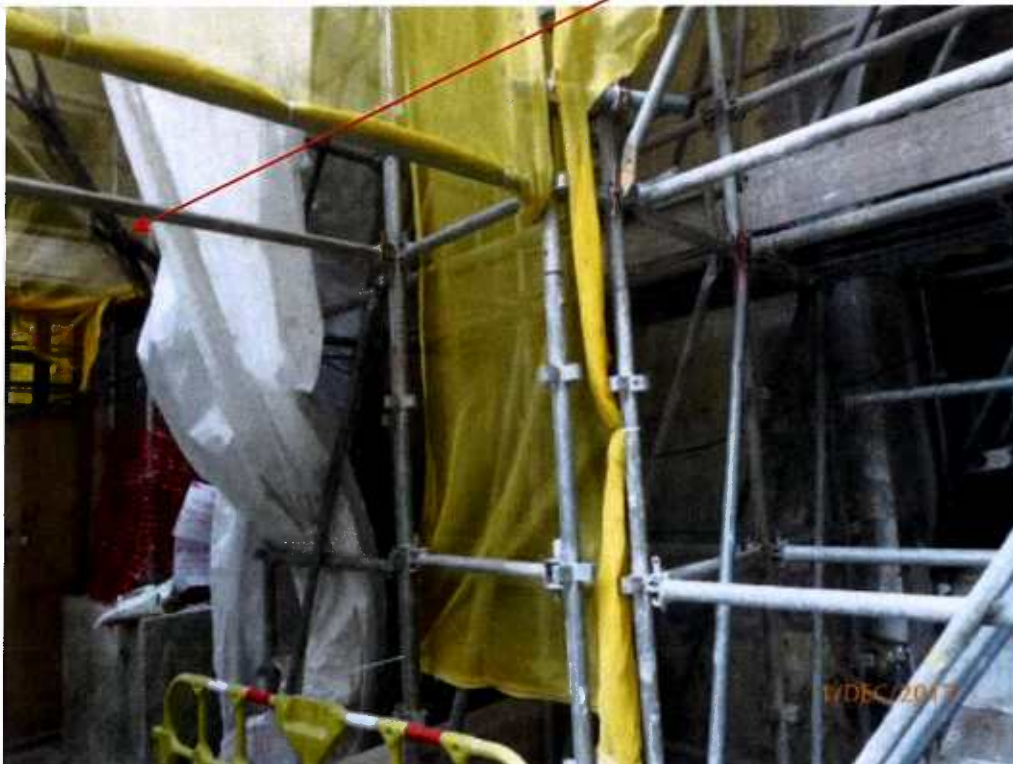
Fig. 12 Overall view of Tree-11 during inspection on 1st December 2017.
