Central Police Station Conservation
and Revitalisation Project:
75th Monthly EM&A Report
(1 January to 31 January 2018)

Issue Date: February 2018

Reference 0095646

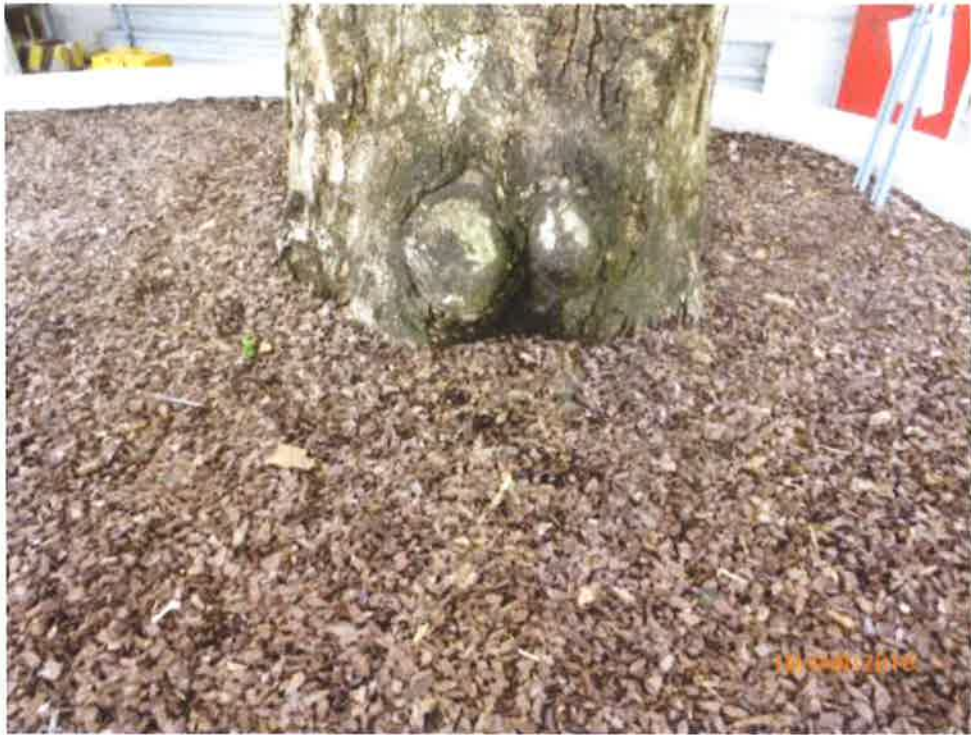
Fig. 3 Health condition of the lower trunk is fair.

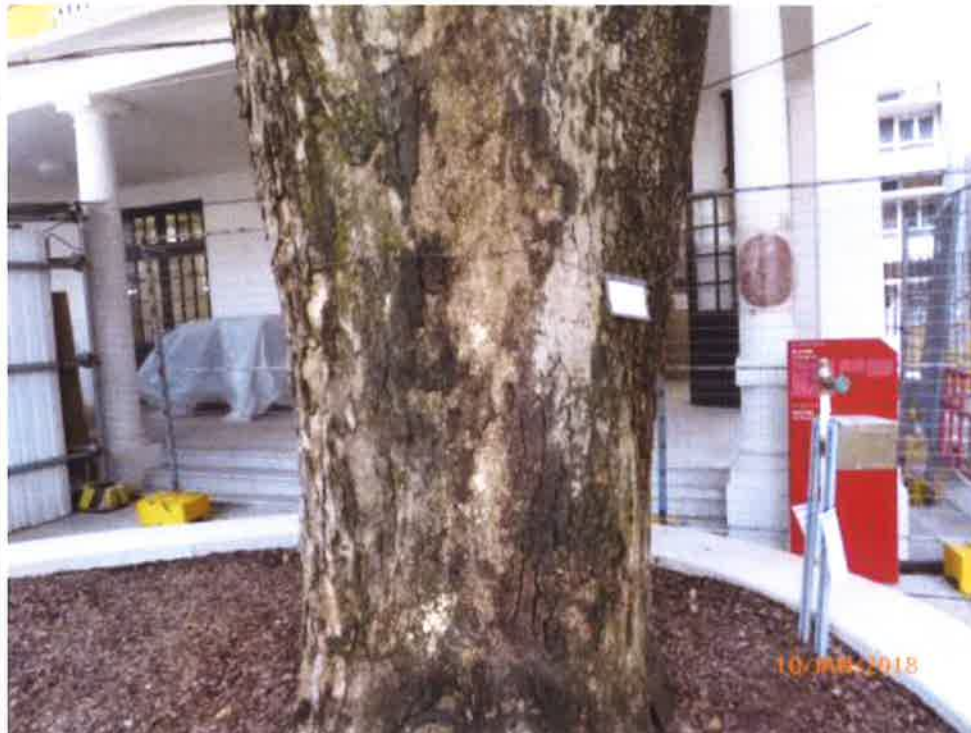
Fig. 4 Health condition of the mid trunk is fair.

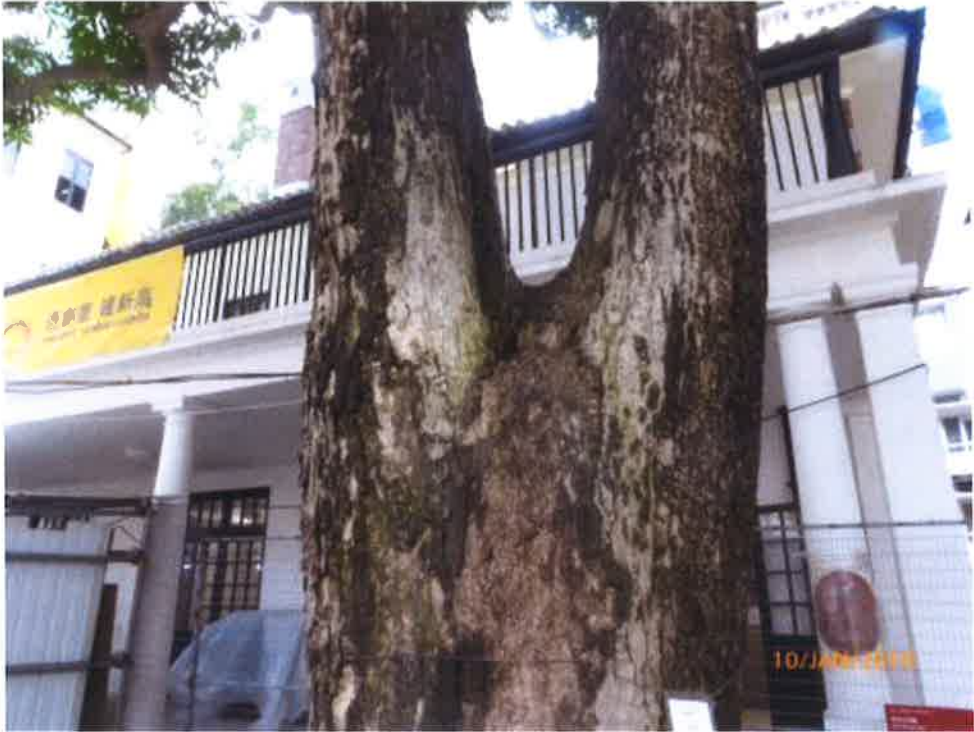
Fig. 5 Health condition of the upper trunk also is fair.

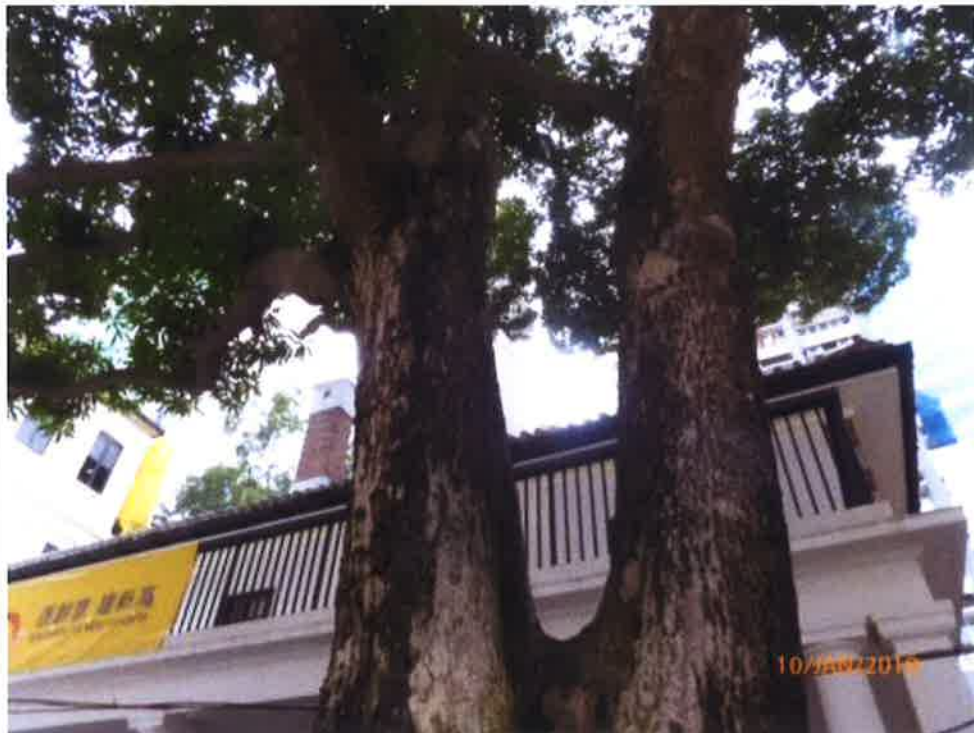
Fig. 6 The crown is full of vigorous and green leaves.

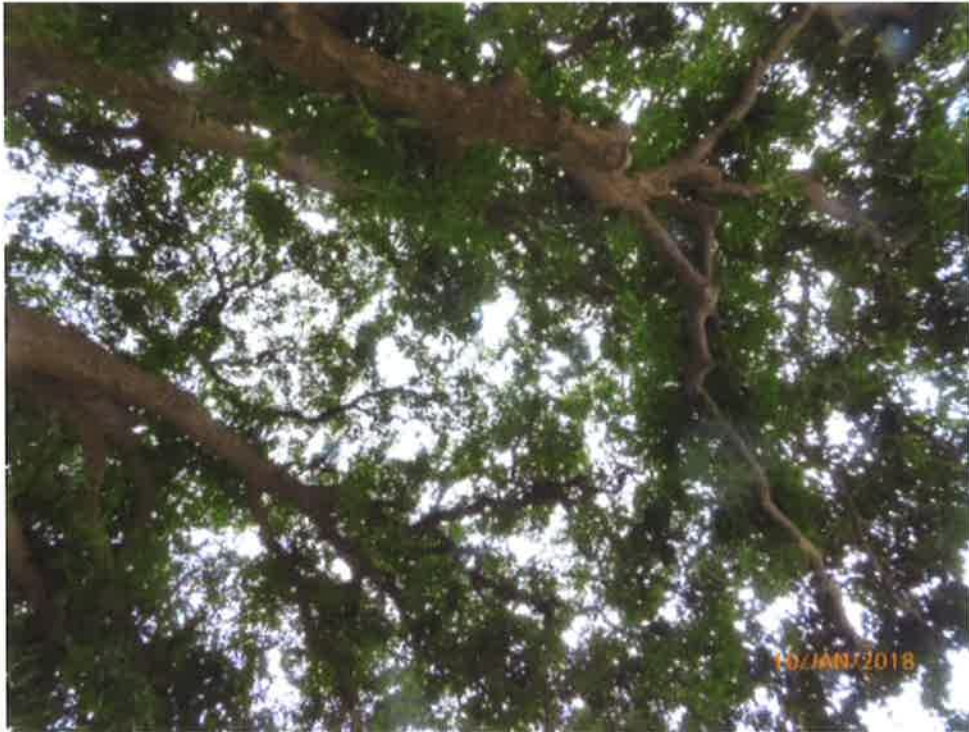
Fig. 7 Vigorous and green leaves also are growing on the lower branches.

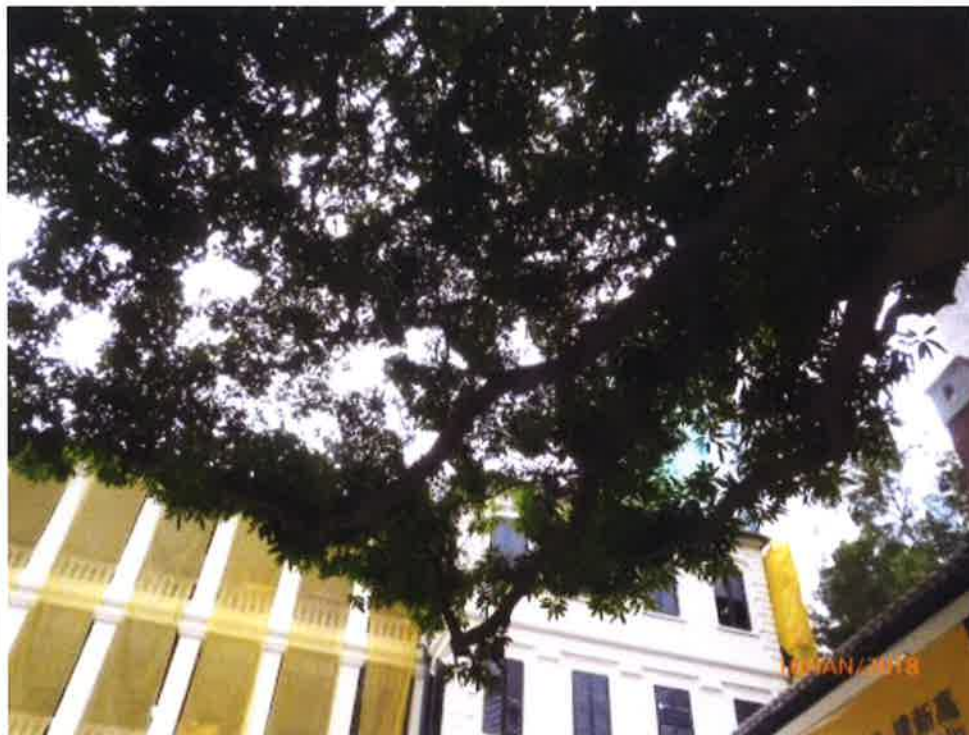
Fig. 8 Many young and green leaves appear on the tree.

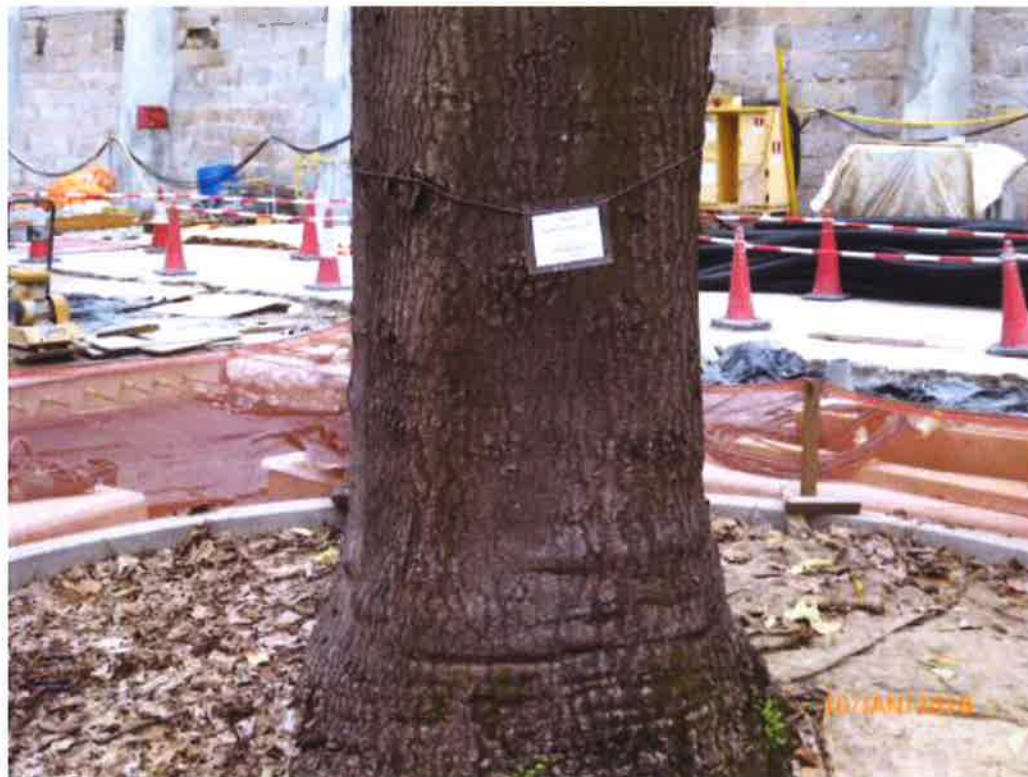
Fig. 4 Health condition of the mid trunk is fair.

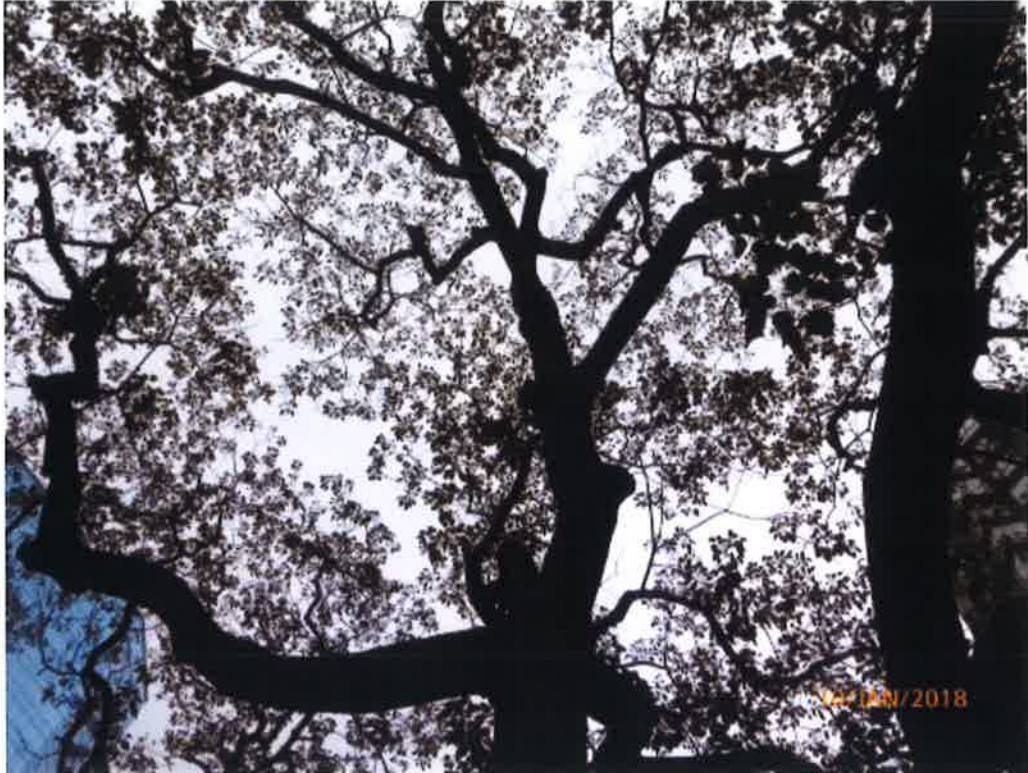
Fig. 7 Leaves on the lower branches are normal.

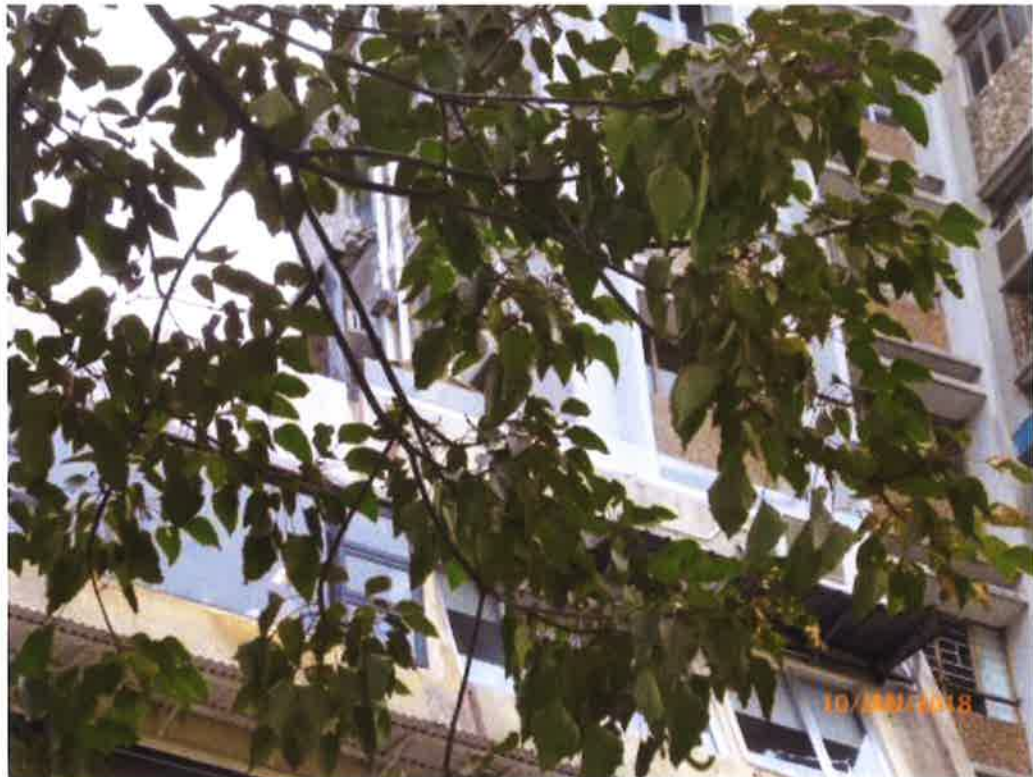
Fig. 8 Some young and green leaves appear on the tree.

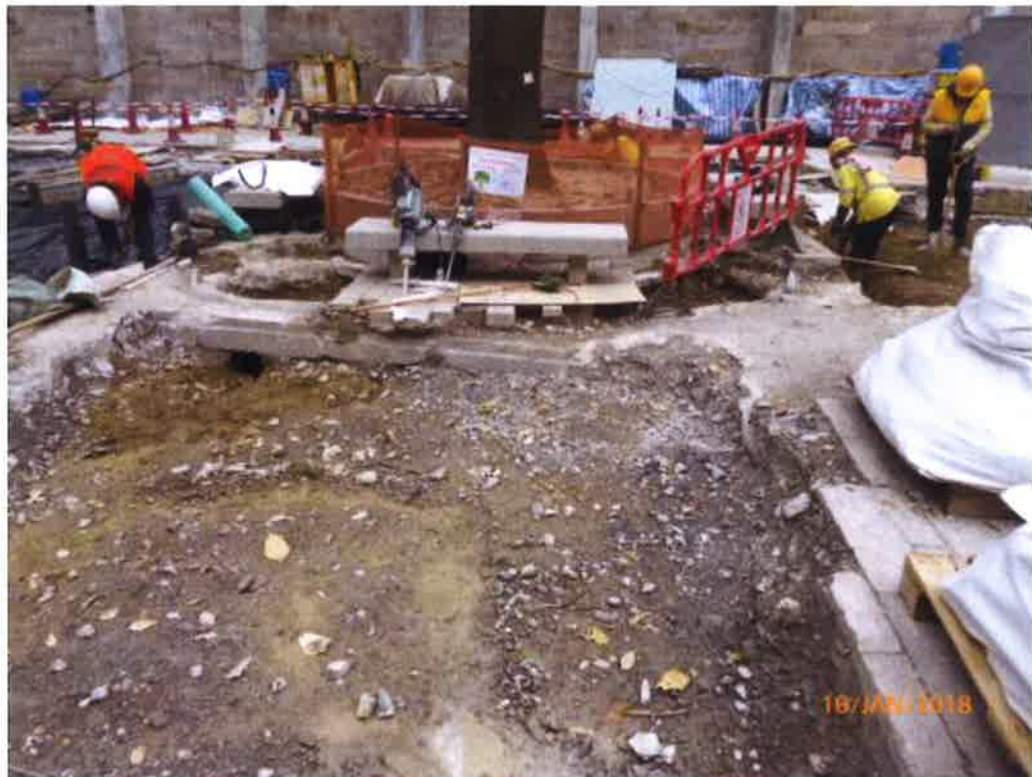
Fig. 12 Overall view of Tree-6 during inspection on 10th January 2018.

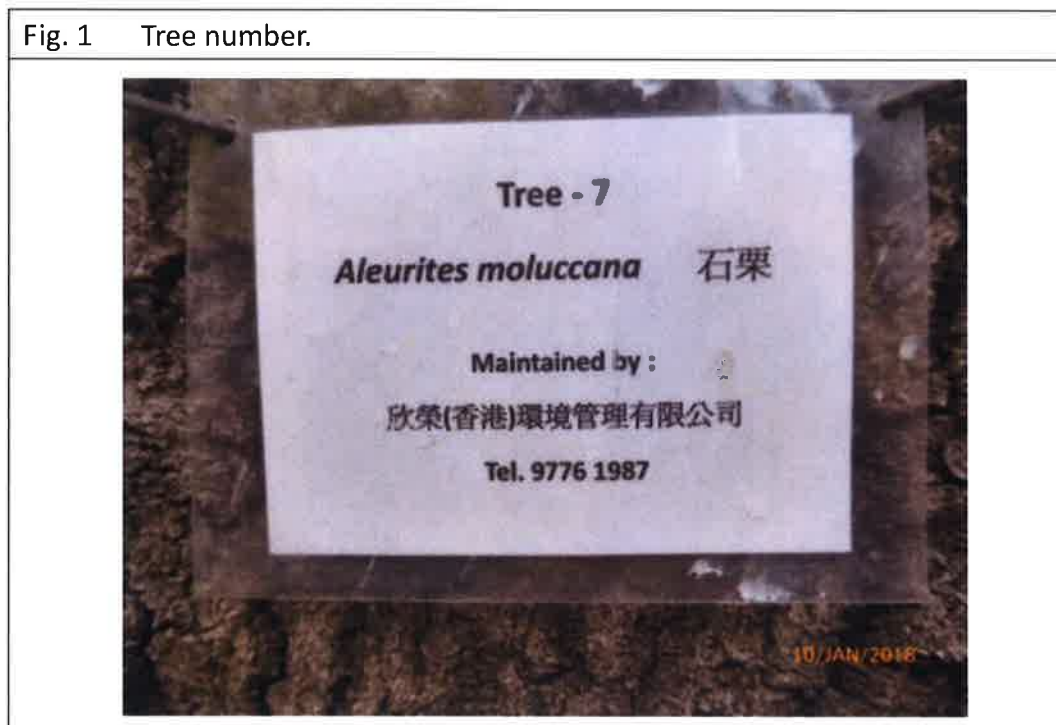
Fig. 2 Root collar is normal. The planter is covered with wet hessian clothes.

1. Keep close monitoring on the growth of the tree.

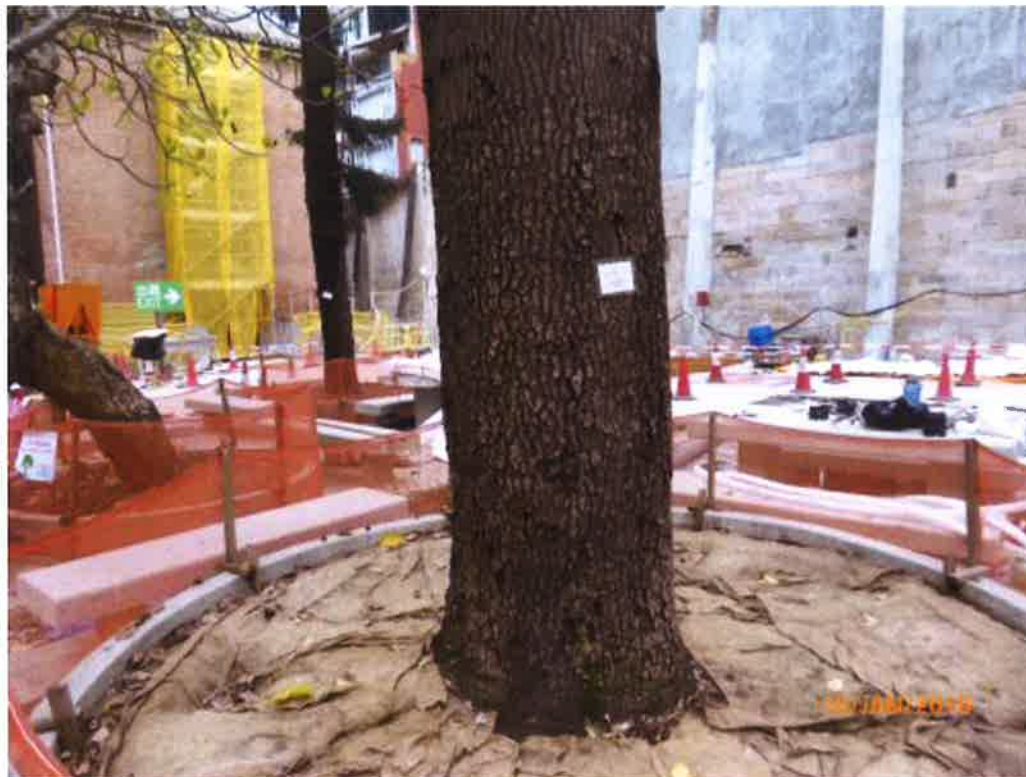
Fig. 4 Health condition of the mid trunk also is fair.

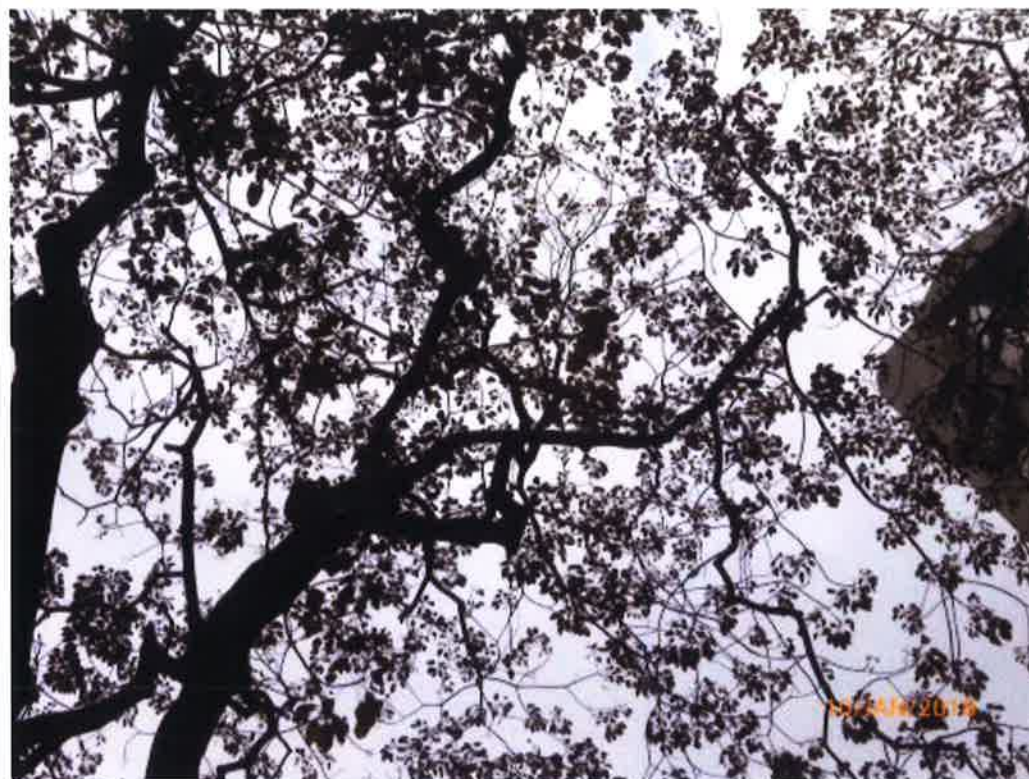
Fig. 6 Leaves on the lower branches are normal.

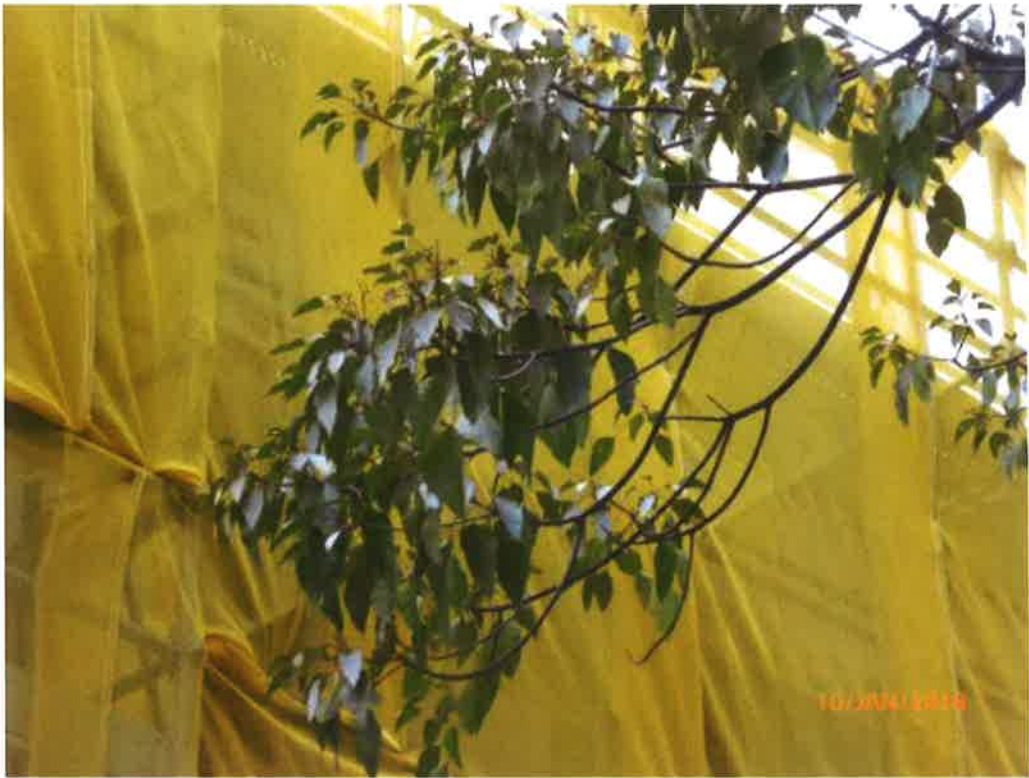
Fig. 7 Some young and green leaves appear on the tree.

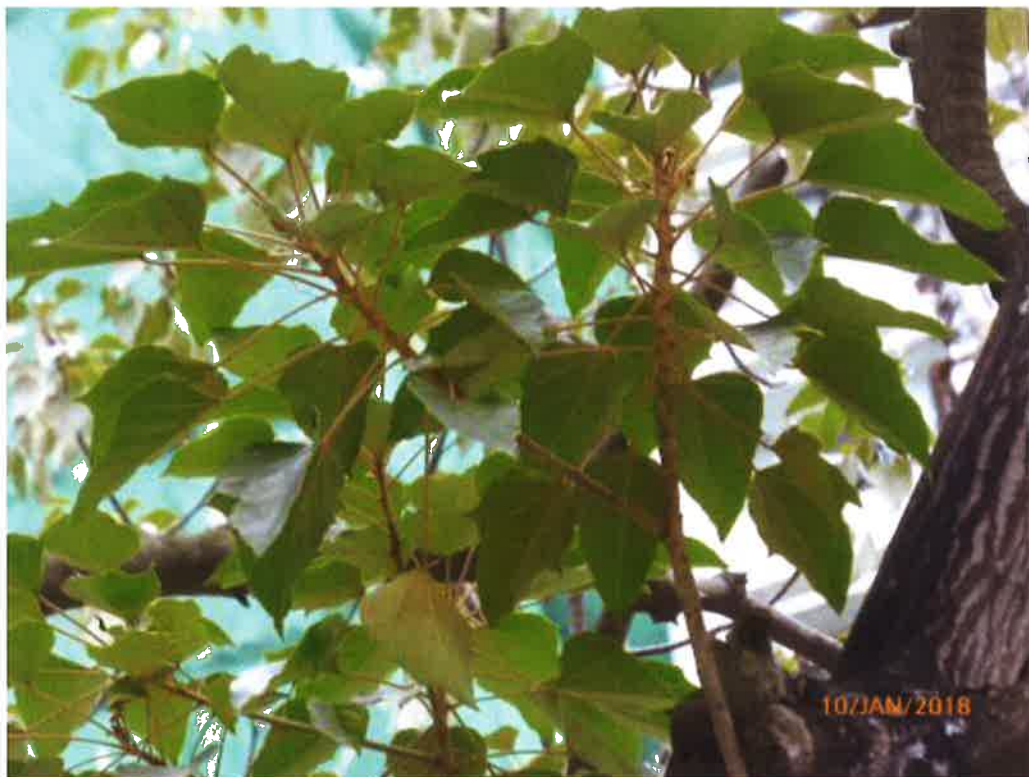
Fig. 8 As dry season has come, some leaves on the tree become faded.

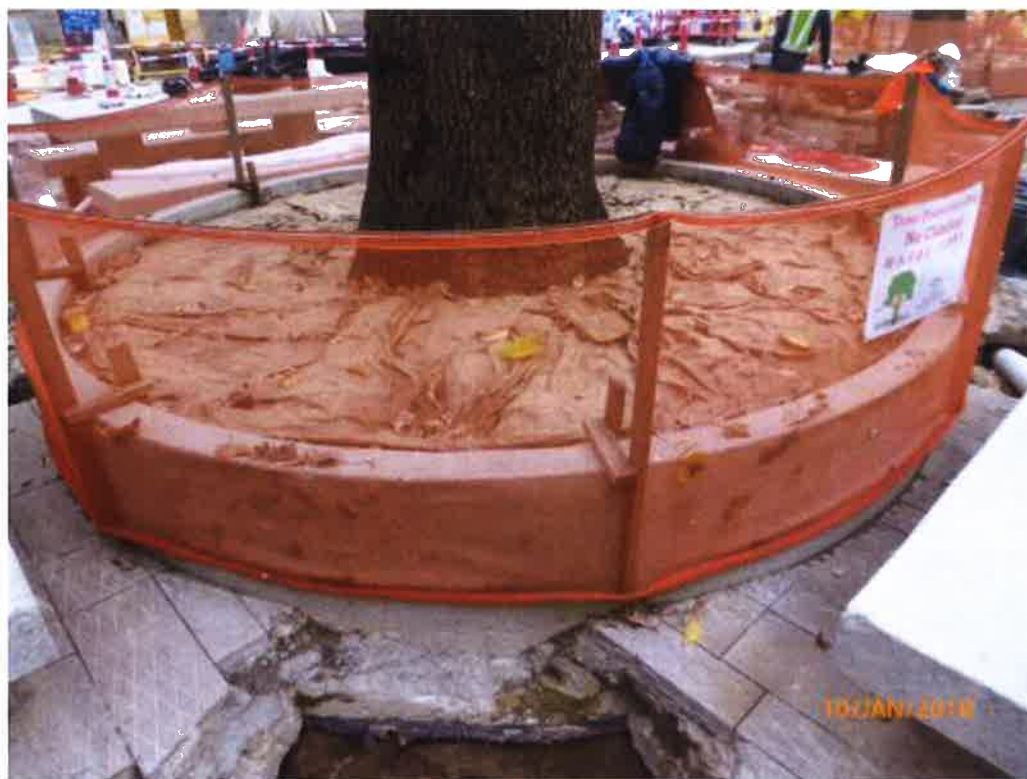
Fig. 10 The bare roots at the pits have been wrapped with hessian clothes.

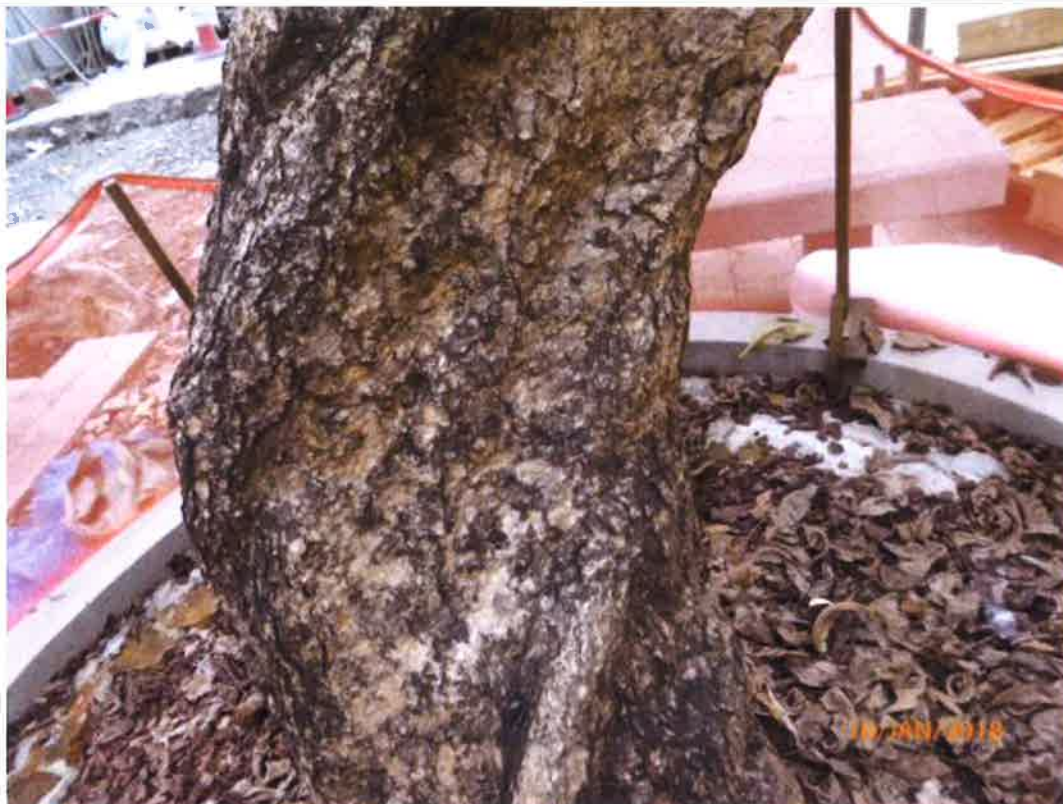
Fig. 4 Health condition of the mid trunk is fair.

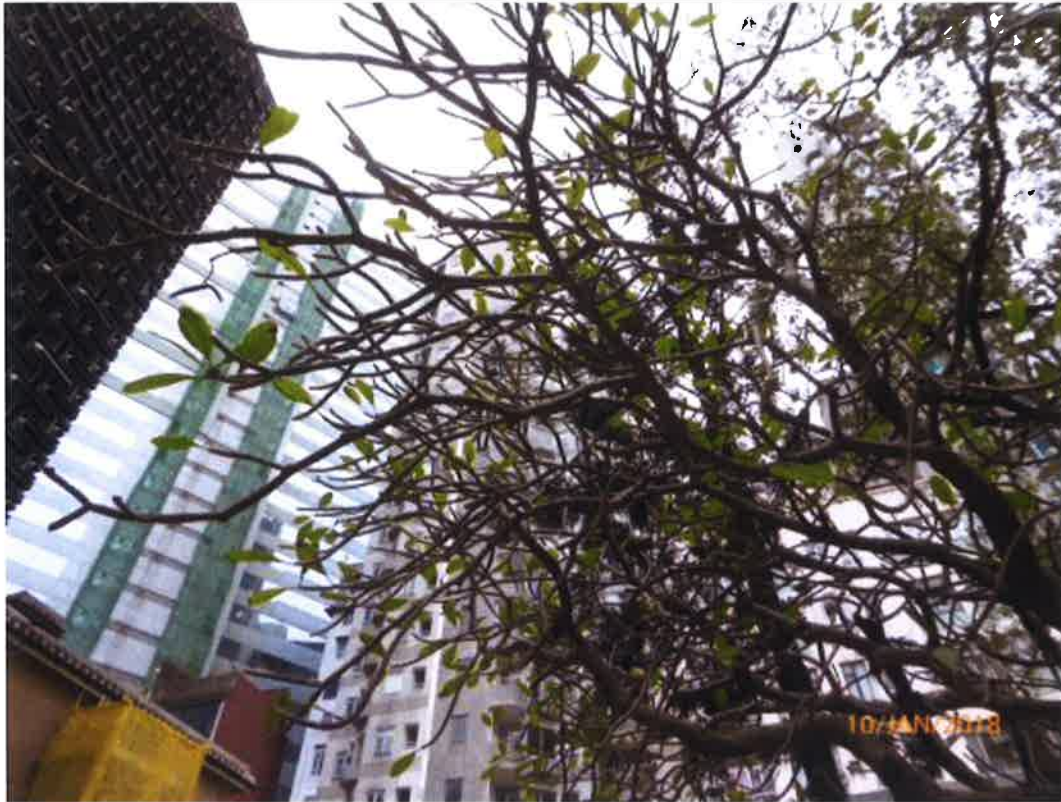
Fig. 6 As dry season has come, leaves on the tree become sparse.

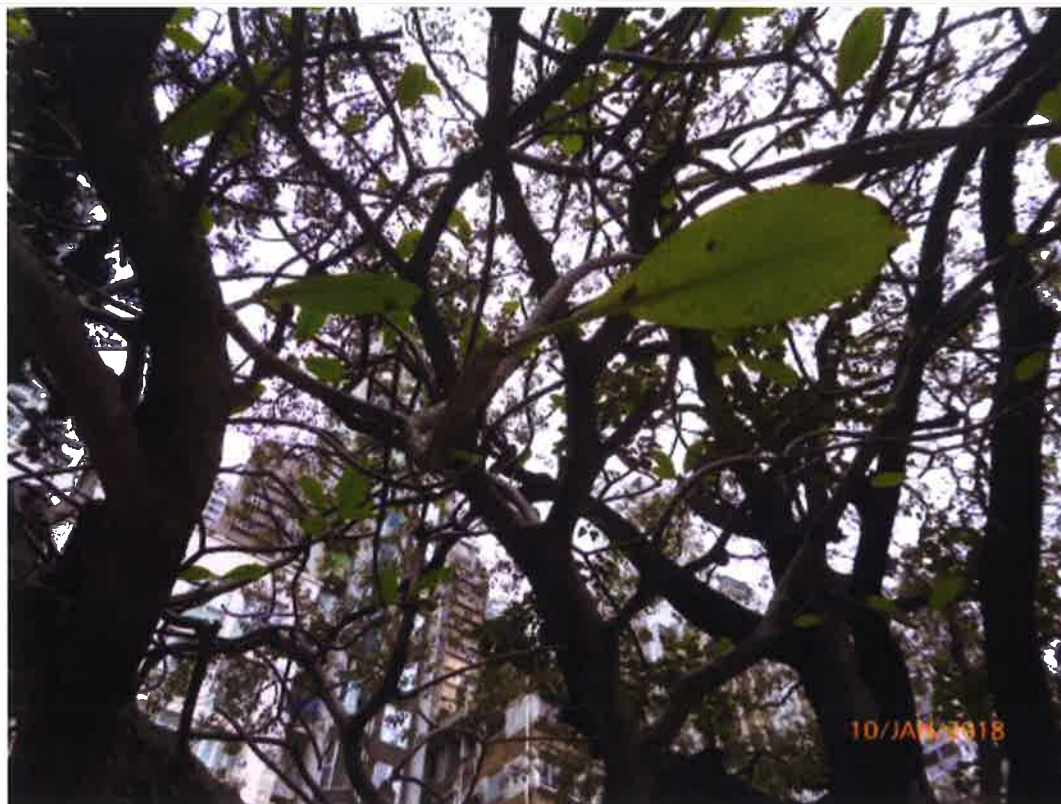
Fig. 7 Some leaves still remain on the lower branches.

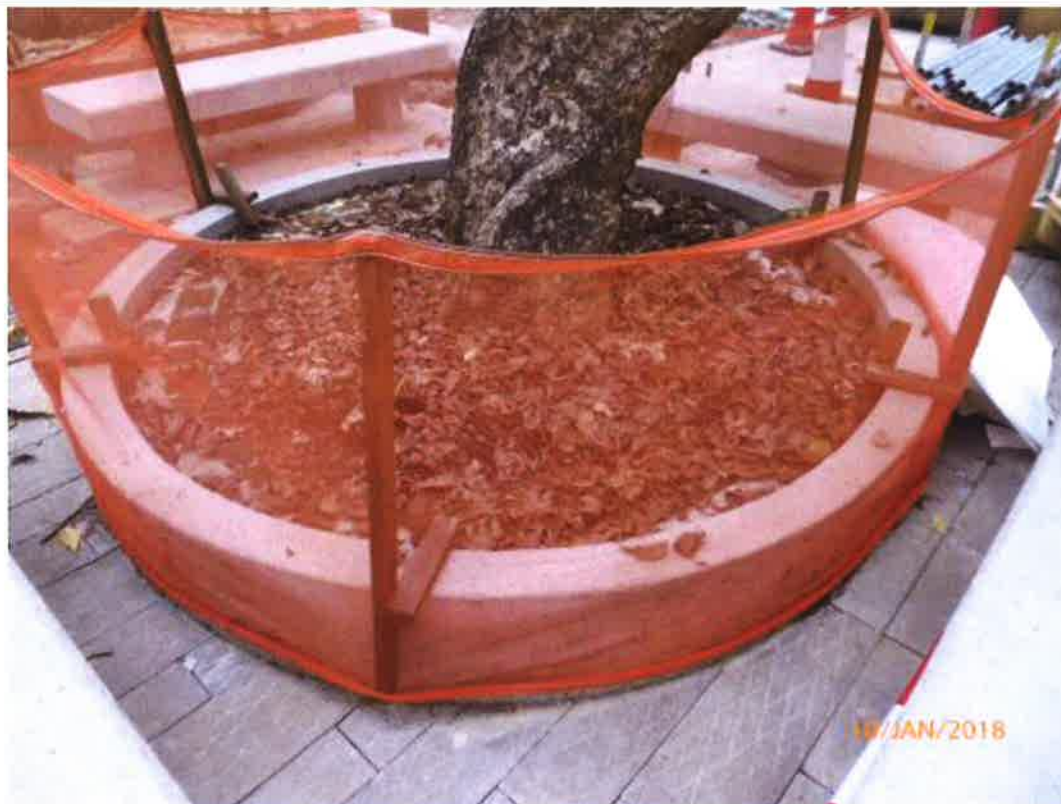
Fig. 9 The tree protection zone is in good order.

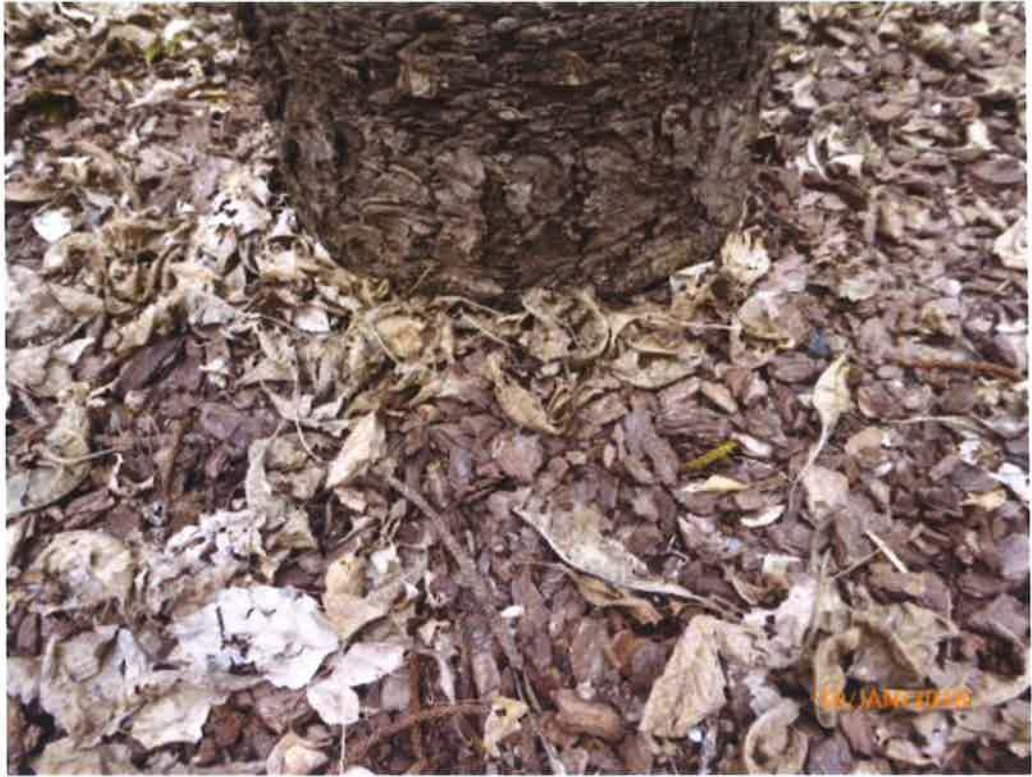
Fig. 3 Health condition of the lower trunk is fair.

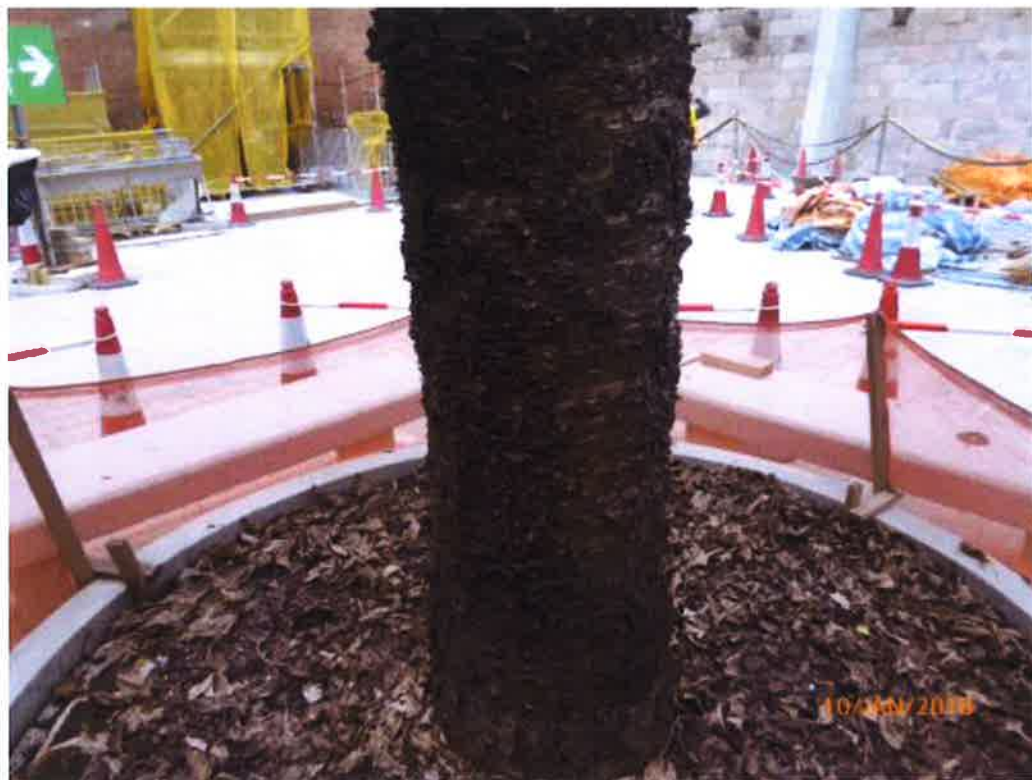
Fig. 4 Health condition of the mid trunk is fair.

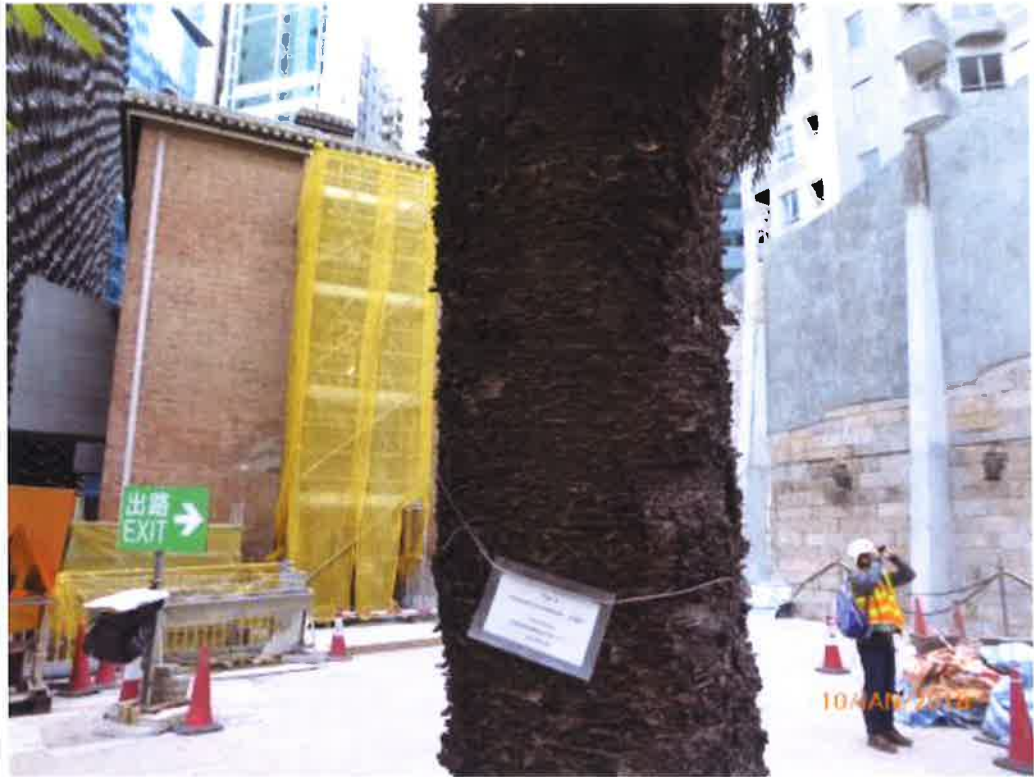
Fig. 5 Health condition of the upper trunk also is fair.

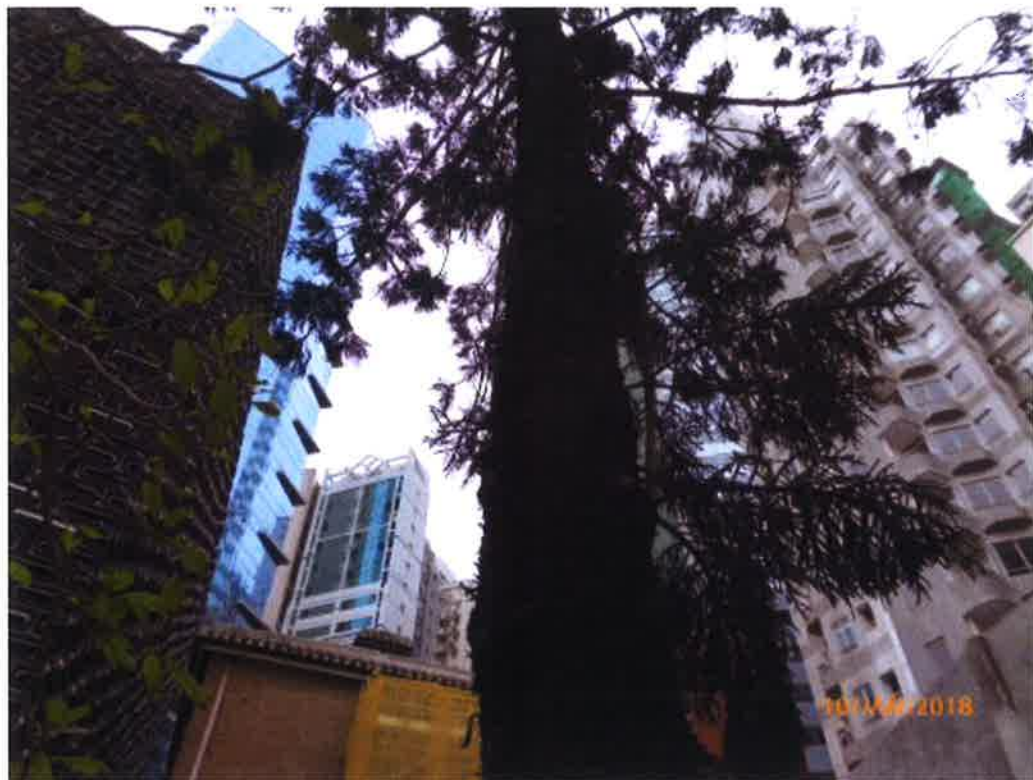
Fig. 6 The crown is full of vigorous and green leaves.

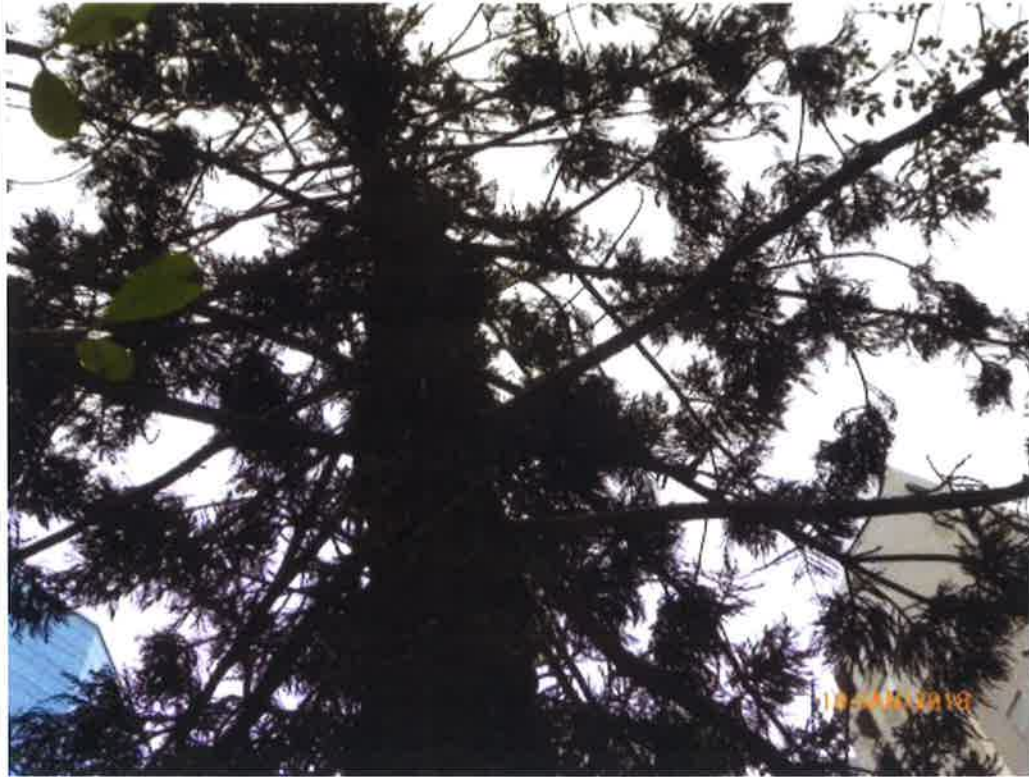
Fig. 7 Vigorous and green leaves also are growing on the lower branches.

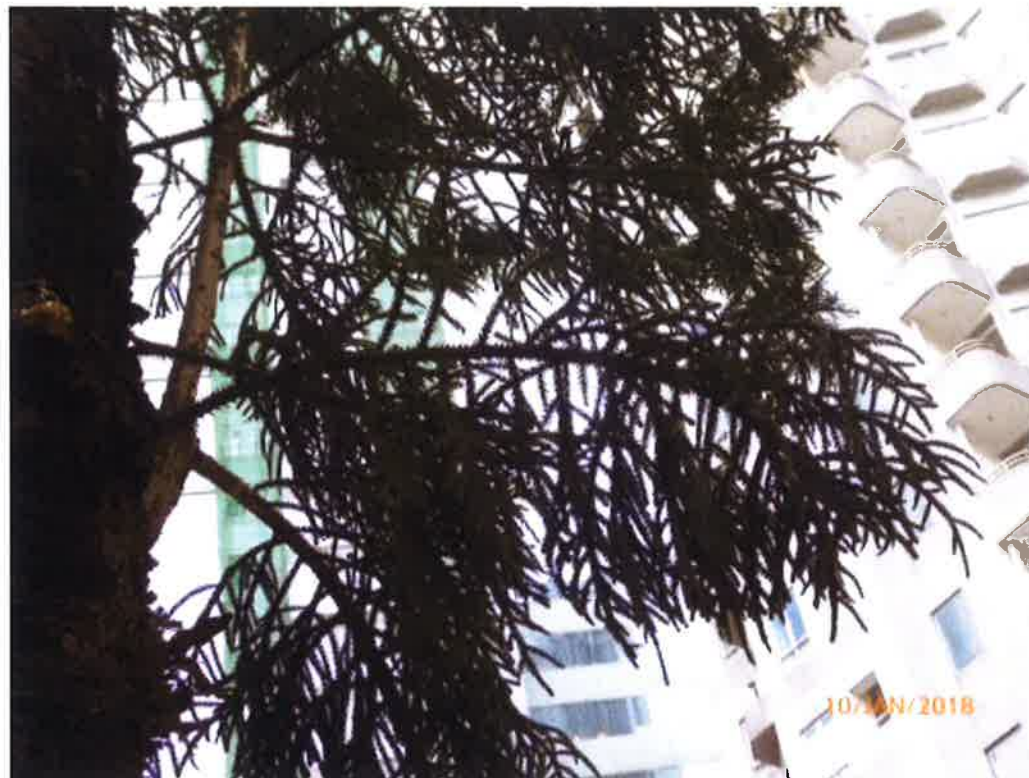
Fig. 8 Some young and green leaves appear on the mid trunk.

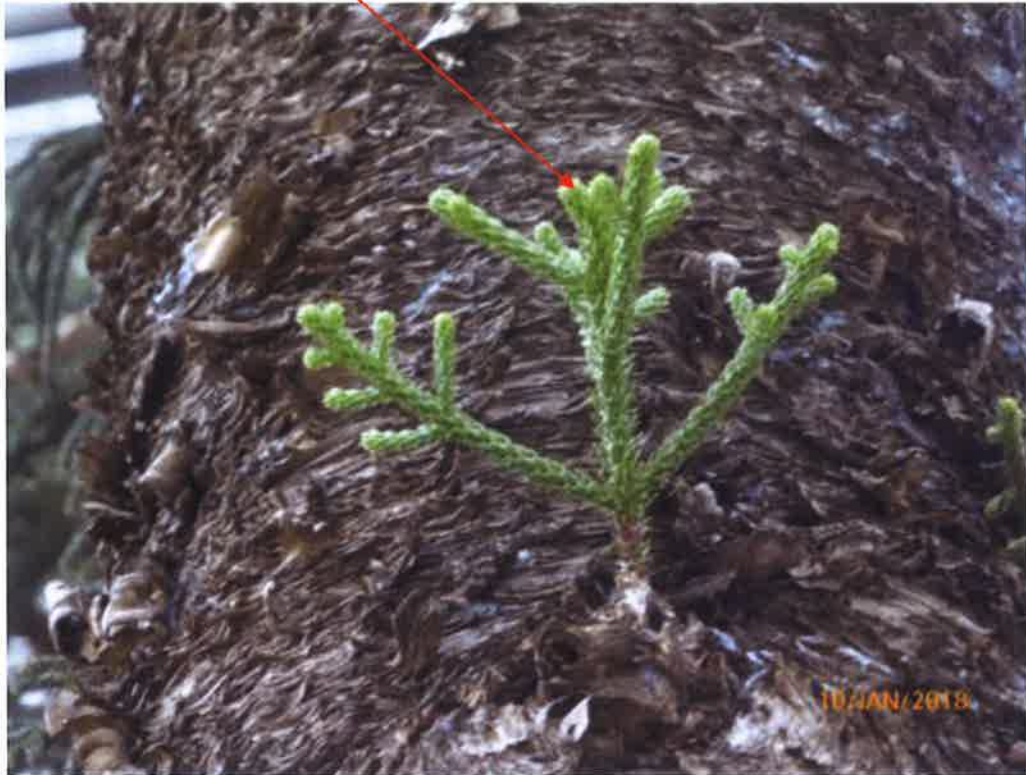
Fig. 9 Young and green leaves also appear on the lower branches.

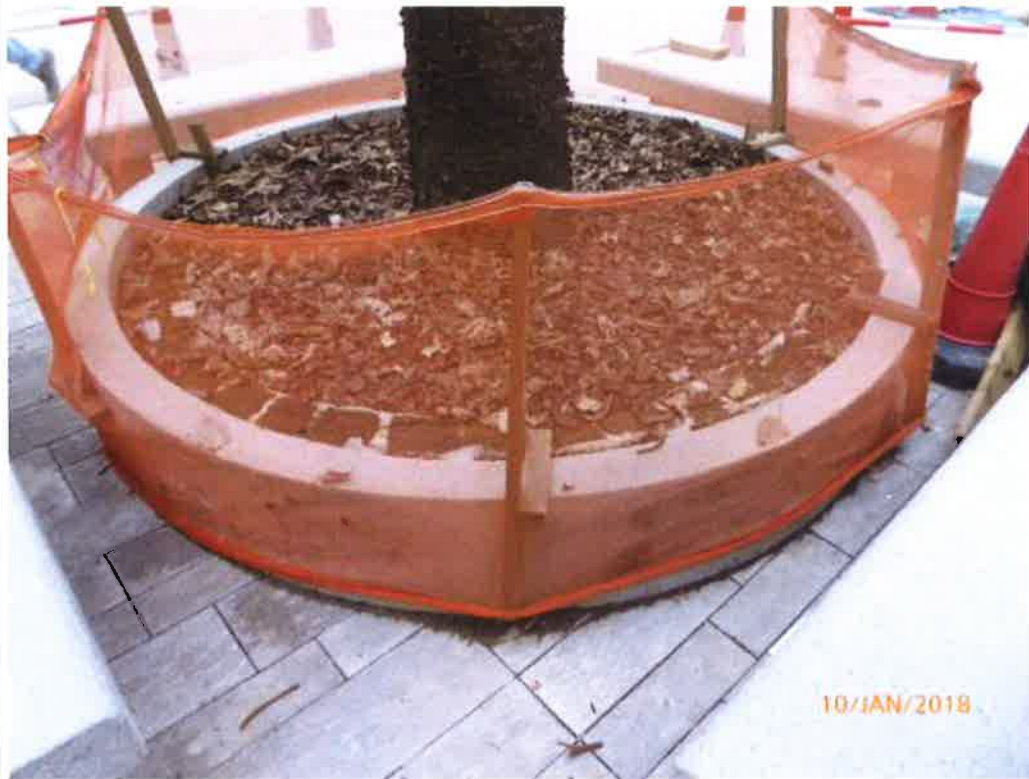
Fig. 11 The site near Tree-9 is clean and tidy.

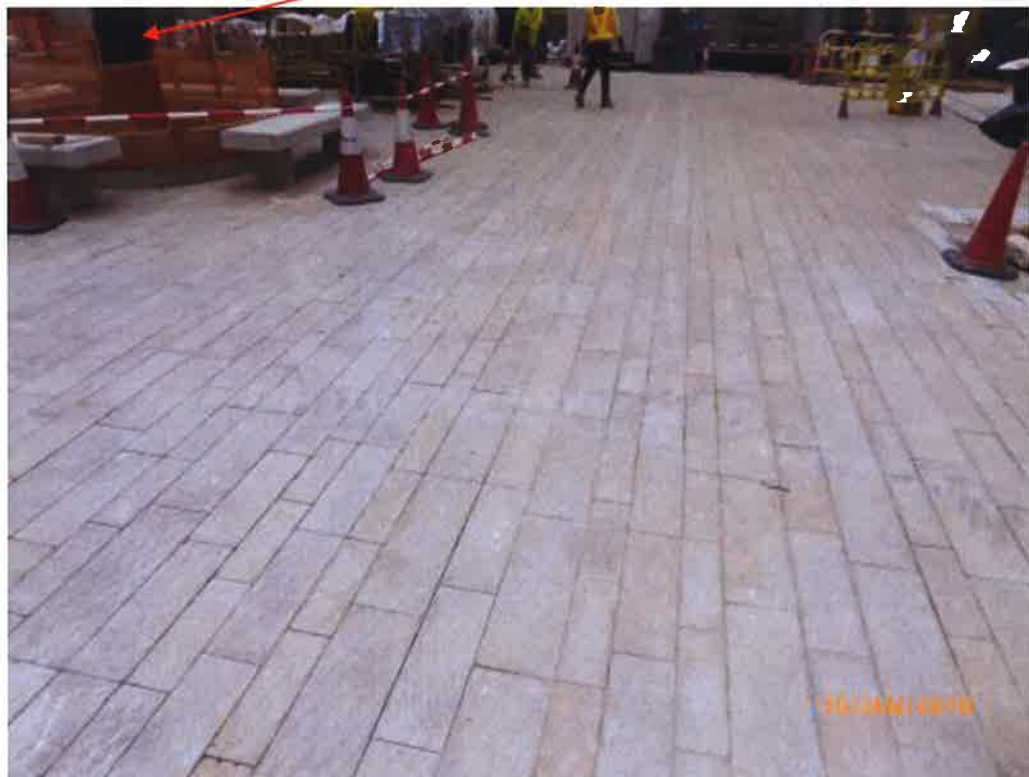
Fig. 12 Overall view of Tree-9 during inspection on 10th January 2018.
