Central Police Station Conservation
and Revitalisation Project:
75th Monthly EM&A Report
(1 January to 31 January 2018)

Issue Date: February 2018

Reference 0095646

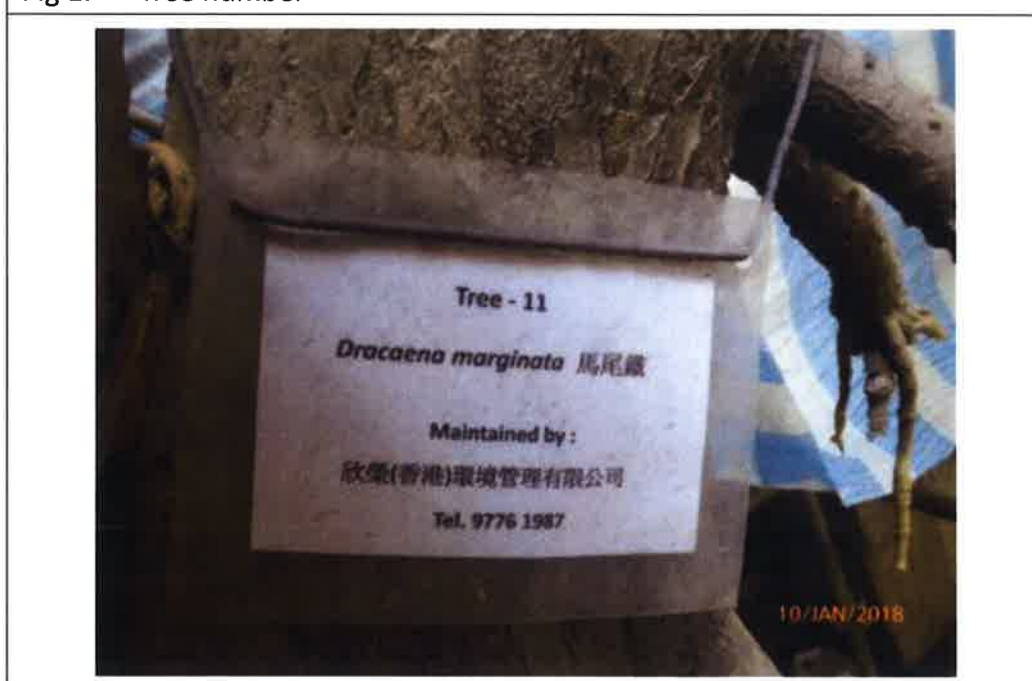
1. Health condition of the tree is fair.
2. Withered leaves still appear on the tree.
3. **A few construction debris remained at the planter.**
4. Two large working platforms have been set up close to Tree-11 for renovation works.

Fig. 2 Root collar is normal. A few construction debris remain at the planter.

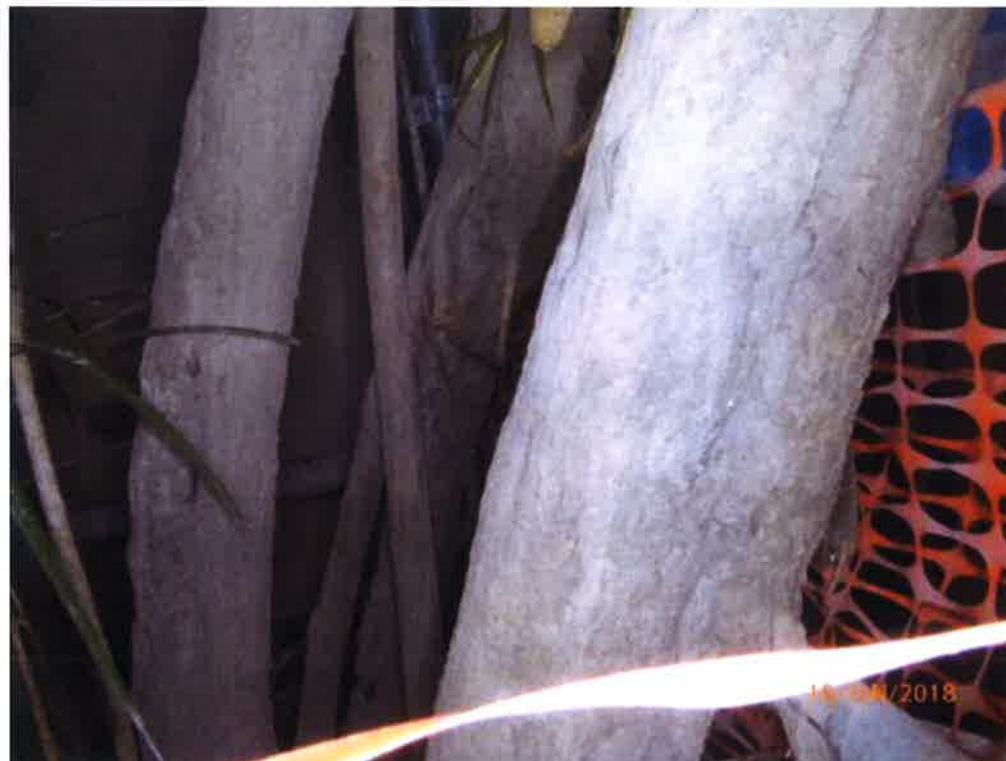
Fig. 4 Health condition of the mid trunk is fair.

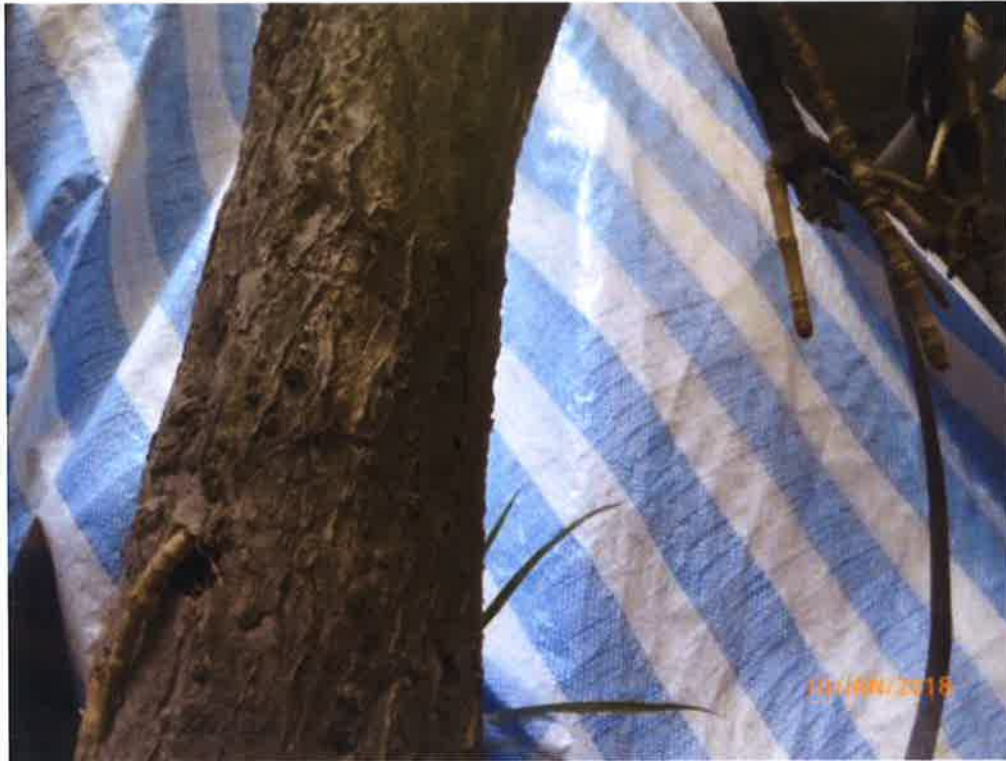
Fig. 6 Some leaves on the bottom part of Tree-11 are covered with cement.

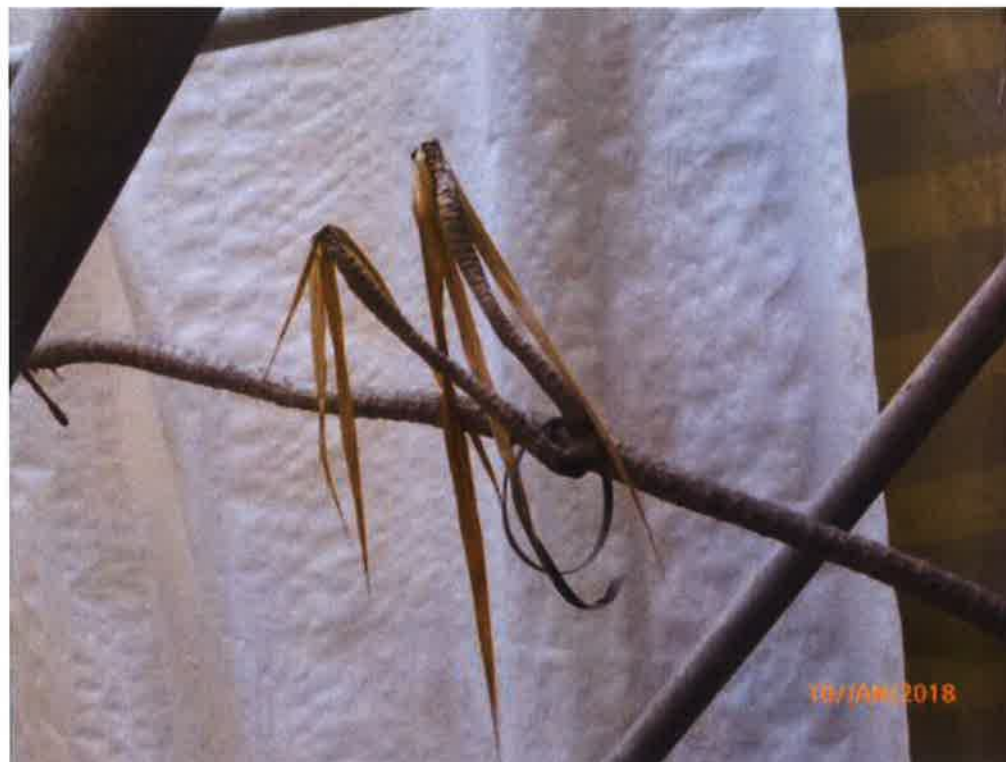
Fig. 8 Withered leaves also appear on the upper branches.

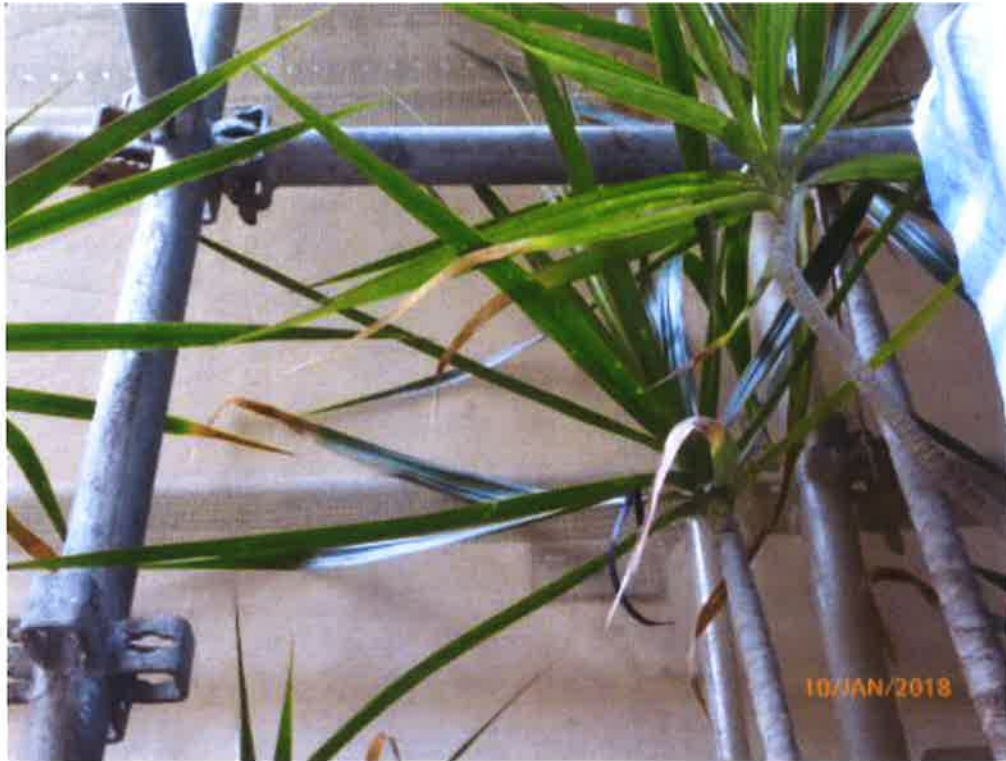
Fig. 9 A large working platform has been set up close to Tree-11.

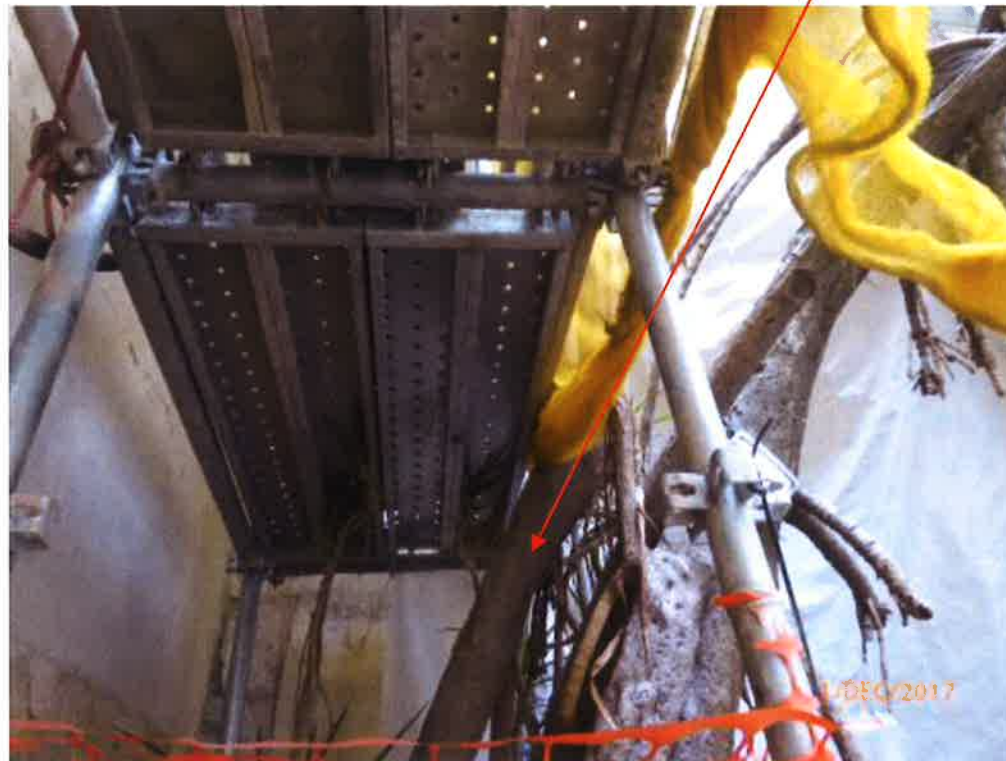
Fig. 10 Another large working platform also set up close to Tree-11 for renovation works.

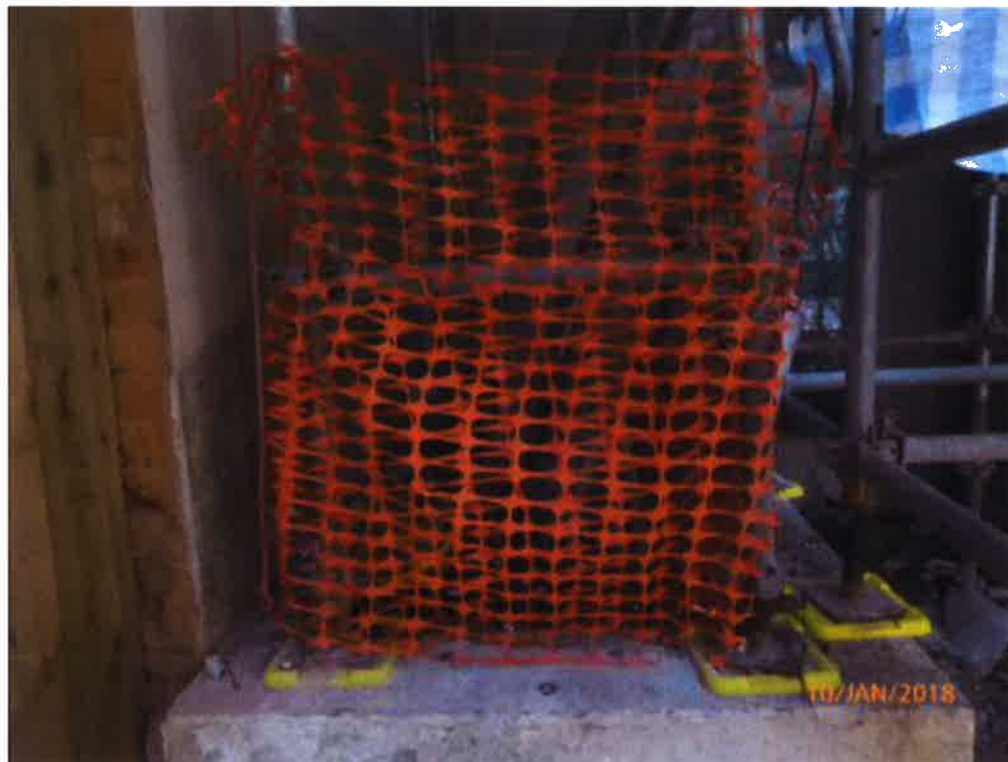
Fig. 12 Overall view of Tree-11 during inspection on 10th January 2018.
