The Jockey Club CPS Limited

Central Police Station Conservation
and Revitalisation Project:
69th Monthly EM&A Report
(1 July to 31 July 2017)

Issue Date: August 2017

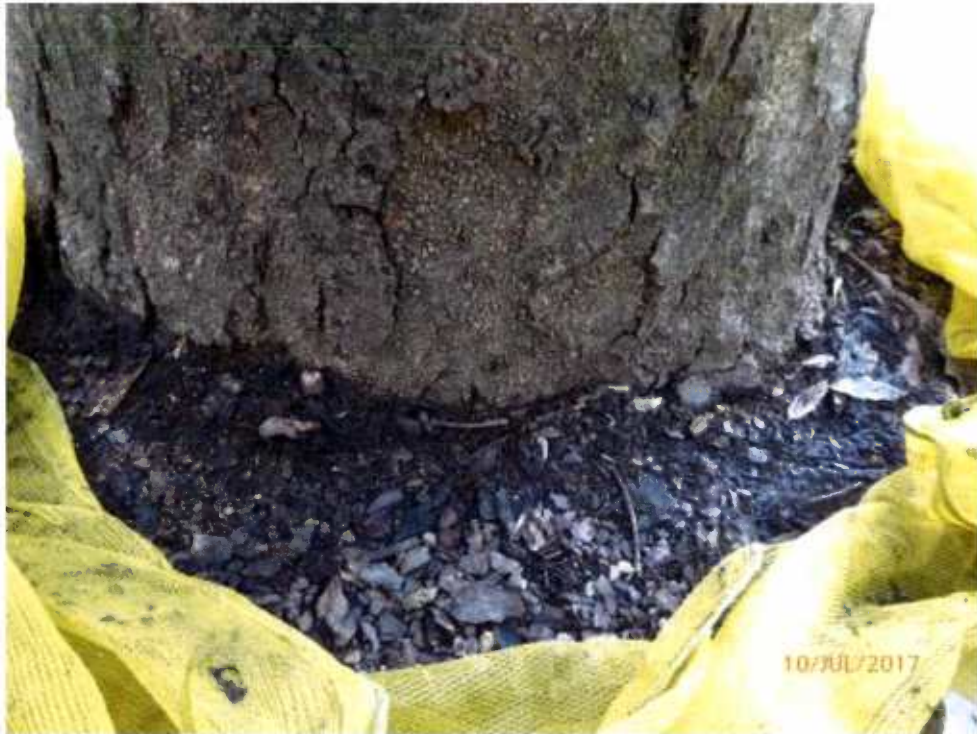
Fig 2. The root collar is normal. The planter is covered with small pieces of pine bark.

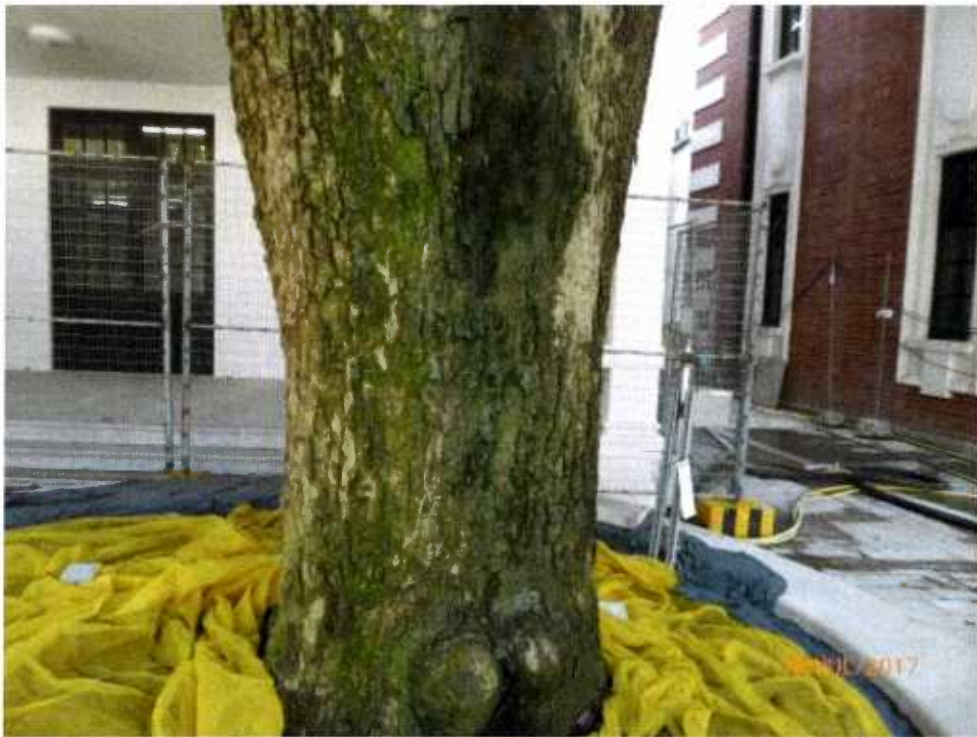
Fig. 3 Health condition of the lower trunk is fair.

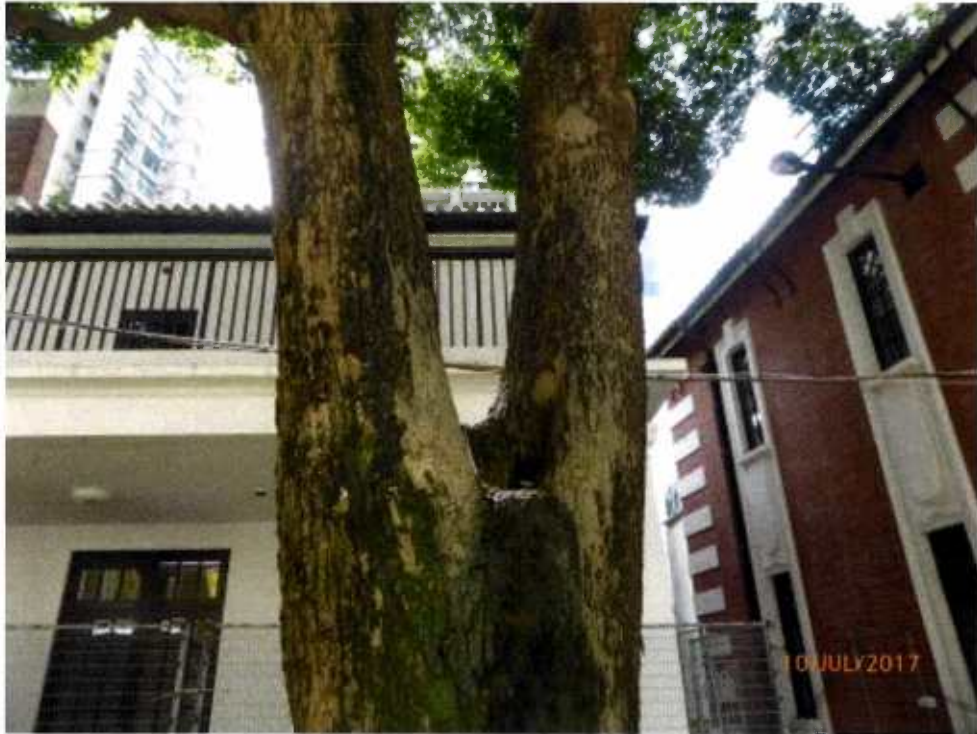
Fig. 4 Health condition of the mid trunk is fair.

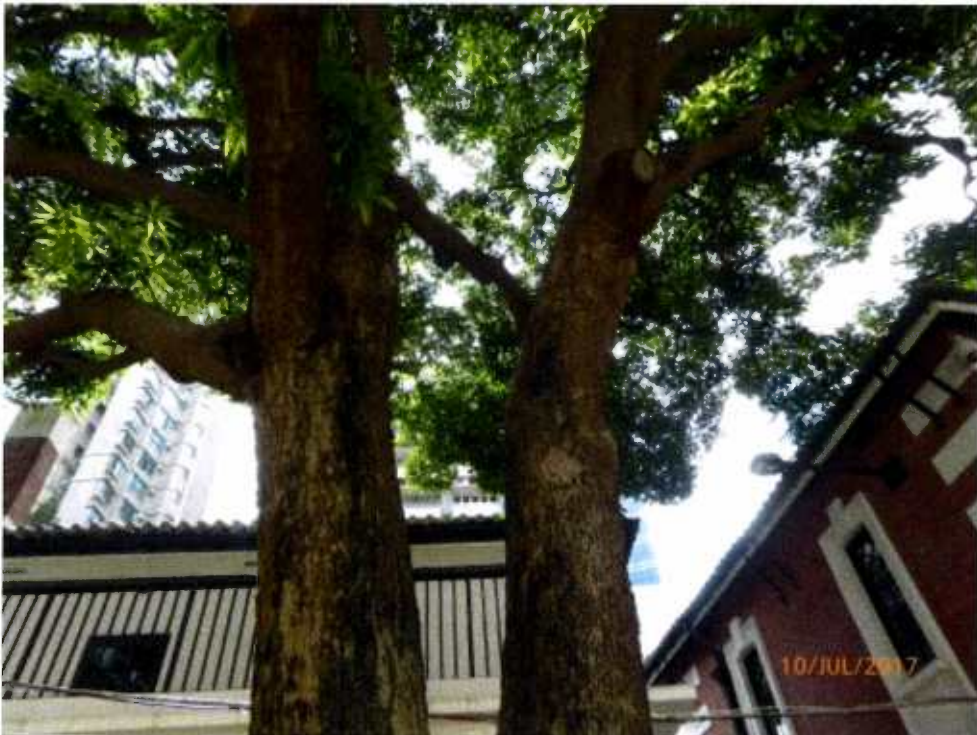
Fig. 5 Health condition of the upper trunk also is fair.

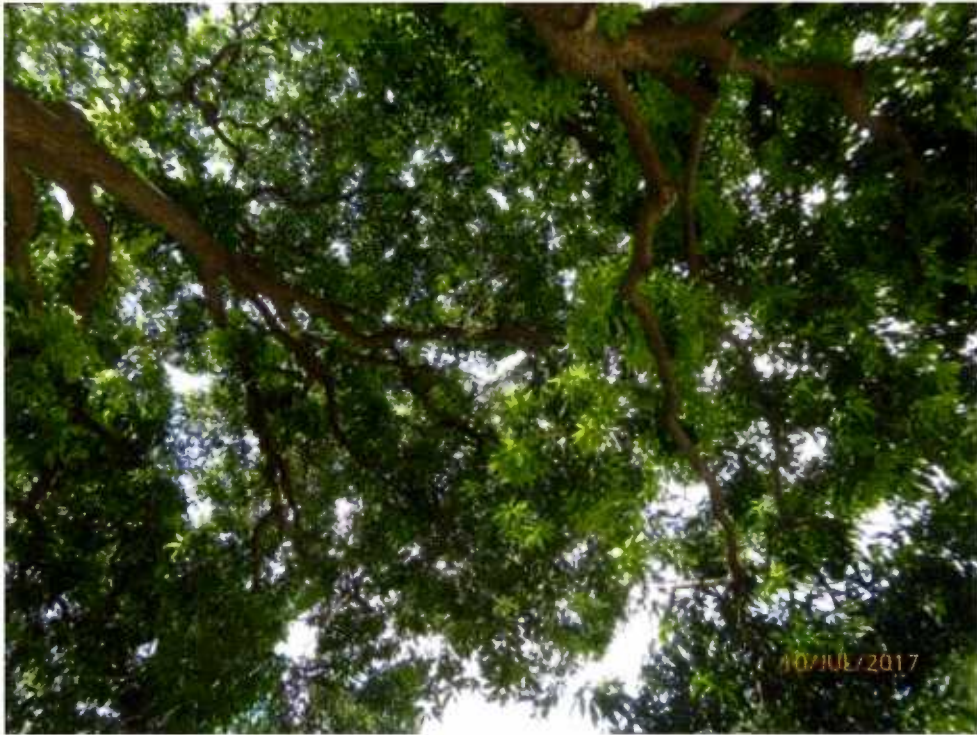
Fig. 6 The crown is full of vigorous and green leaves.

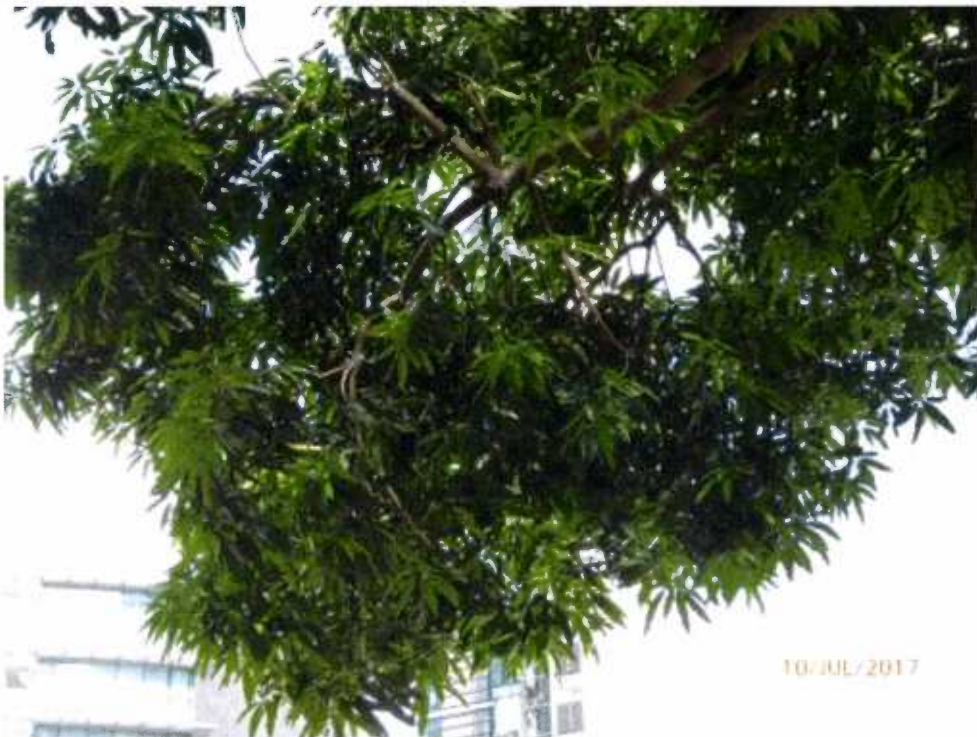
Fig. 7 Vigorous and green leaves also are growing on the lower branches.

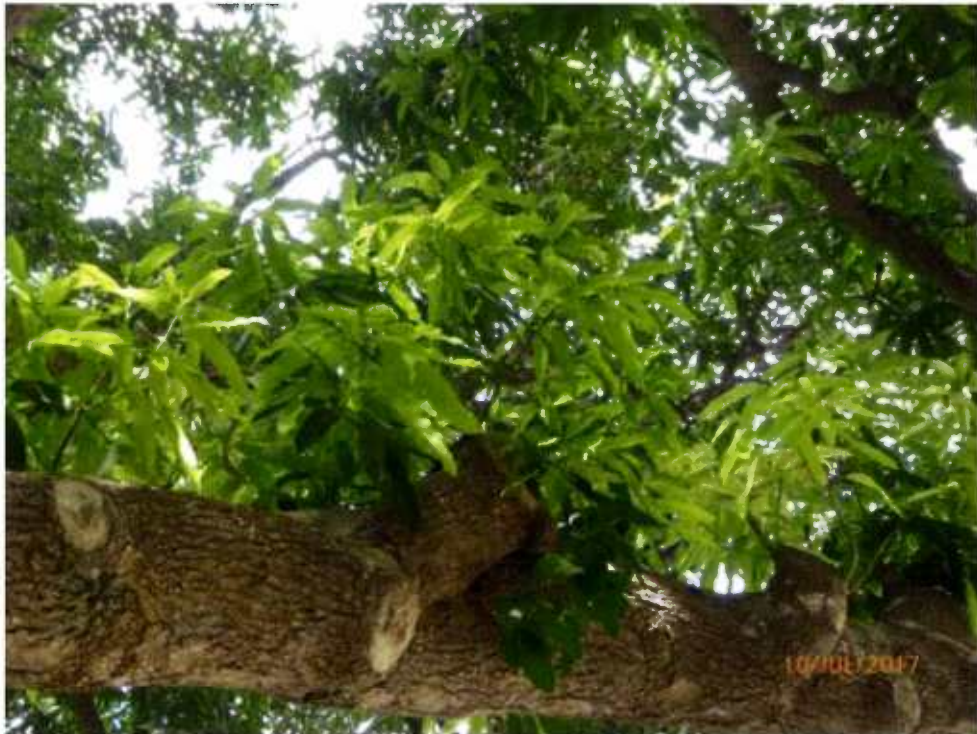
Fig. 8 Young and green leaves appear on the tree.

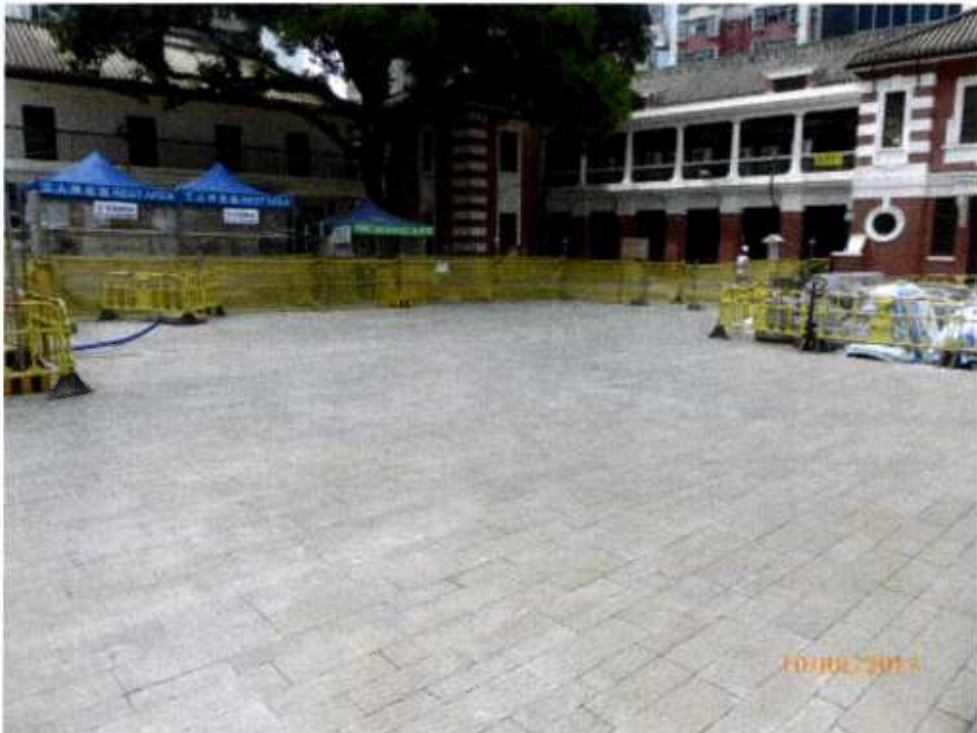
Fig. 11 The site near Tree-5 also is clean and tidy.

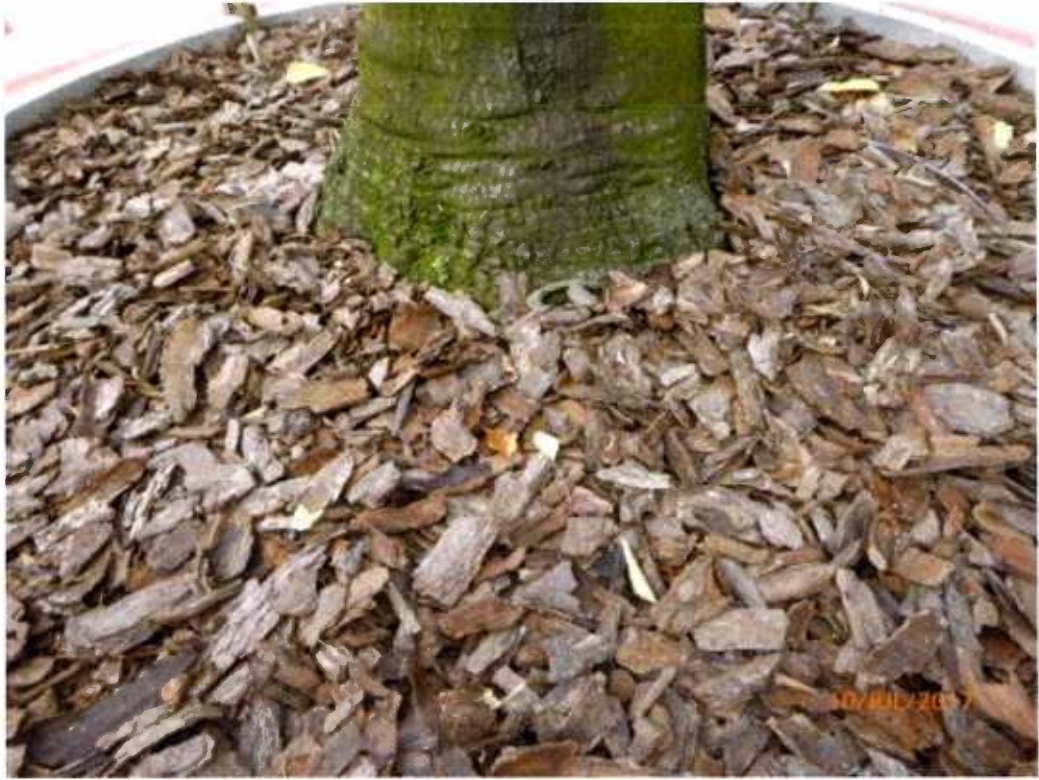
Fig 2. Root collar is normal. The planter is covered with reasonable mulch.

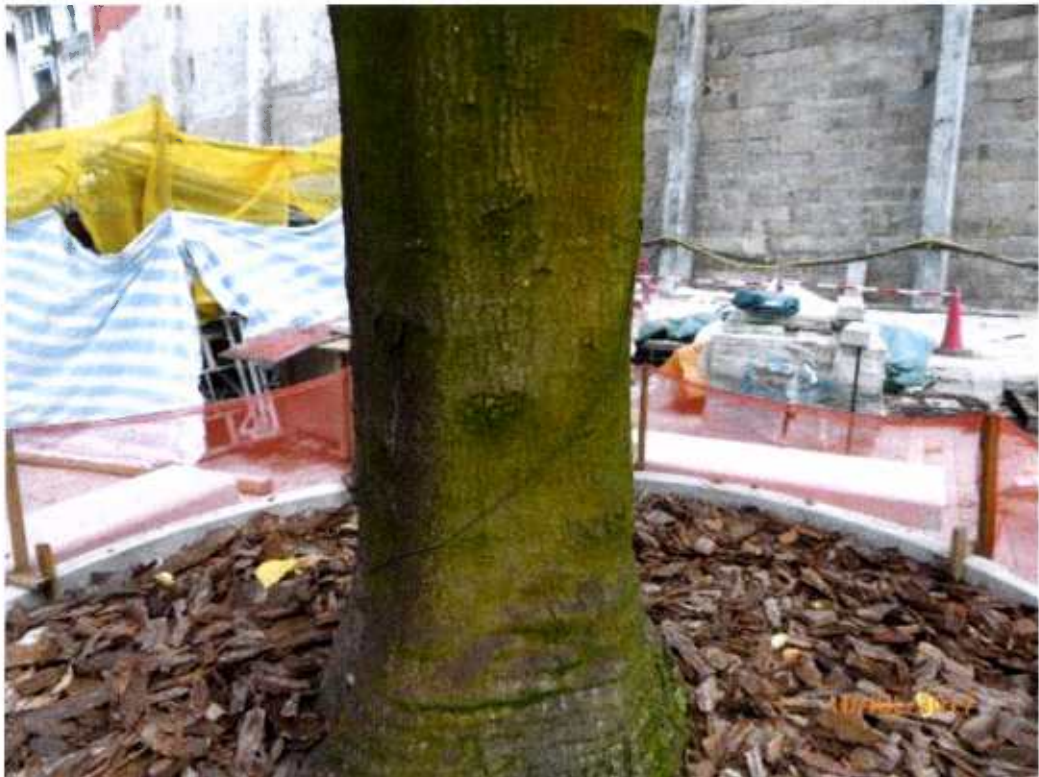
Fig 3. Health condition of the lower trunk is fair.

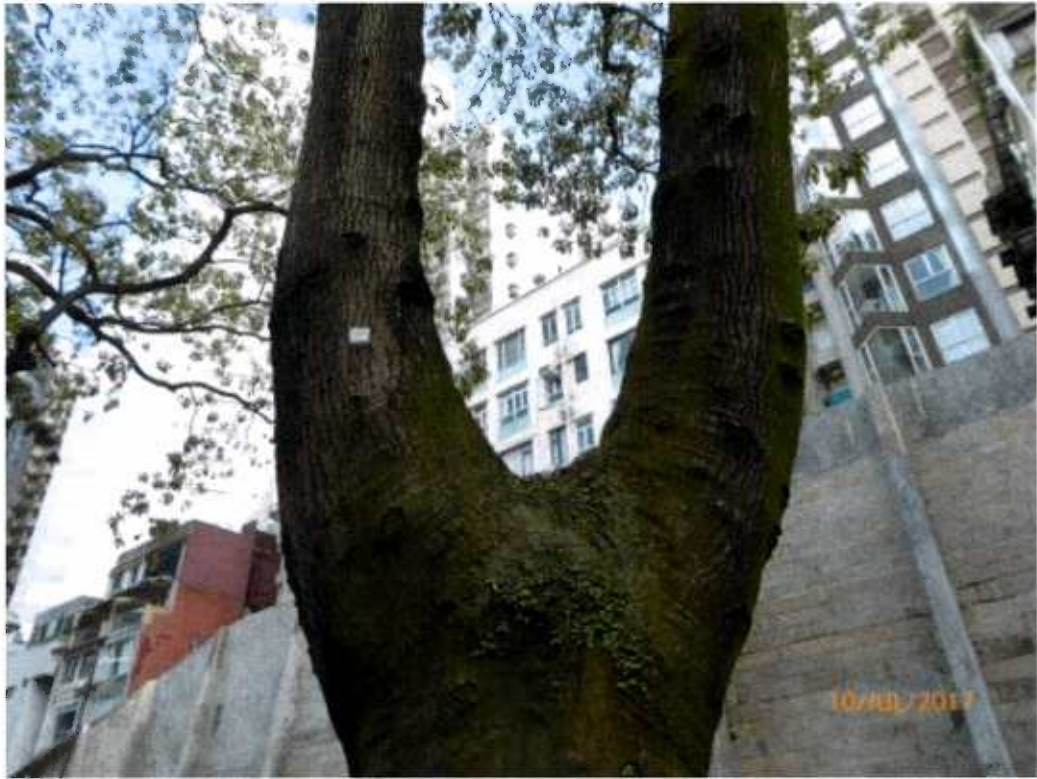
Fig. 4 Health condition of the mid trunk is fair.

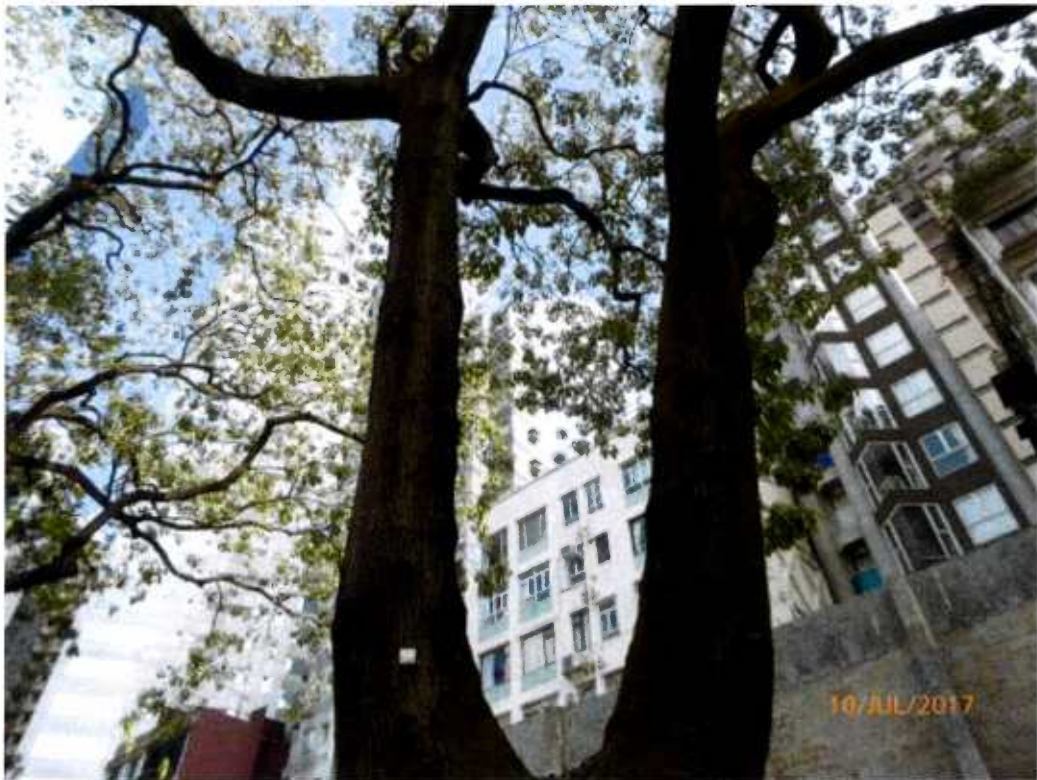
Fig. 5 Health condition of the upper trunk also is fair.

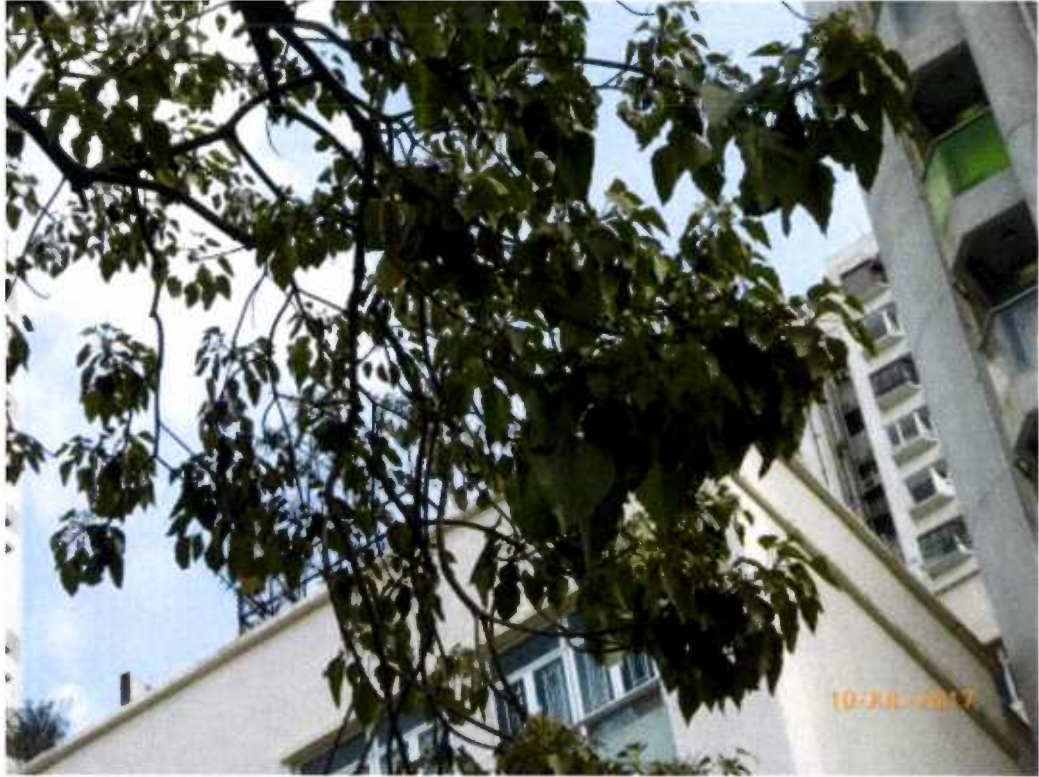
Fig. 6 Vigorous and green leaves are growing on the lower branches.

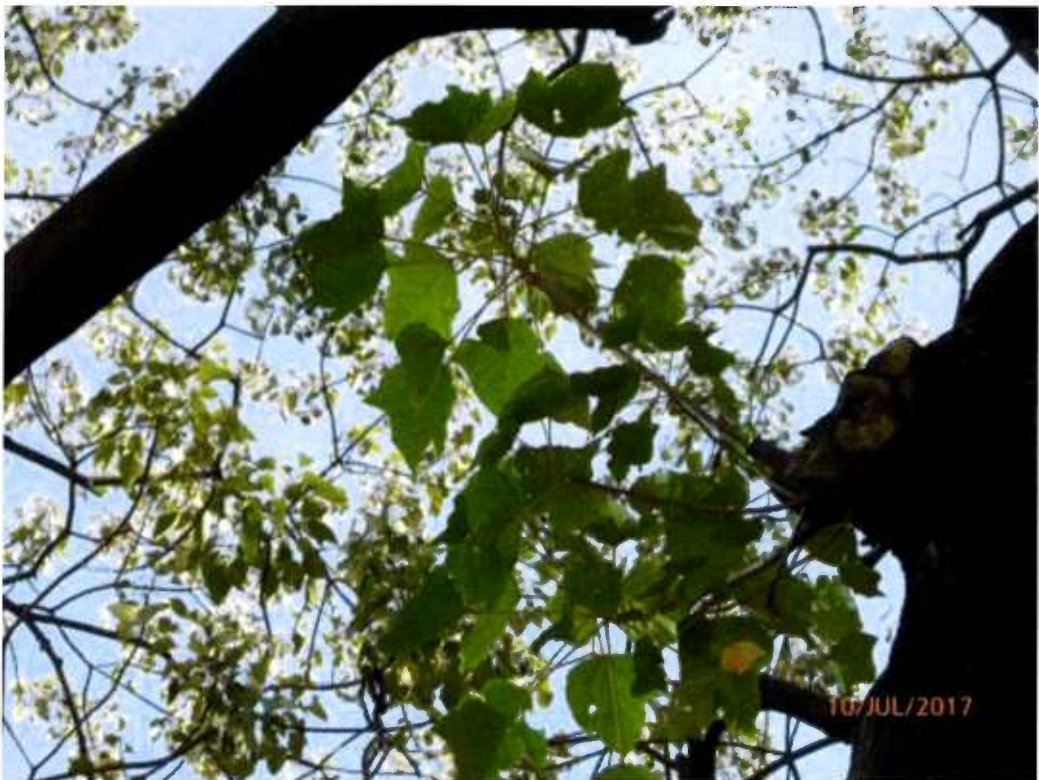
Fig. 7 Some young and green leaves appear on the tree.

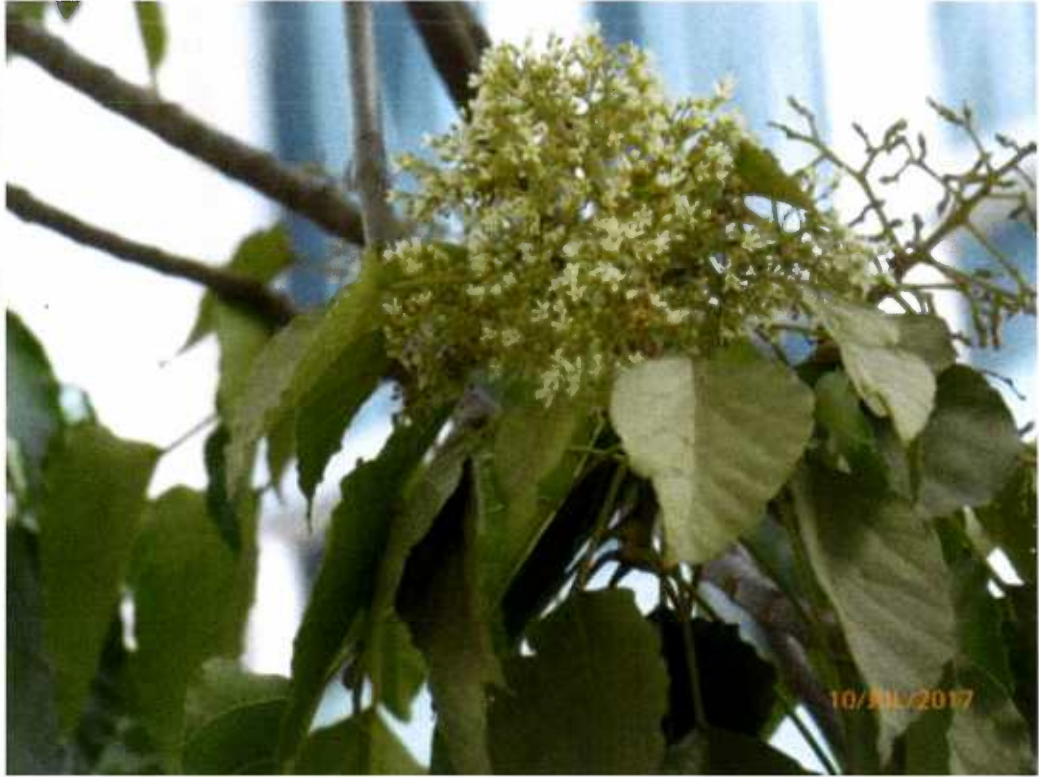
Fig. 8 Many flowers still remain on the tree.

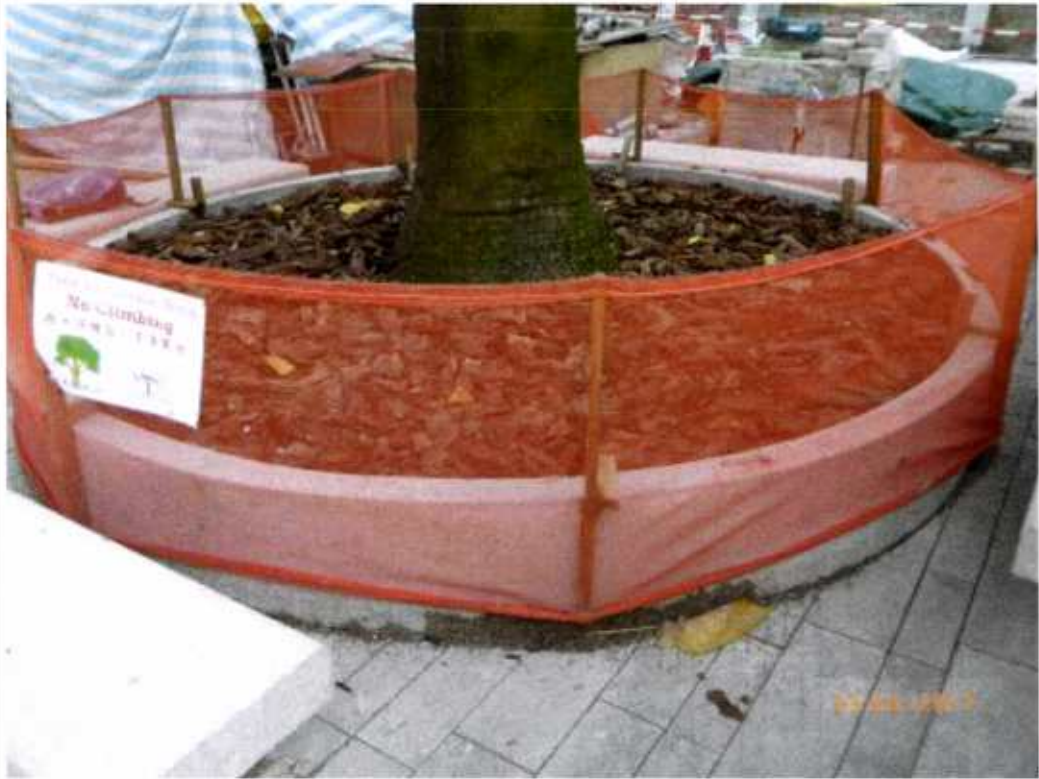
Fig. 10 The Tree Protection Zone is in good order.

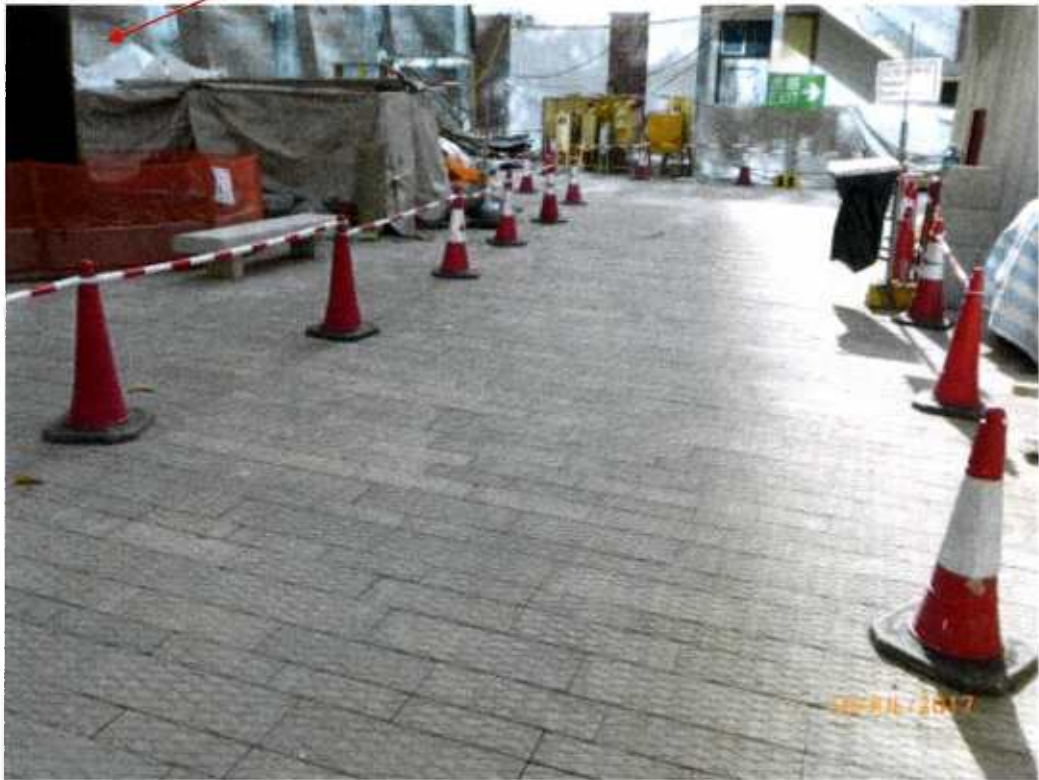
Fig. 11 The site near Tree-6 is clean and tidy.

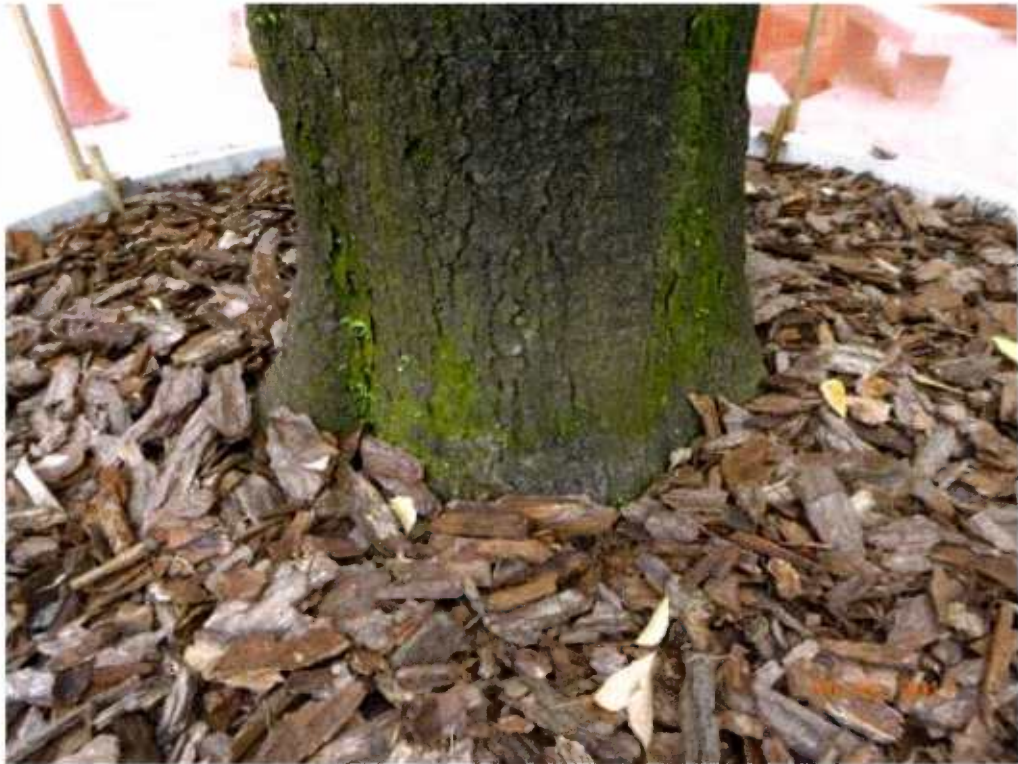
Fig. 2 Root collar is normal. The planter is covered with reasonable mulch.

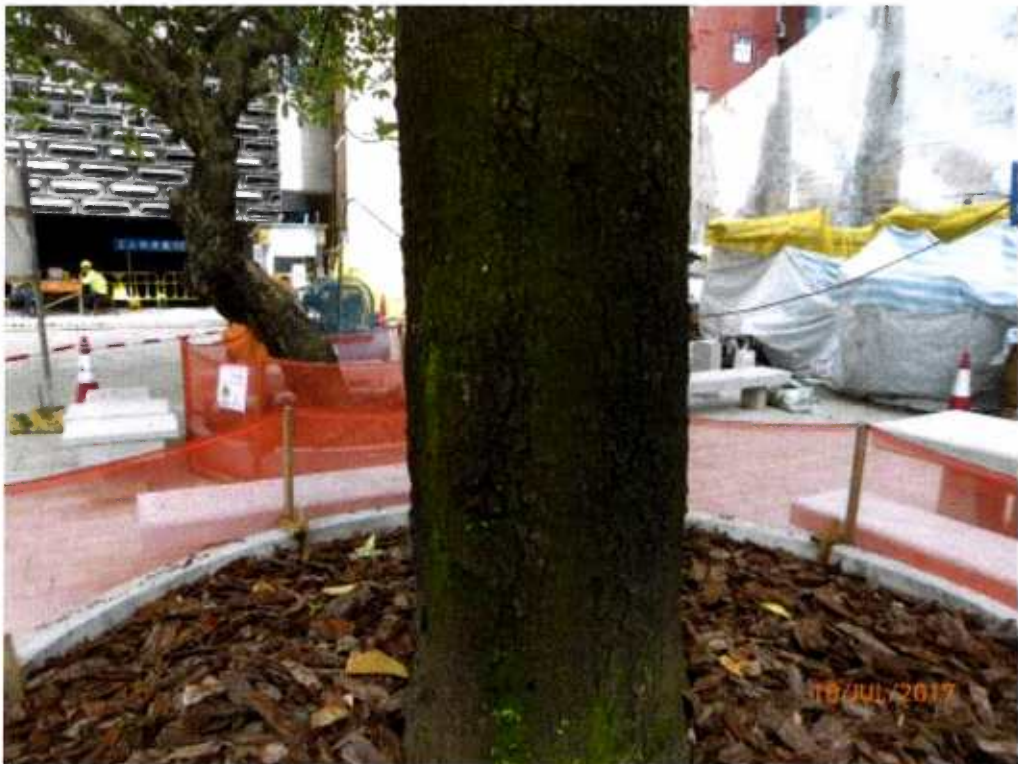
Fig 3. Health condition of the lower trunk is fair.

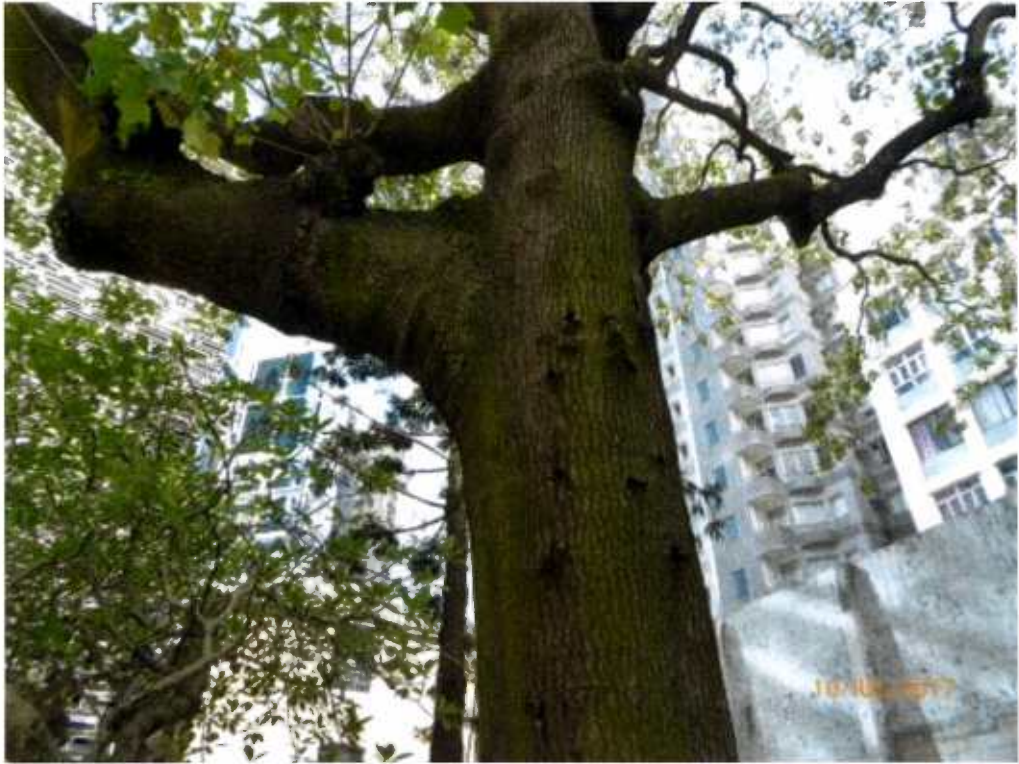
Fig. 4 Health condition of the mid trunk is fair.

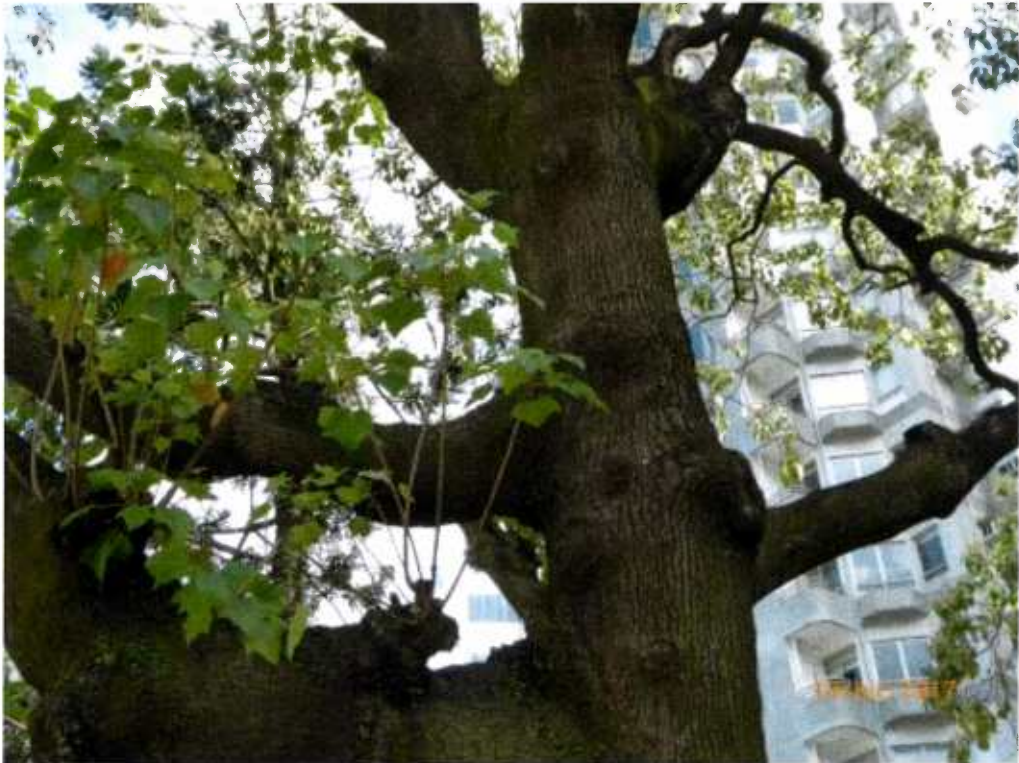
Fig. 5 Health condition of the upper trunk also is fair.

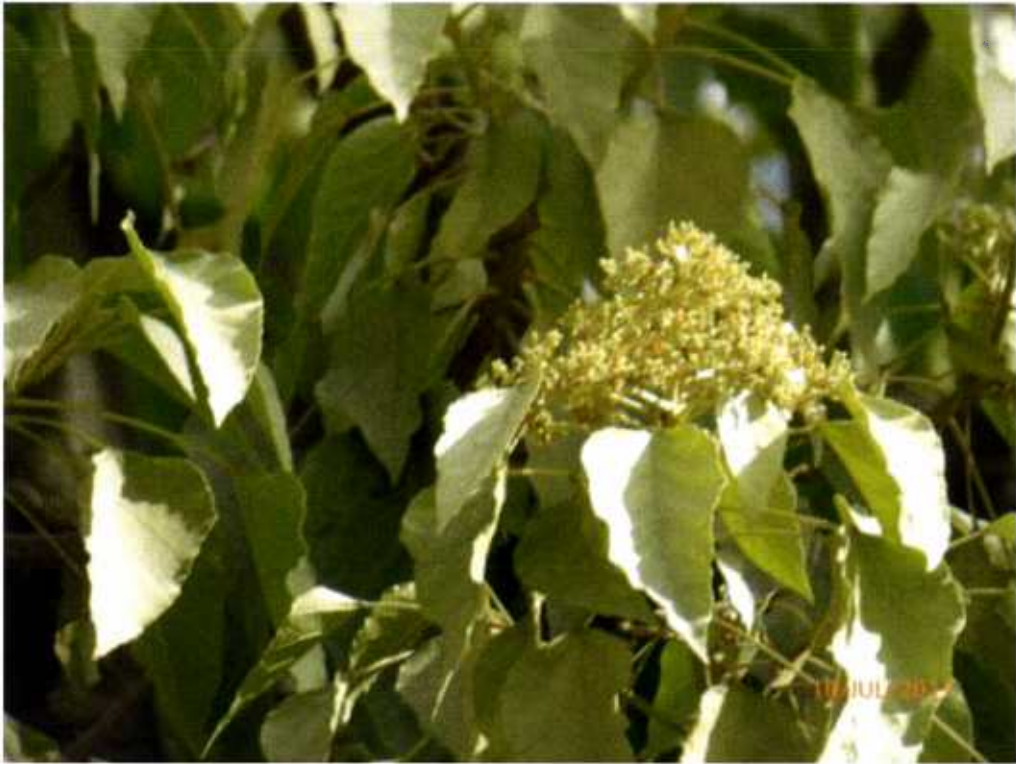
Fig. 6 Flowers still remain on the tree.

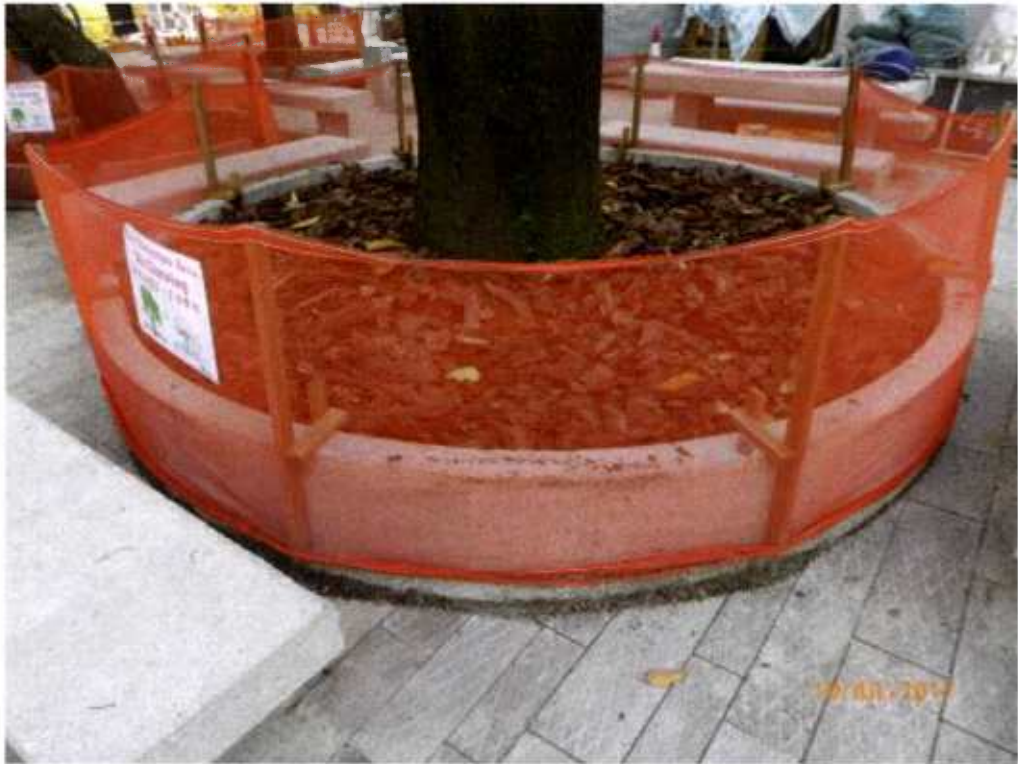
Fig. 10 The Tree Protection Zone is in good order.

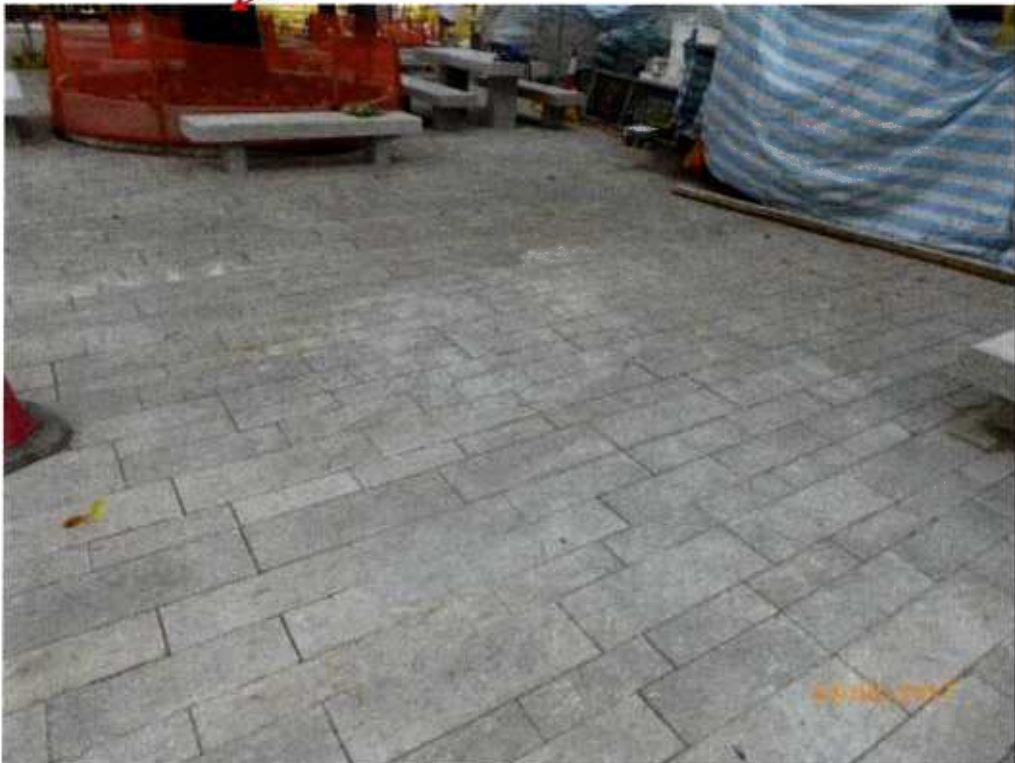
Fig. 11 The site near Tree-7 is clean and tidy.

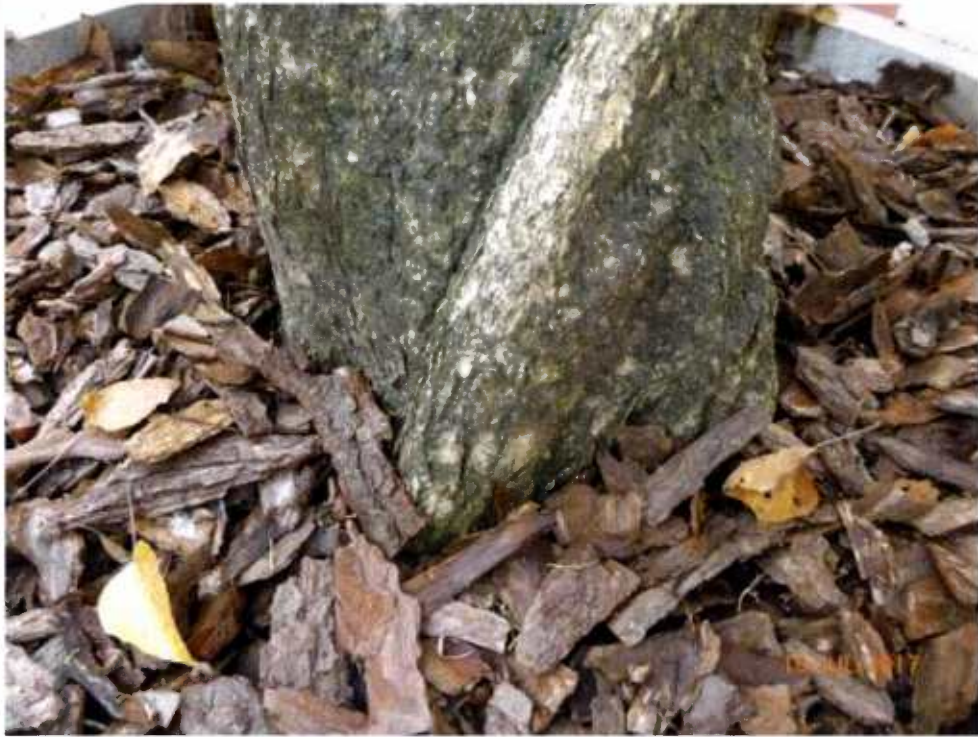
Fig. 2 Root collar is normal. The planter is covered with reasonable mulch.

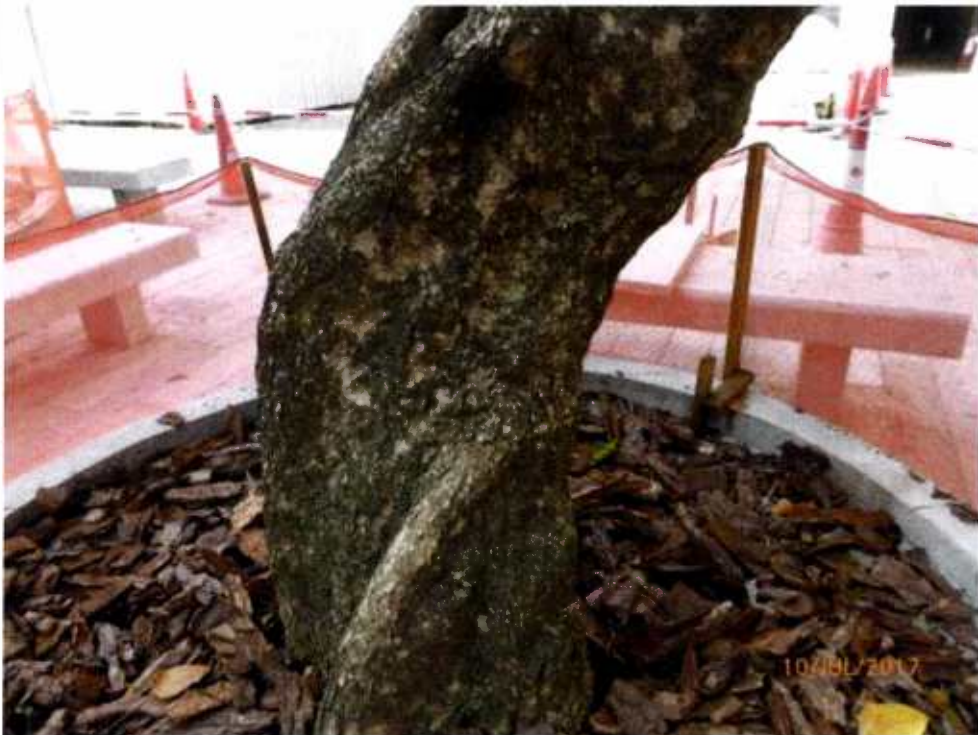
Fig. 4 Health condition of the mid trunk is fair.

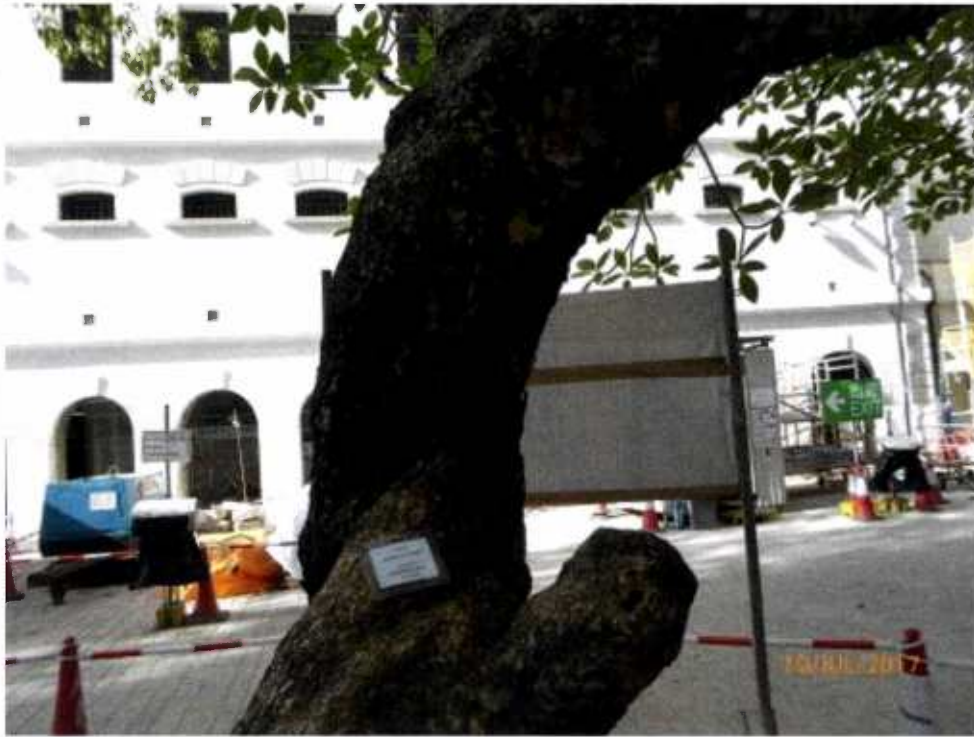
Fig. 5 Health condition of the upper trunk also is fair.

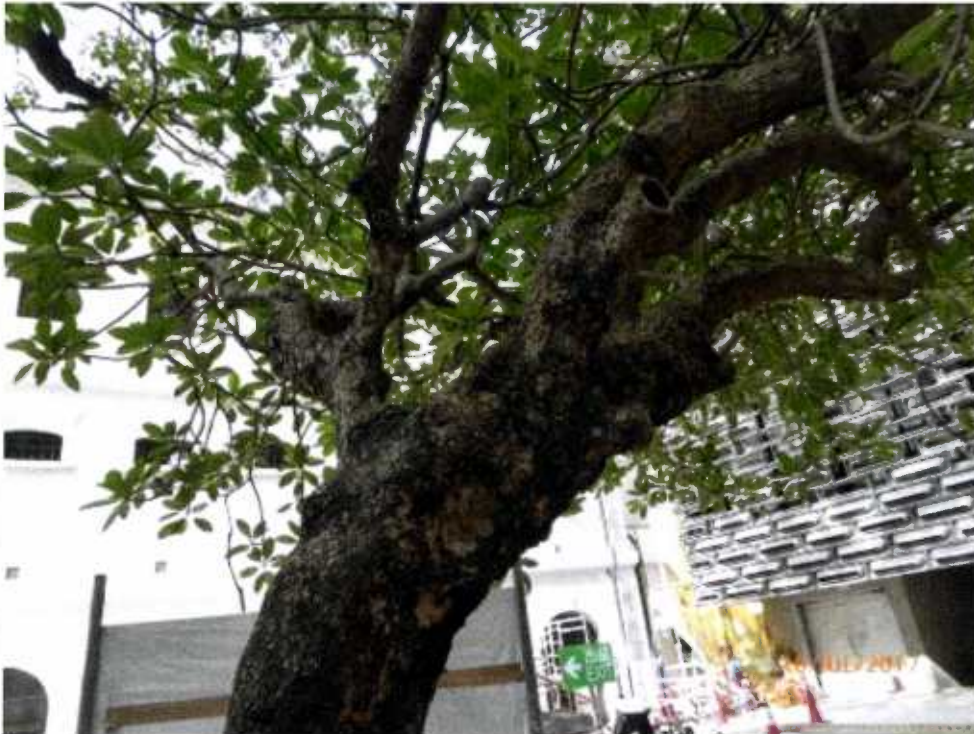
Fig. 6 The crown is full of vigorous and green leaves.

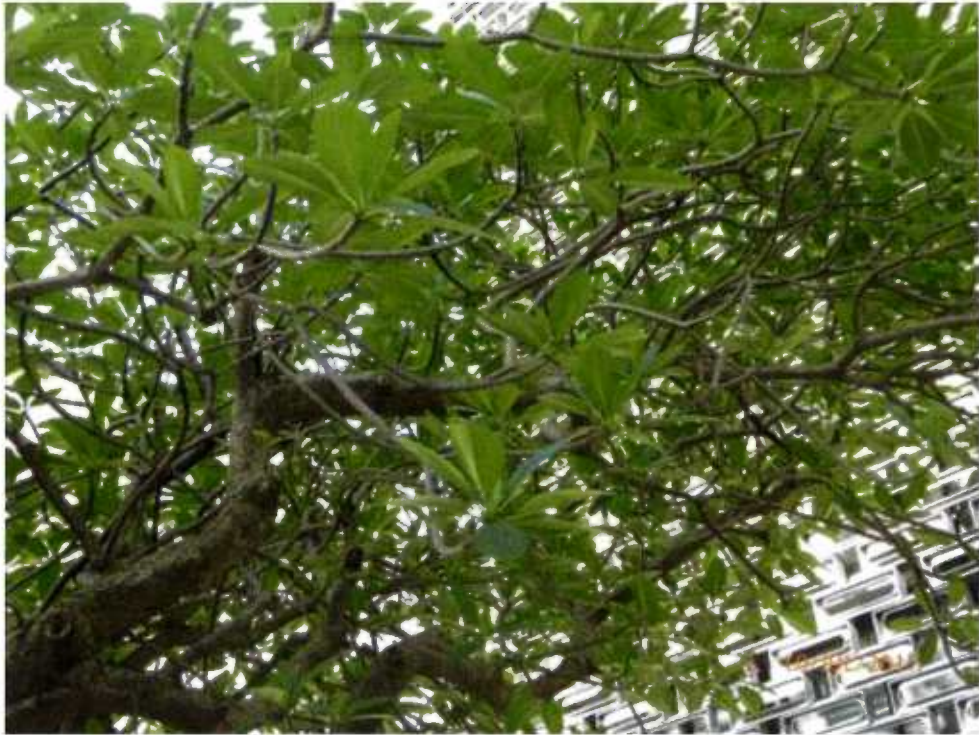
Fig. 7 Vigorous and green leaves also are growing on the lower branches.

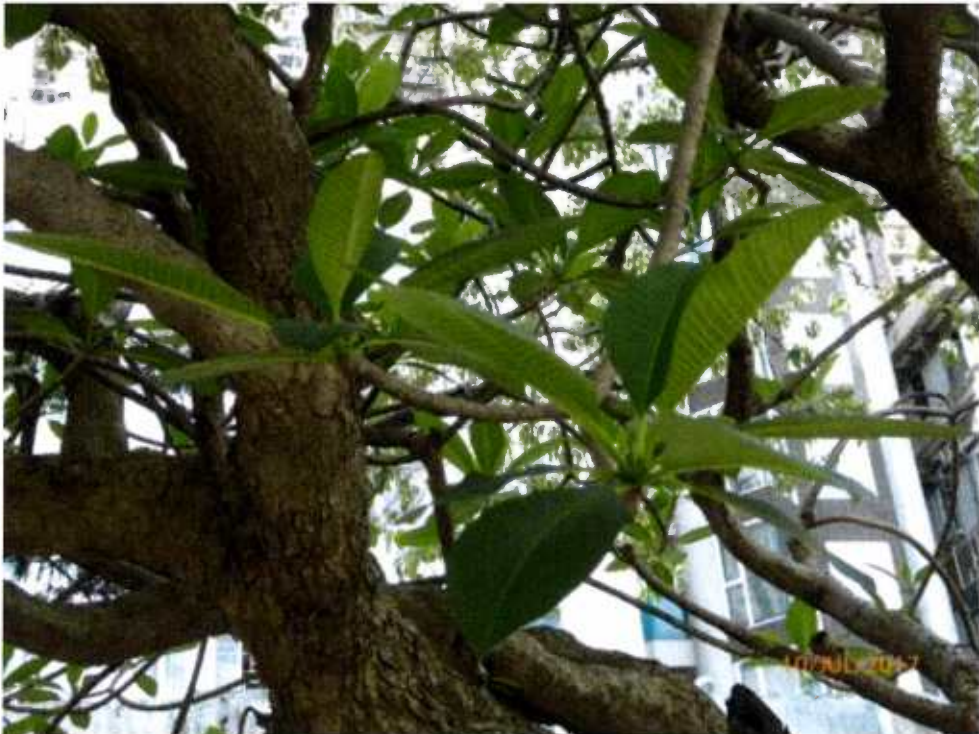
Fig. 8 Glorious flowers still appear on the tree.
