The Jockey Club CPS Limited

Central Police Station Conservation
and Revitalisation Project:
69th Monthly EM&A Report
(1 July to 31 July 2017)

Issue Date: August 2017

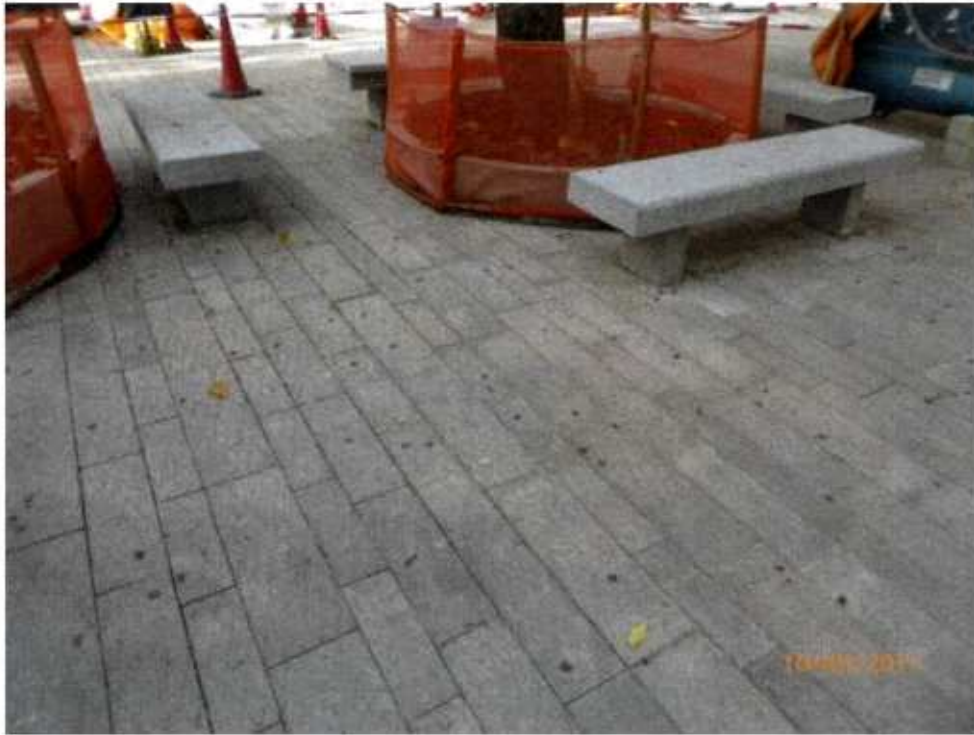
Fig. 11 The access near Tree-8 also appears clean and tidy.

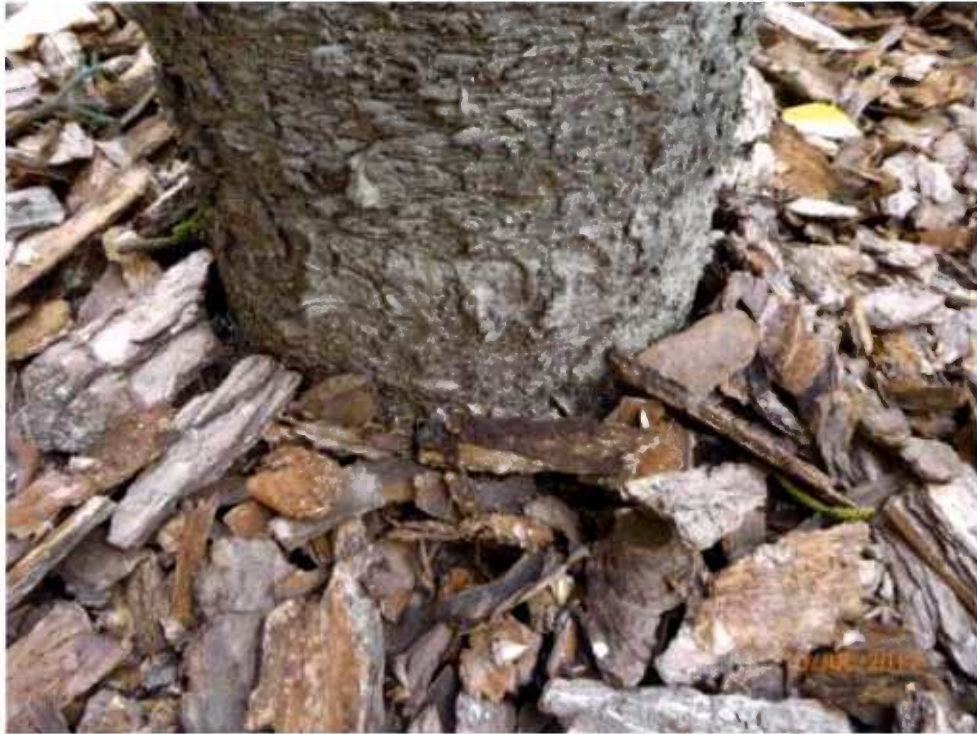
Fig. 3 The planter is covered with reasonable mulch.

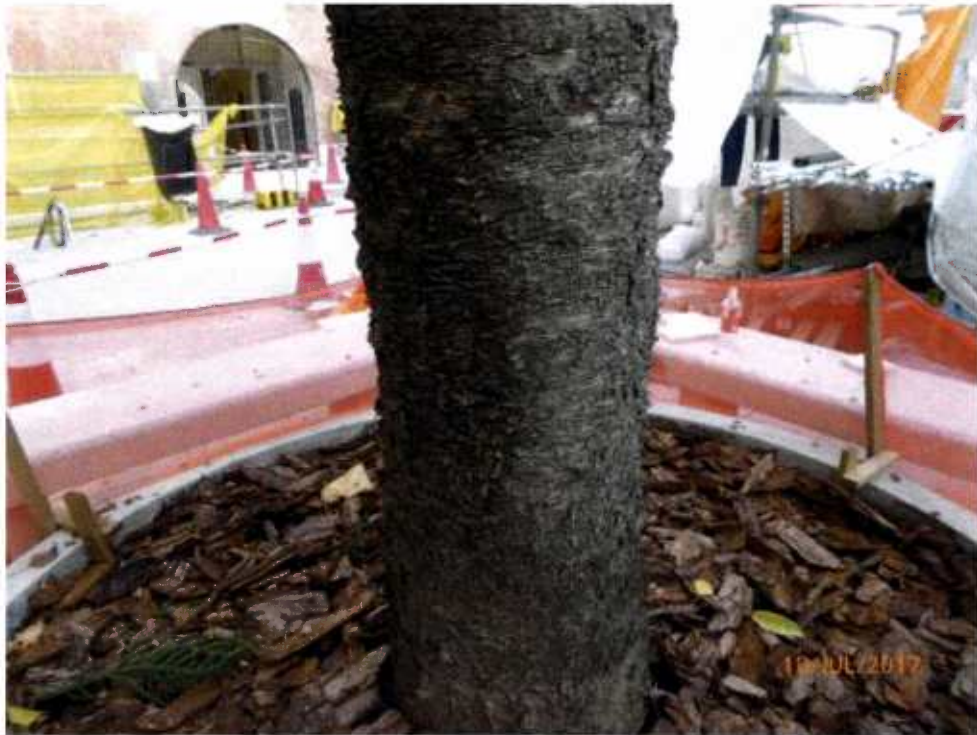
Fig. 5 Health condition of the mid trunk is fair.

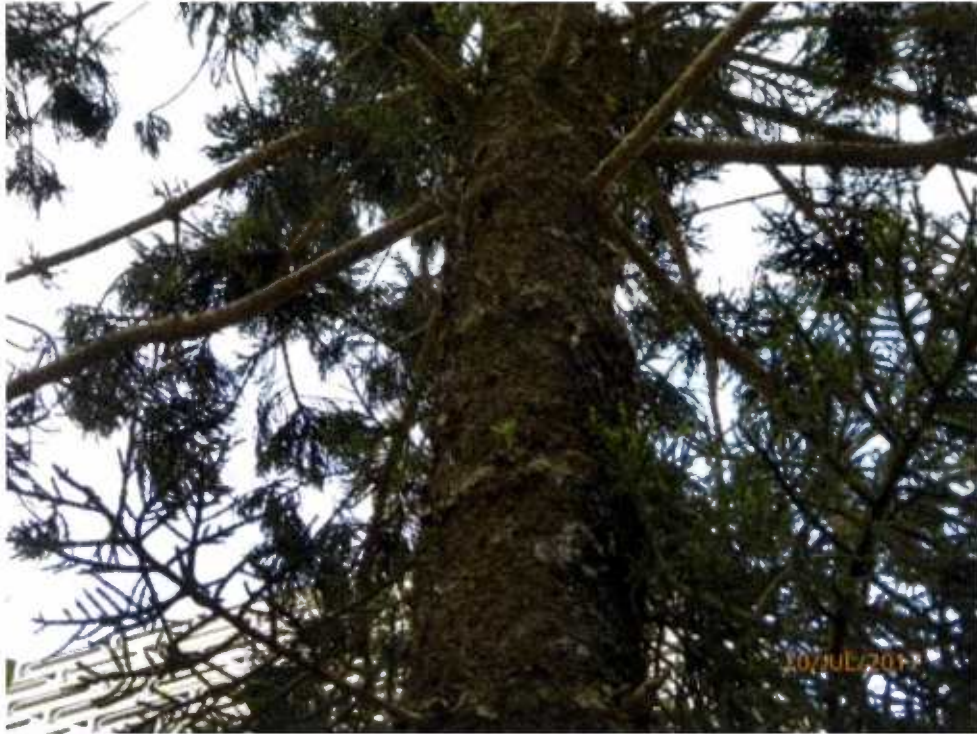
Fig. 7 The crown is full of vigorous and green leaves.

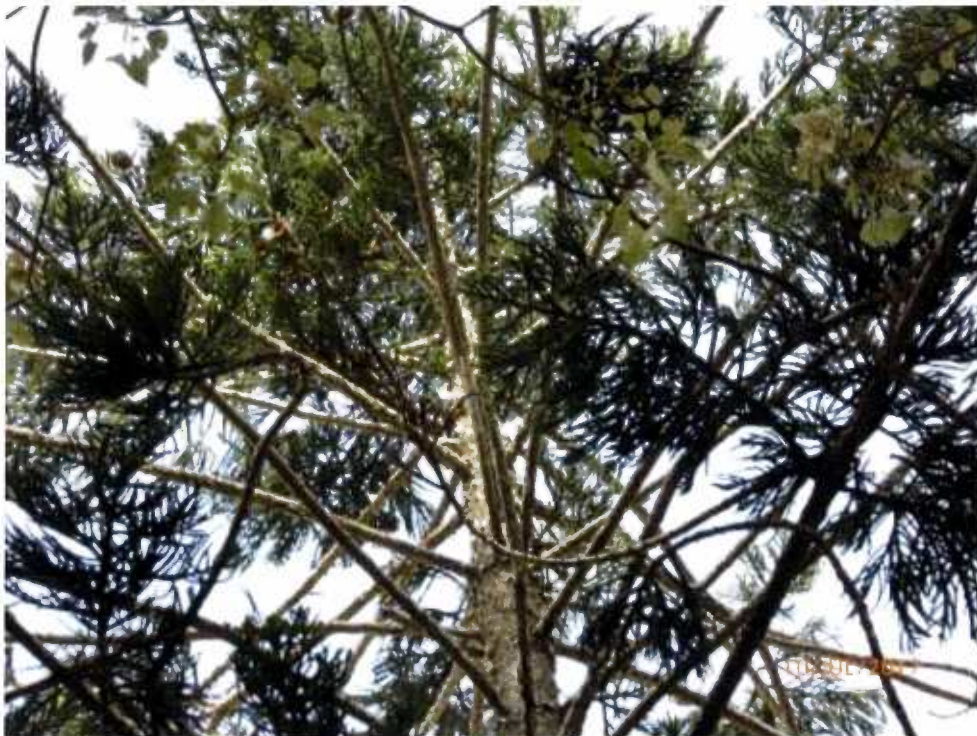
Fig. 8 Vigorous and green leaves also are growing on the lower branches.

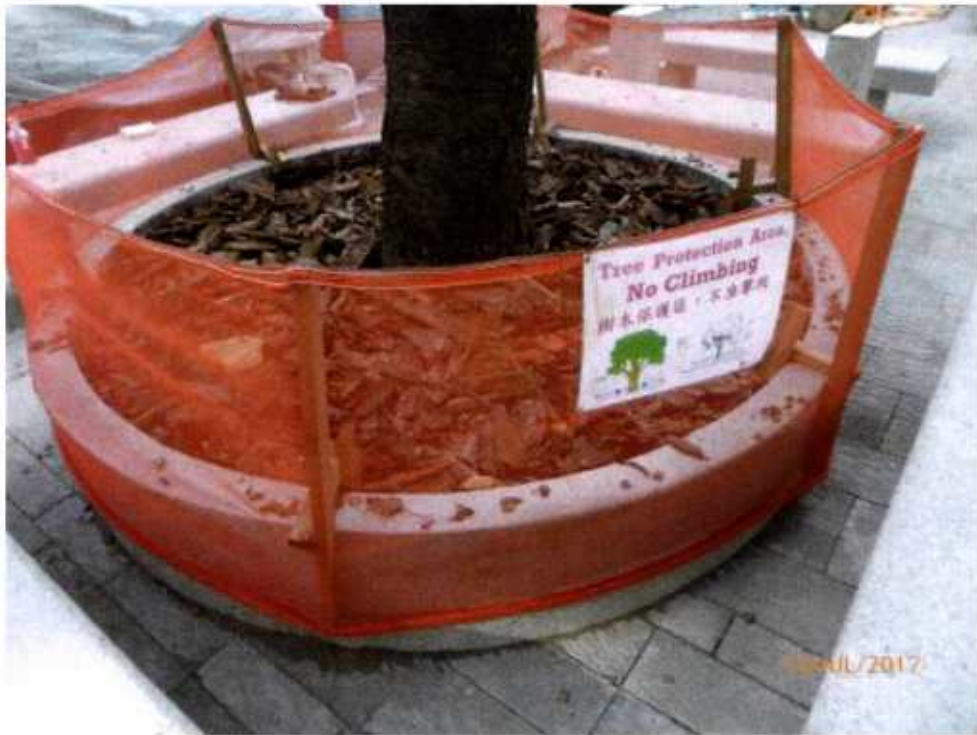
Fig. 11 The site near Tree-9 appears clean and tidy.

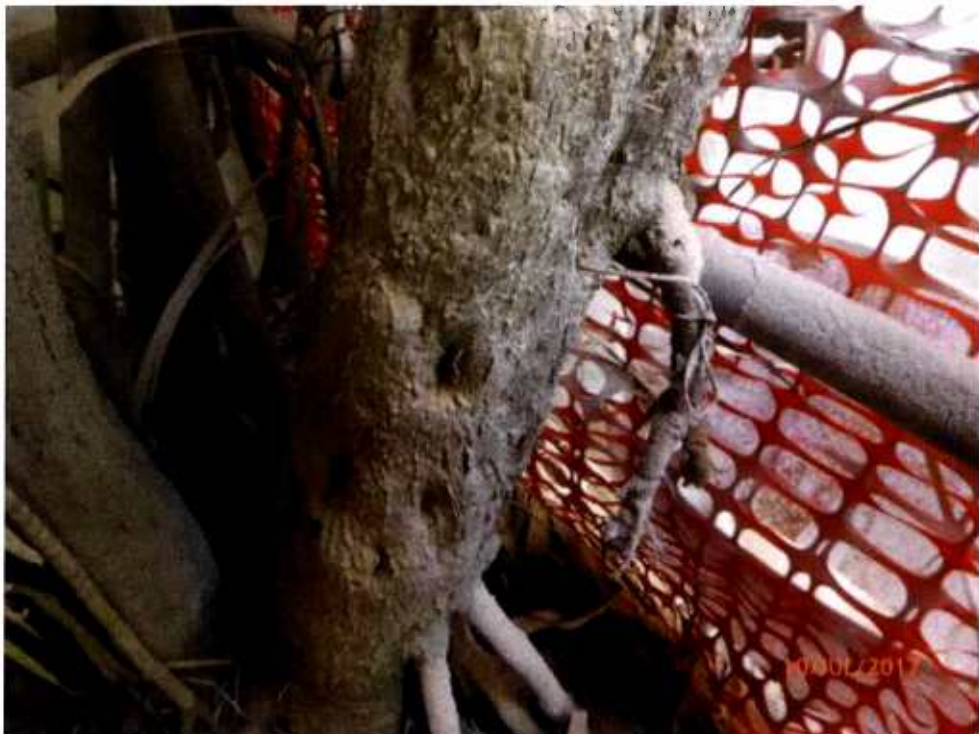
Fig. 5 Health condition of the lower trunk is fair.

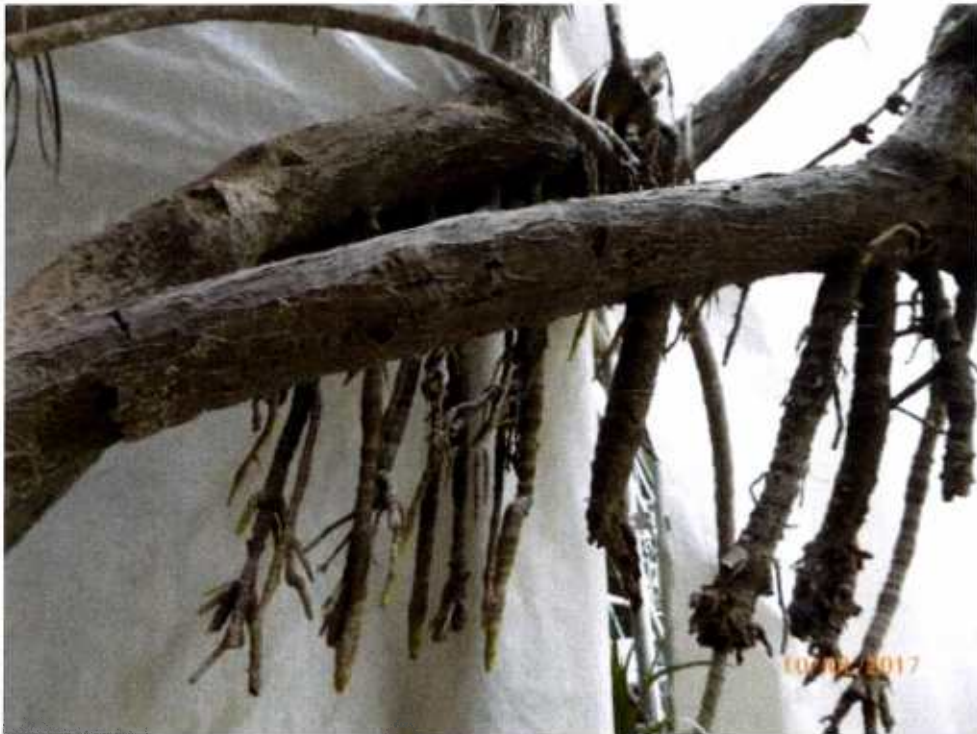
Fig. 7 Health condition of the upper trunk also is fair.

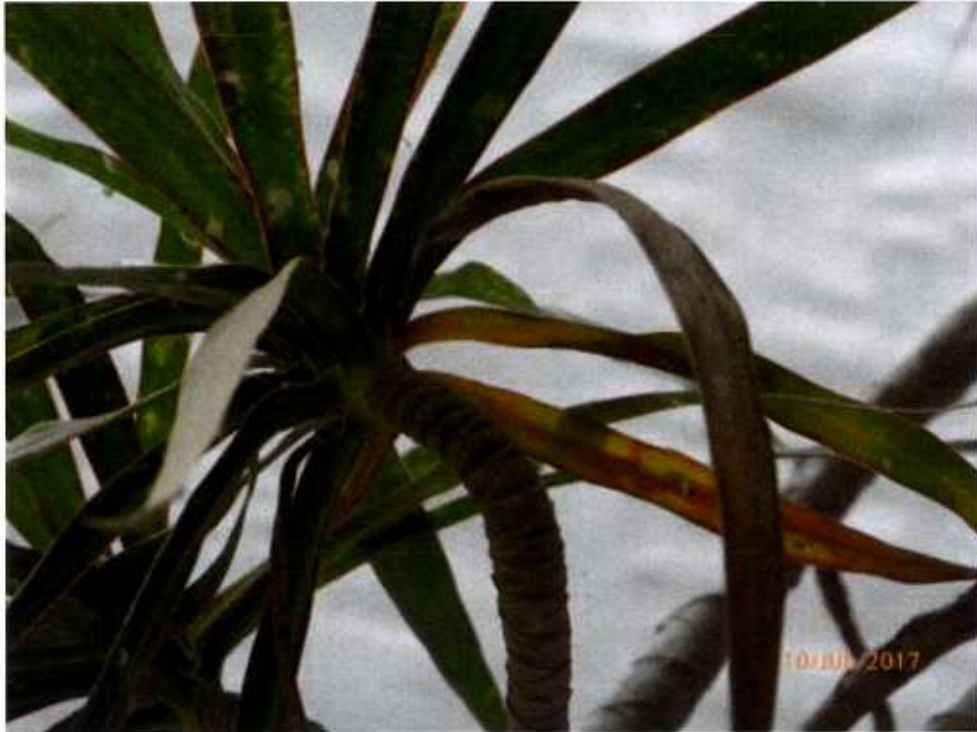
1. Health condition of the tree is fair.
2. Root collar is normal, **The planter is covered with much construction dust.**
3. Withered leaves still appear on the tree.
4. Many construction materials are placed near the tree.

Fig. 8 Withered leaves still remain on the crown.

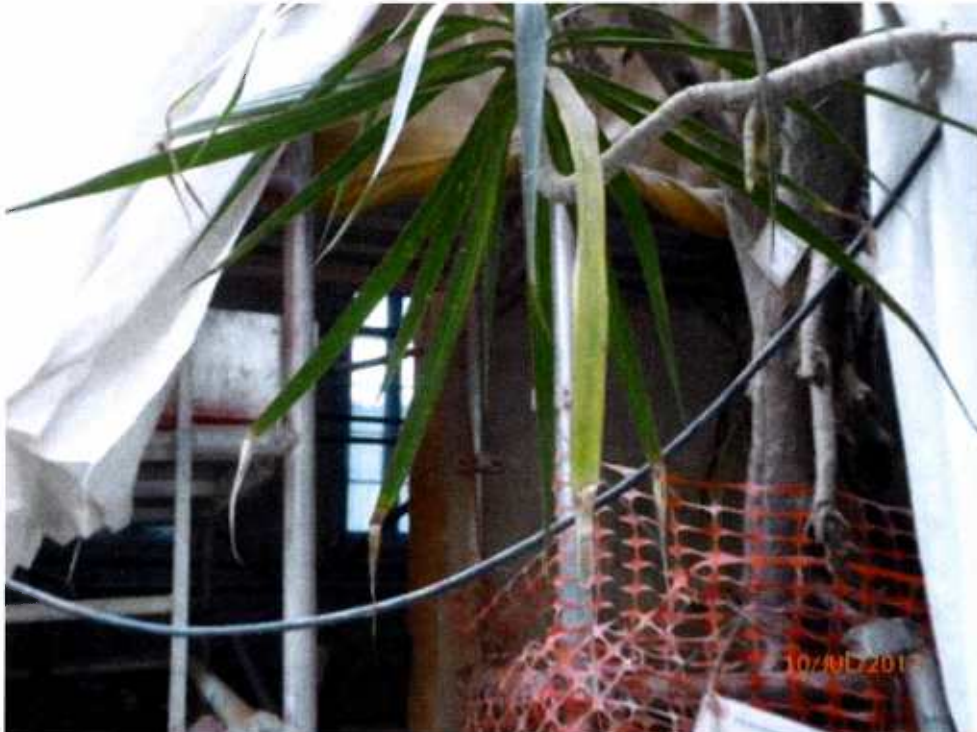
Fig. 9 Withered leaves also appear on the lower branches.
