Central Police Station Conservation
and Revitalisation Project:
61st Monthly EM&A Report
(1 November to 30 November 2016)

Issue Date: December 2016

Environmental Resources Management

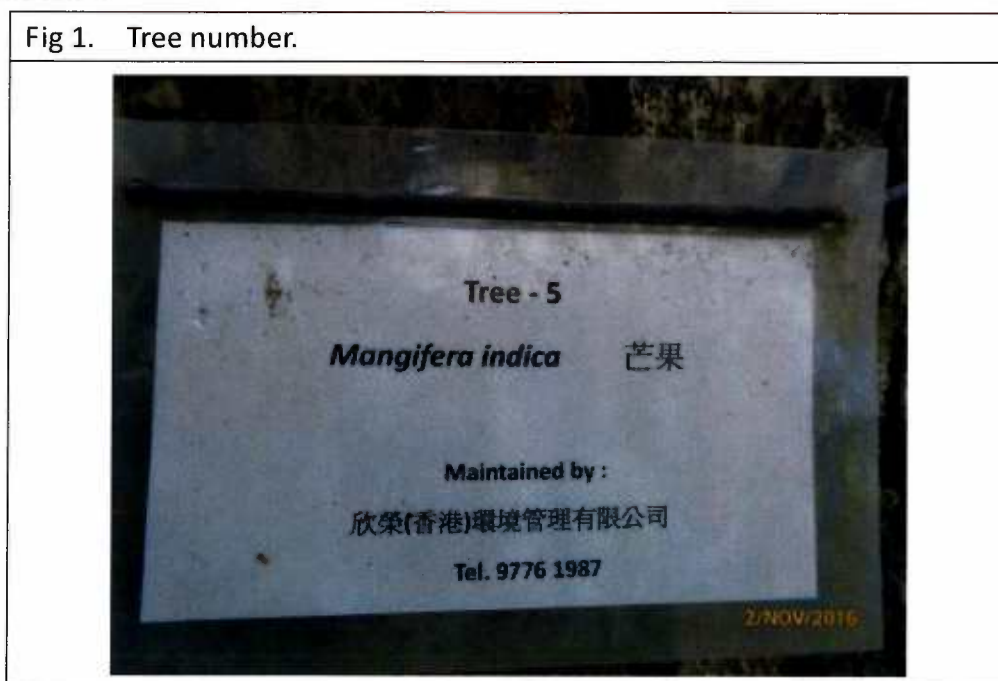
Fig 2. Root collar is normal. The topsoil is covered with mulch and leaves.

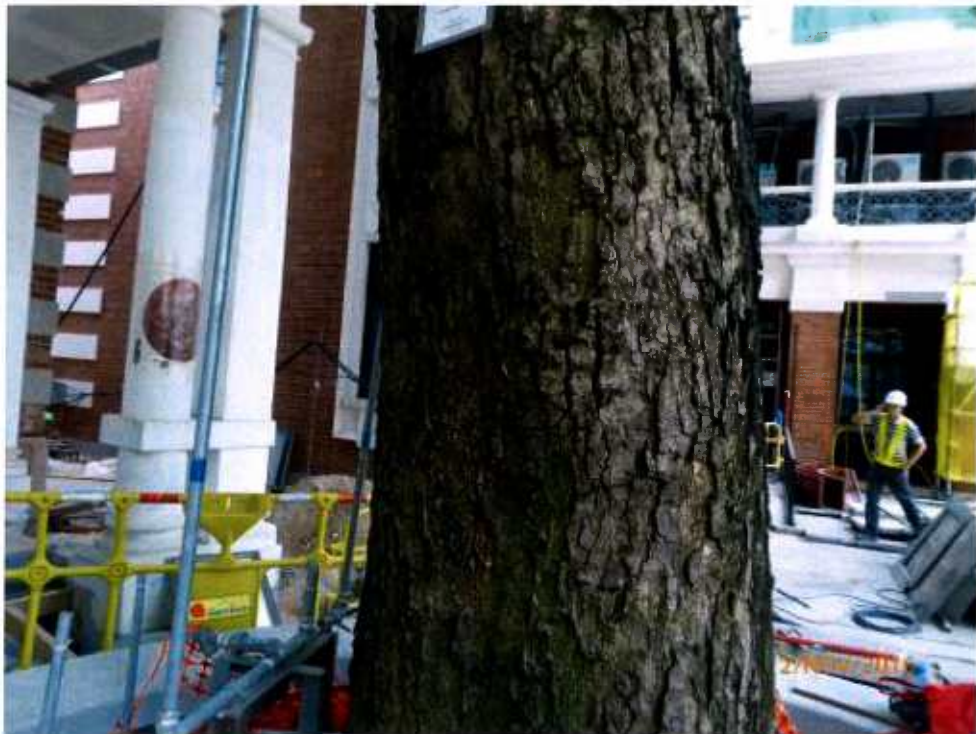
Fig. 4 Health condition of the mid trunk is fair.

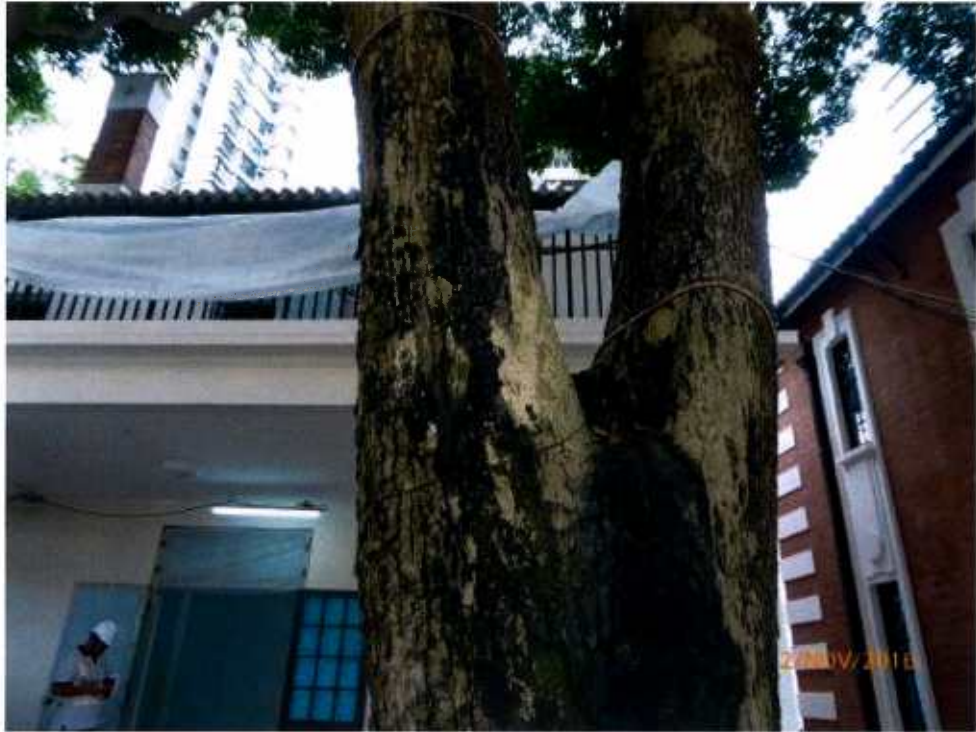
Fig. 5 Health condition of the upper trunk also is fair.

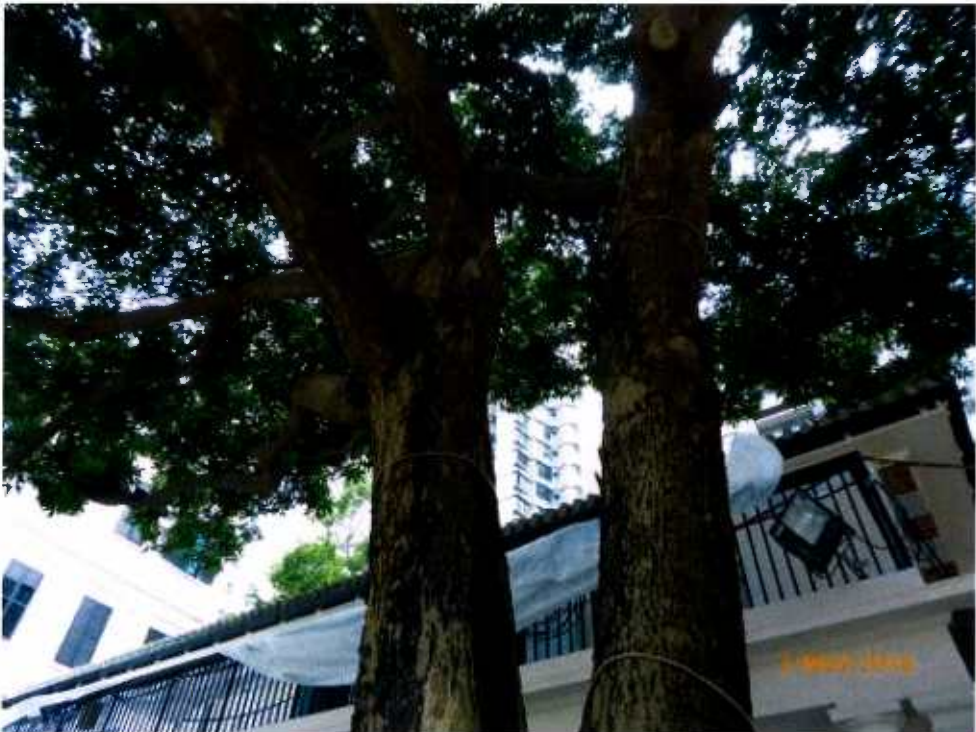
Fig. 6 The crown is full of vigorous and green leaves.

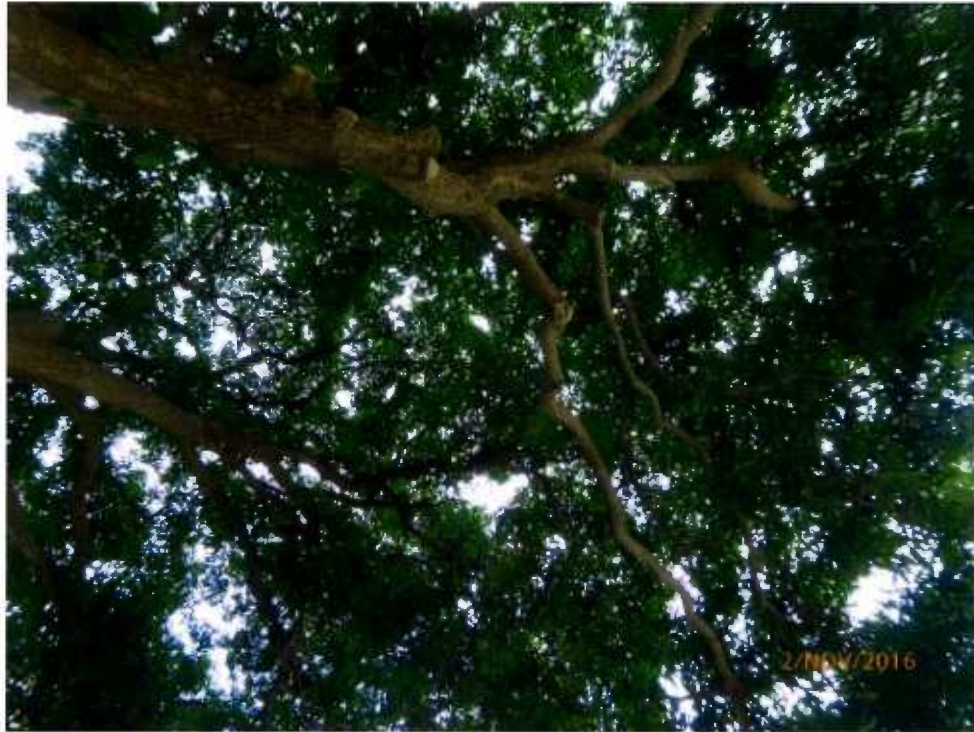
Fig. 7 Vigorous and green leaves also are growing on the lower branches.

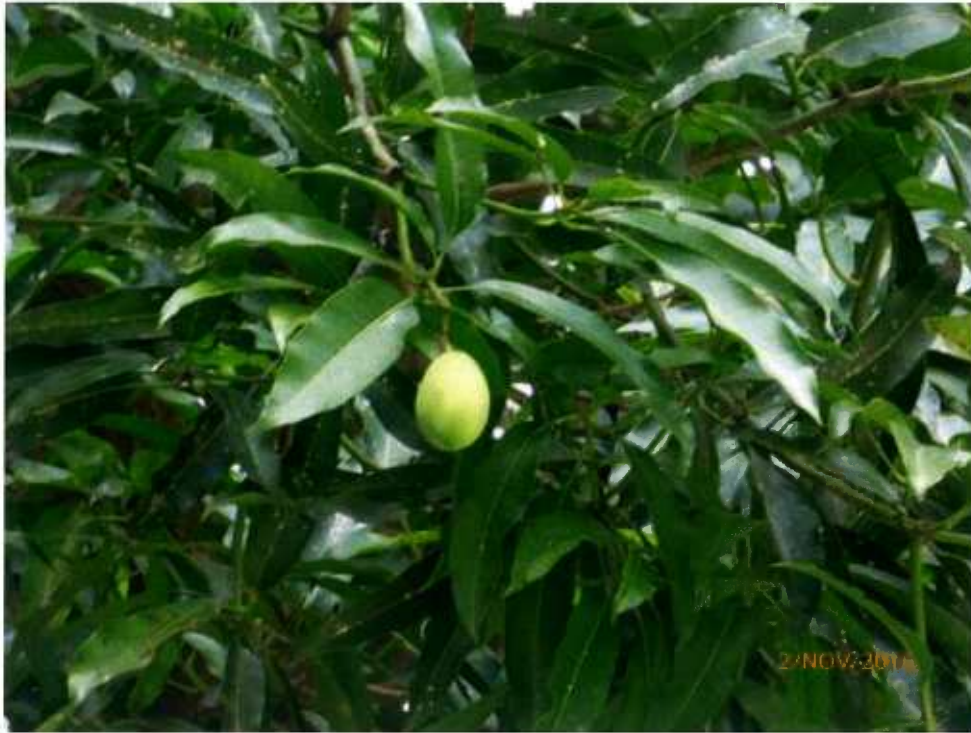
Fig. 9 The tree protection zone is in good order.

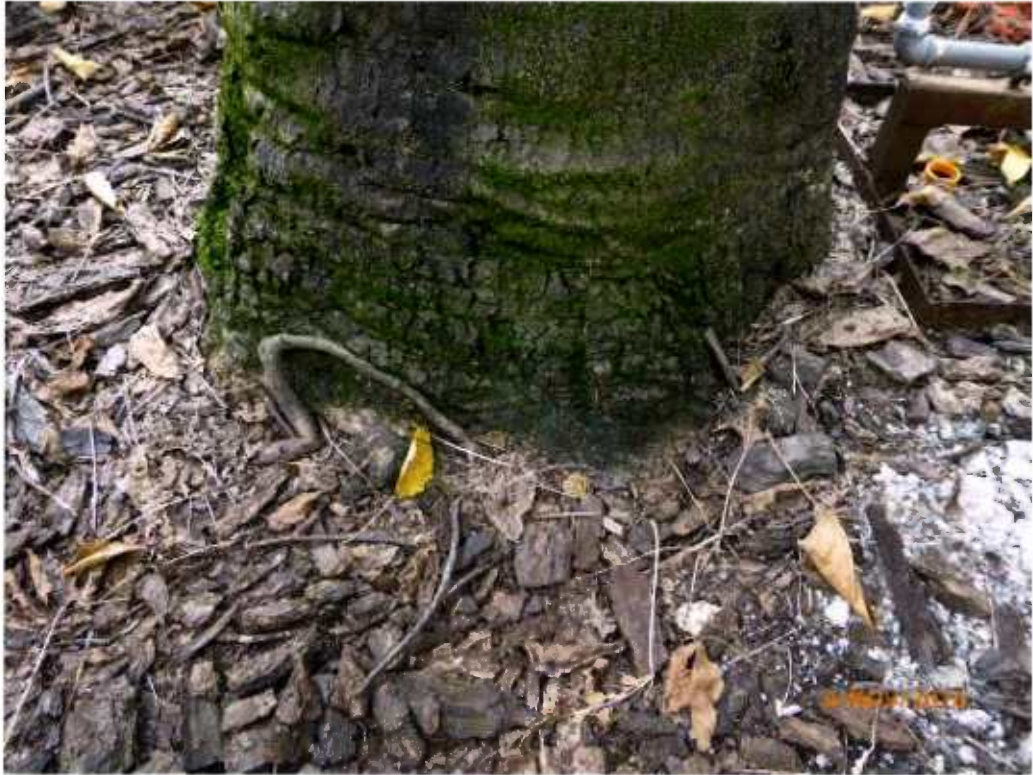
Fig 3. Health condition of the lower trunk is fair.

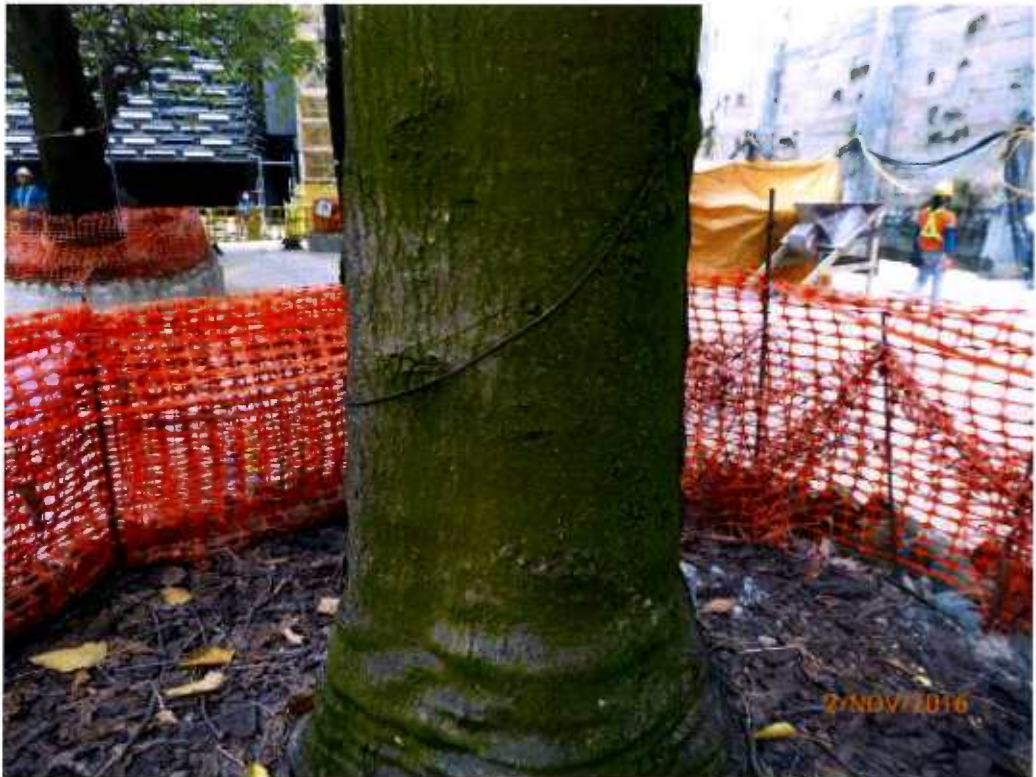
Fig. 4 Health condition of the mid trunk is fair.

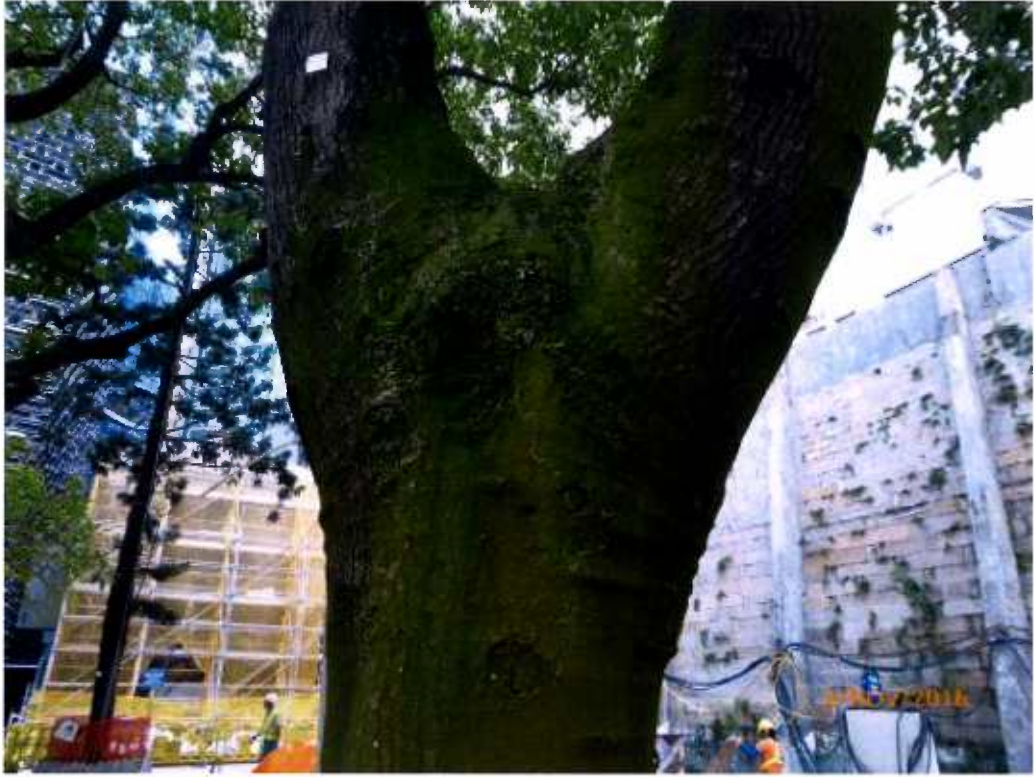
Fig. 5 Health condition of the upper trunk also is fair.

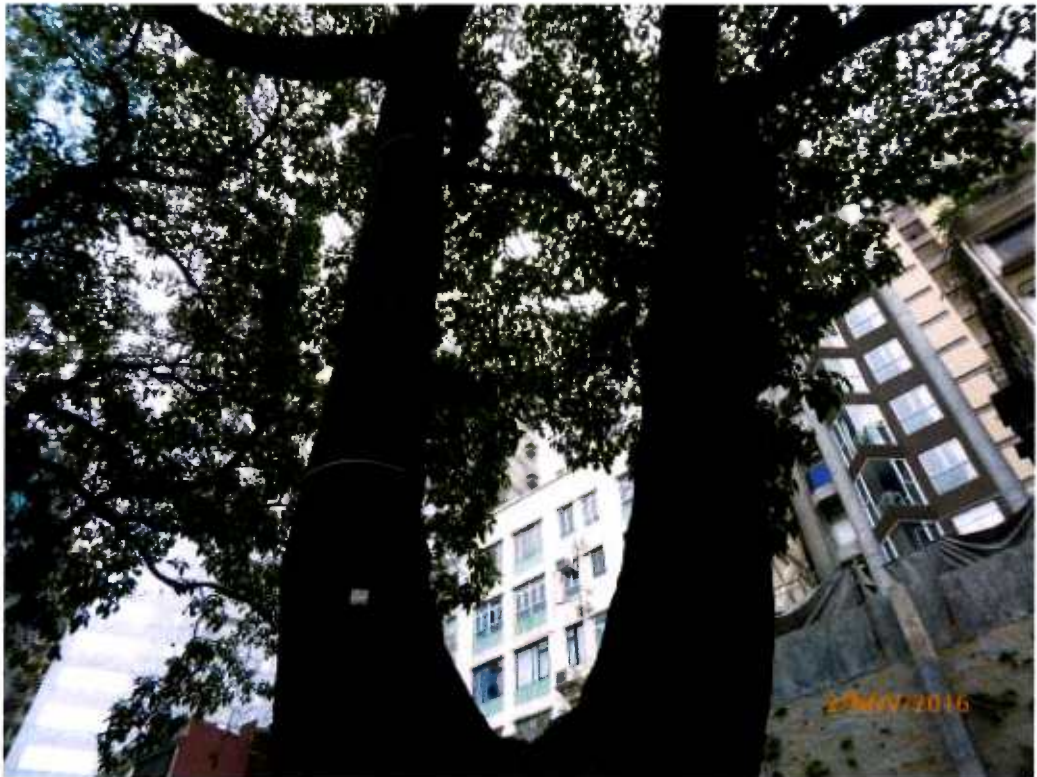
Fig. 6 The crown is full of vigorous and green leaves.

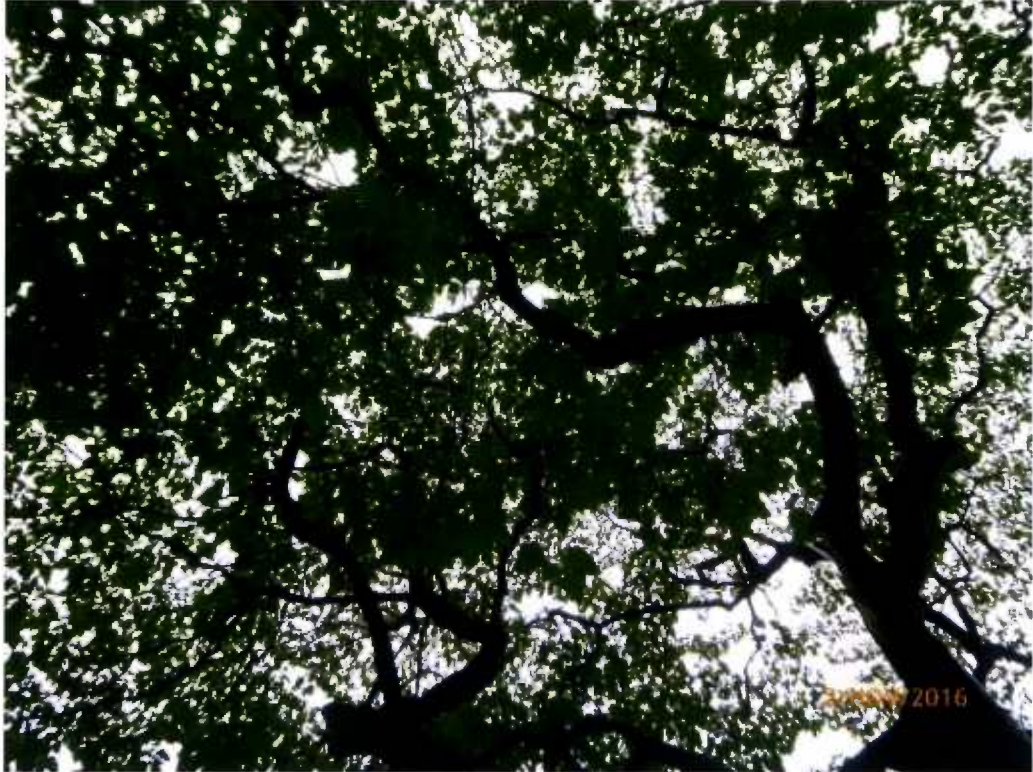
Fig. 7 Vigorous and green leaves also are growing on the lower branches.

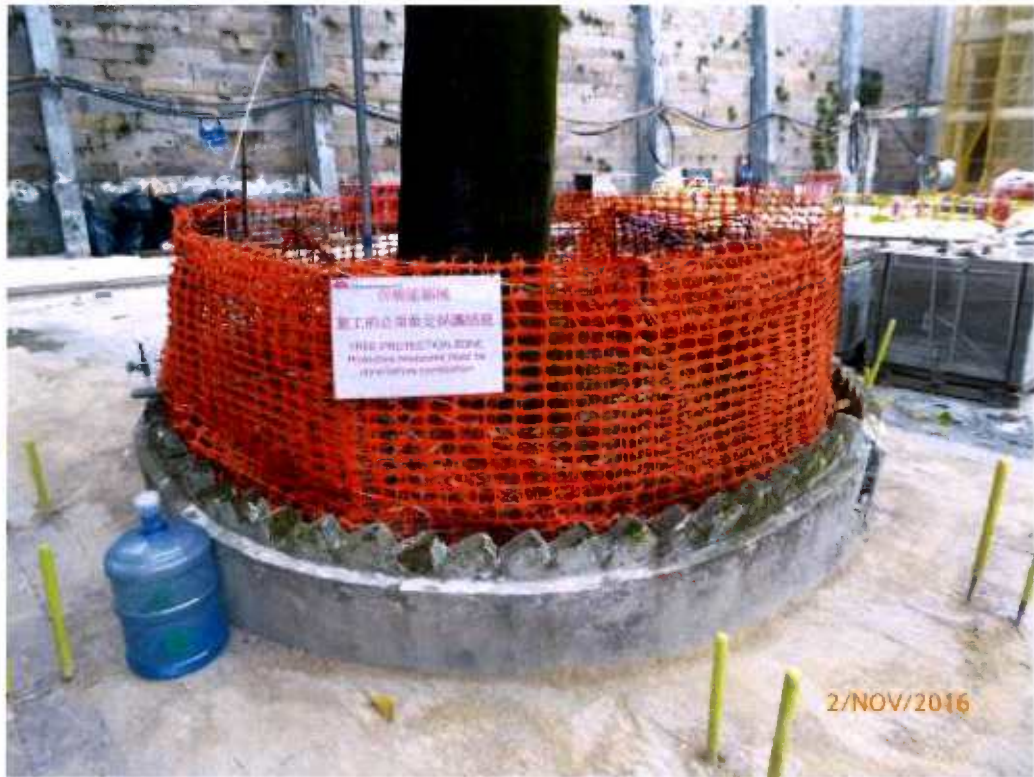
Fig. 11 The site near Tree-6 appears clean and tidy.

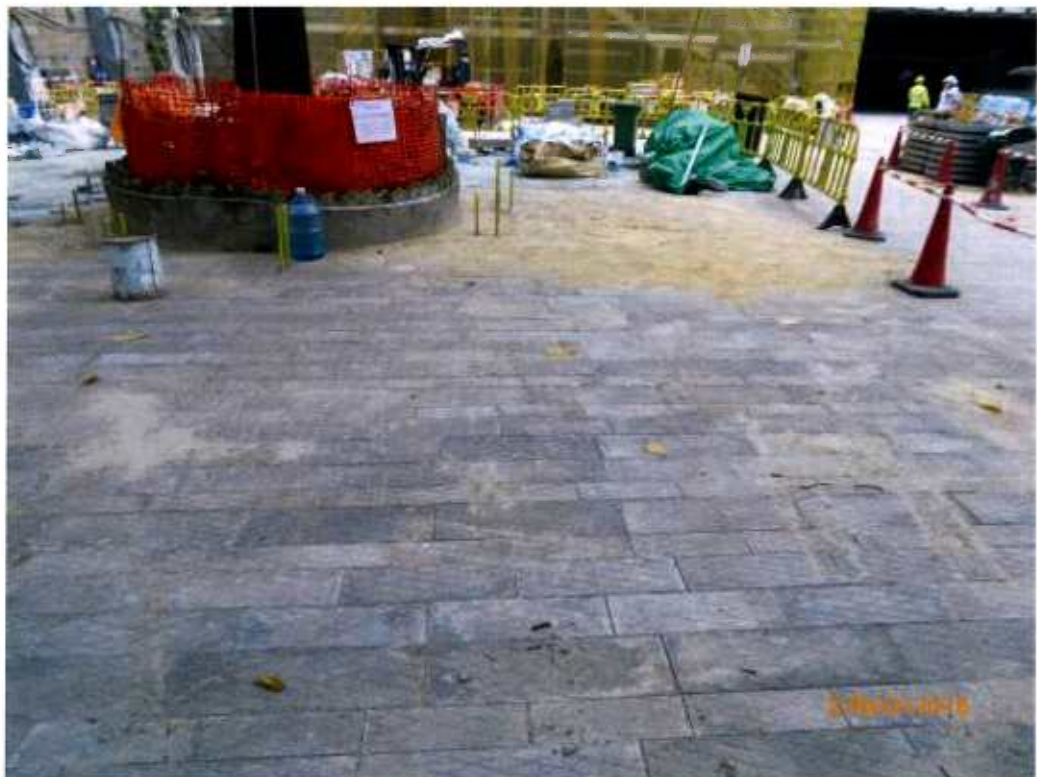
Fig. 12 Overall view of Tree-6 during inspection on 2nd November 2016.

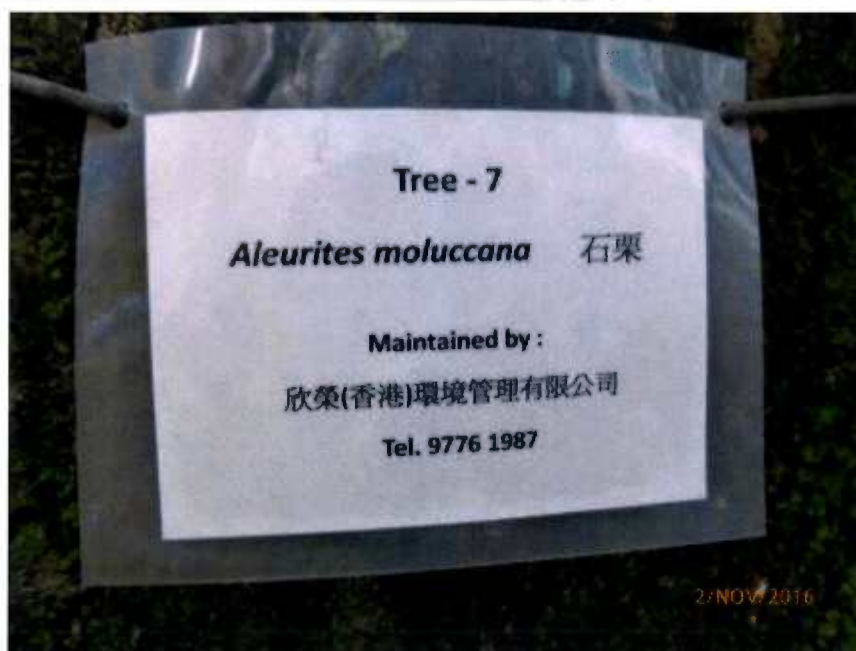
Fig 2. Root collar is normal. The topsoil is covered with mulch and leaves.

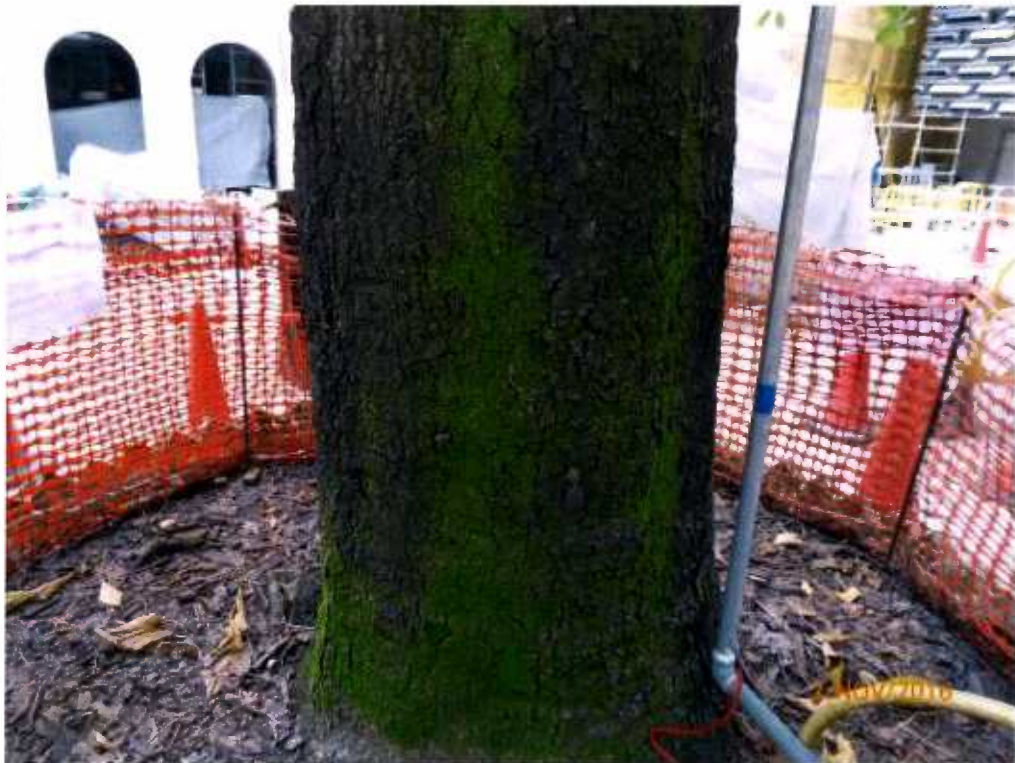
Fig. 4 Health condition of the mid trunk is fair.

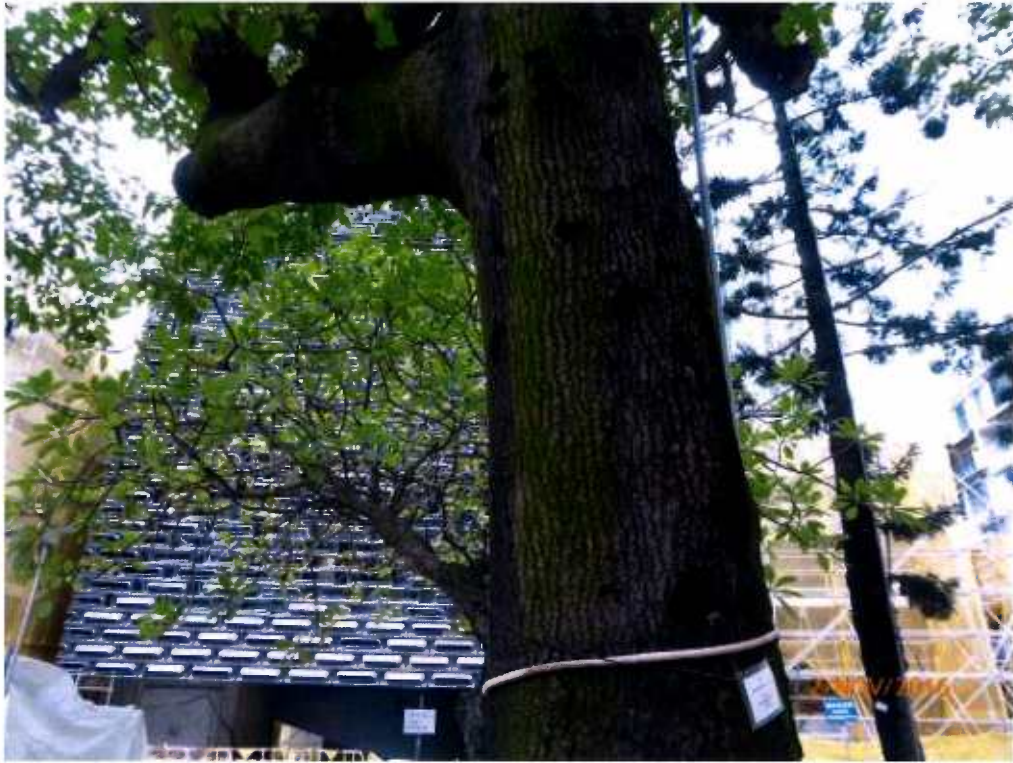
Fig. 5 Health condition of the upper trunk also is fair.

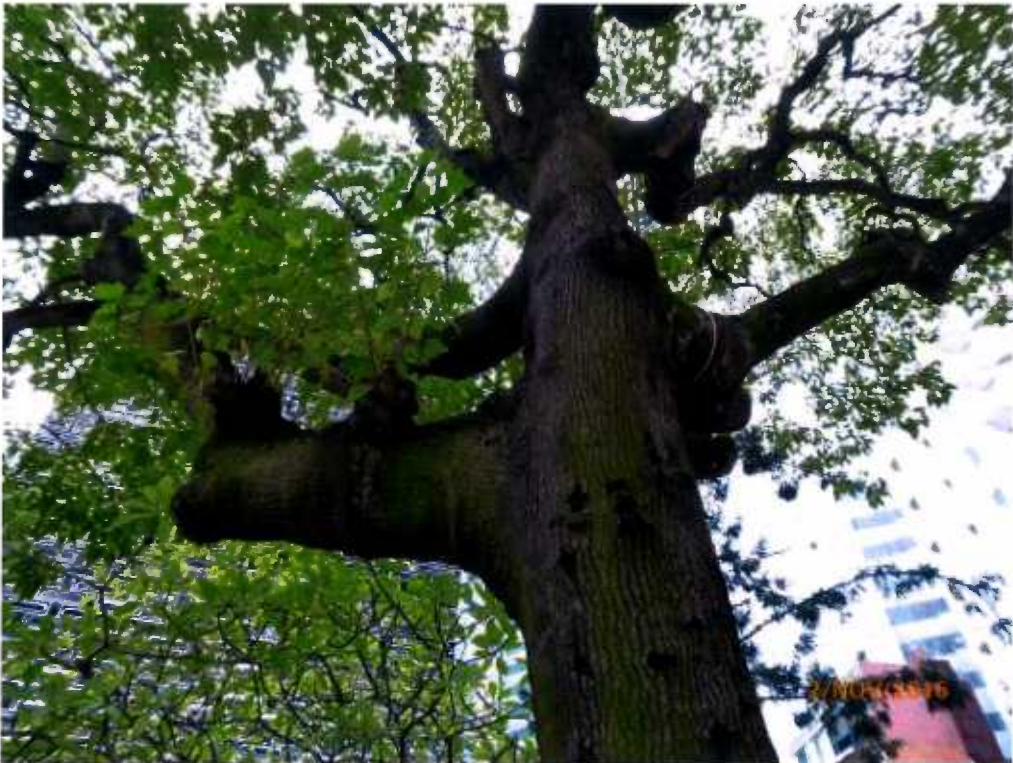
Fig. 6 The crown is full of vigorous and green leaves.

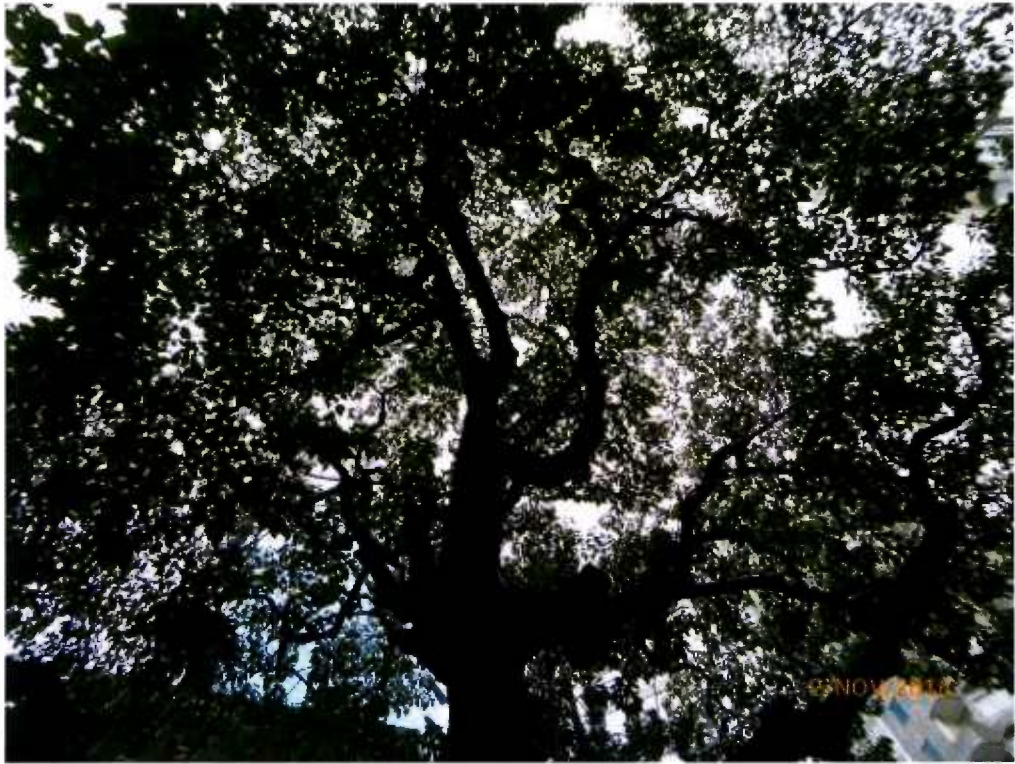
Fig. 7 Vigorous and green leaves also appear on the lower branches.

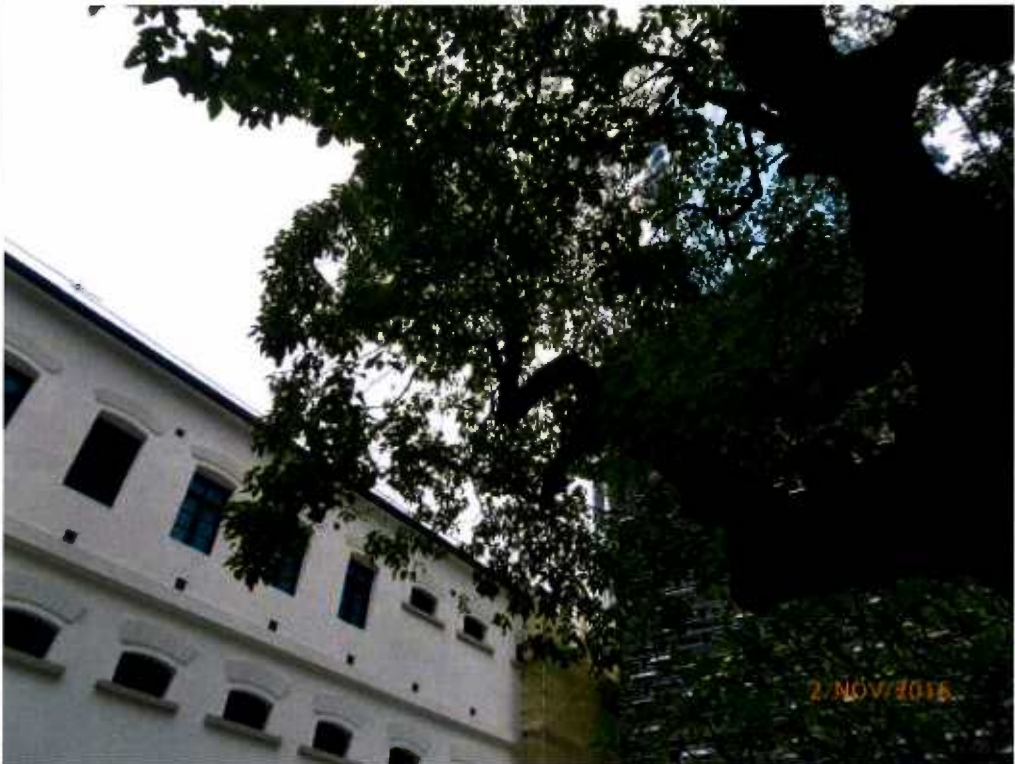
Fig. 8 As dry season has come, some leaves on the tree become faded.

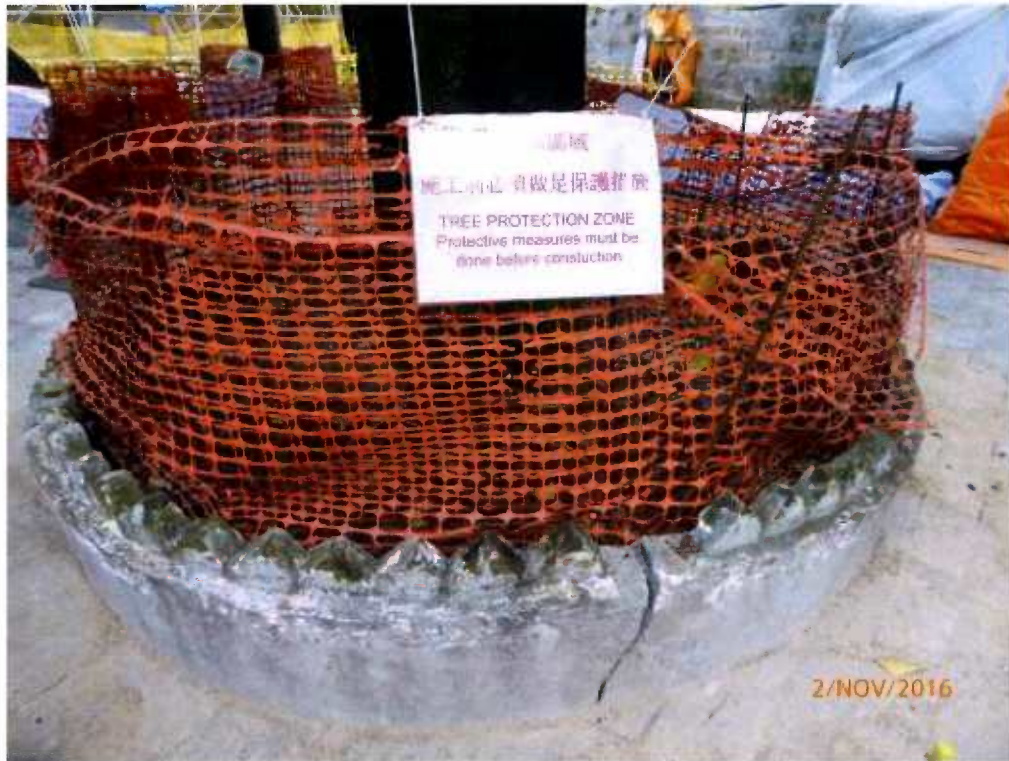
Fig. 11 The site near the tree appears clean and tidy.

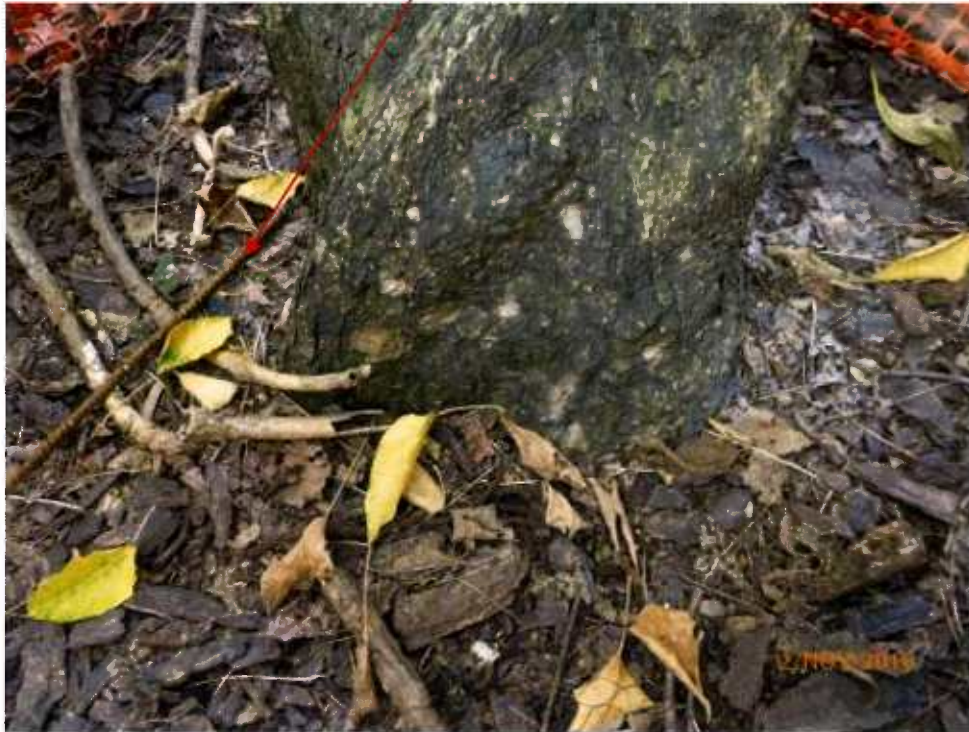
Fig. 3 Health condition of the lower trunk is fair.

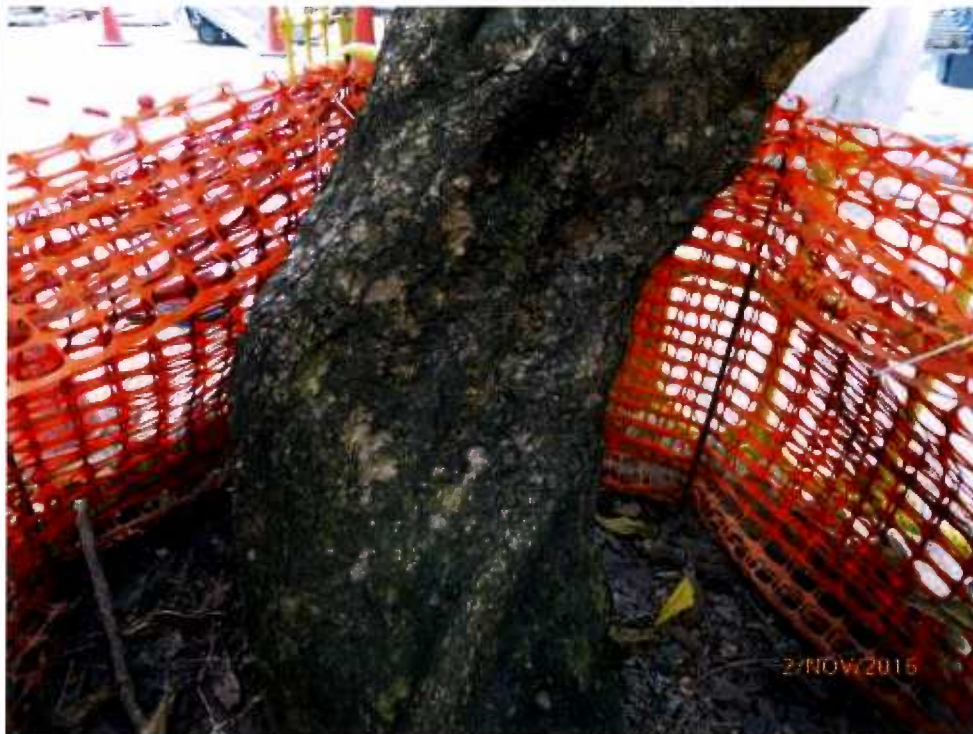
Fig. 4 Health condition of the mid trunk is fair.

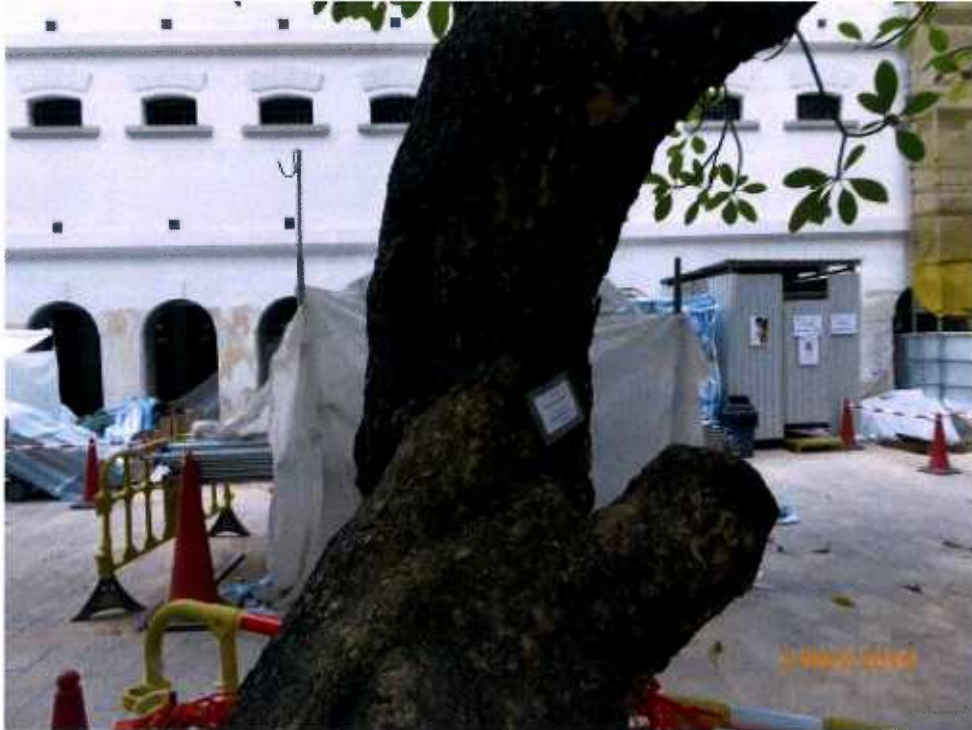
Fig. 5 Health condition of the upper trunk also is fair.

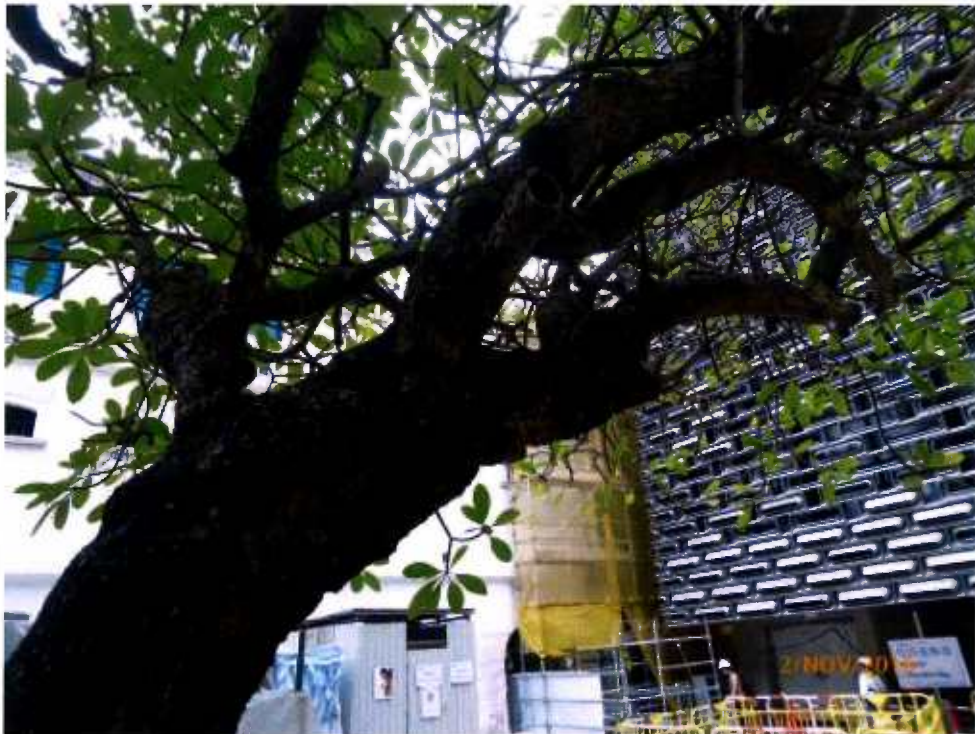
Fig. 6 The crown is full of green and vigorous leaves.

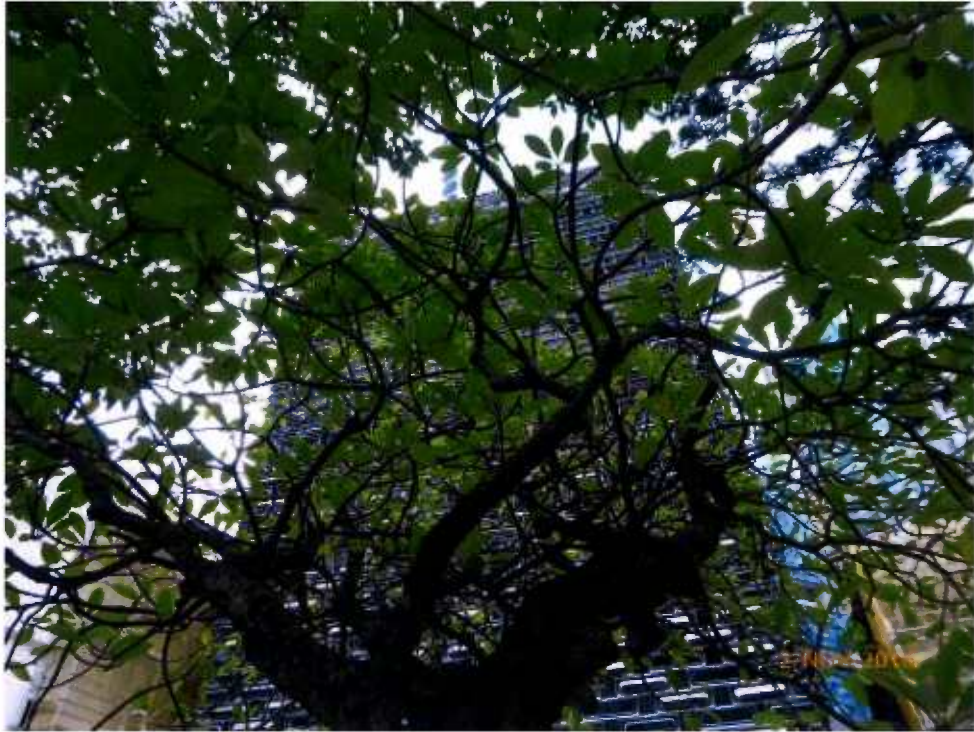
Fig. 7 Green and vigorous leaves also are growing on the lower branches.

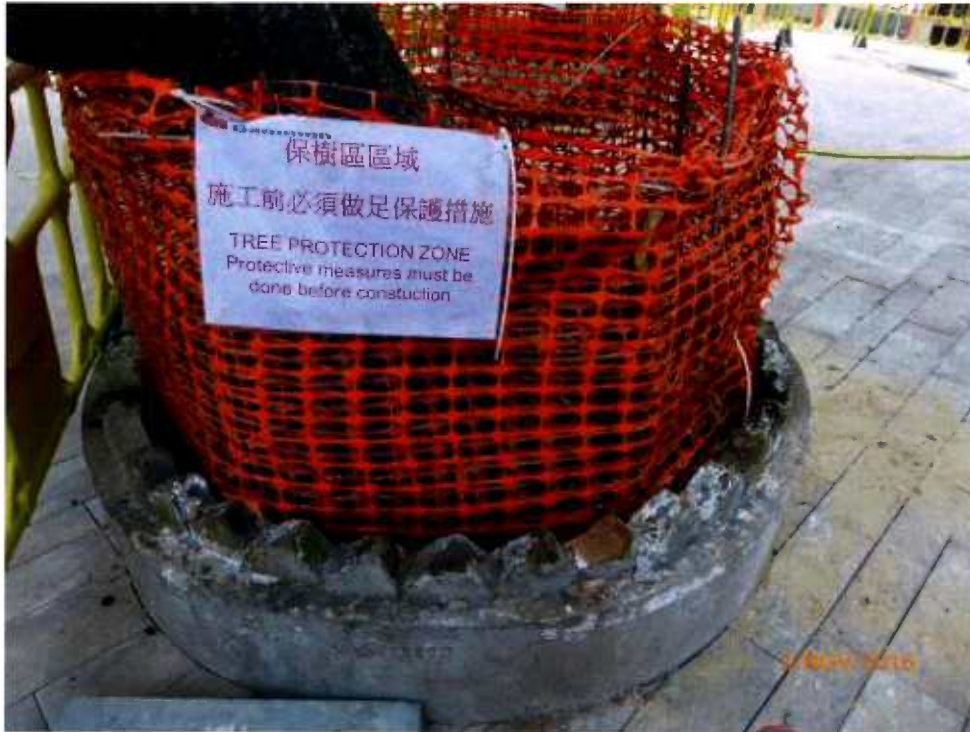
Fig. 9 The site near Tree-8 appears clean and tidy.

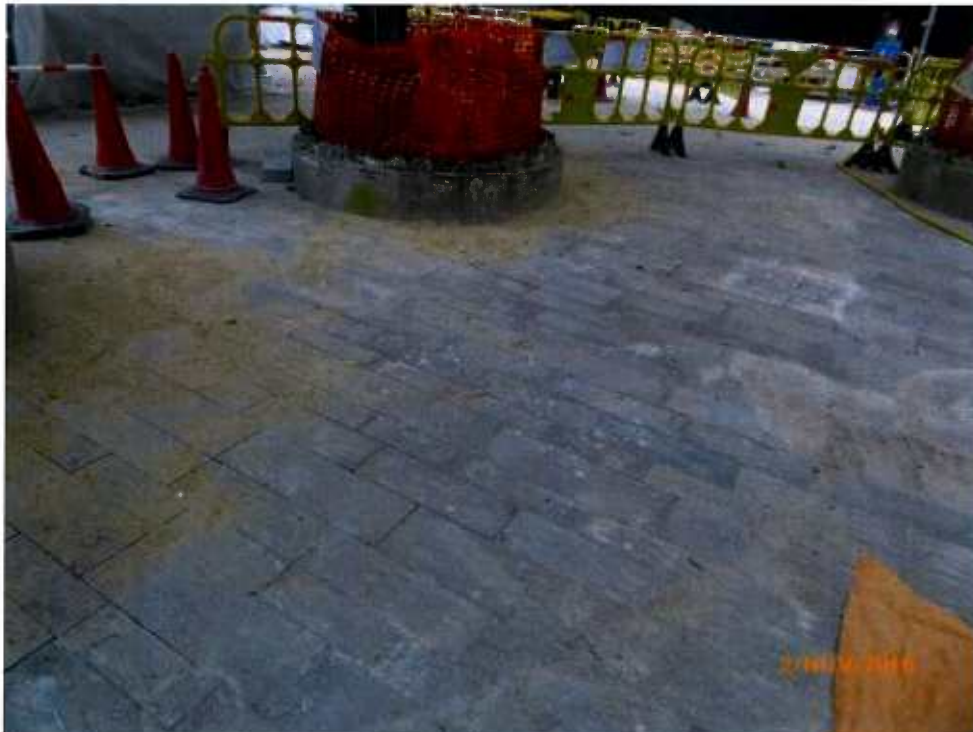
Fig. 10 Overall view of Tree-8 during inspection on 2nd November 2016.

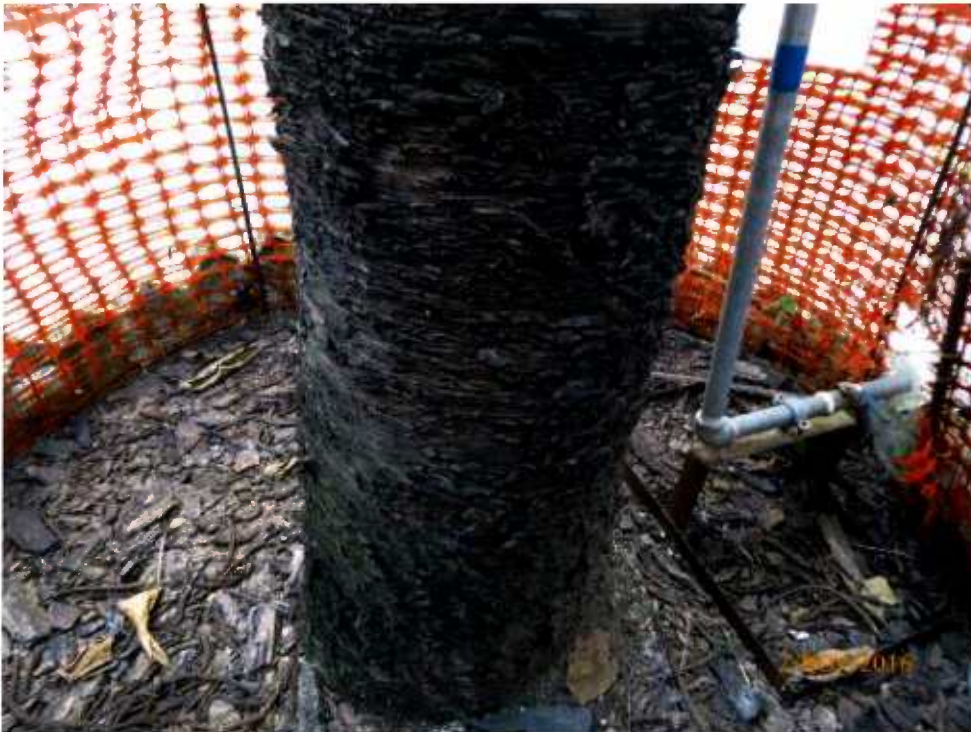
Fig. 4 Health condition of the mid trunk is fair.

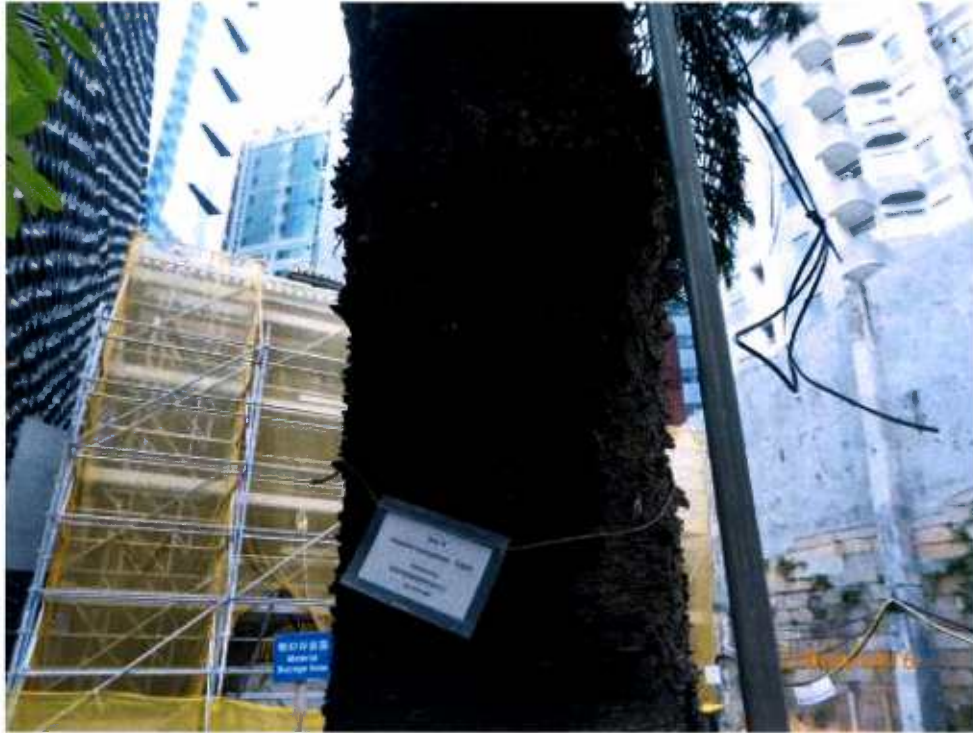
Fig. 5 Health condition of the upper trunk also is fair.

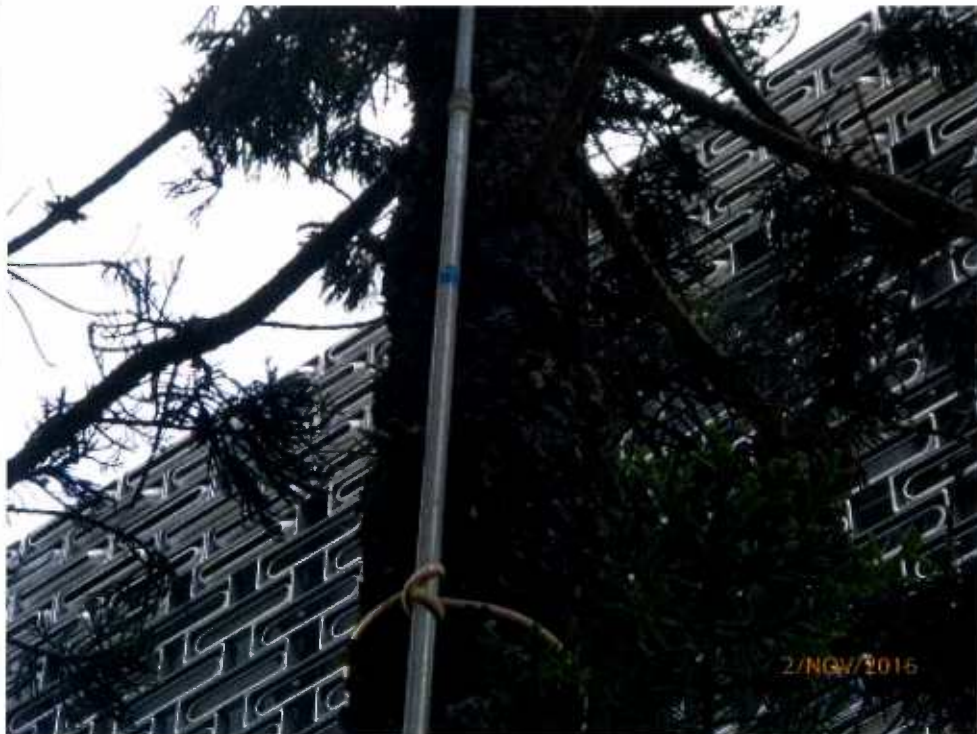
Fig. 6 The crown is full of vigorous and green leaves.
