Central Police Station Conservation
and Revitalisation Project:
61st Monthly EM&A Report
(1 November to 30 November 2016)

Issue Date: December 2016

Environmental Resources Management

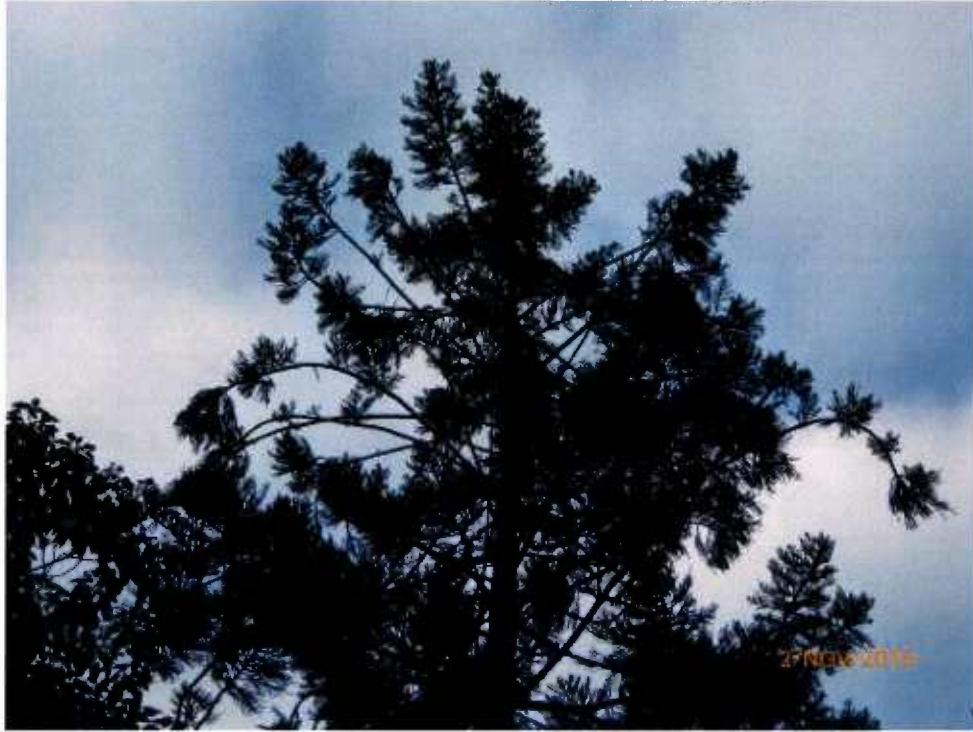
Fig. 7 Vigorous and green leaves also are growing on the lower branches.

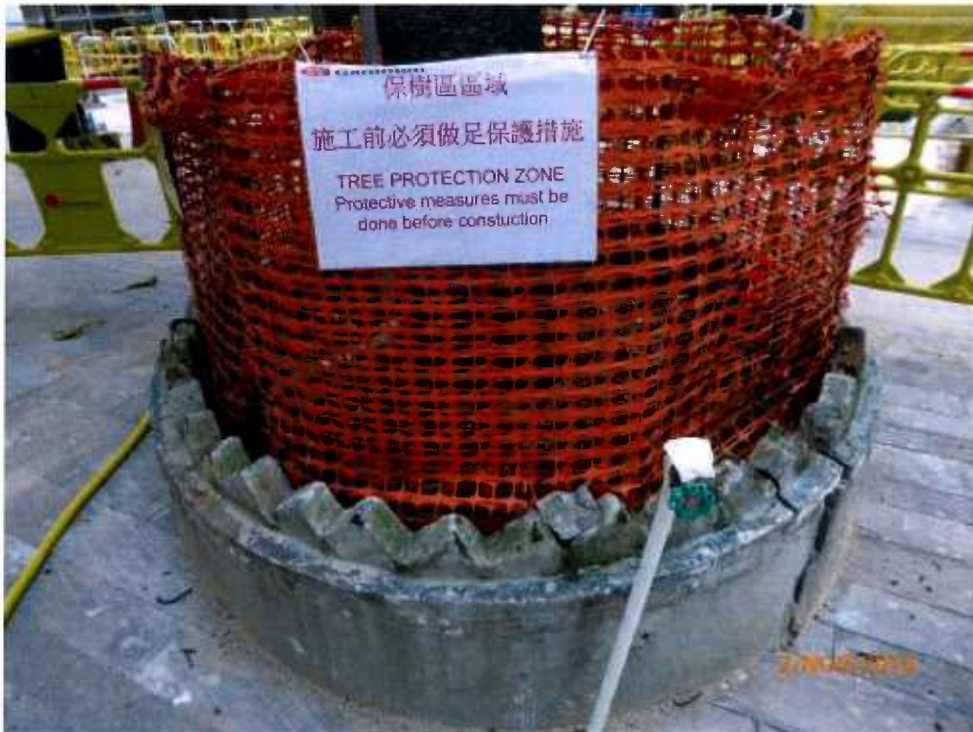
Fig. 10 The site near Tree-9 is clean and tidy.

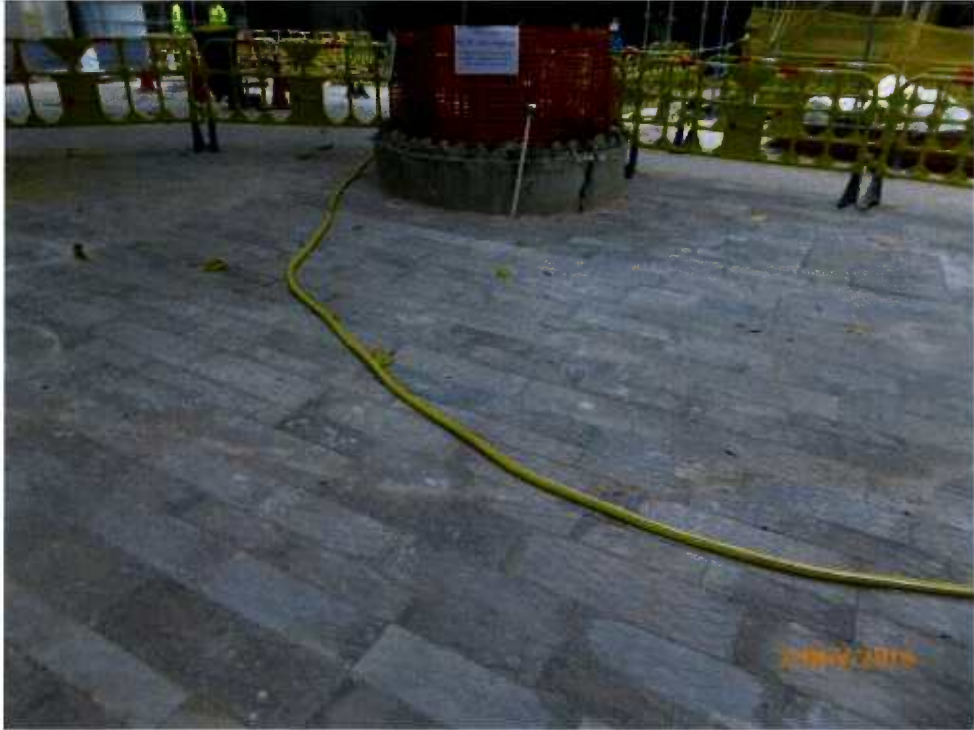
Fig. 11 The access near Tree-9 also is clean and tidy.

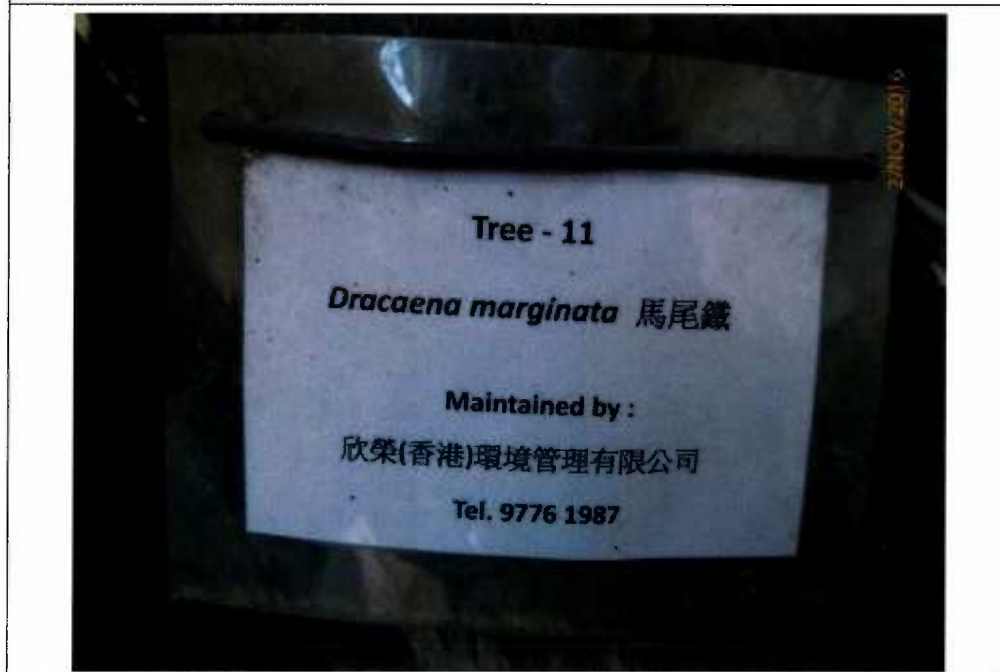
1. Health condition of the tree is fair.
2. Root collar is normal. **Some withered leaves remain at the planter.**
3. **Many withered leaves appear on the tree.**
4. Renovation works are in progress near the planter.

Fig. 2 Root collar is normal. Some withered leaves remain at the planter.

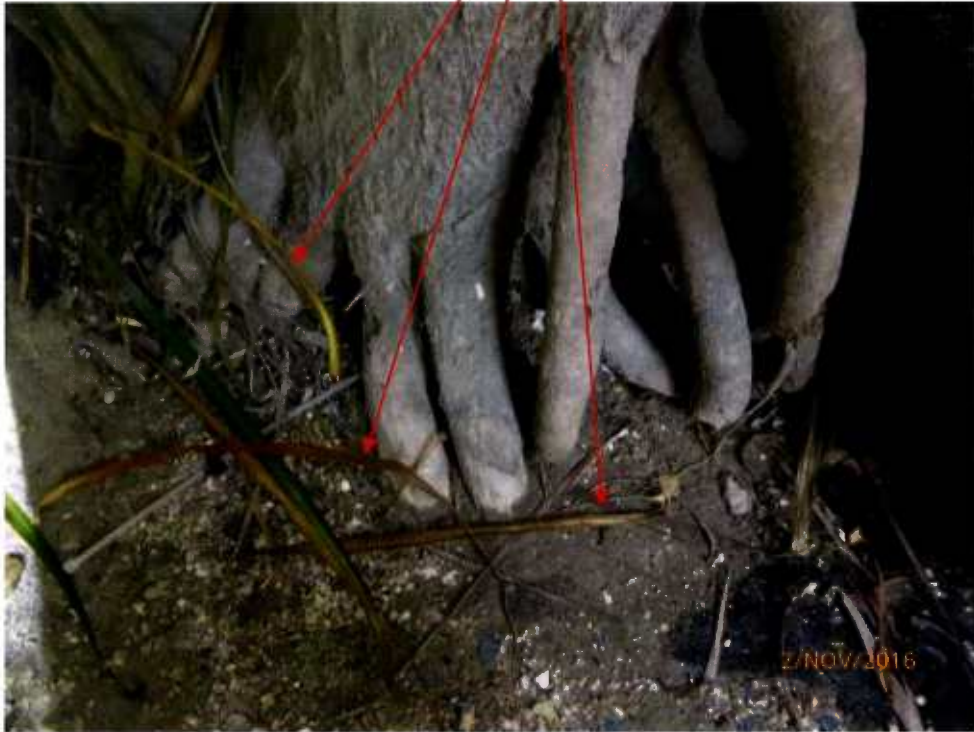
Fig. 3 Health condition of the lower trunk is fair.

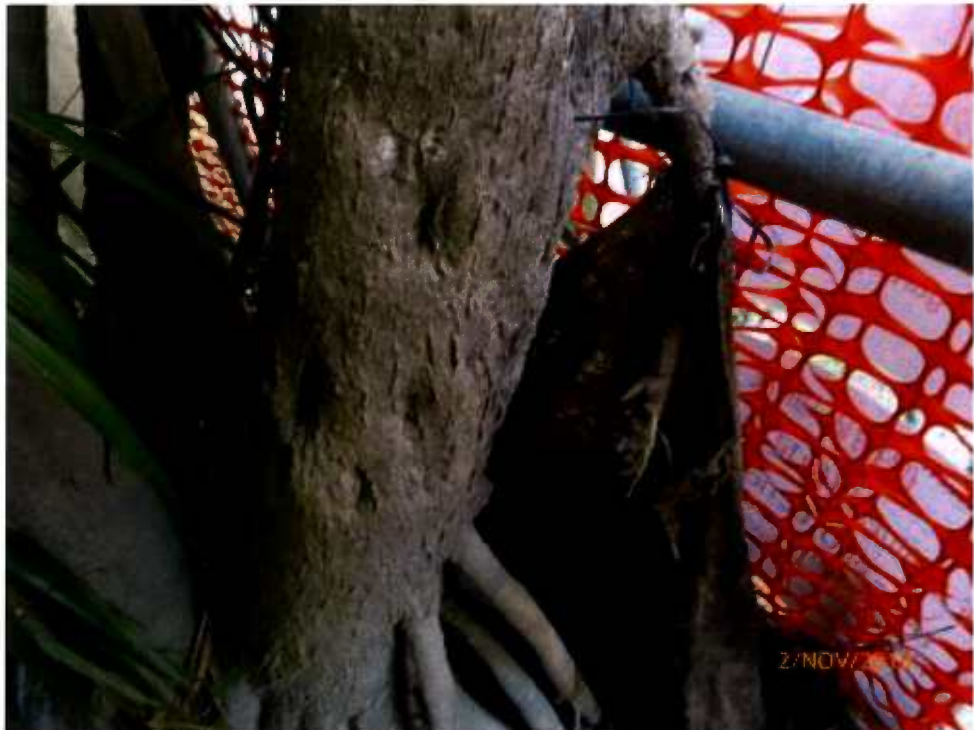
Fig. 4 Health condition of the mid trunk is fair.

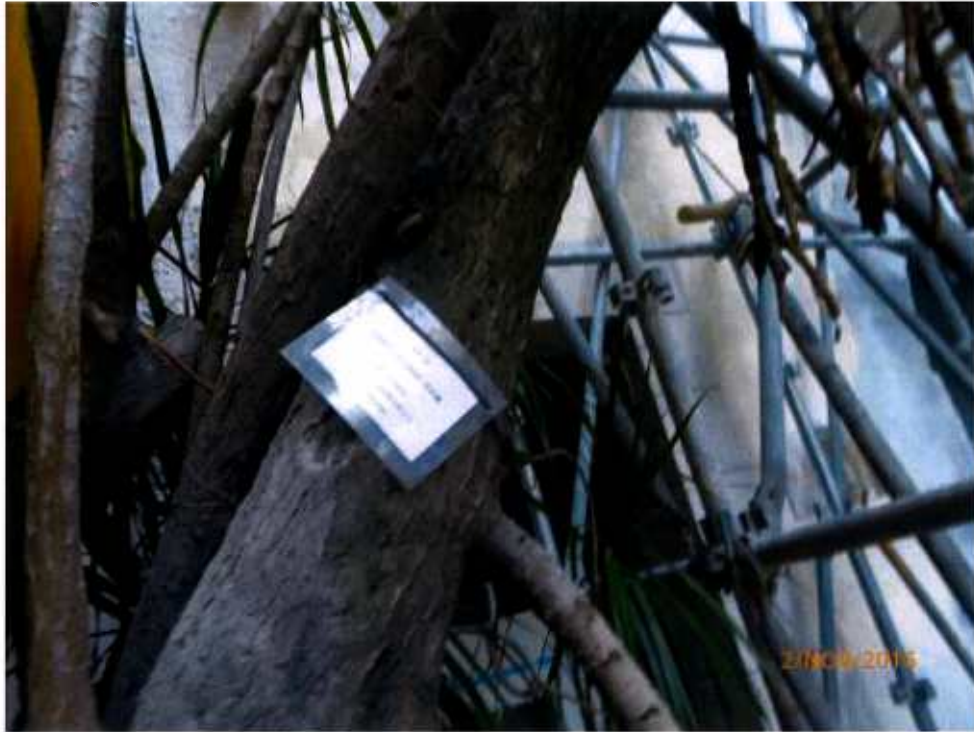
Fig. 5 Health condition of the upper trunk also is fair.

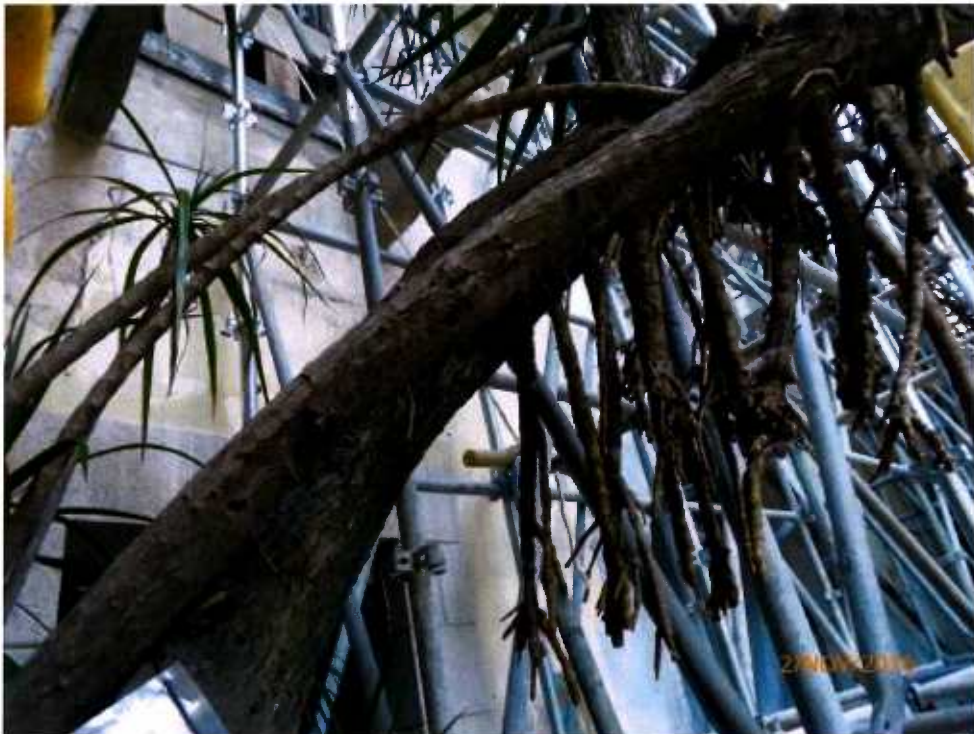
Fig. 6 Withered leaves appear on the crown of the tree.

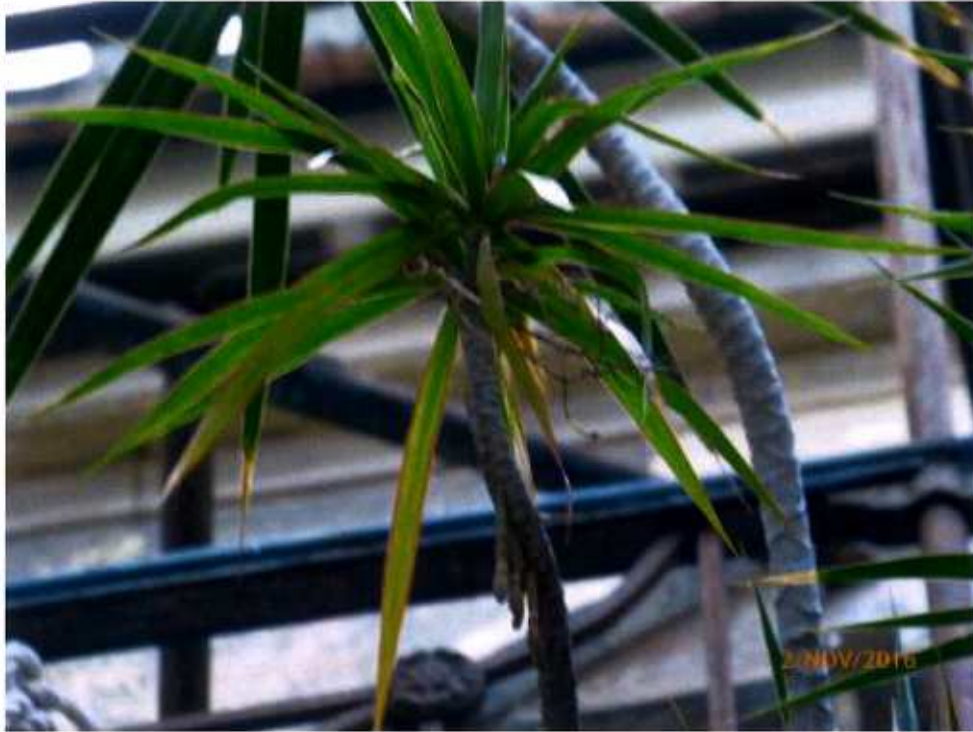
Fig. 7 Withered leaves also appear on the lower branches of the tree.

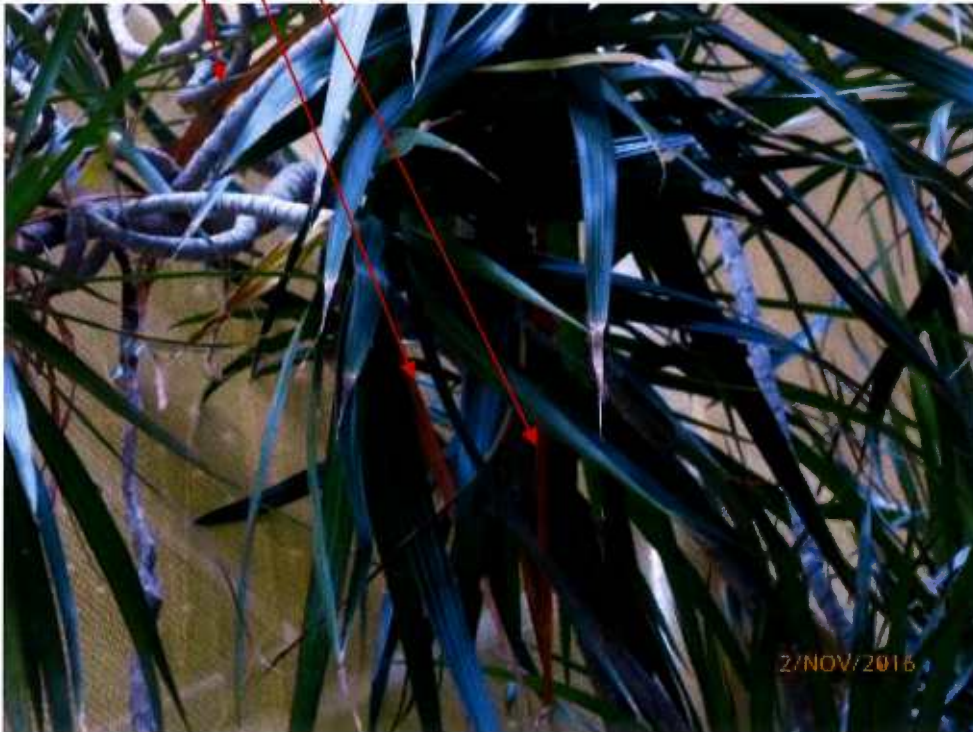
Fig. 8 Some withered leaves remain at the site near the planter.

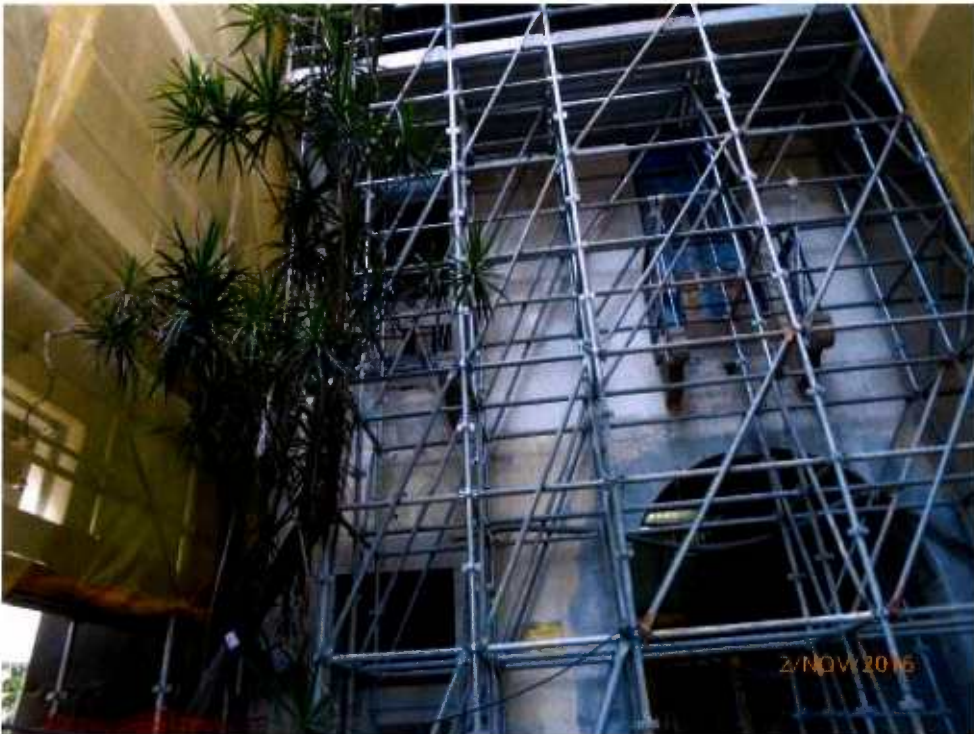
Fig. 10 The tree protection zone is in order.

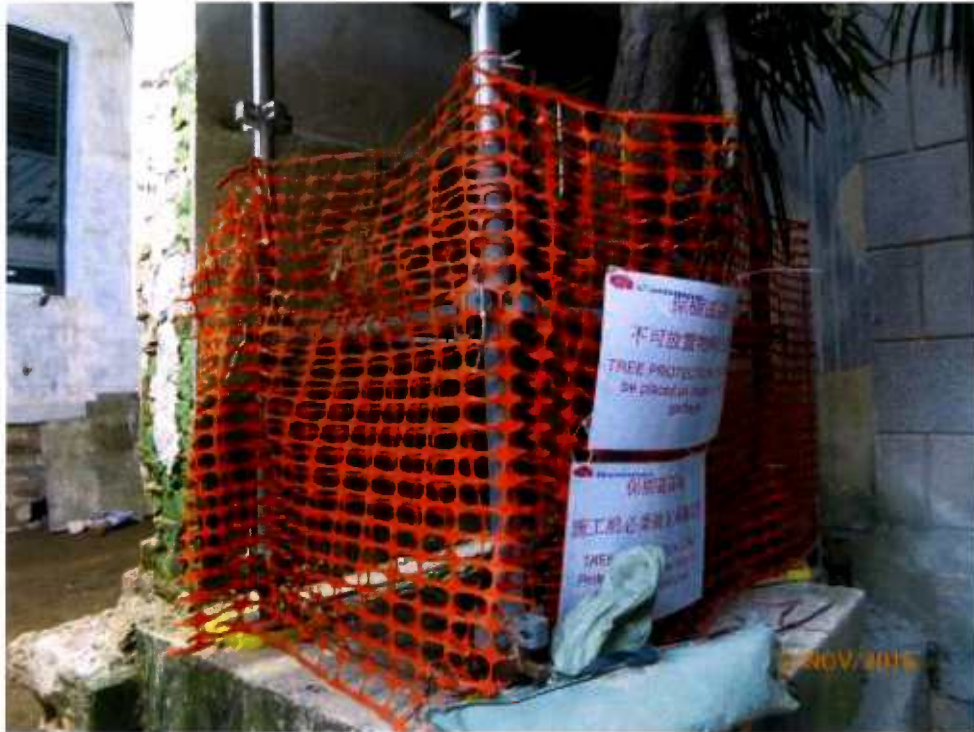
Fig. 11 The site near the tree is clean and tidy.
