Central Police Station Conservation
and Revitalisation Project:
72nd Monthly EM&A Report
(1 October to 31 October 2017)

Issue Date: November 2017

Environmental Resources Management

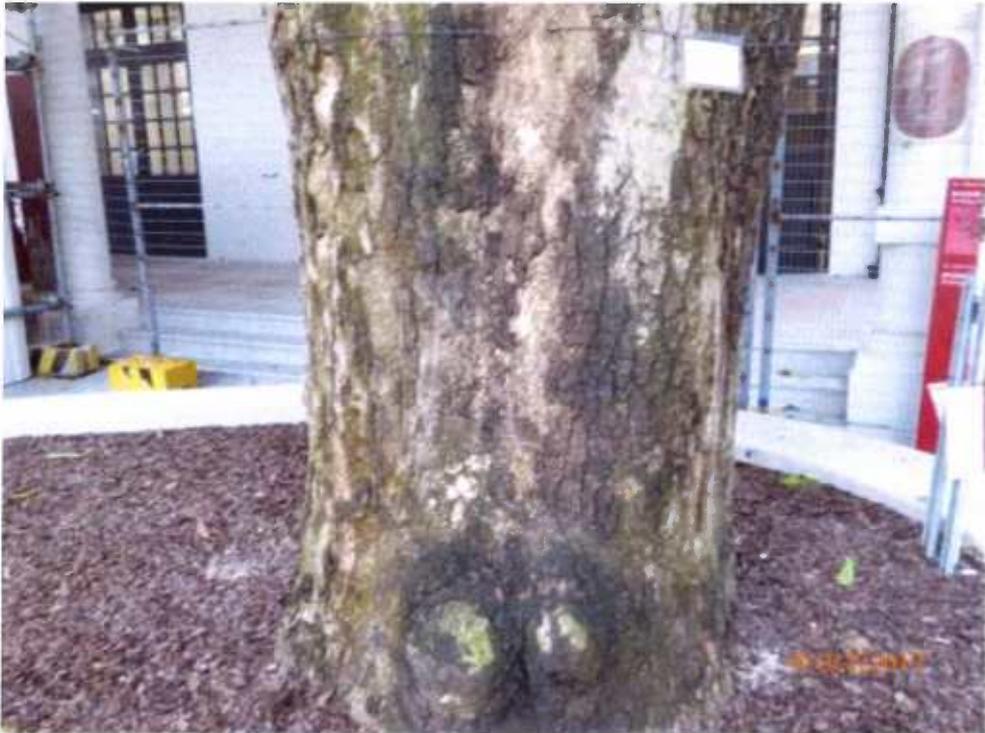
Fig. 3 Health condition of the lower trunk is fair.

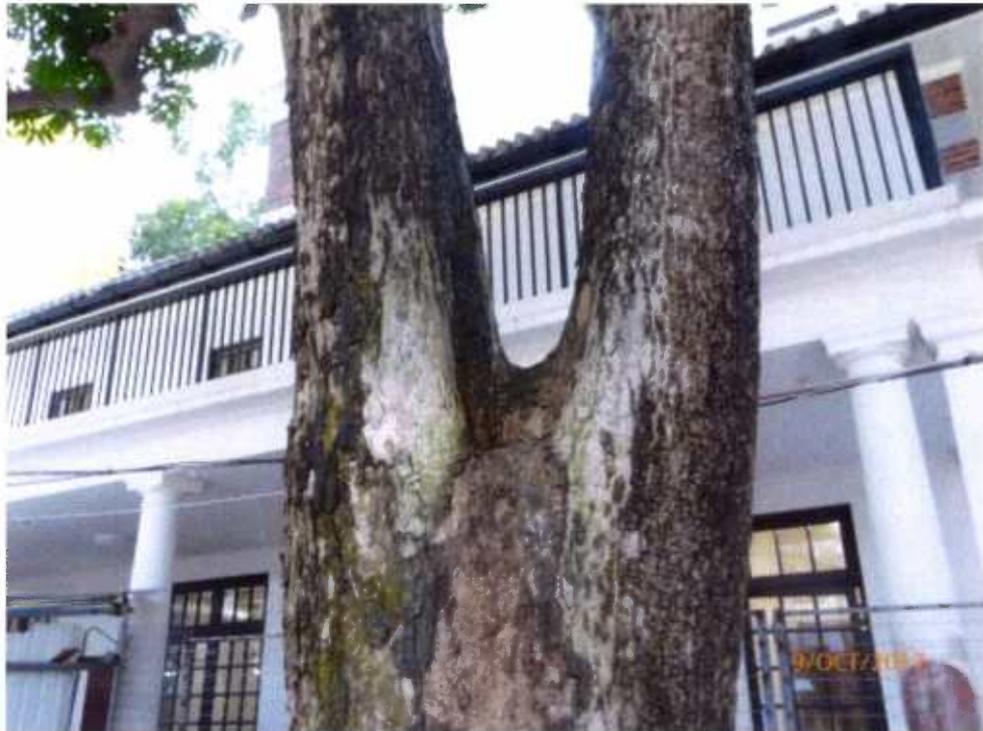
Fig. 4 Health condition of the mid trunk is fair.

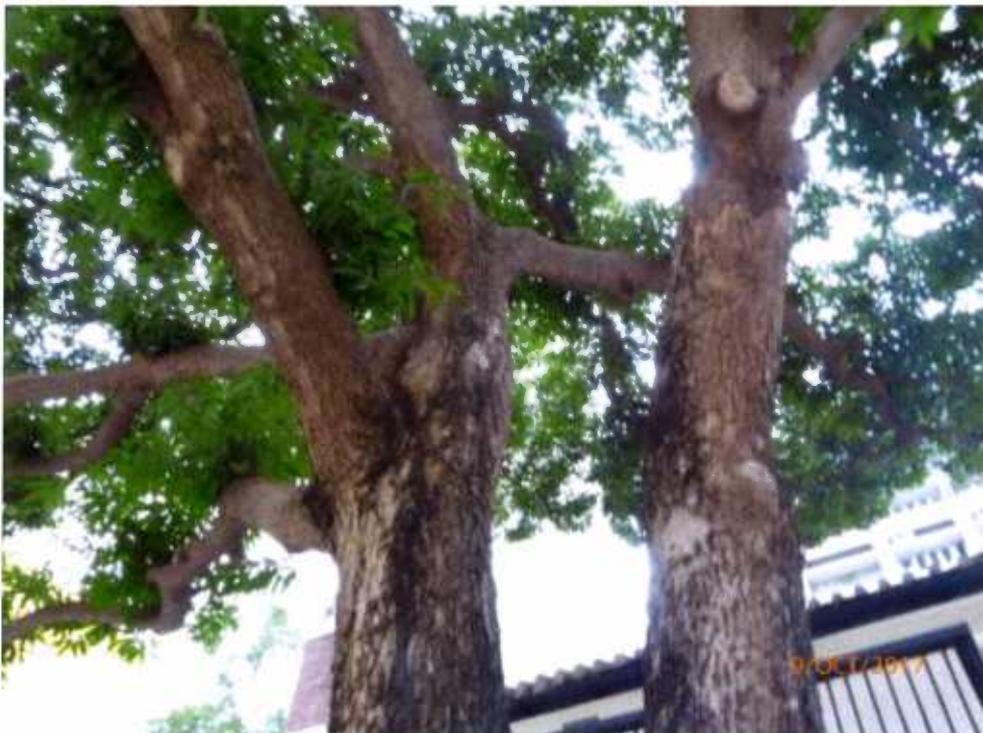
Fig. 5 Health condition of the upper trunk also is fair.

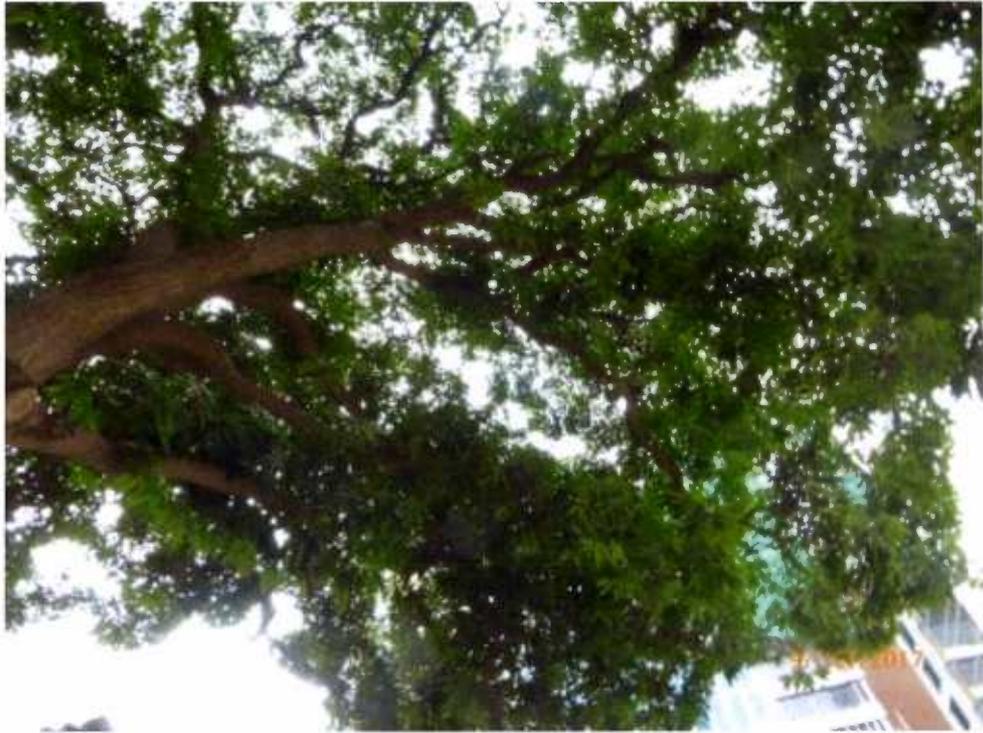
Fig. 6 The crown is full of vigorous and green leaves.

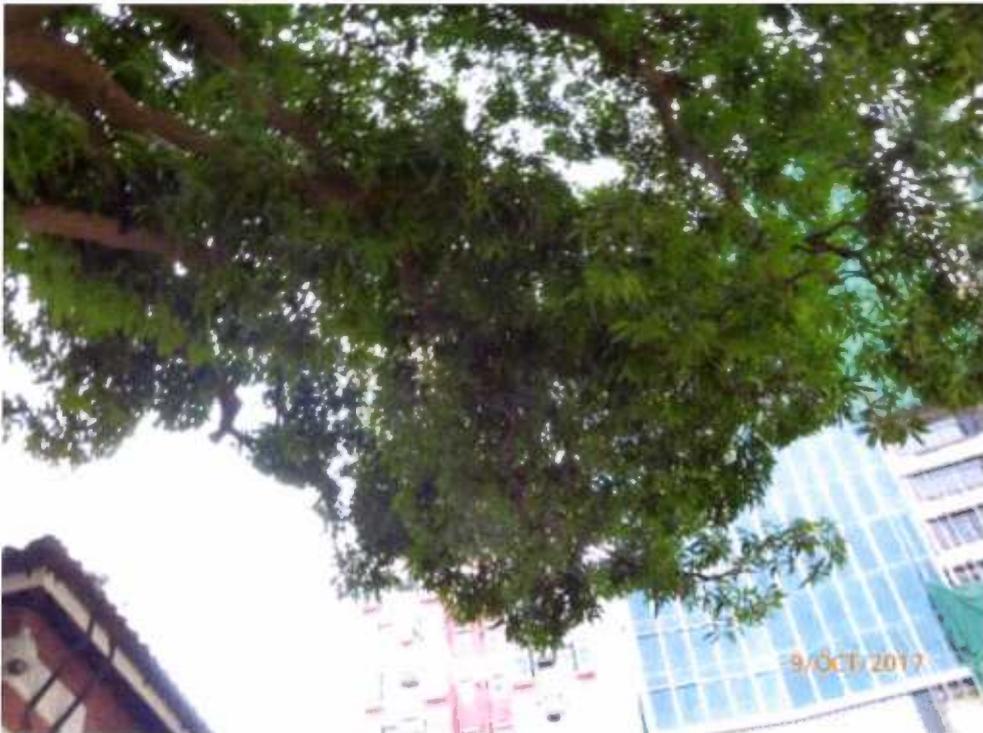
Fig. 7 Vigorous and green leaves also are growing on the lower branches.

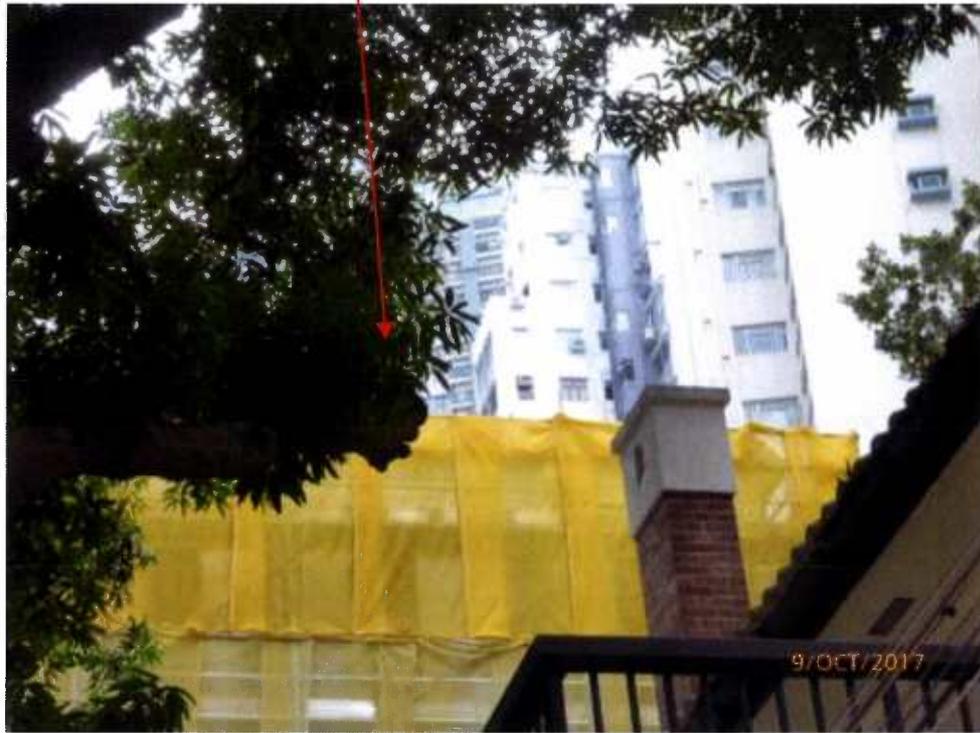
Fig. 10 The overgrown branches have been pruned on 26th Sept. 2017.

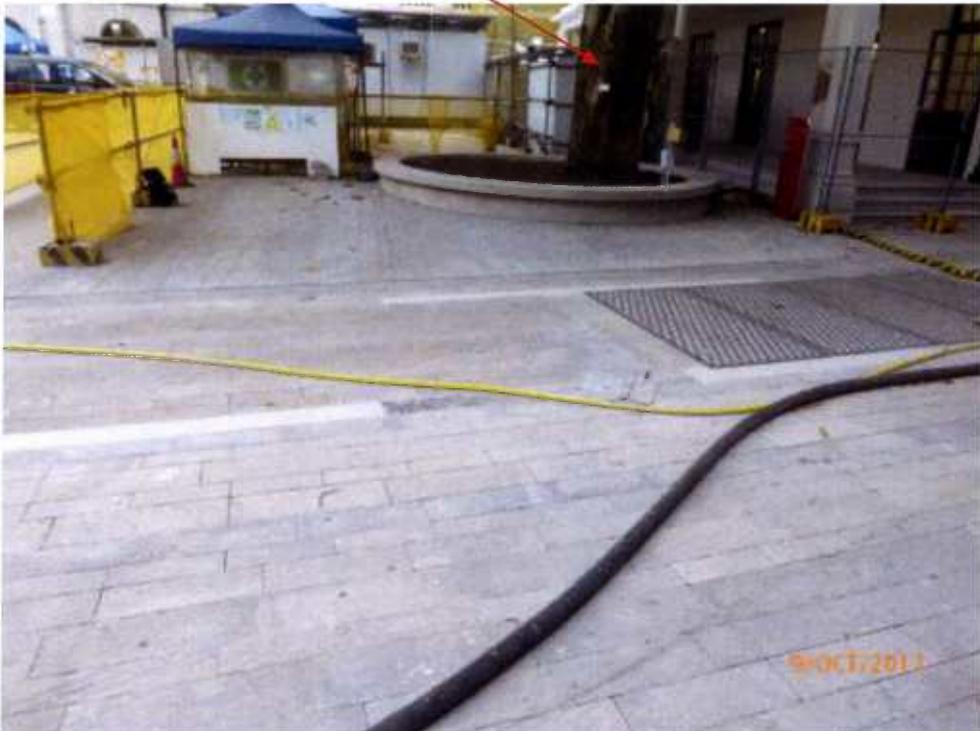
Fig. 11 The site near Tree-5 is clean and tidy.

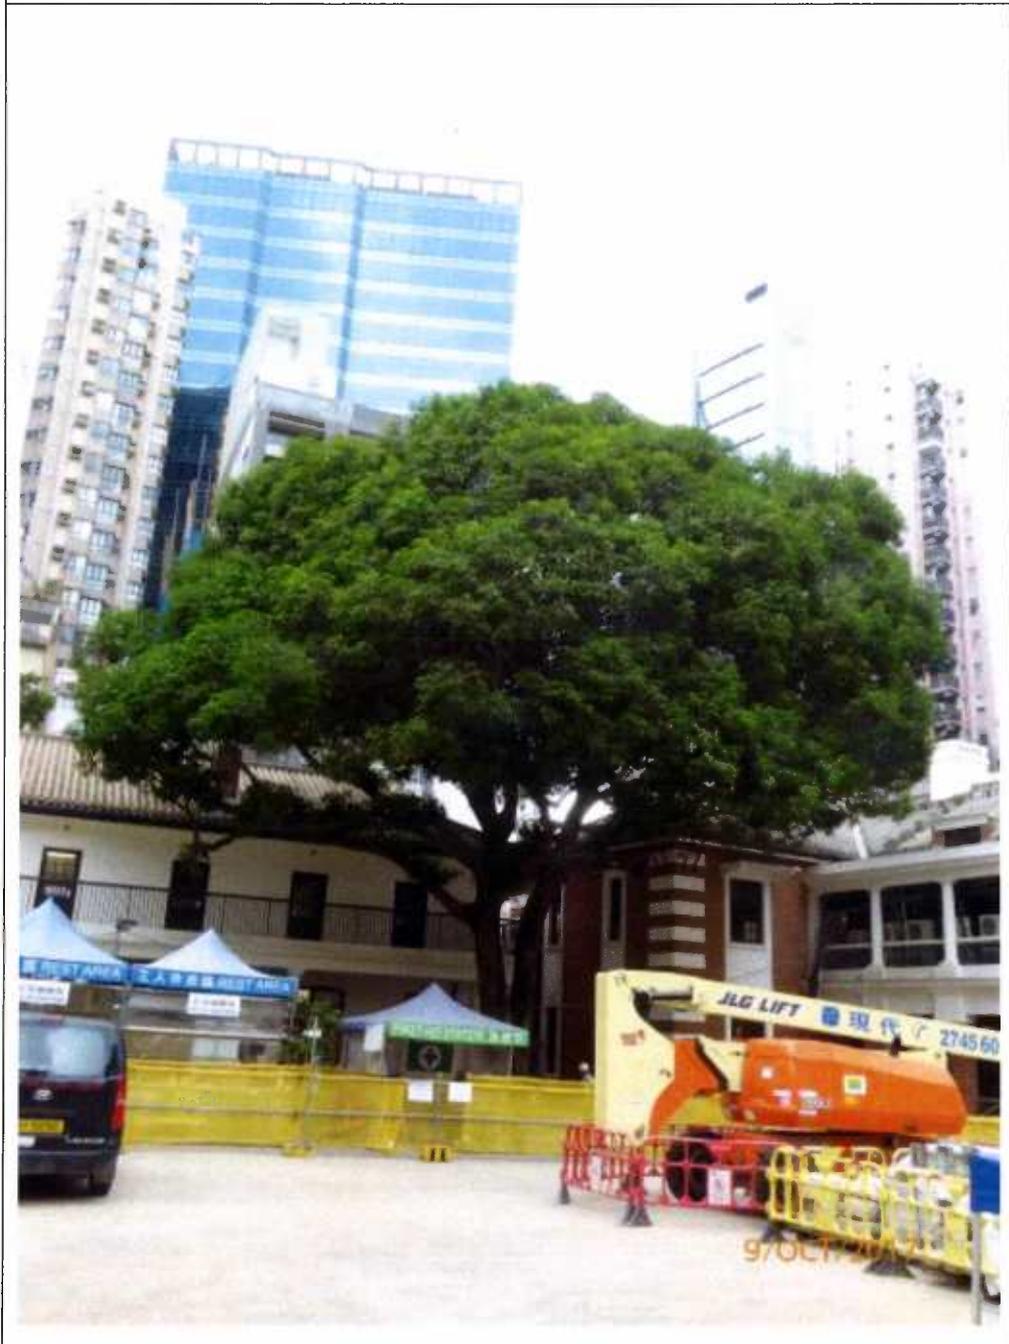
Fig. 12 Overall view of Tree-5 during inspection on 9th Oct. 2017.

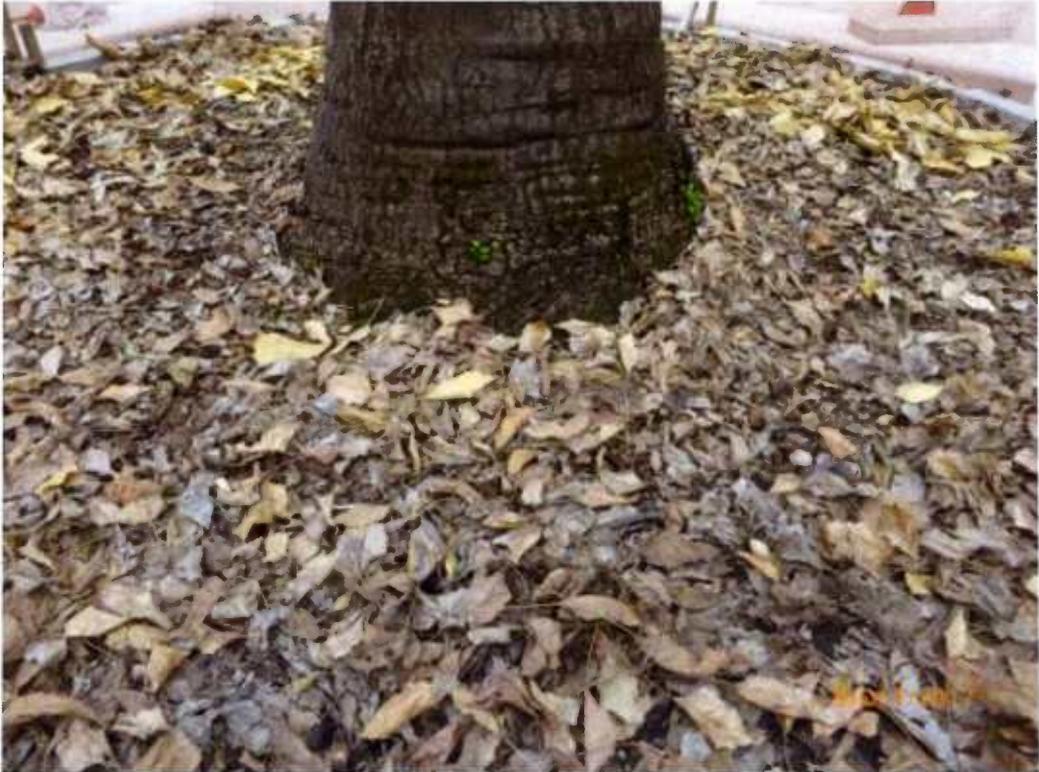
Fig 2. Root collar is normal. The planter is covered with mulch and dry leaves.

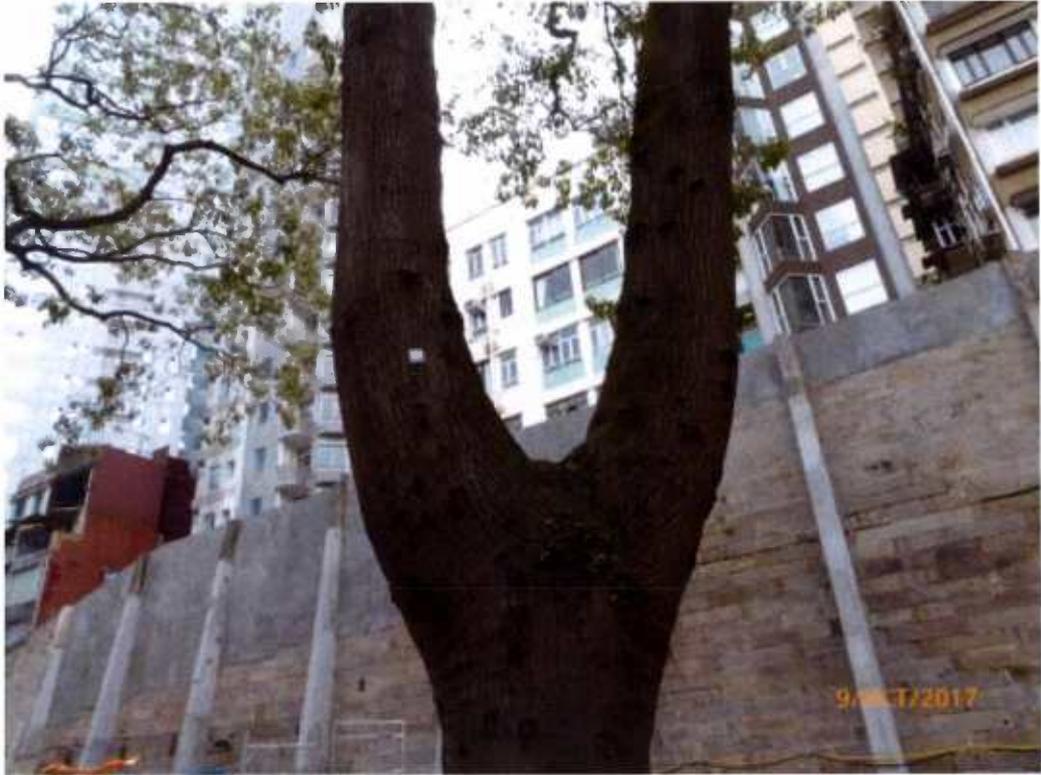
Fig. 4 Health condition of the mid trunk is fair.

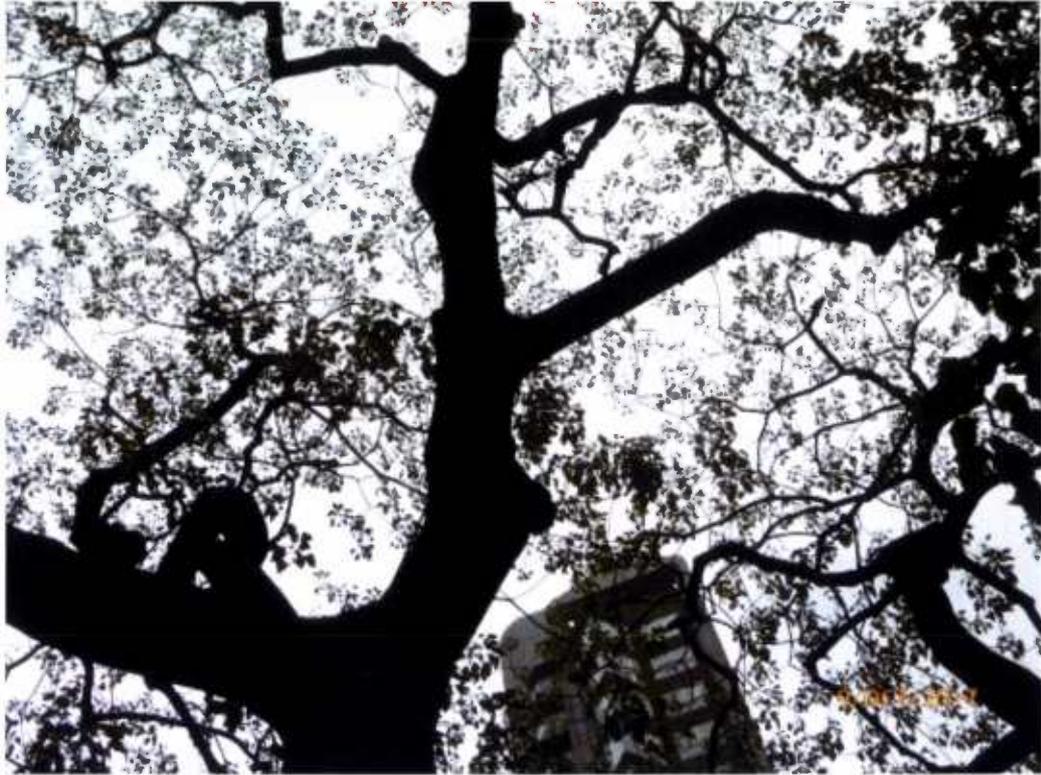
Fig. 6 Leaves on the crown are rather sparse.

1. Keep close monitoring on the growth of the tree.

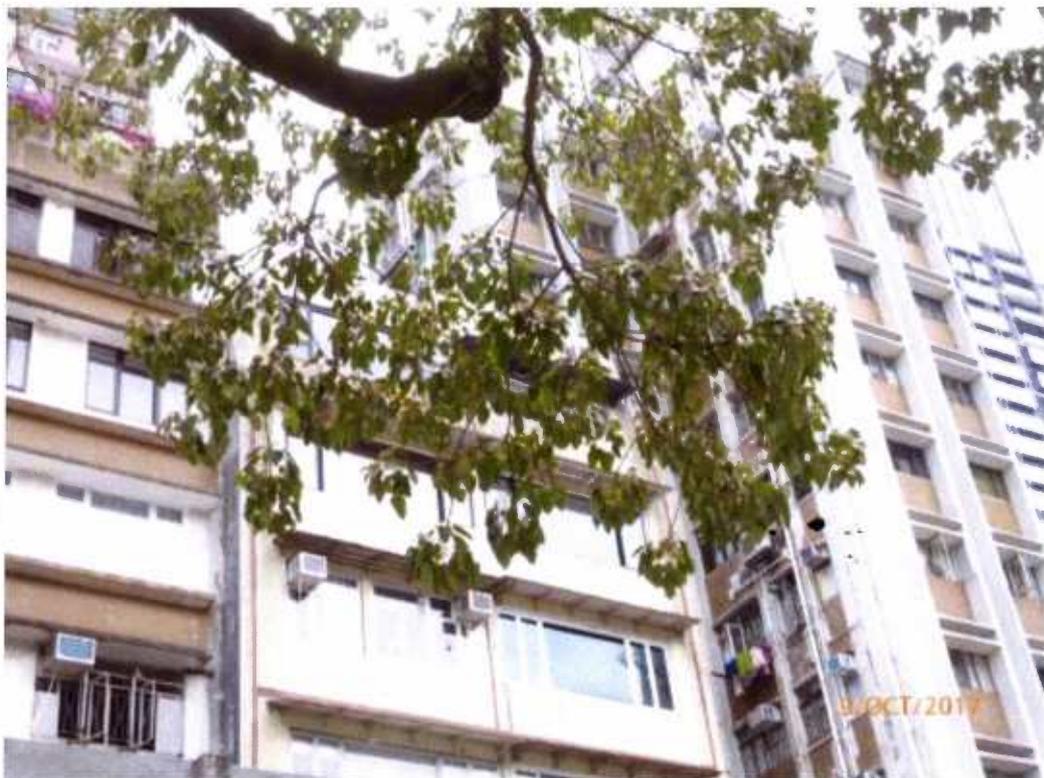
Fig. 7 Leaves on the lower branches are normal.

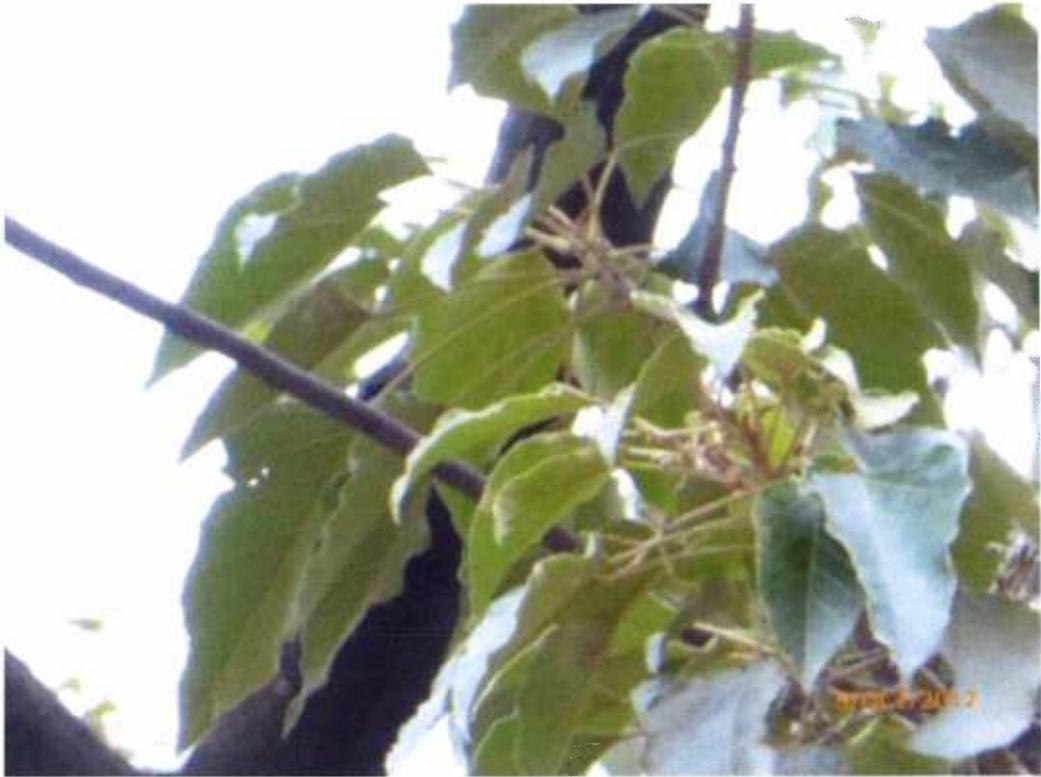
Fig. 8 Flowers still remain on the branches.

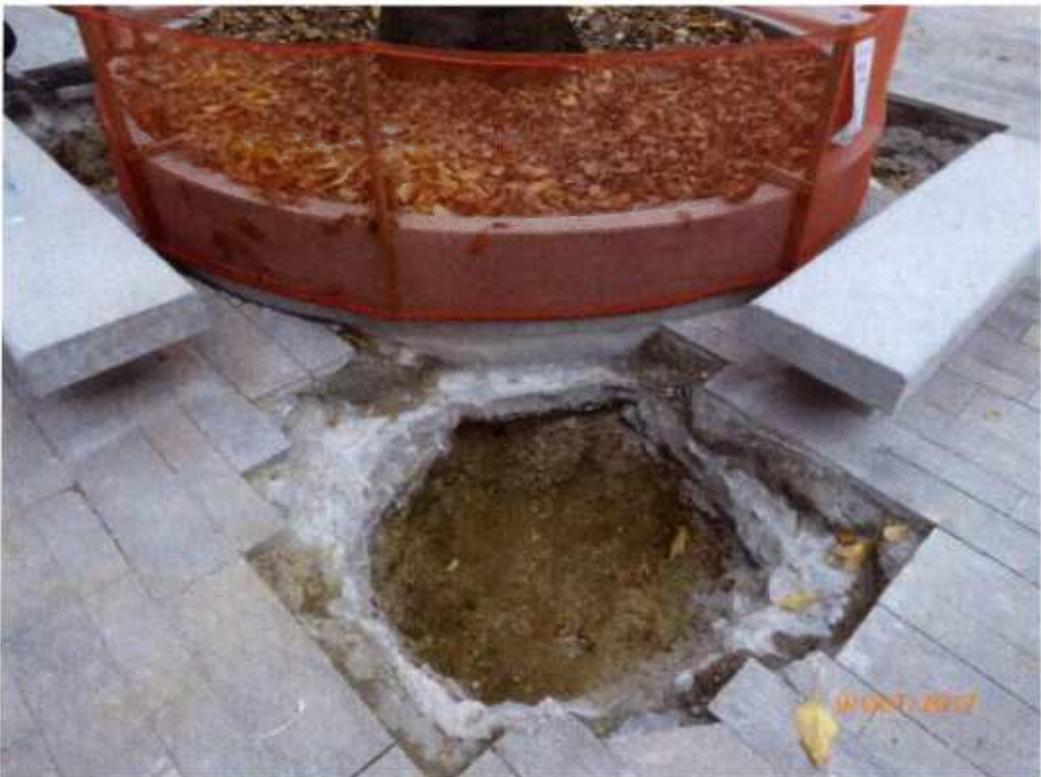
Fig. 11 Four pits have been dug near the planter for ventilation purpose.

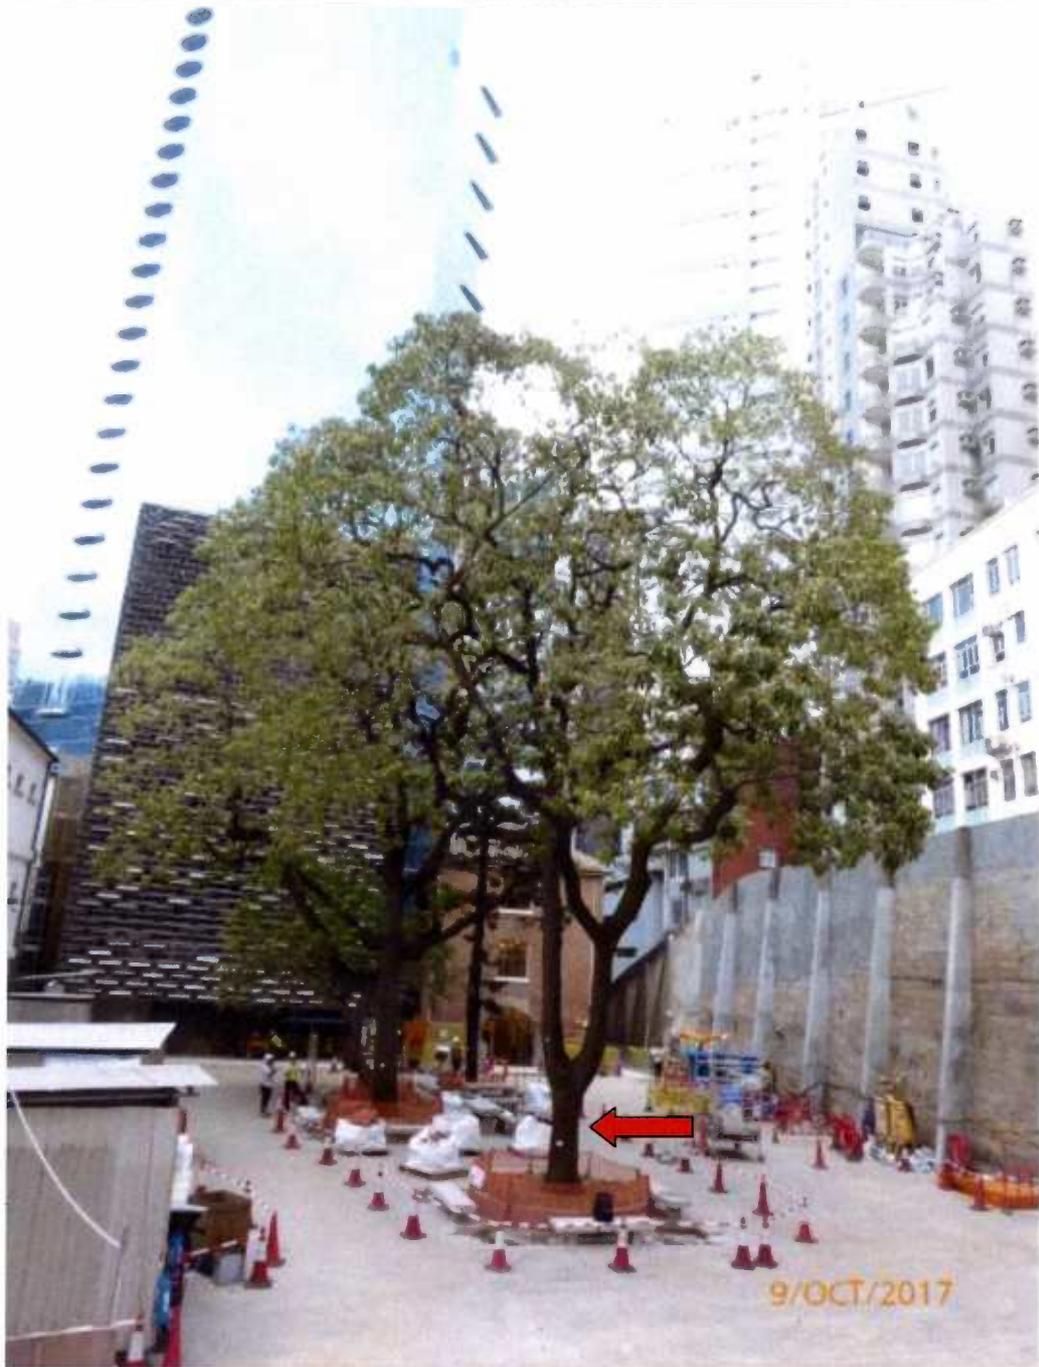
Fig. 12 Overall view of Tree-6 during inspection on 9th Oct. 2017.

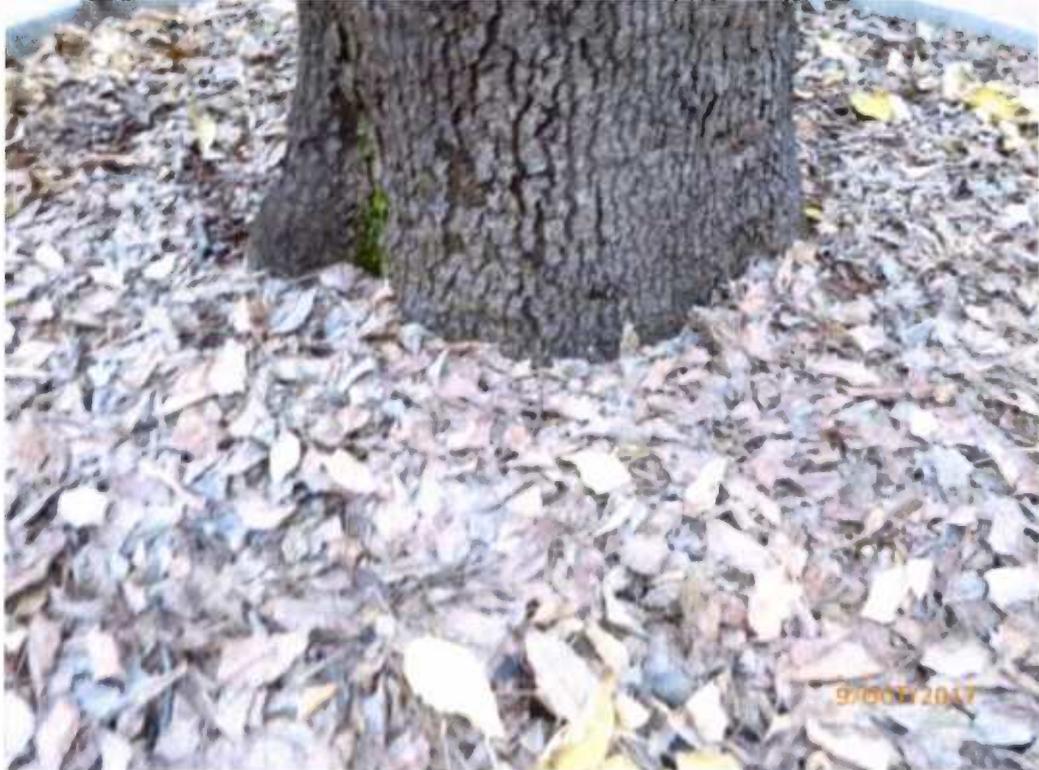
Fig. 2 Root collar is normal. The planter is covered with mulch and dry leaves.

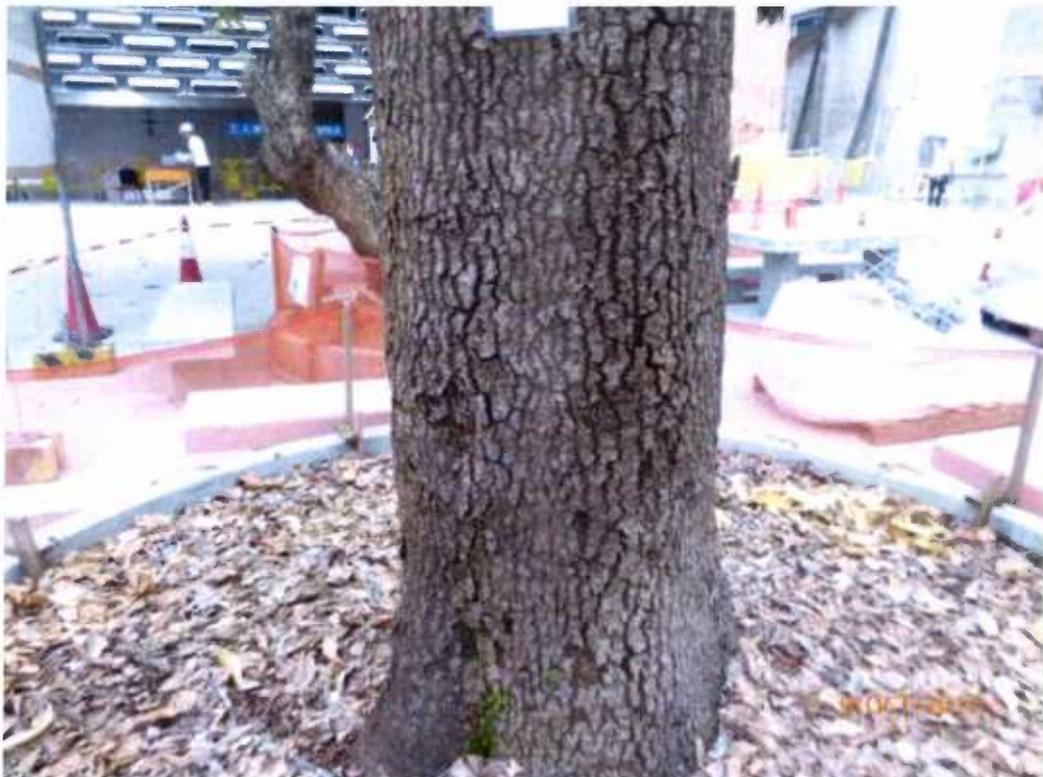
Fig 3. Health condition of the lower trunk is fair.

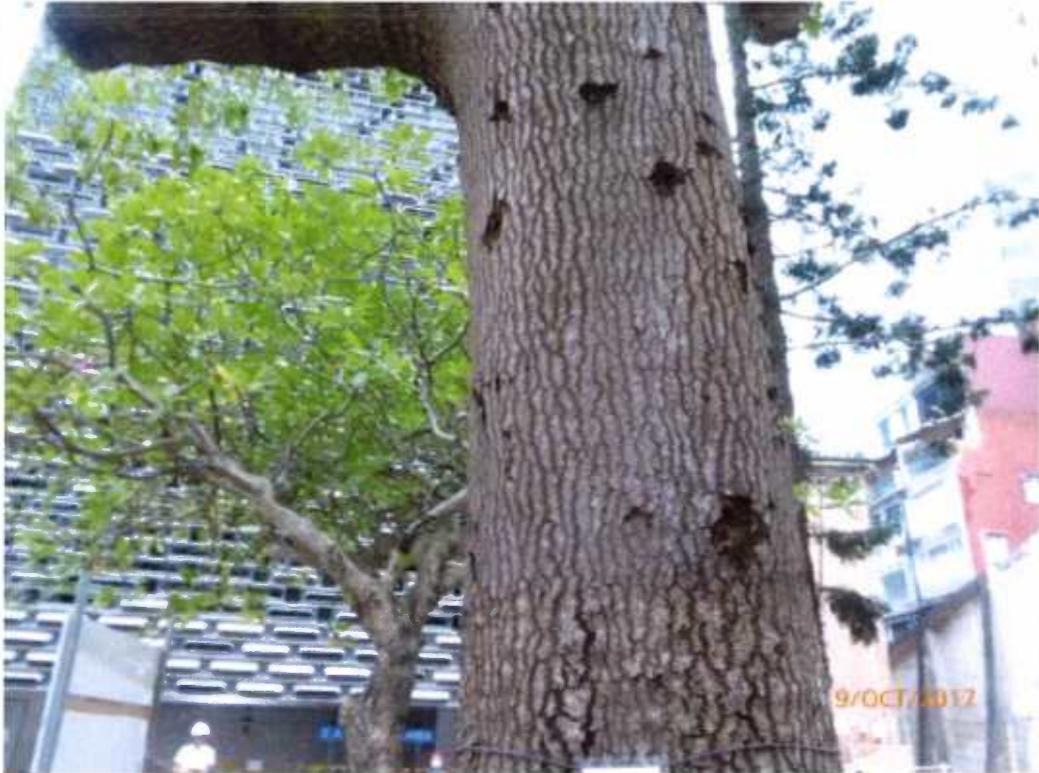
Fig. 4 Health condition of the mid trunk is fair.

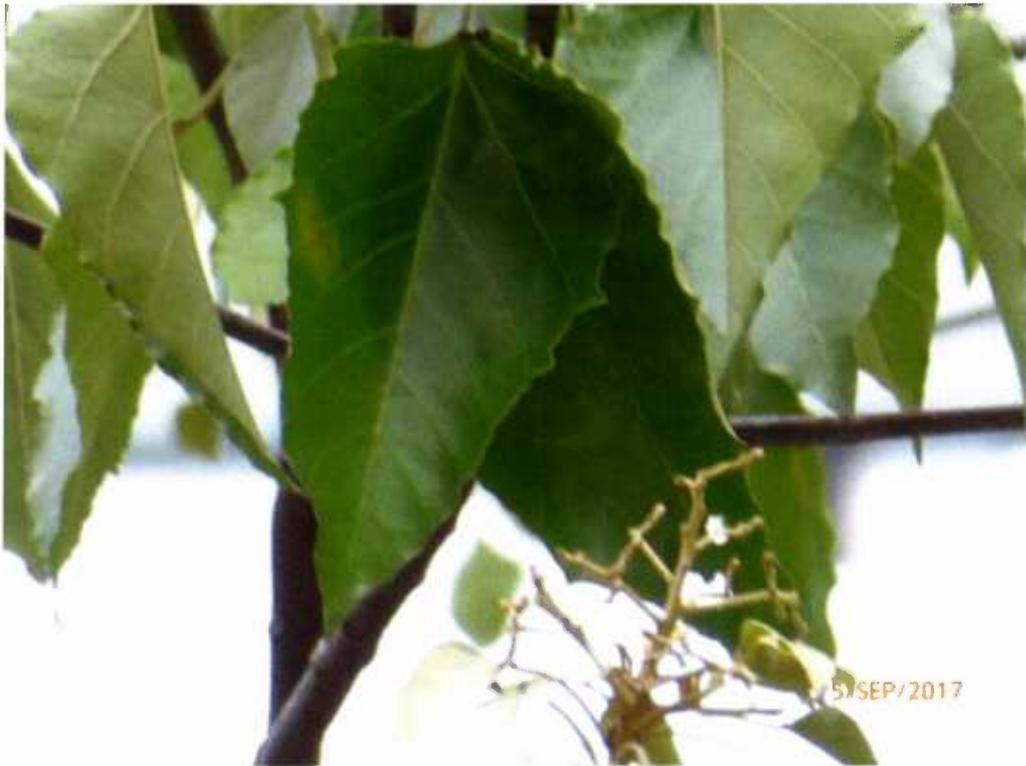
Fig. 7 Signs of Pest “白粉蝨 (*Trialeurodes vaporariorum*)” have apparently reduced due to Pest Control Operation on 3rd & 4th Aug. 2017.

1. Keep close monitoring on the growth of the tree.

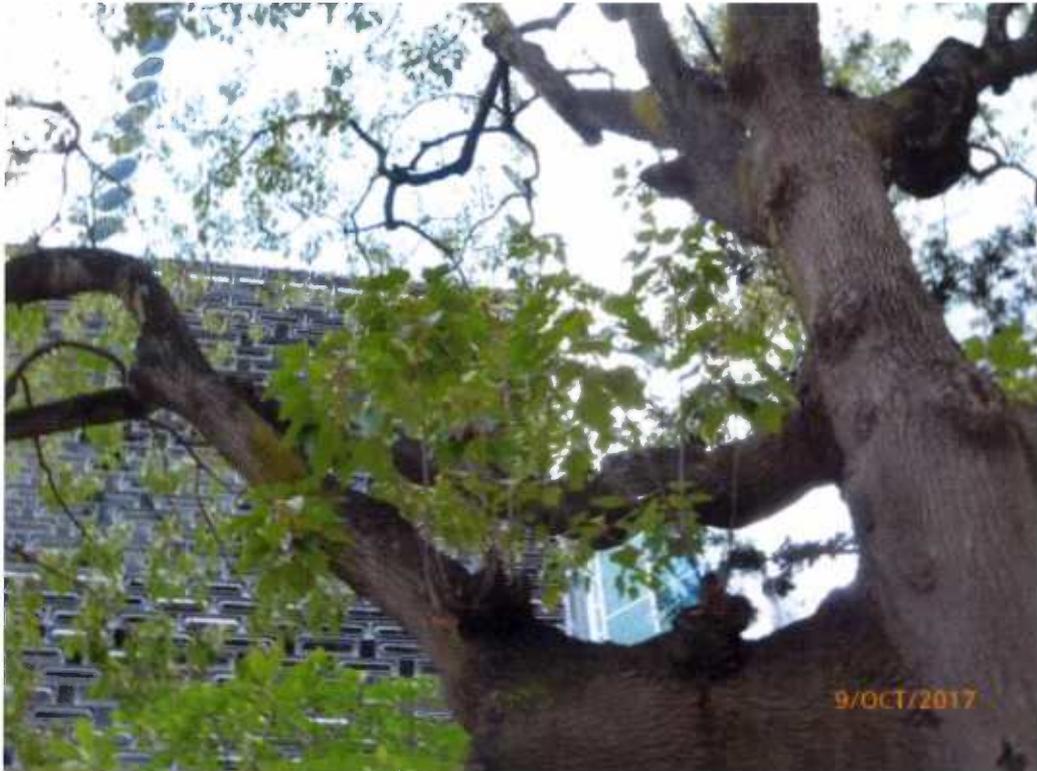
Fig. 8 Young and green leaves are growing on the lower branches.

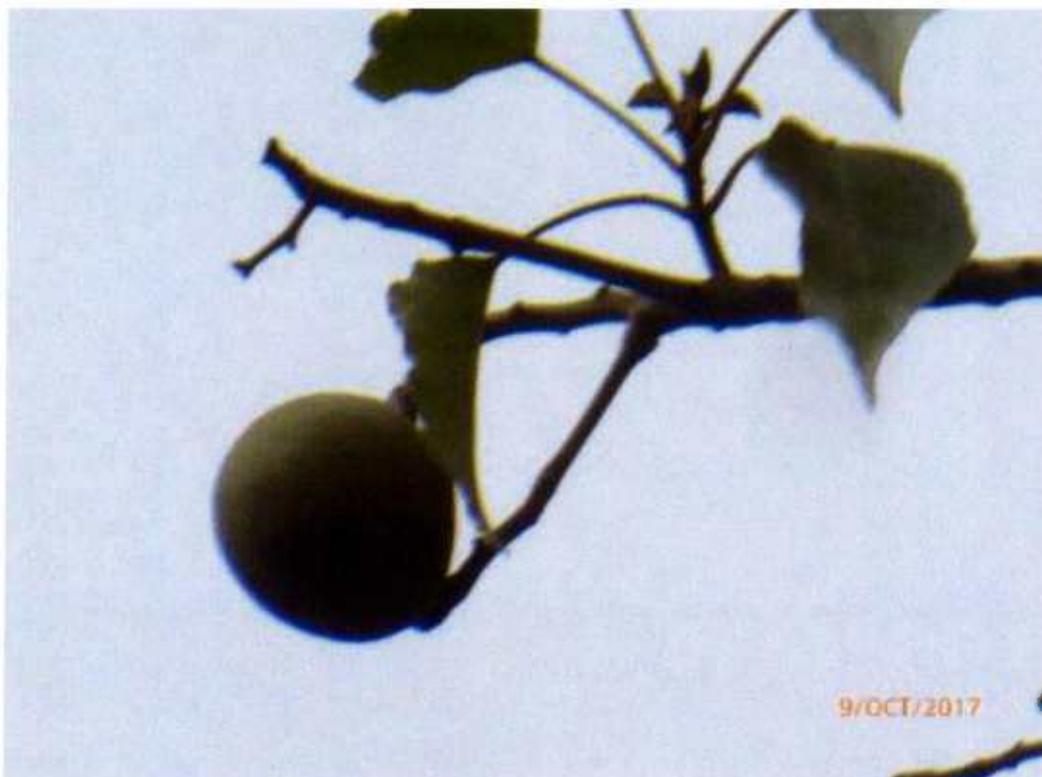
Fig. 9 A fresh nut appears on the top part of Tree-7.

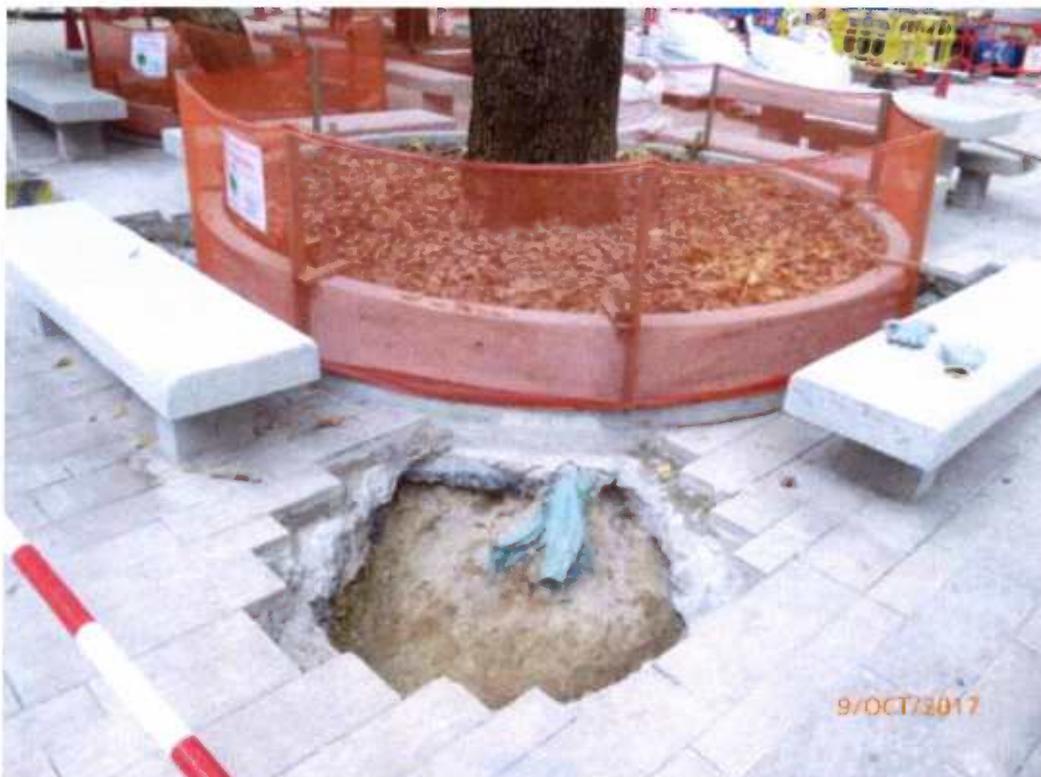
Fig. 11 Four pits have been dug near the planter for ventilation purpose.

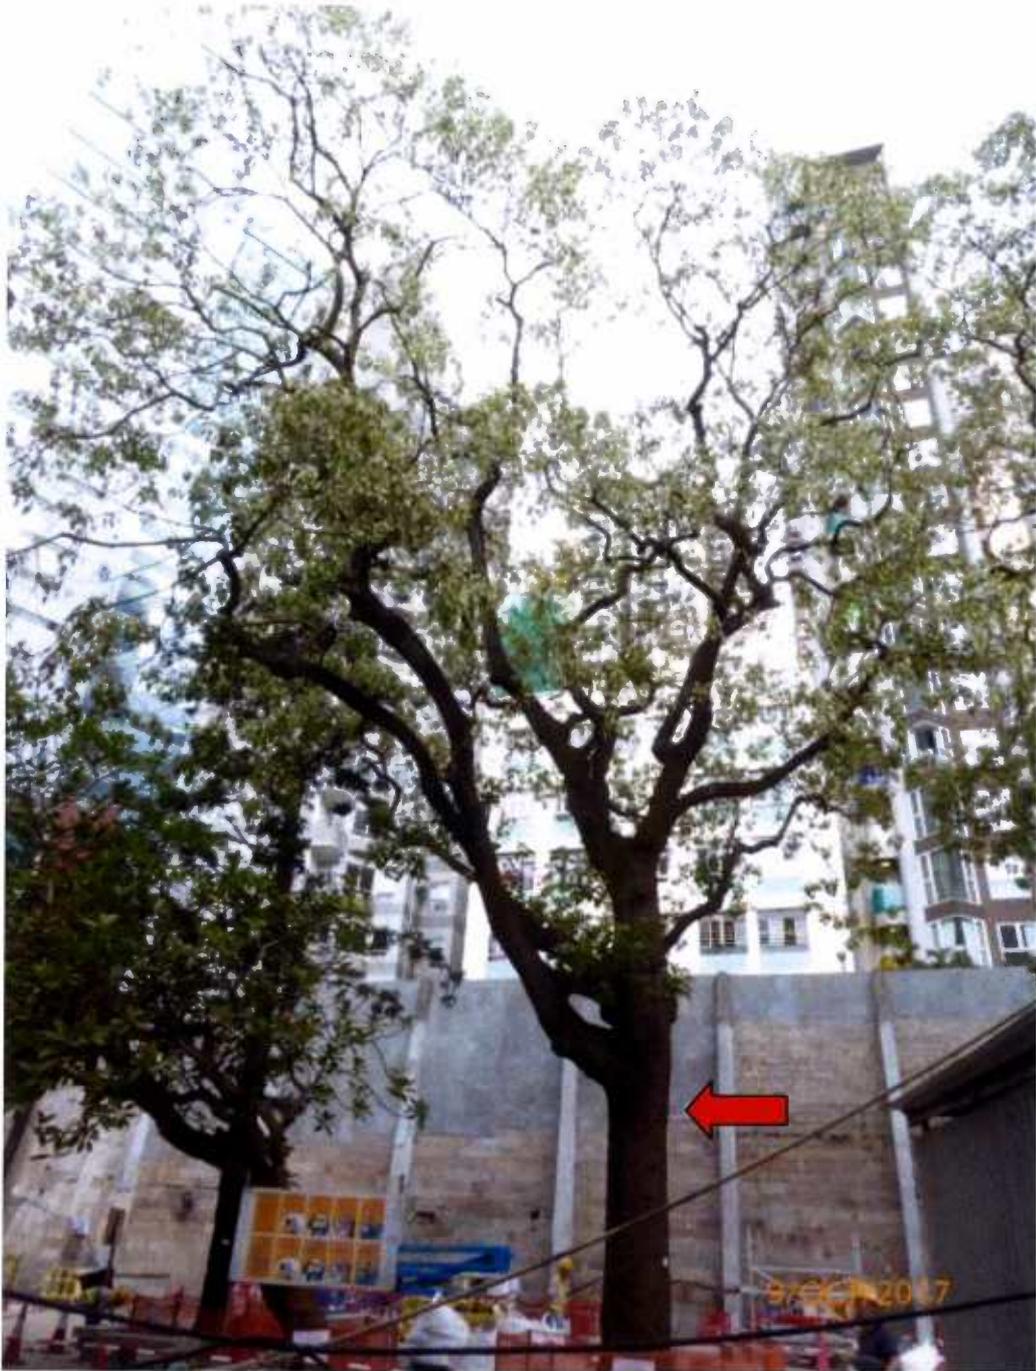
Fig. 12 Overall view of Tree-7 during inspection on 9th October 2017.

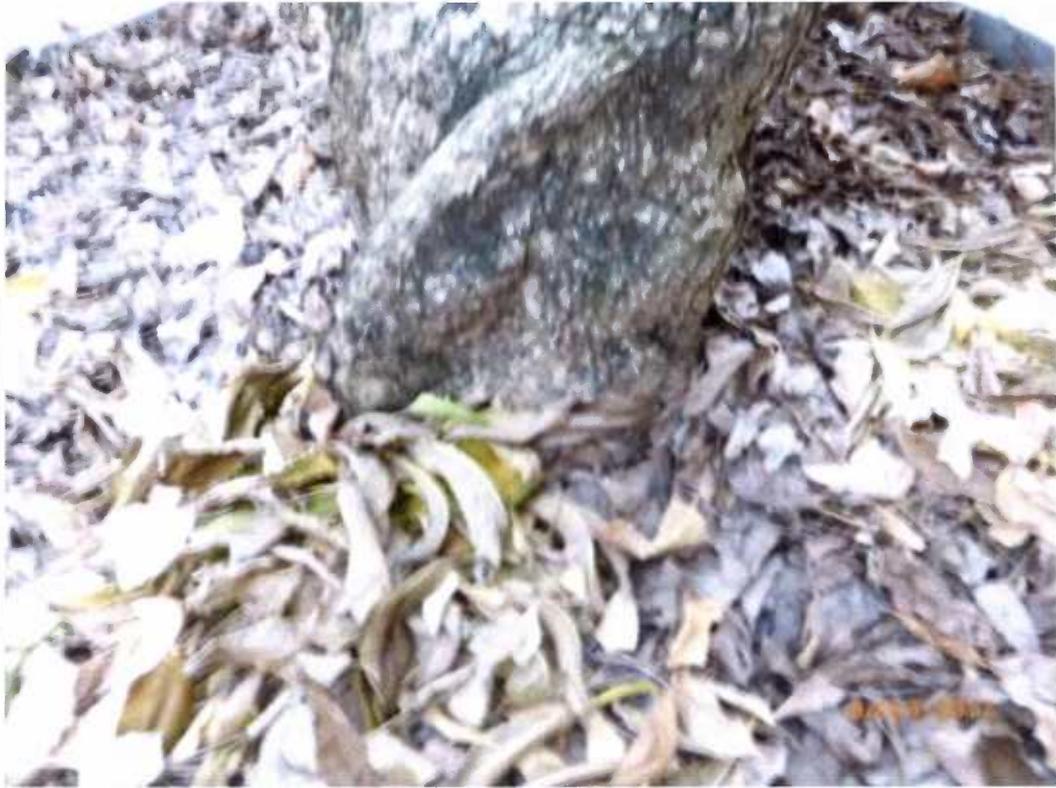
Fig. 2 Root collar is normal. The planter is covered with mulch and dry leaves.

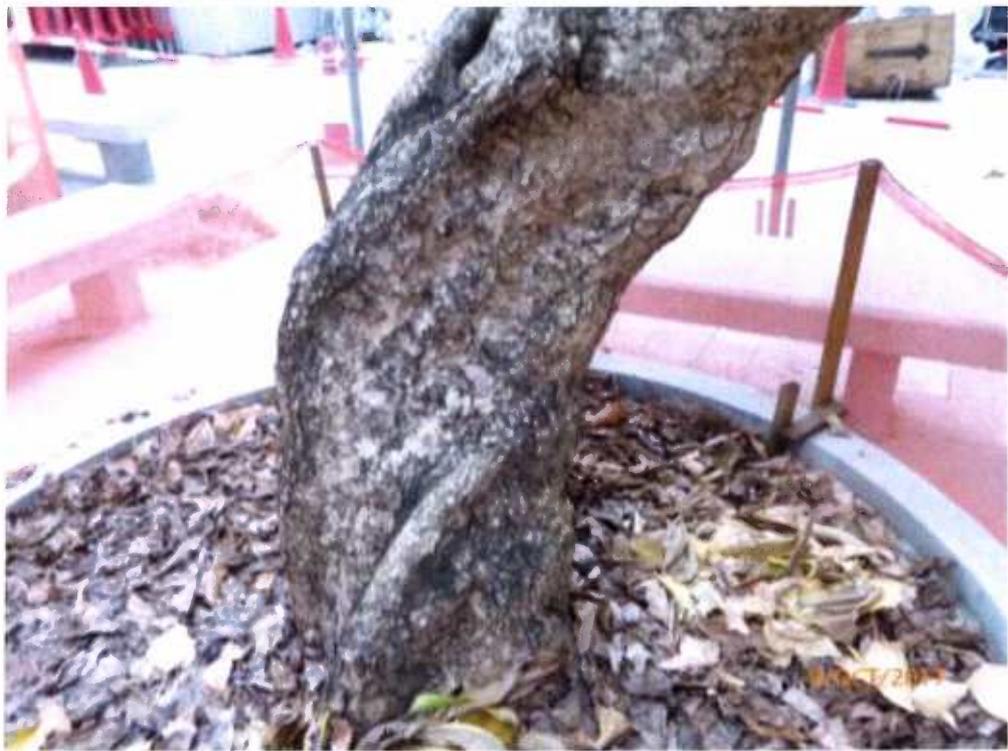
Fig. 3 Health condition of the lower trunk is fair.

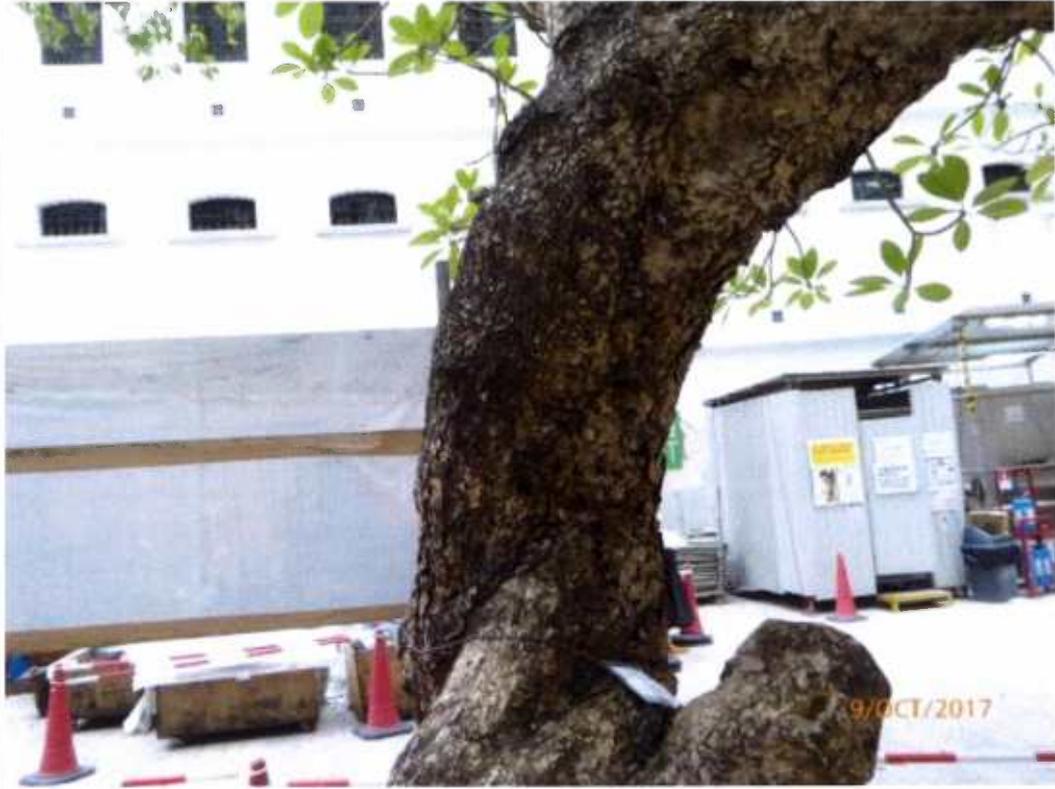
Fig. 5 Health condition of the upper trunk also is fair.
