Central Police Station Conservation
and Revitalisation Project:
72nd Monthly EM&A Report
(1 October to 31 October 2017)

Issue Date: November 2017

Environmental Resources Management

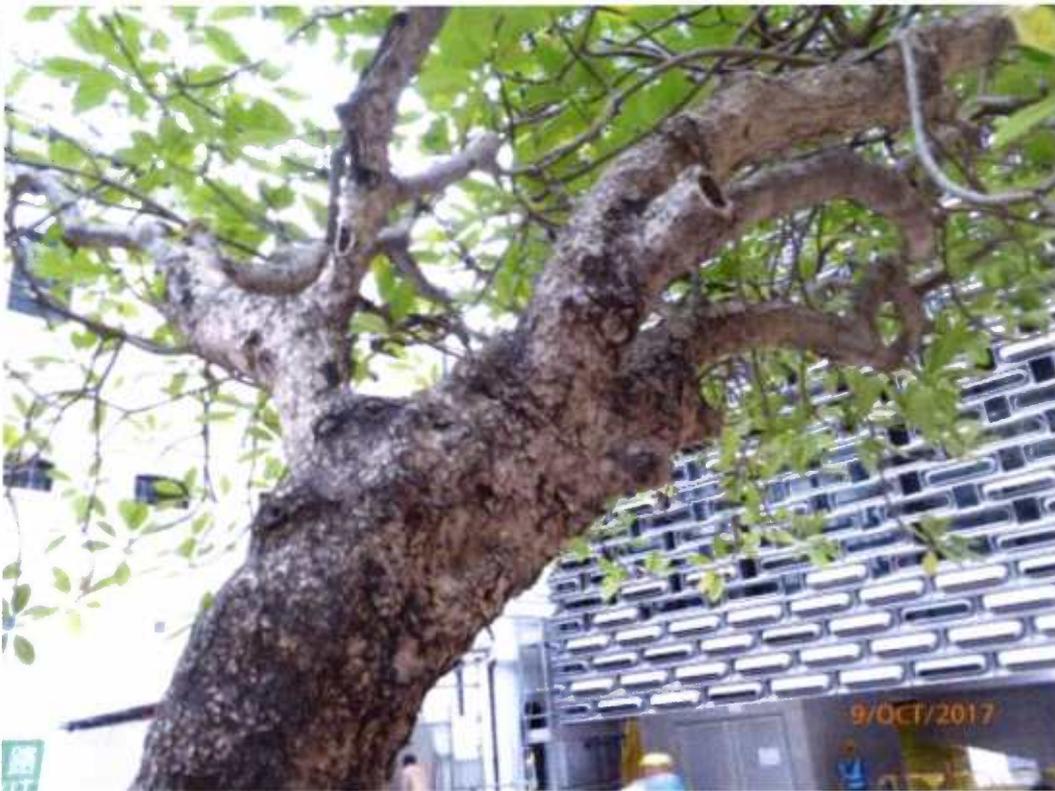
Fig. 6 The crown is full of vigorous and green leaves.

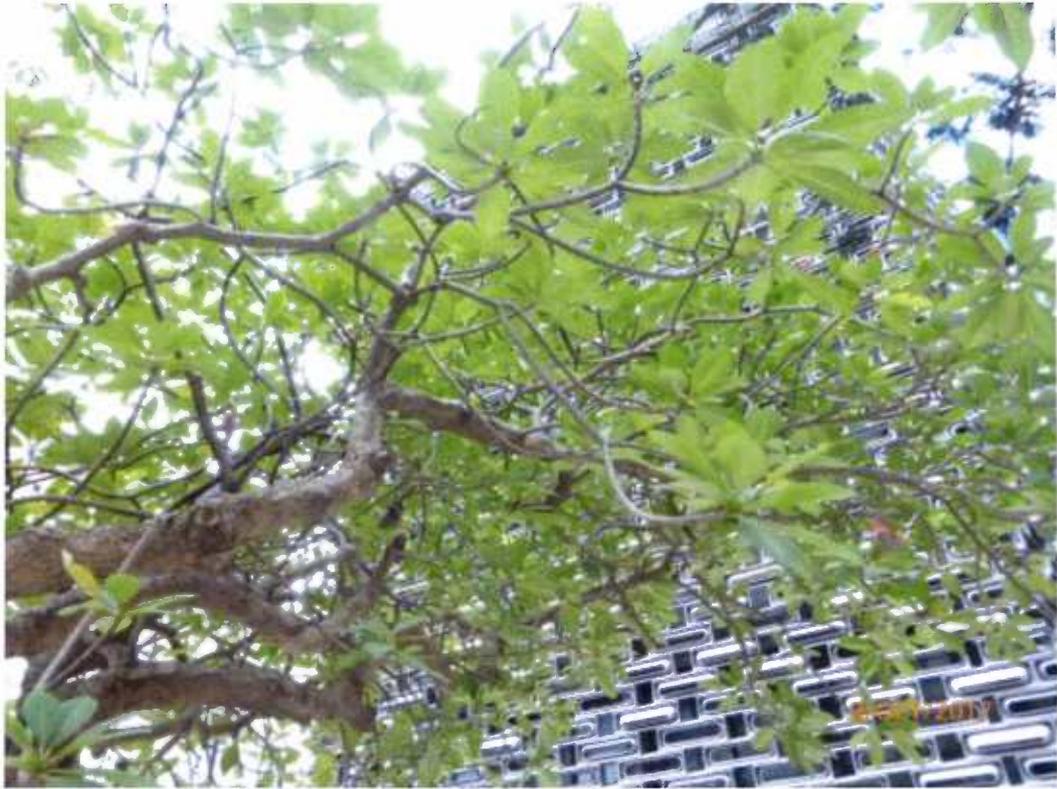
Fig. 7 Vigorous and green leaves also are growing on the lower branches.

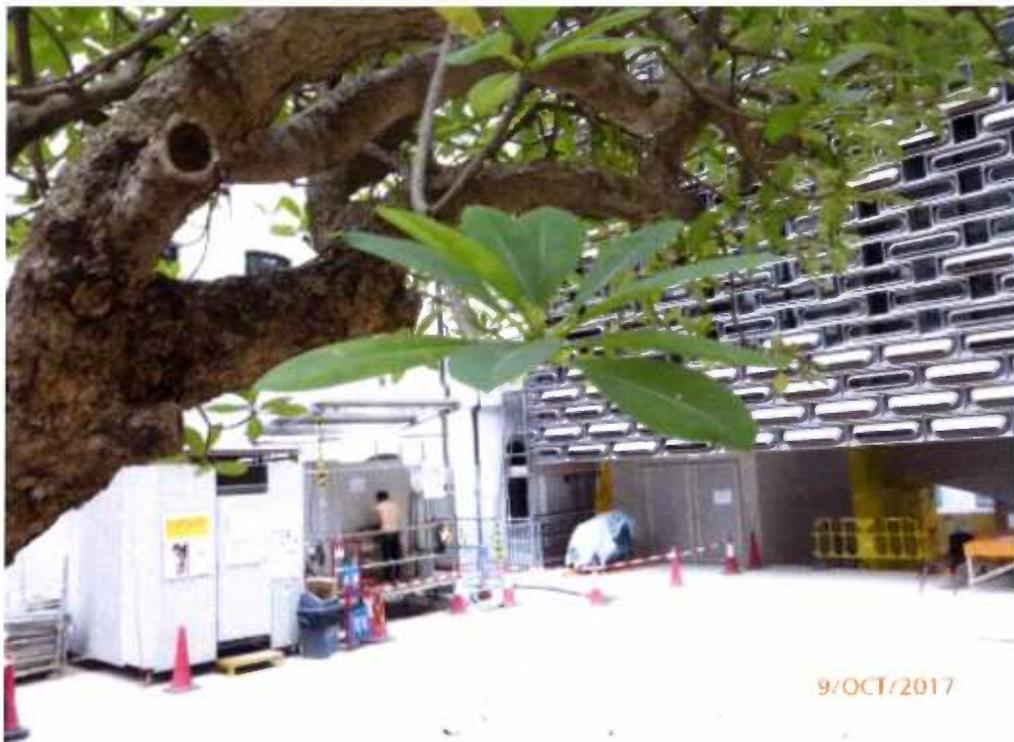
Fig. 8 Flowers still appear on the tree.

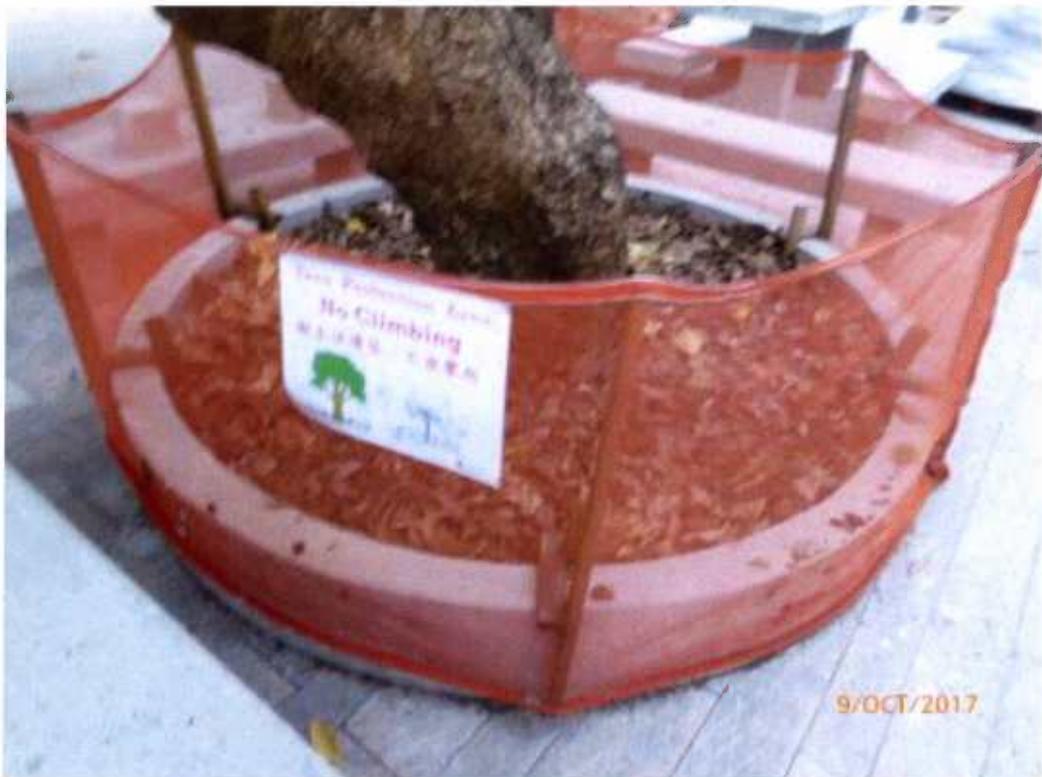
Fig. 10 The site near the planter is clean and tidy.

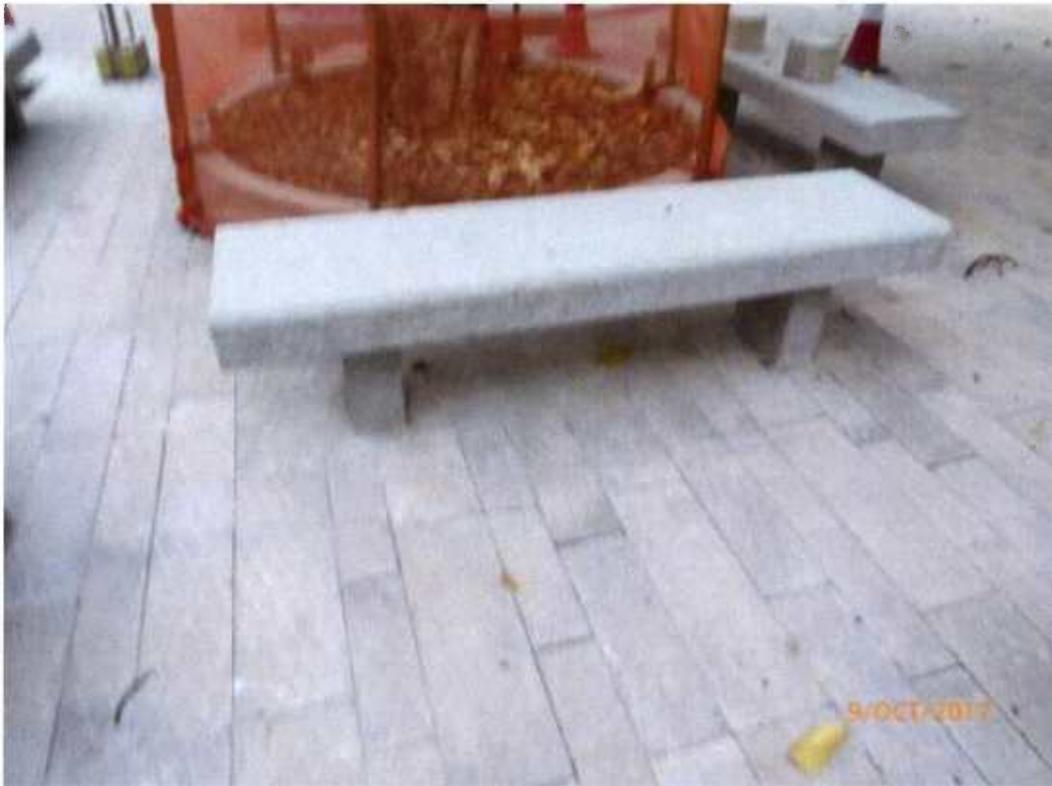
Fig. 11 The access near Tree-8 also is clean and tidy.

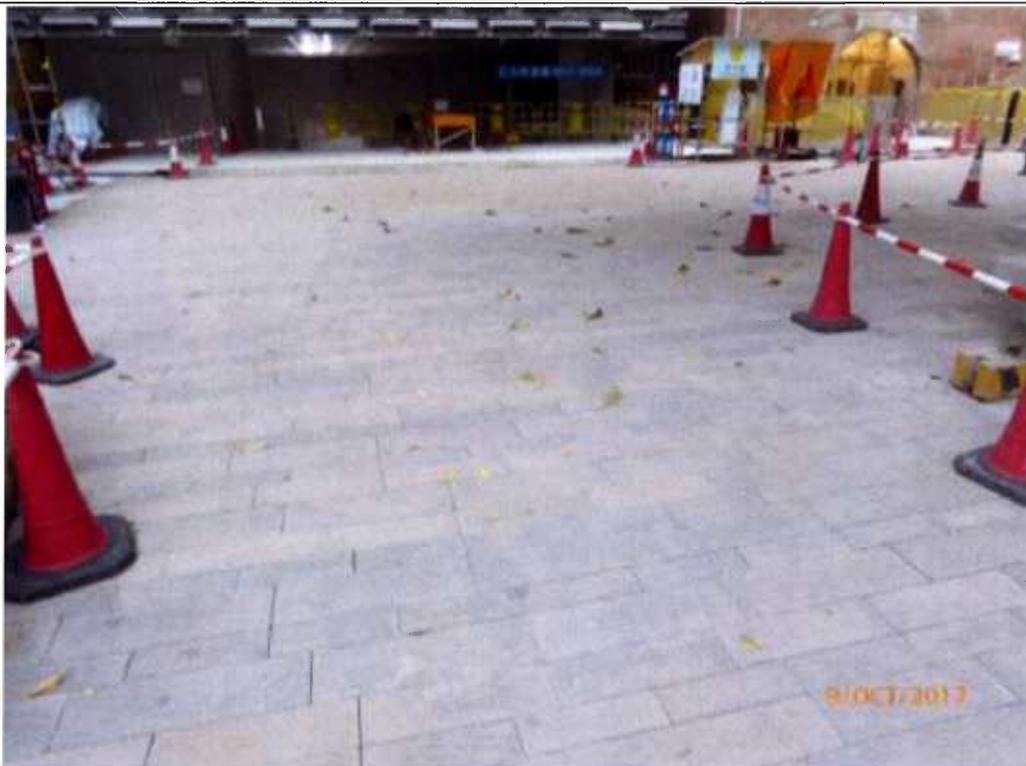
Fig. 12 Overall view of Tree-8 during inspection on 9th Oct. 2017.

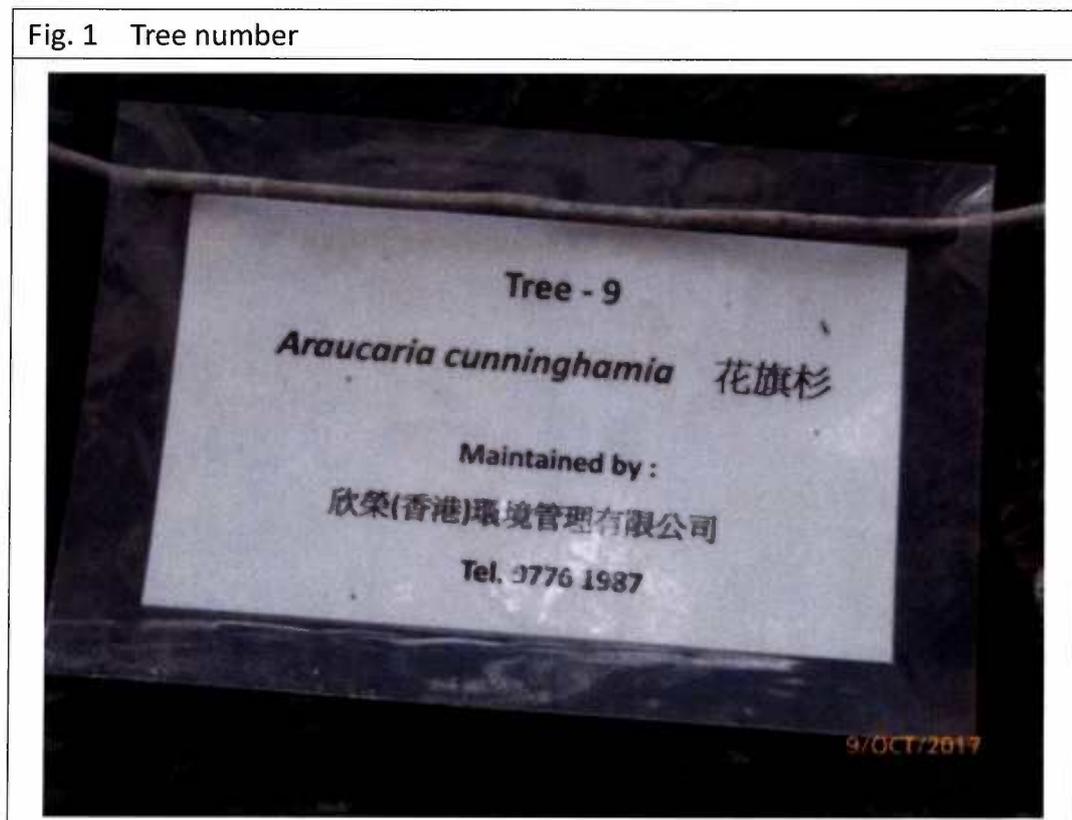
Fig. 2 Root collar is normal. The planter is covered with mulch and dry leaves.

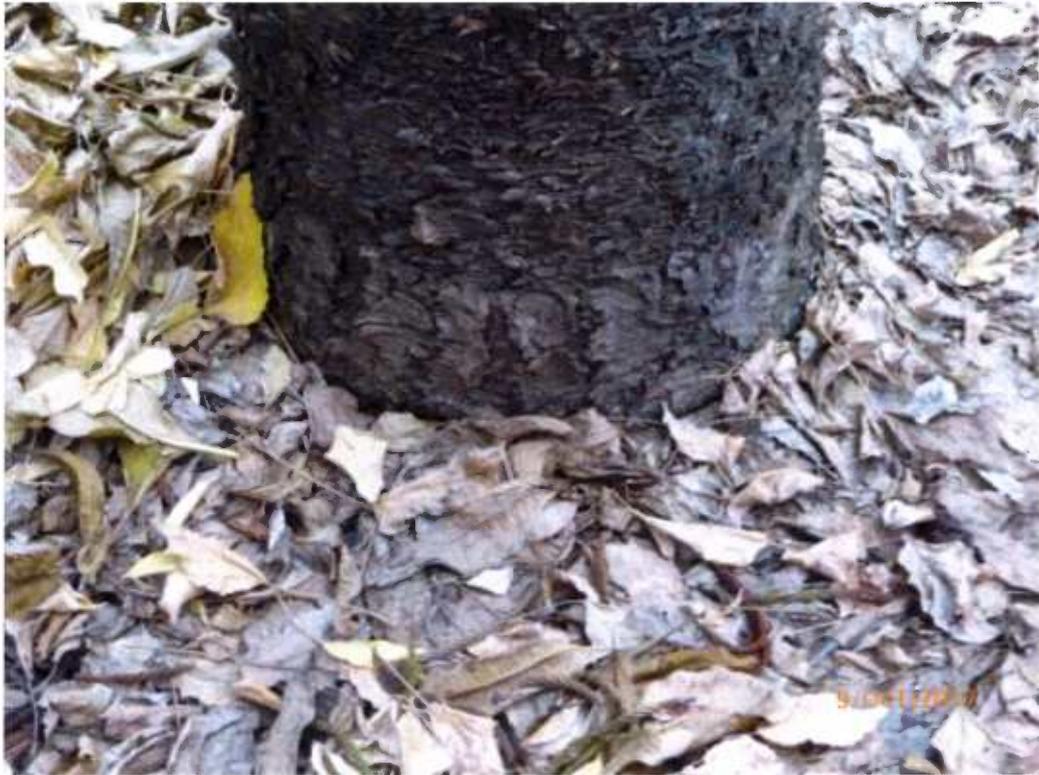
Fig. 3 Health condition of the lower trunk is fair.

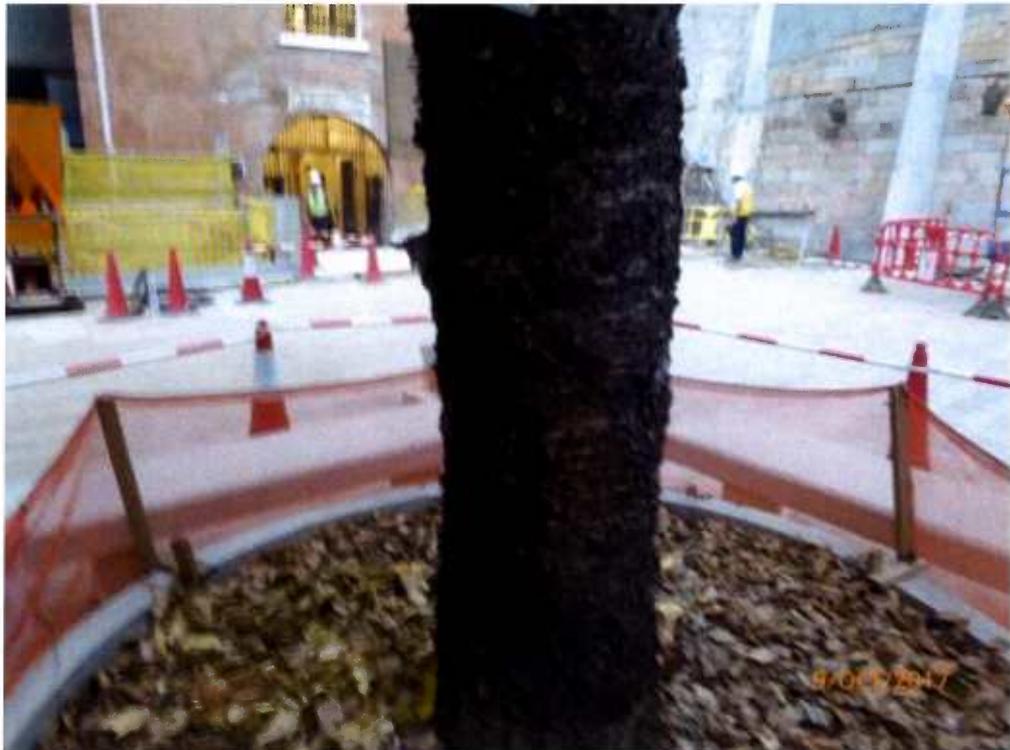
Fig. 4 Health condition of the mid trunk is fair.

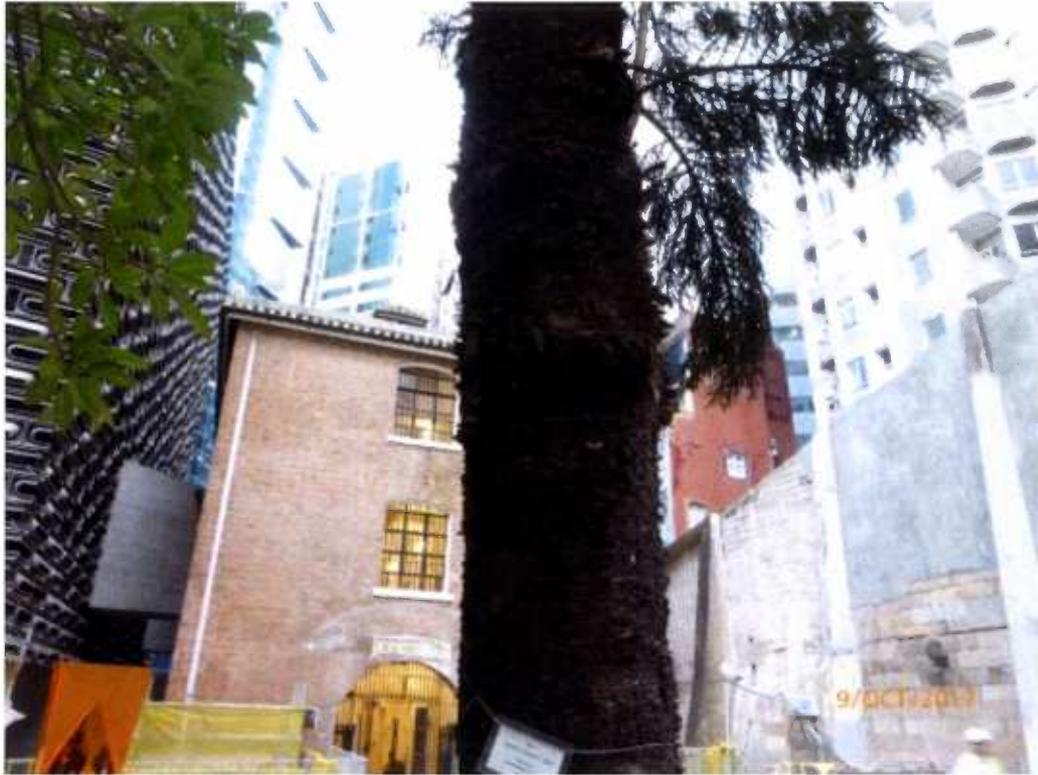
Fig. 5 Health condition of the upper trunk also is fair.

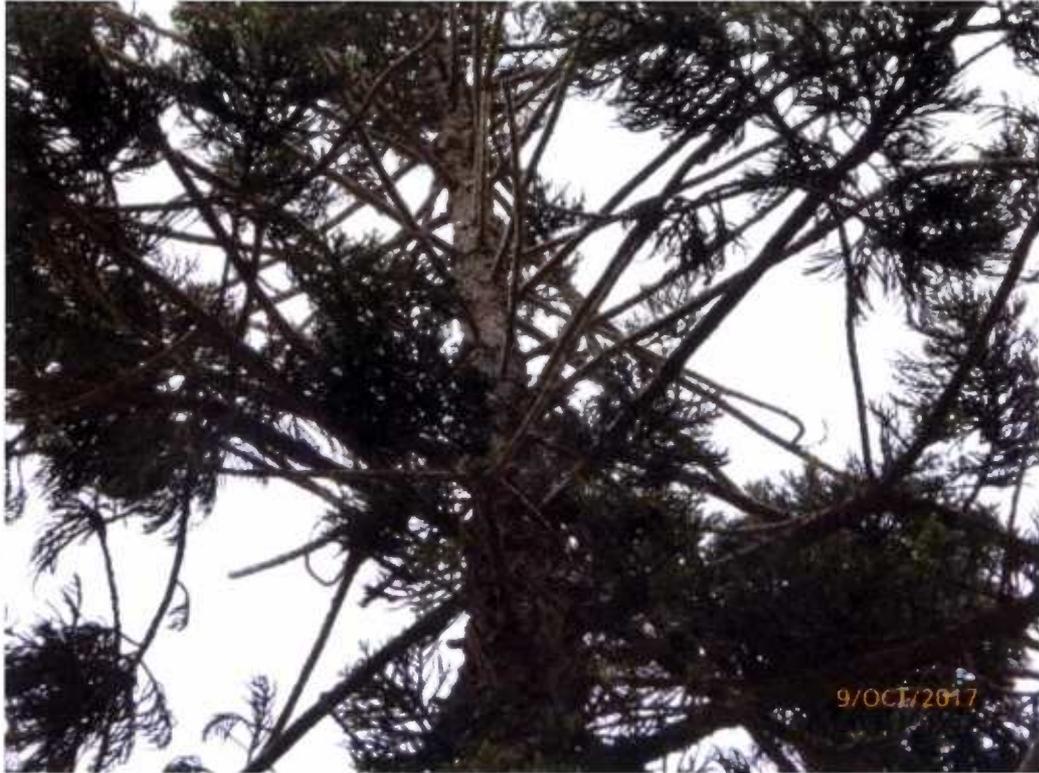
Fig. 7 Vigorous and green leaves also are growing on the lower branches.

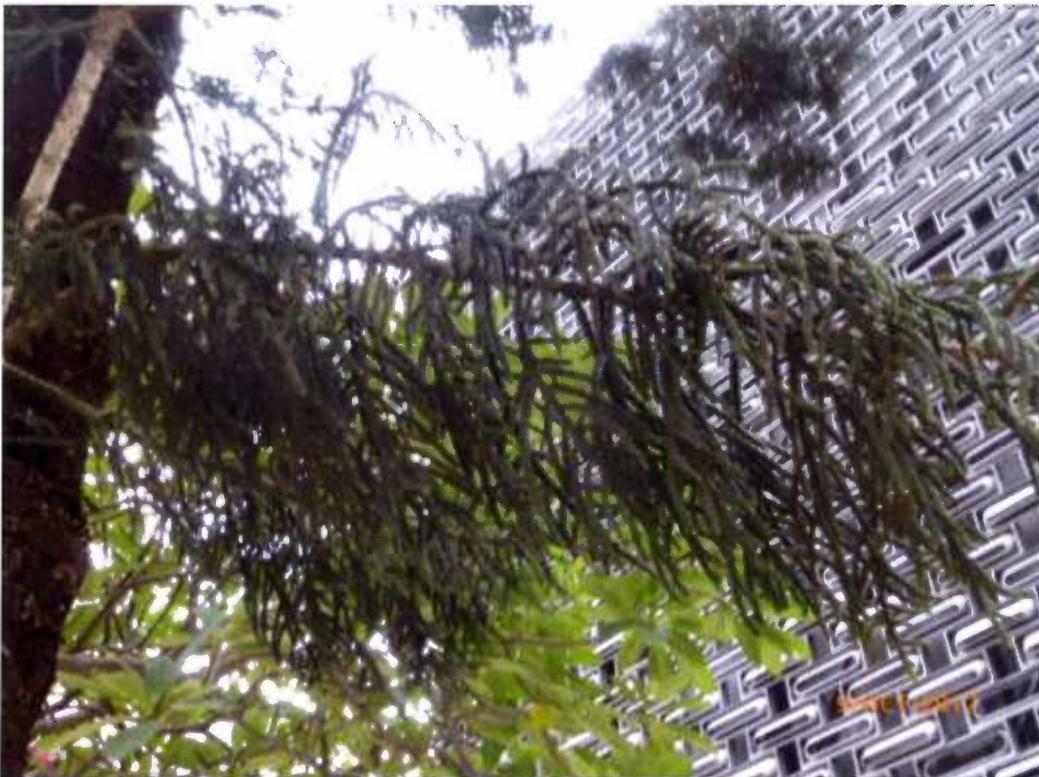
Fig. 8 Some young and green leaves appear on the mid trunk.

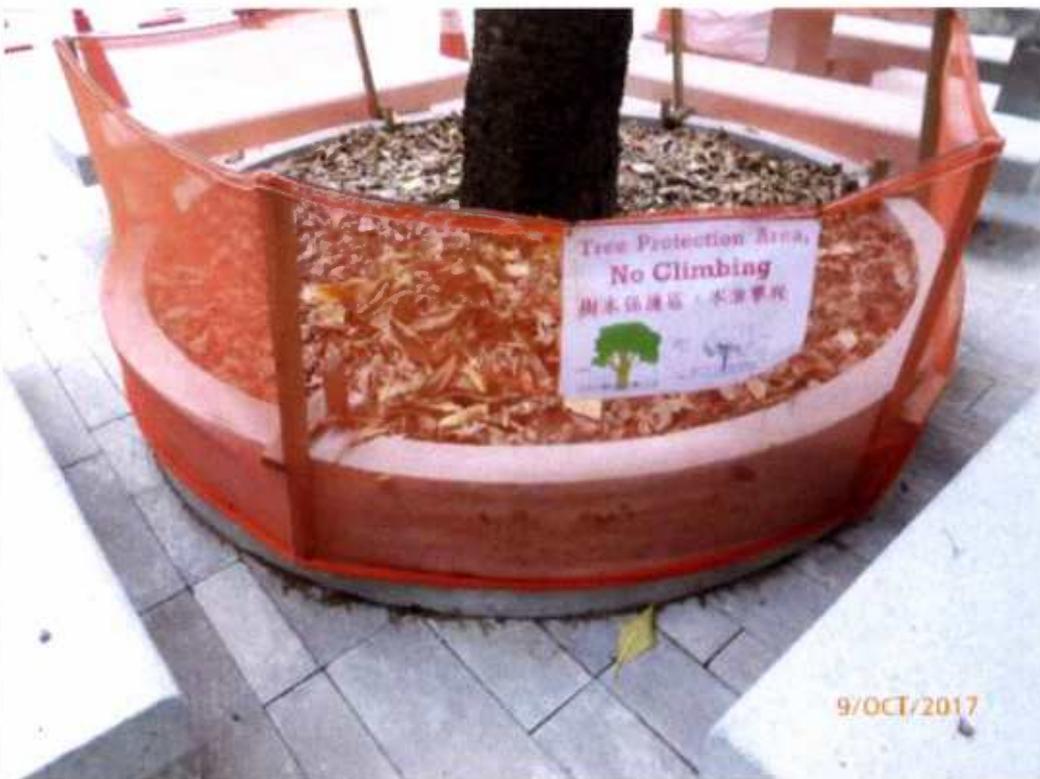
Fig. 10 The site near the planter is clean and tidy.

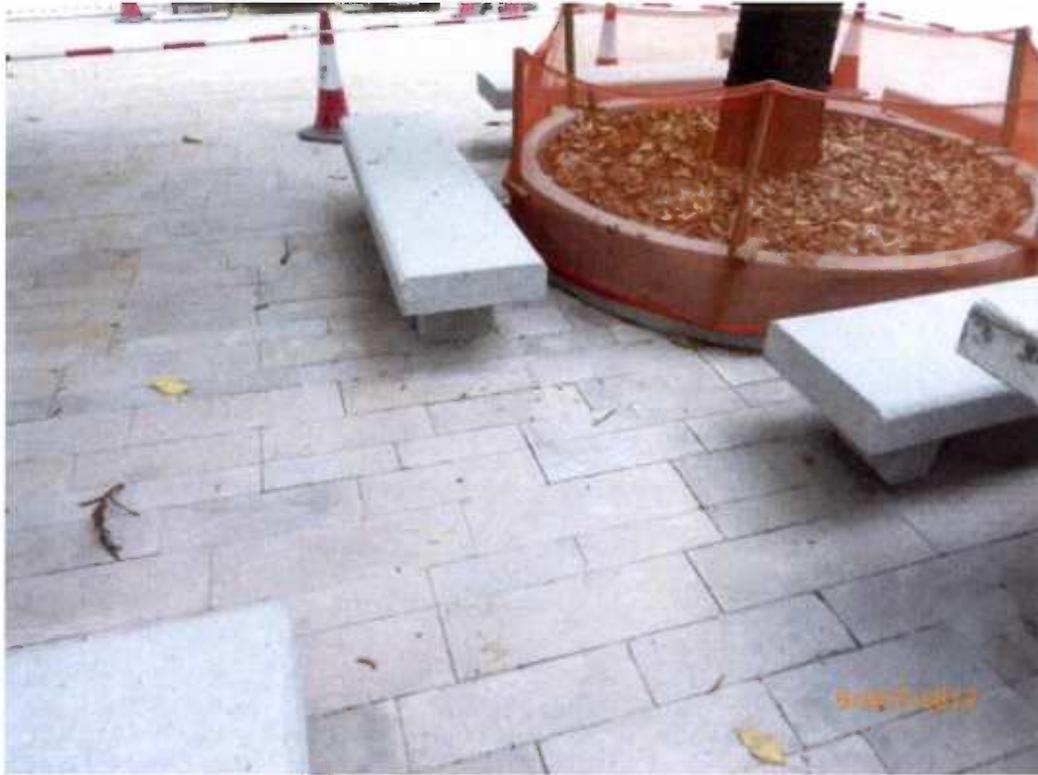
Fig. 11 The access near Tree-9 also is clean and tidy.

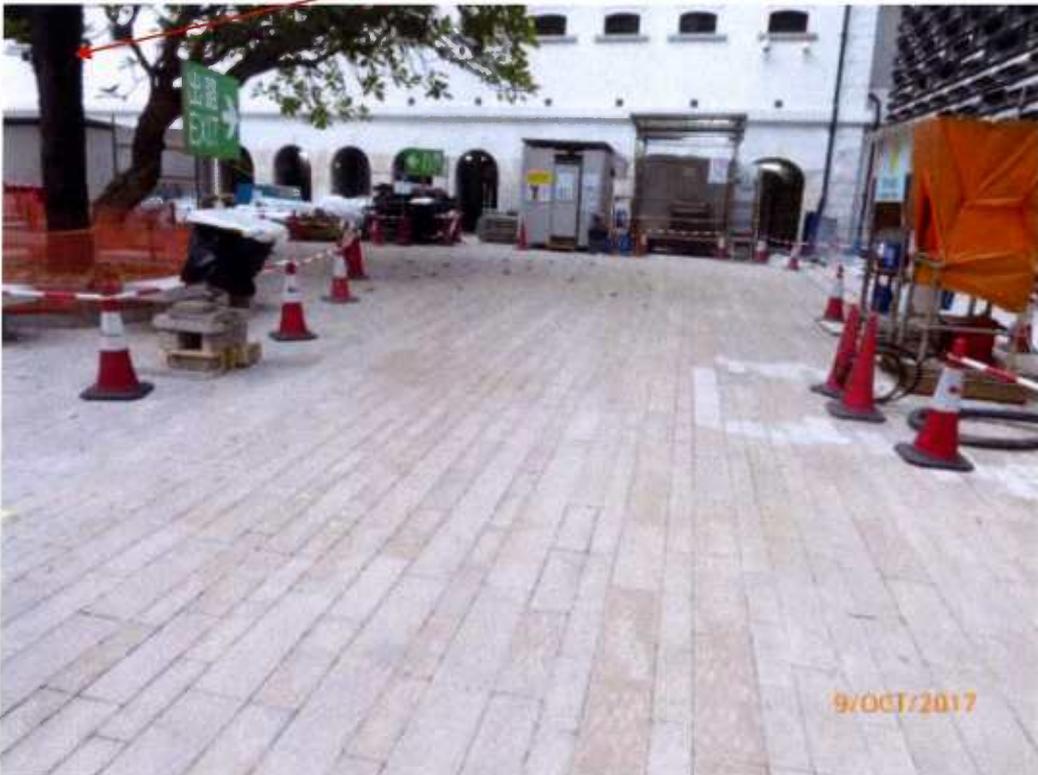
Fig. 12 Overall view of Tree-9 during inspection on 9th October 2017.

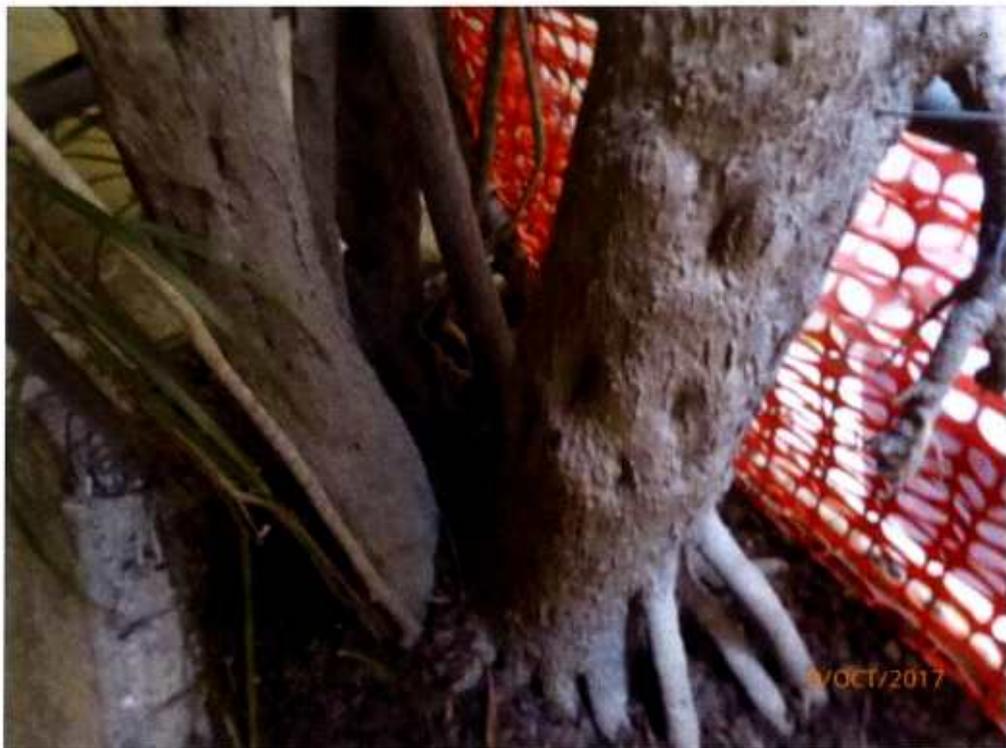
Fig. 4 Health condition of the mid trunk is fair.

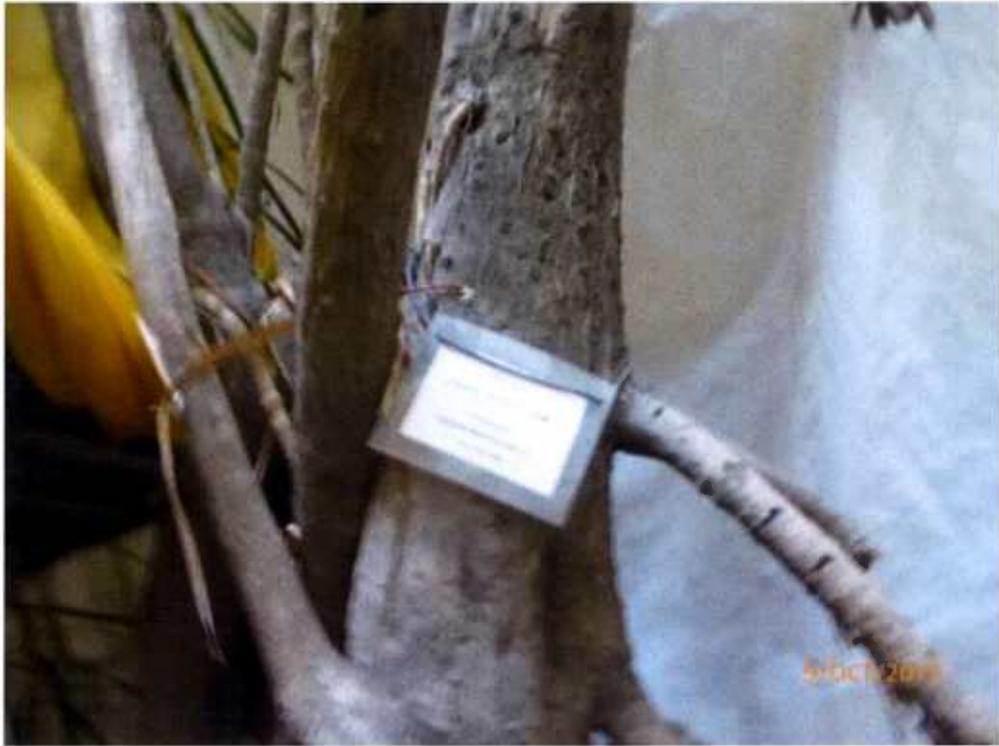
Fig. 5 Health condition of the upper trunk also is fair.

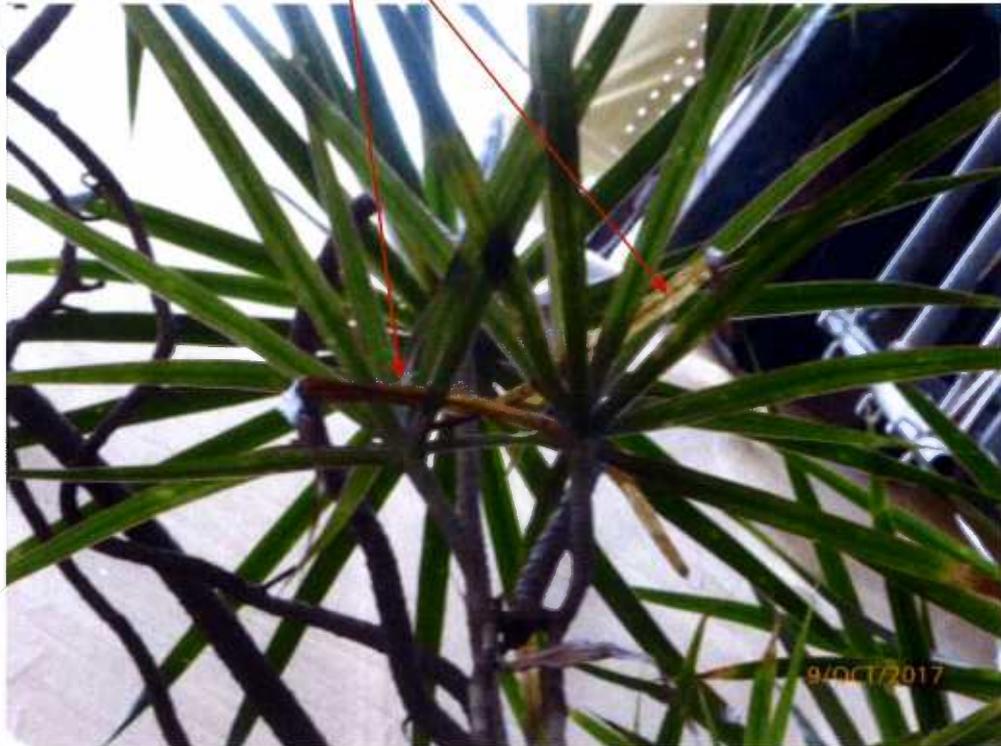
Fig. 7 Withered leaves also appear on the lower branches.

1. Keep close monitoring on the growth of Tree-11 especially during the nearby renovation works are in progress.
