Central Police Station Conservation
and Revitalisation Project:
78th Monthly EM&A Report
(1 April to 30 April 2018)

Issue Date: May 2018

Environmental Resources Management

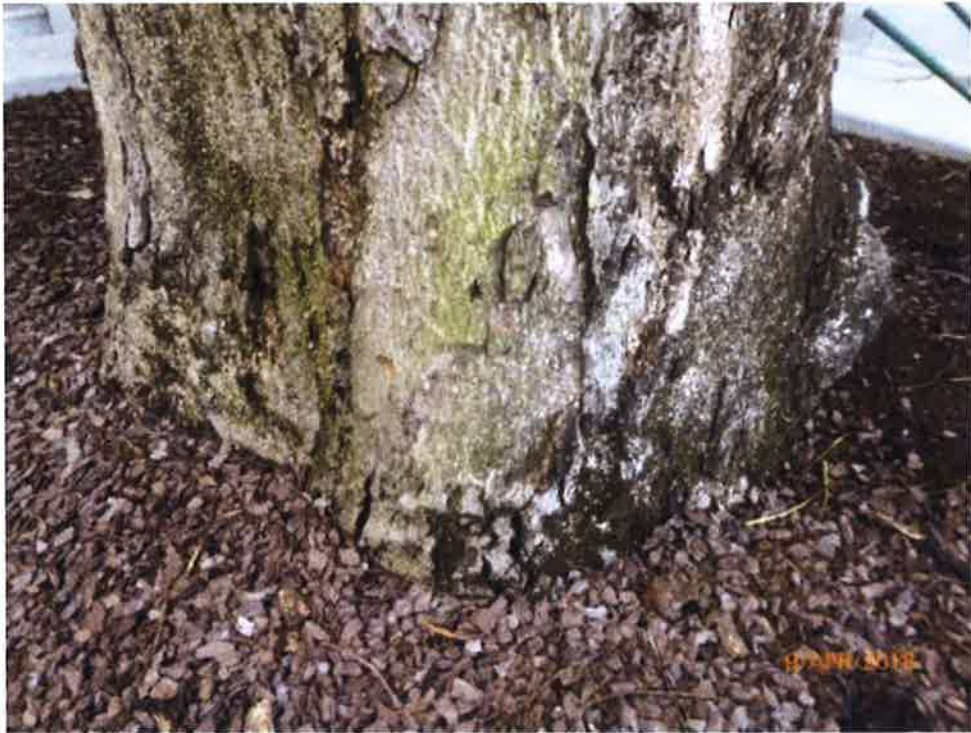
Fig. 2 The root collar is normal.

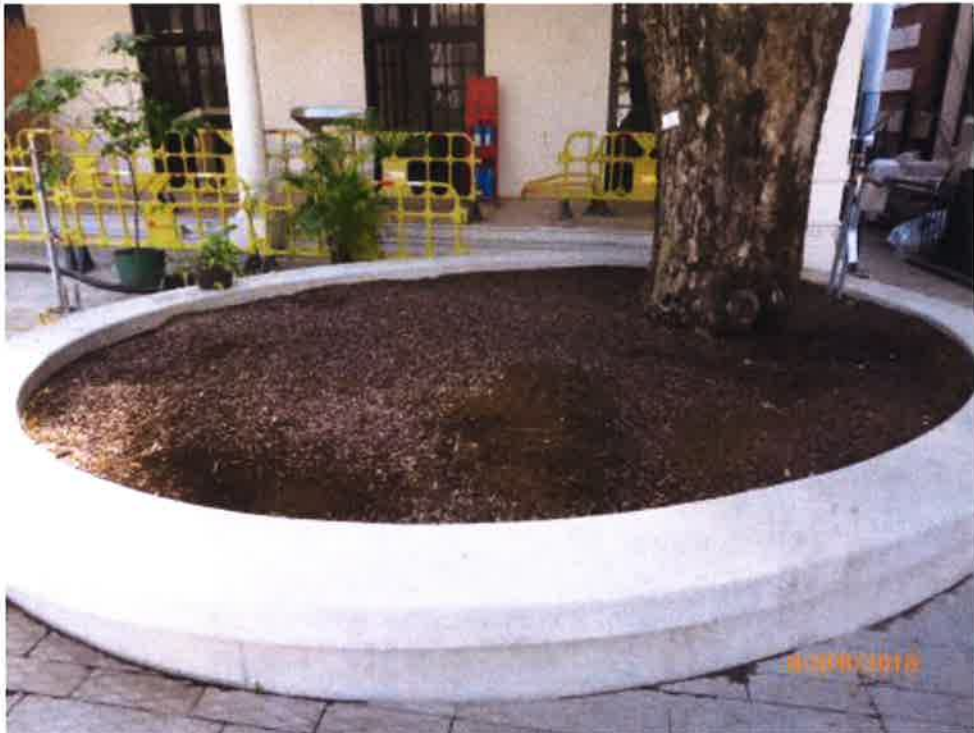
Fig. 3 The planter is covered with small pieces of mulch.

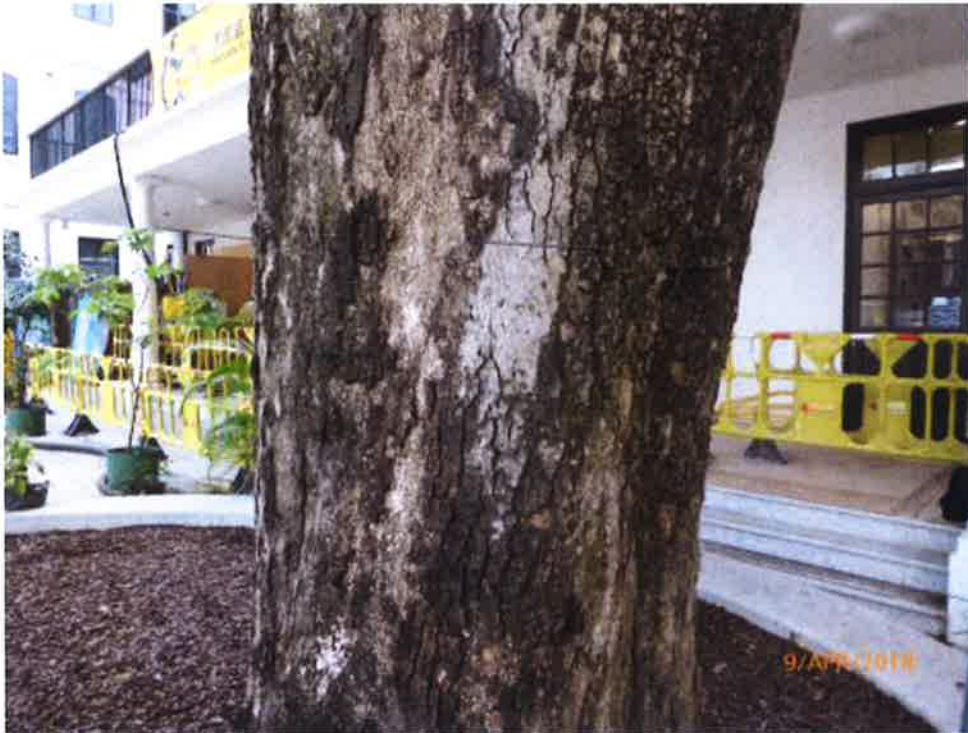
Fig. 4 Health condition of the lower trunk is fair.

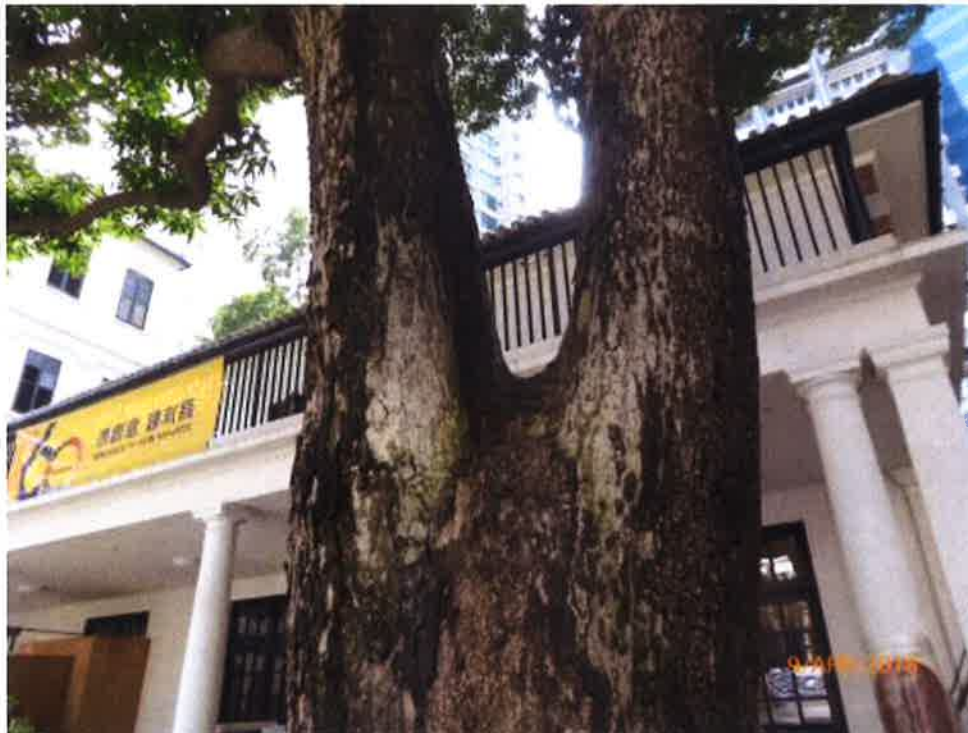
Fig. 5 Health condition of the mid trunk is fair.

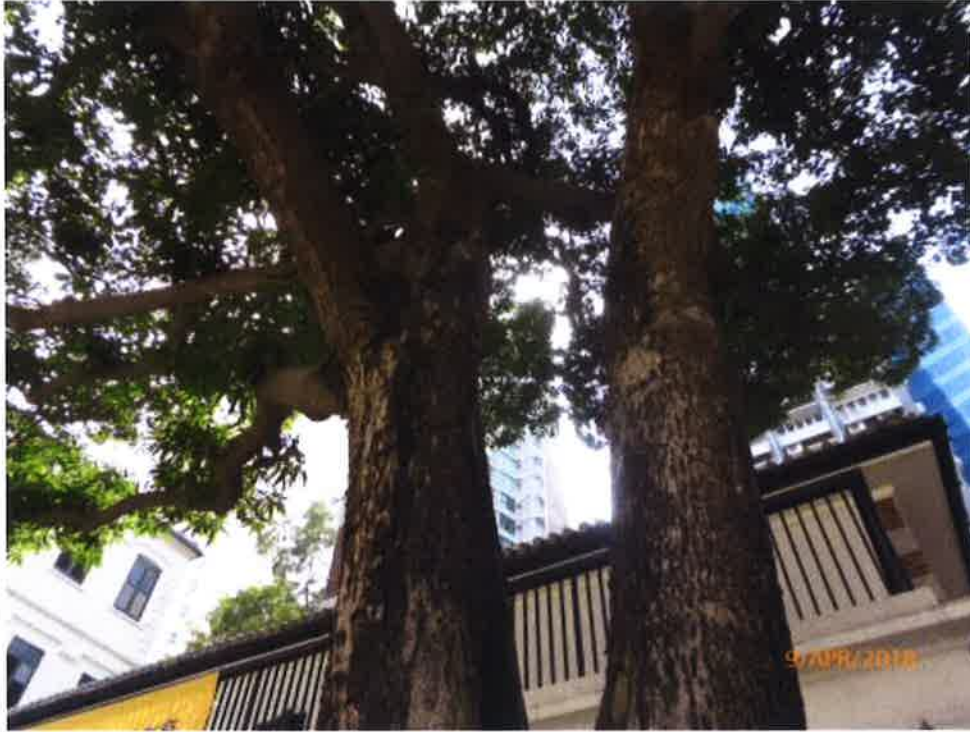
Fig. 6 Health condition of the upper trunk also is fair.

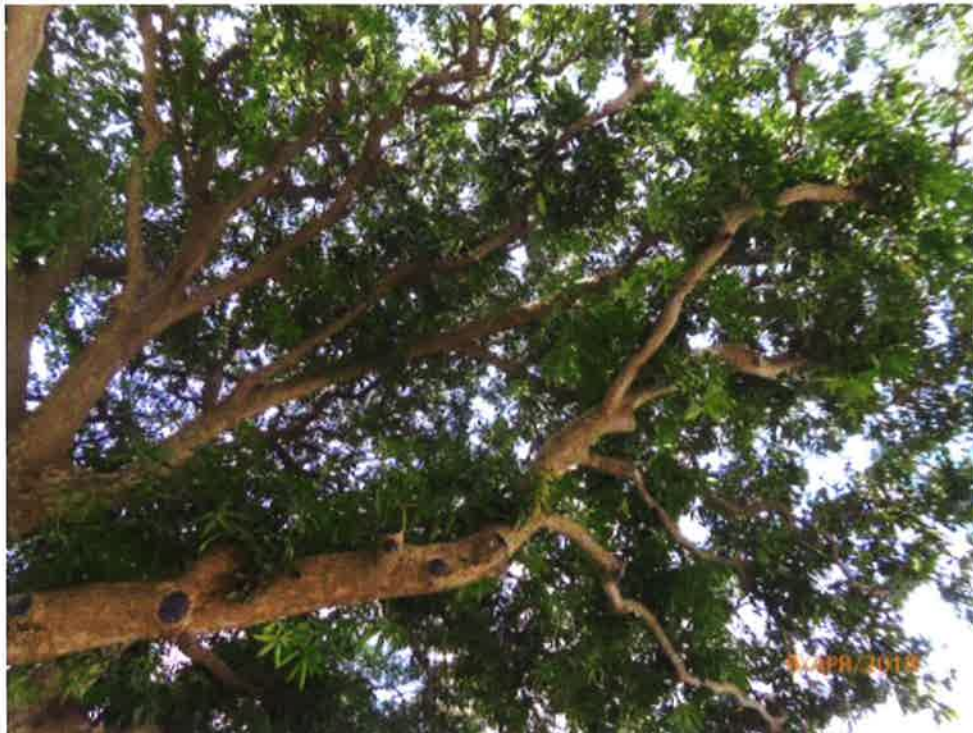
Fig. 7 The crown is full of vigorous and green leaves.

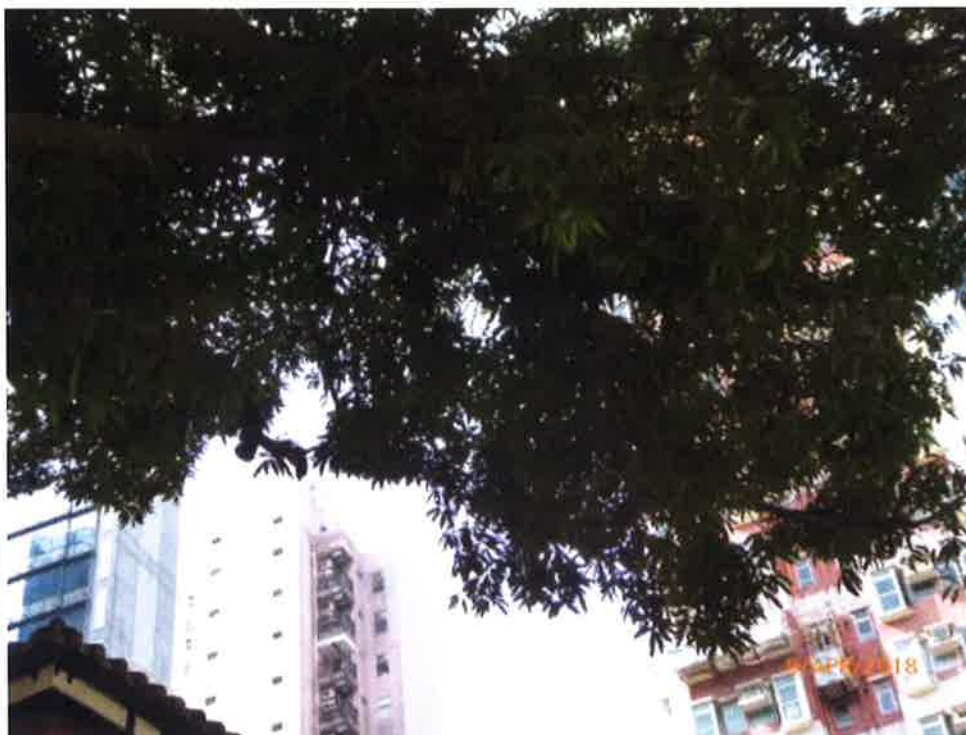
Fig. 8 Vigorous and green leaves also are growing on the lower branches.

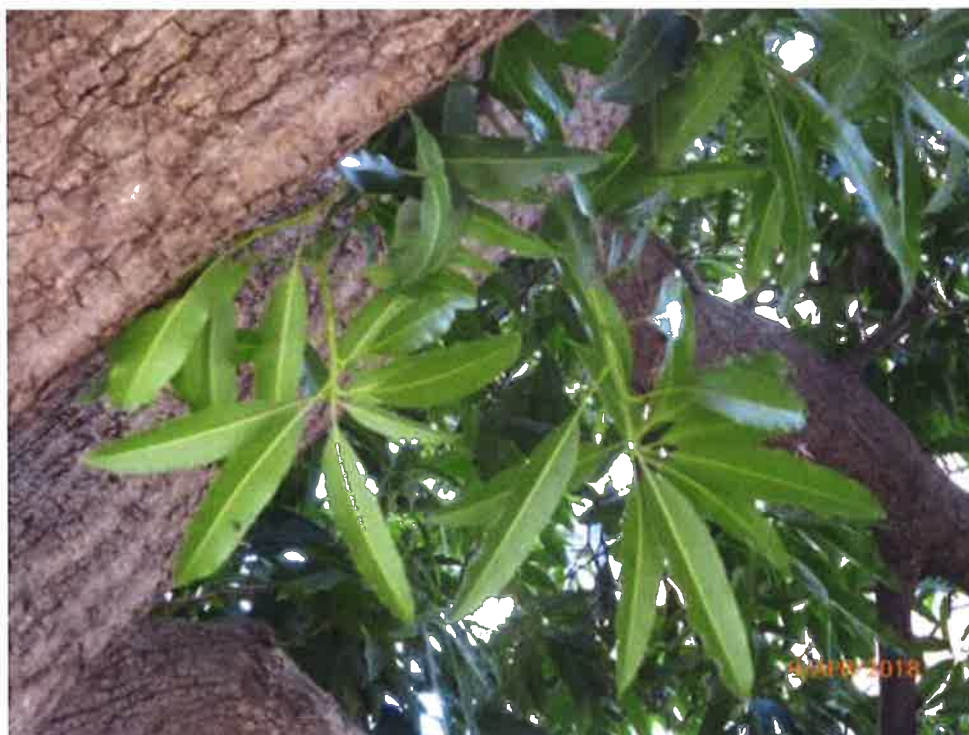
Fig. 9 Some young and green leaves appear on the mid trunk.

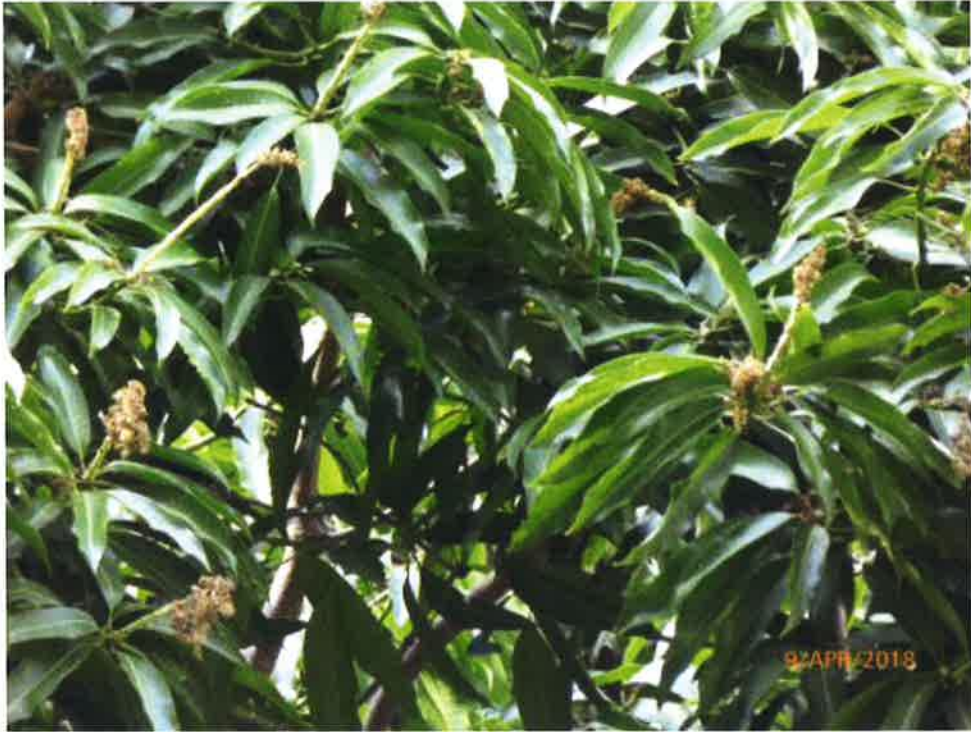
Fig. 10 Flowers still remain on the tree.

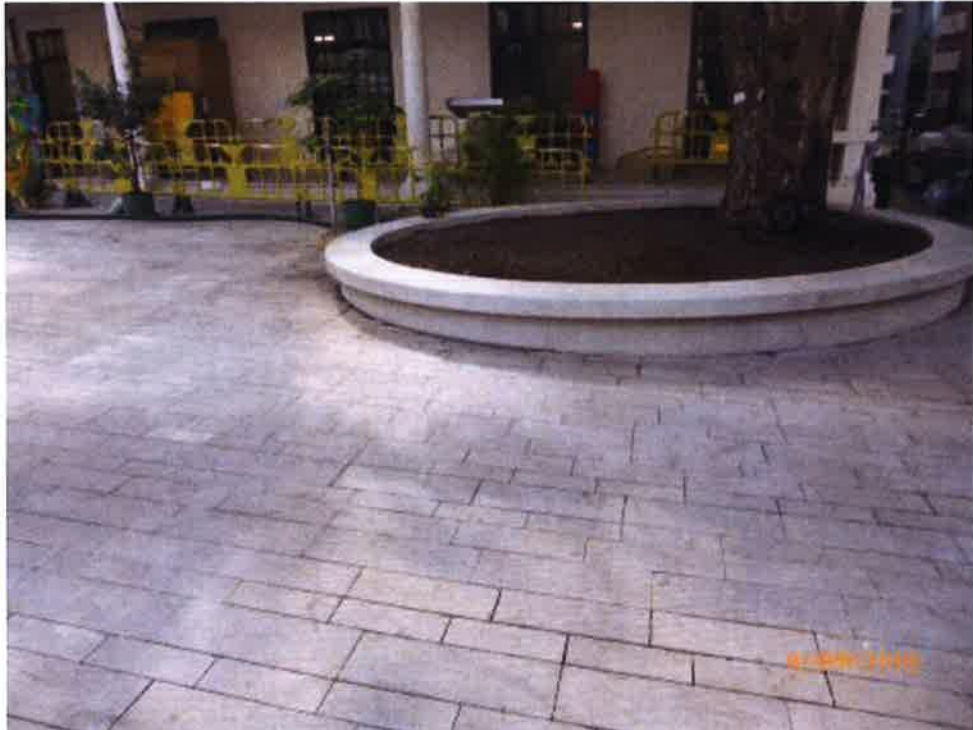
Fig. 11 The site near Tree-5 is clean and tidy.

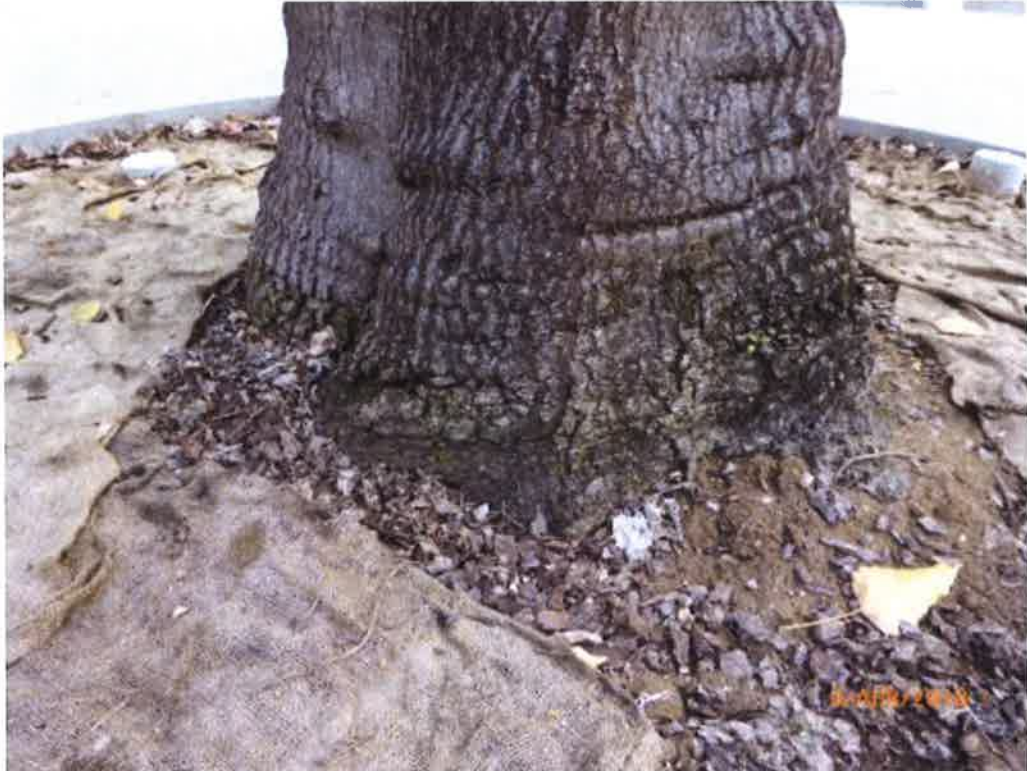
Fig. 2 Root collar is normal.

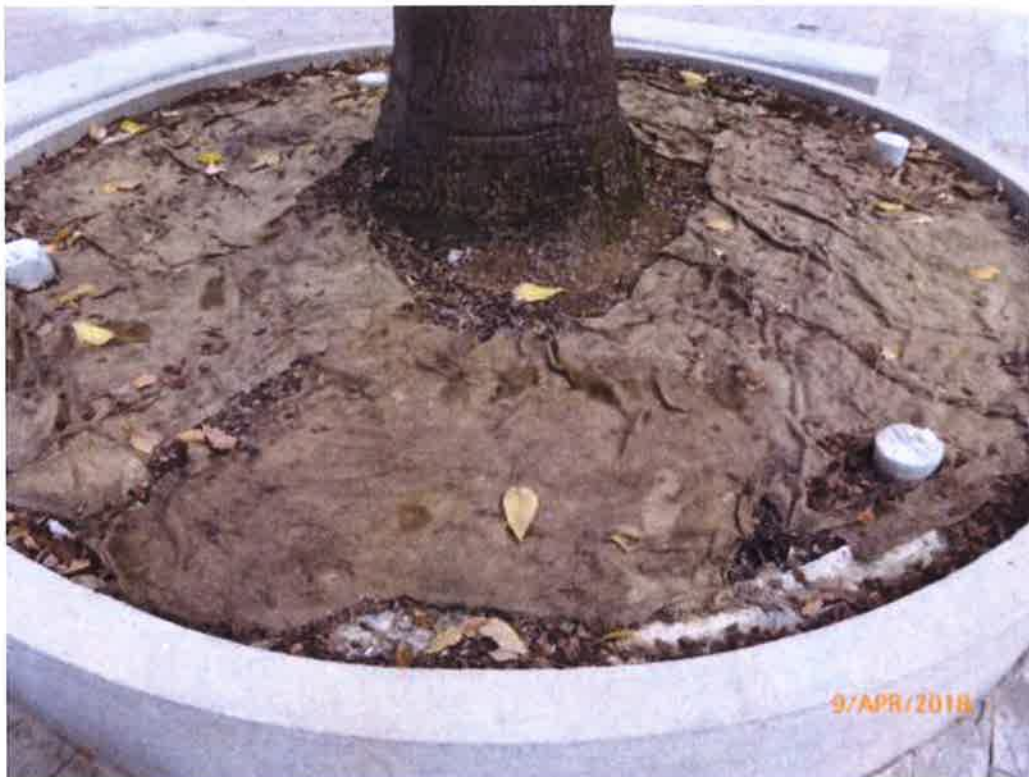
Fig. 3 The planter is covered with wet hessian clothes.

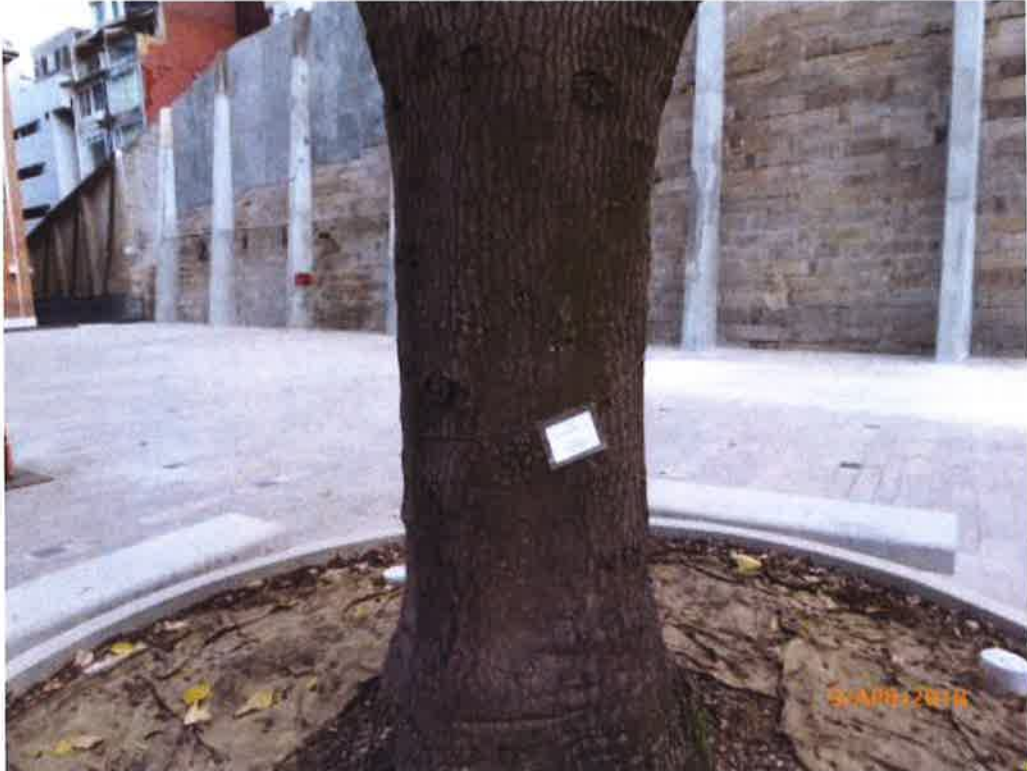
Fig. 4 Health condition of the lower trunk is fair.

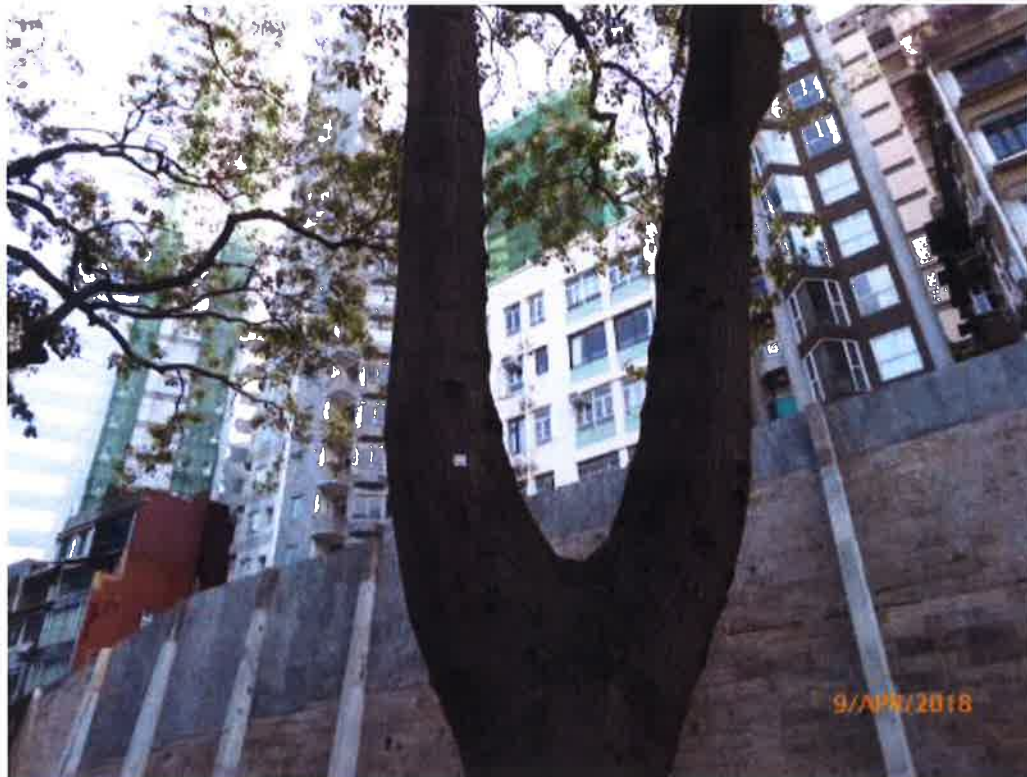
Fig. 5 Health condition of the mid trunk is fair.

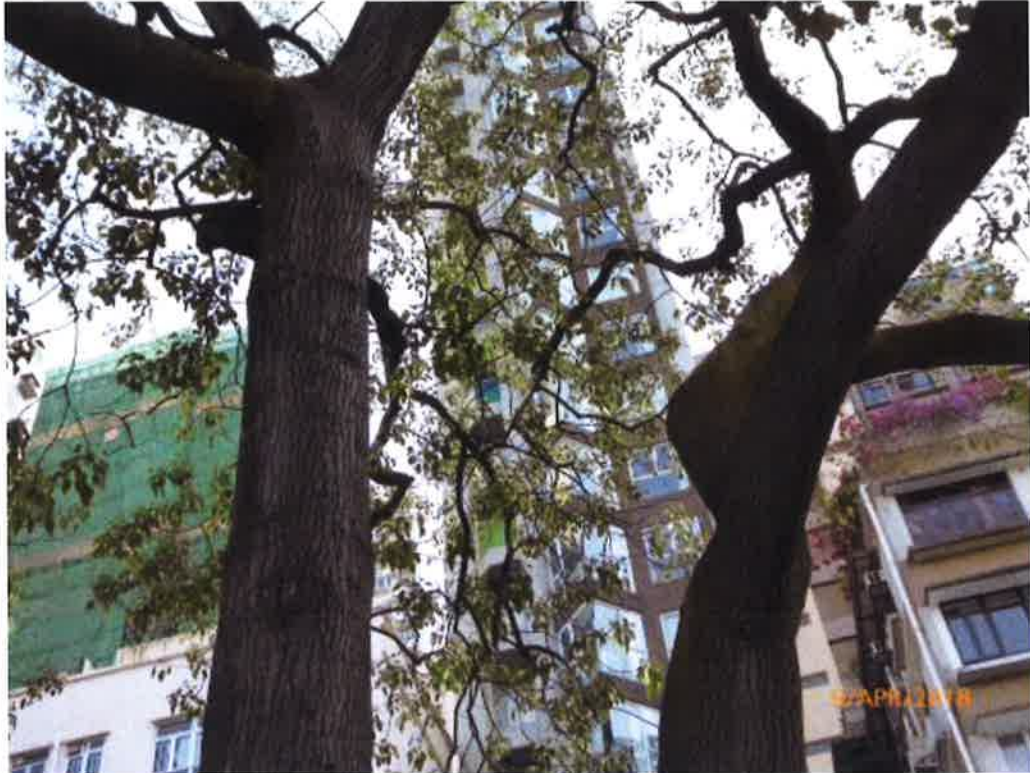
Fig. 6 Health condition of the upper trunk also is fair.

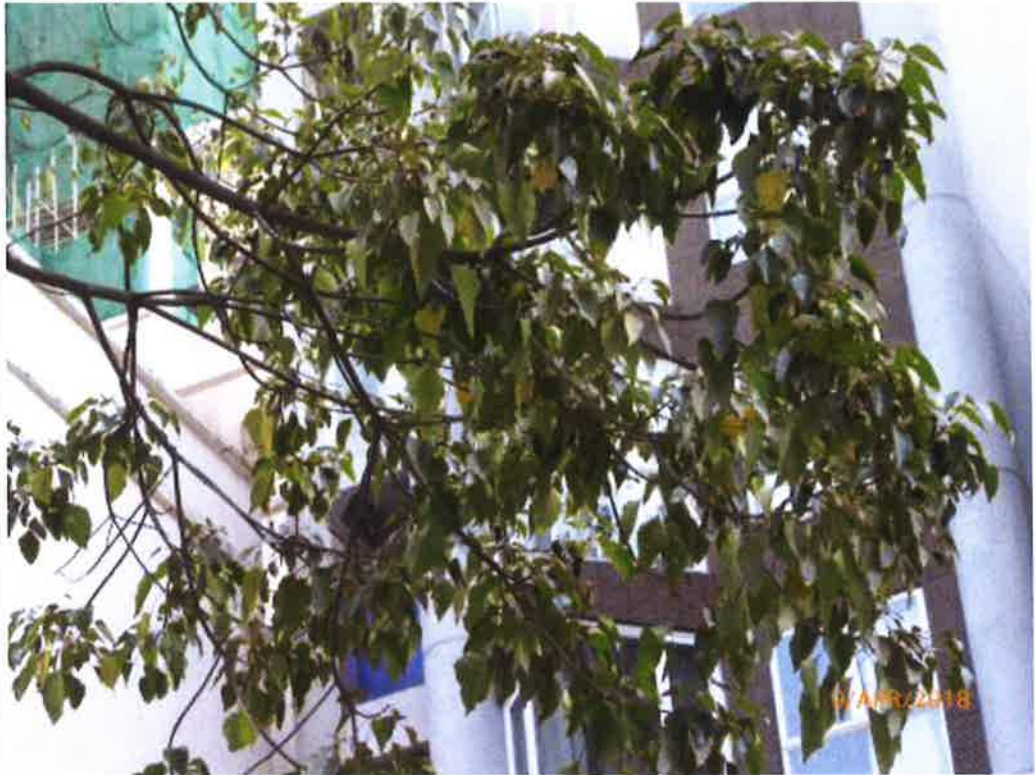
Fig. 8 Leaves on the lower branches are normal.

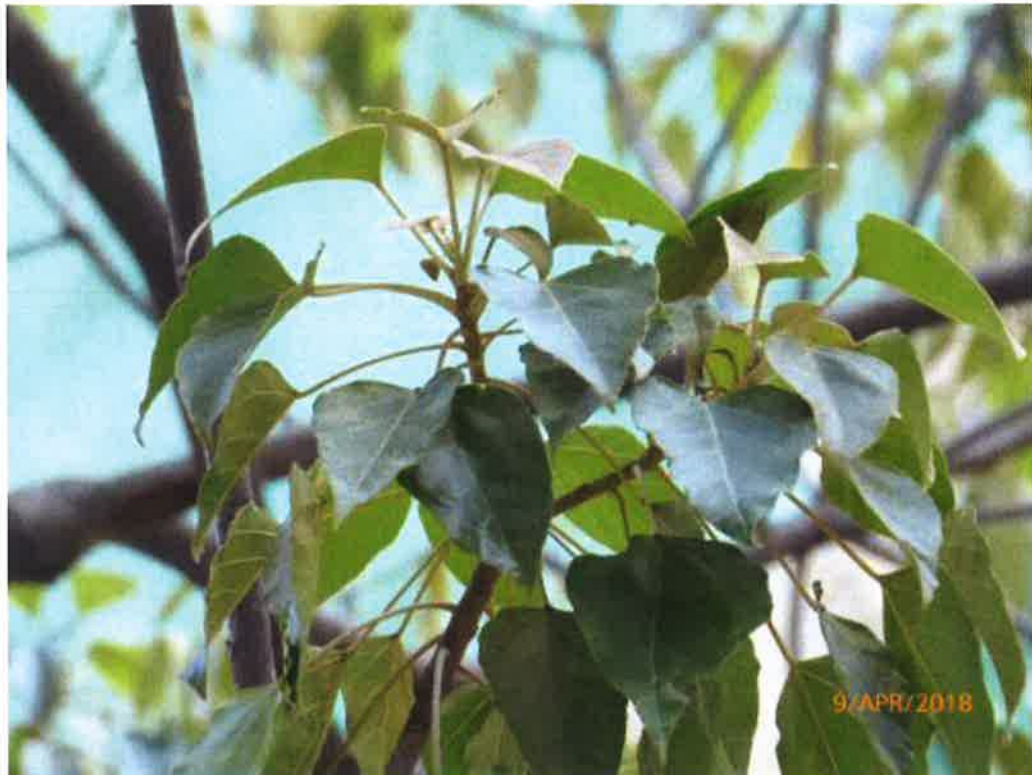
Fig. 9 Some young and green leaves appear on the tree.

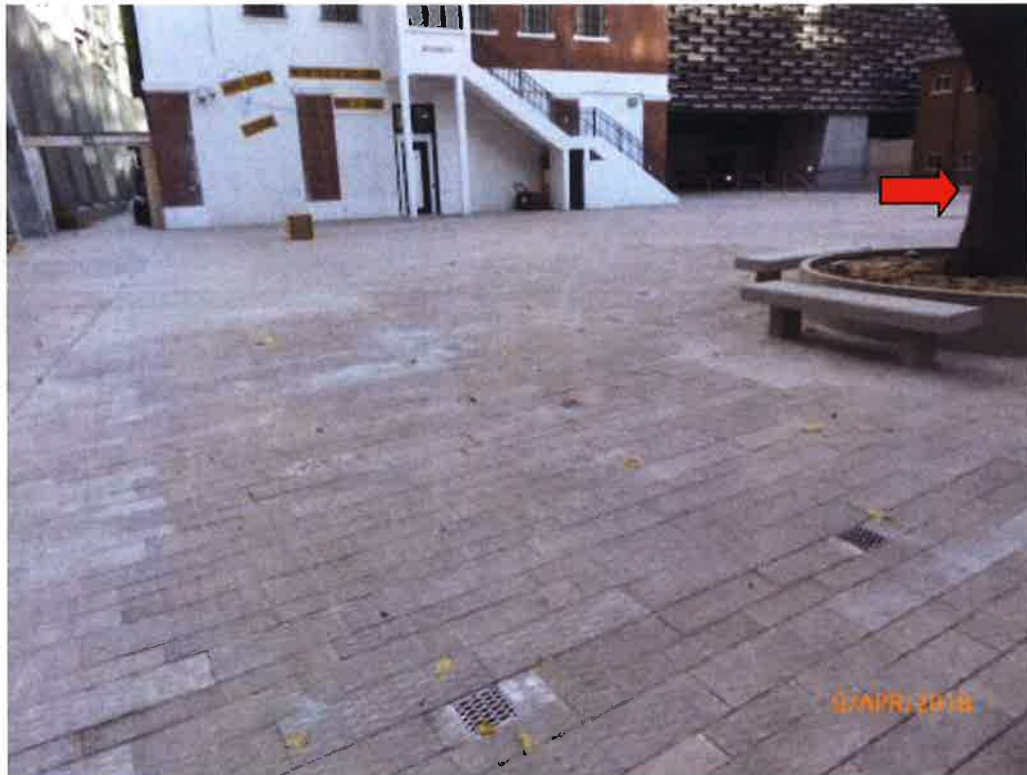
Fig. 11 The site near Tree-6 is clean and tidy.

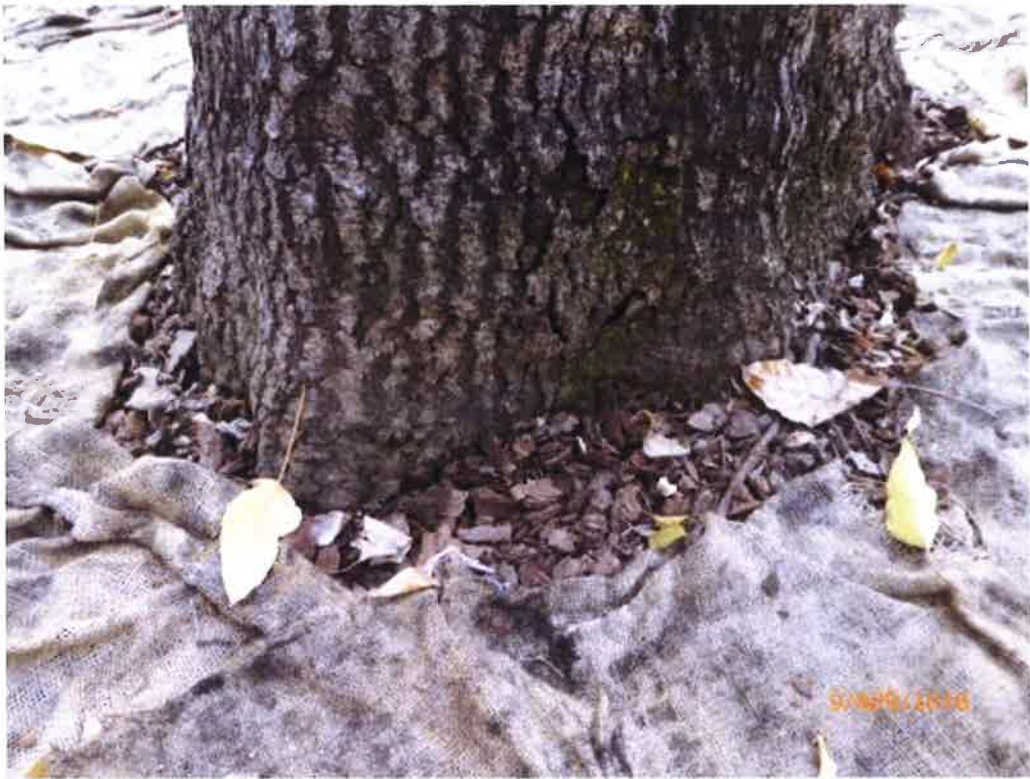
Fig. 2 Root collar is normal.

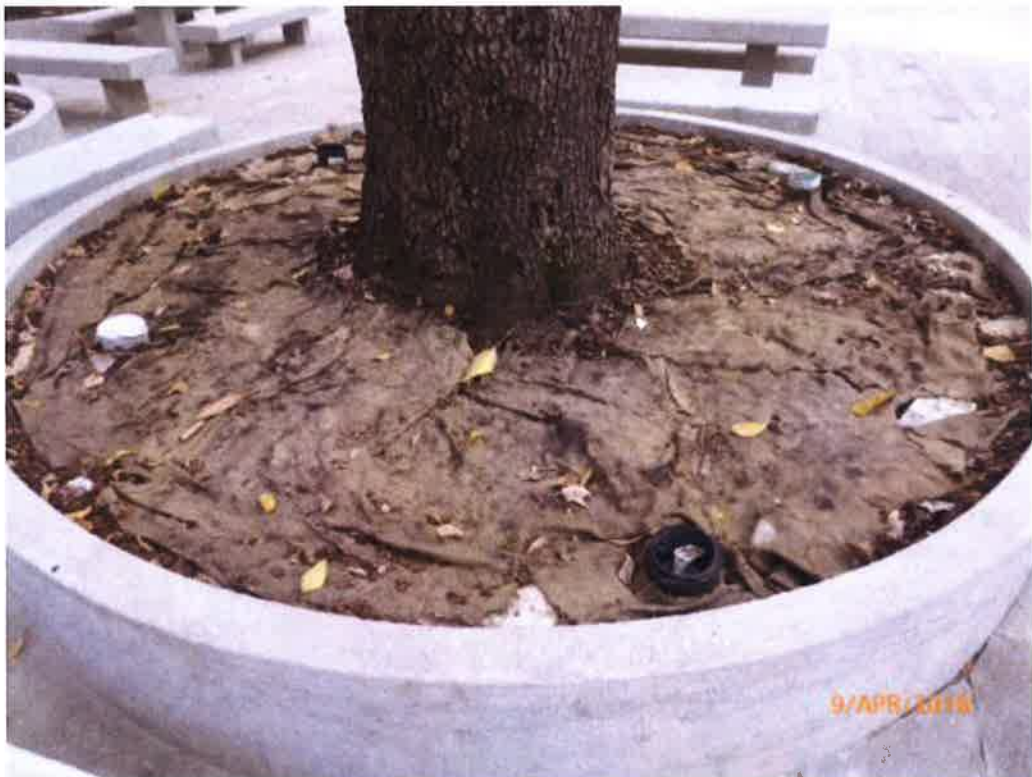
Fig. 3 The planter is covered with wet hessian clothes.

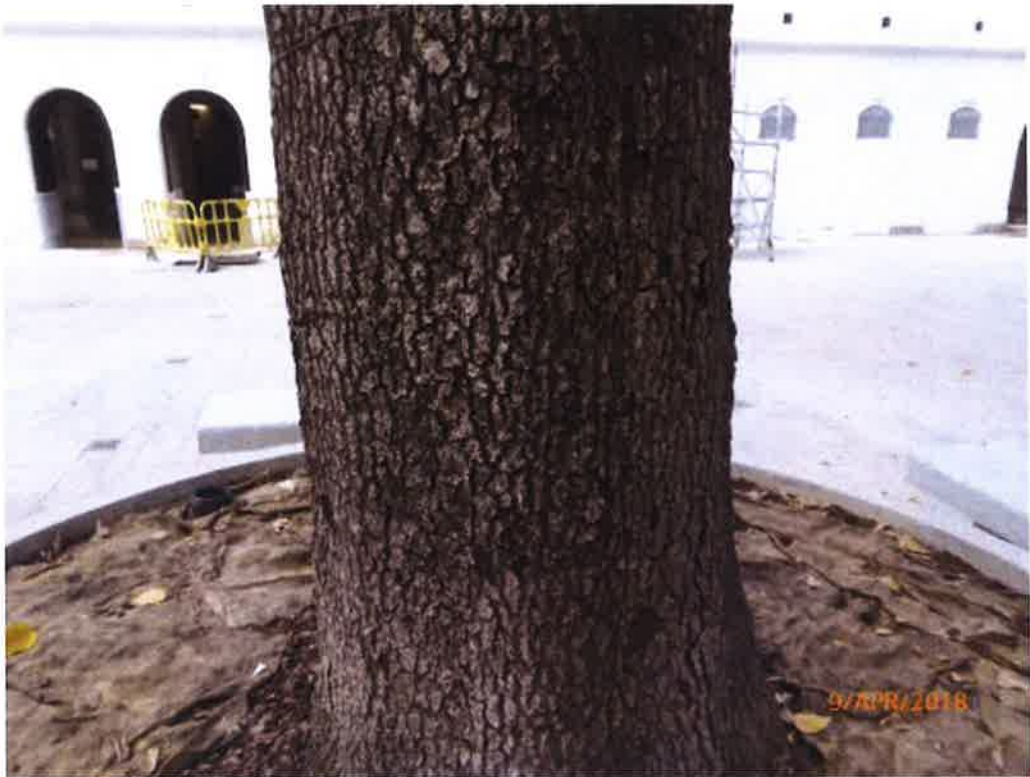
Fig. 4 Health condition of the lower trunk is fair.

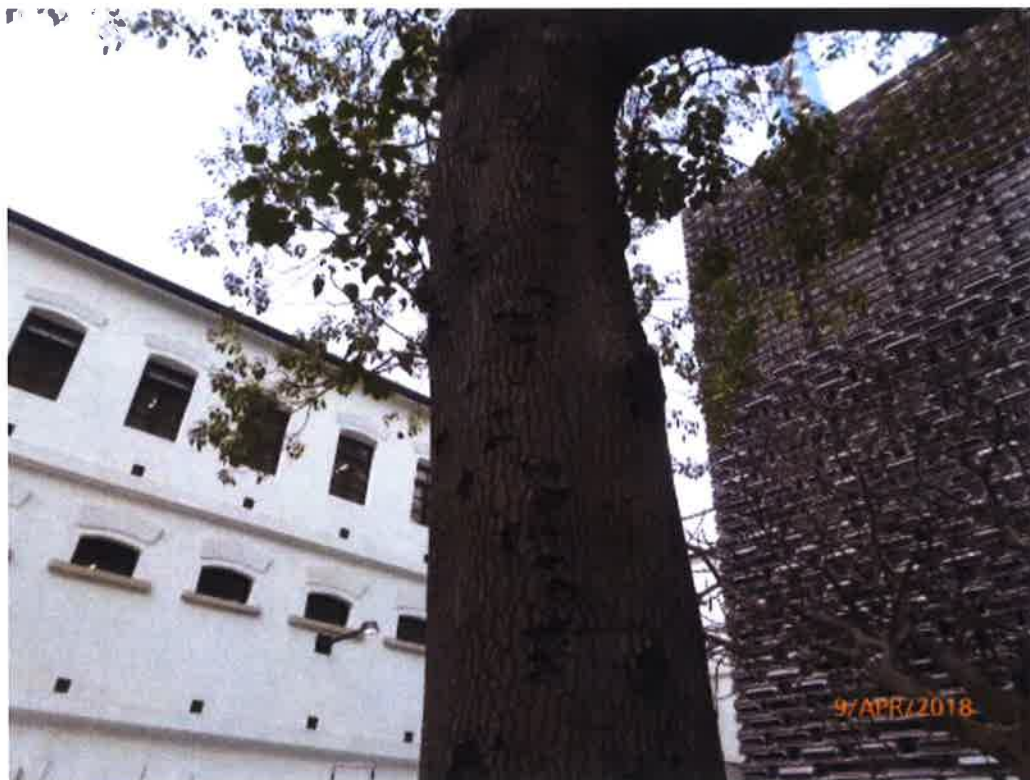
Fig. 5 Health condition of the mid trunk is fair.

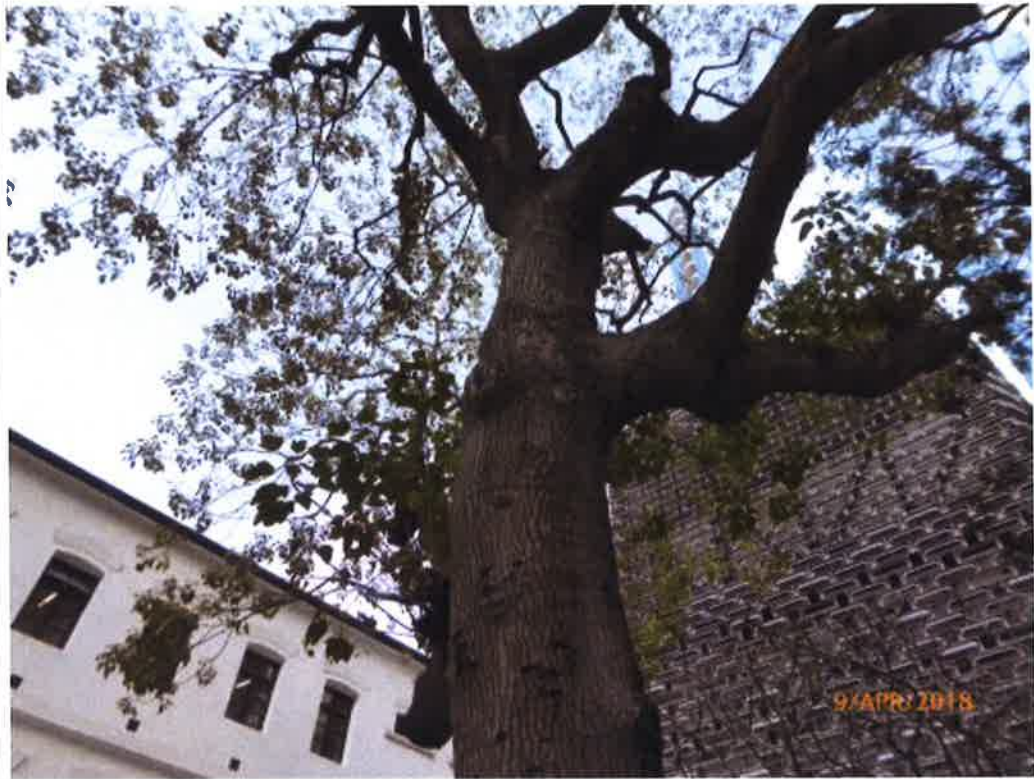
Fig. 6 Health condition of the upper trunk also is fair.

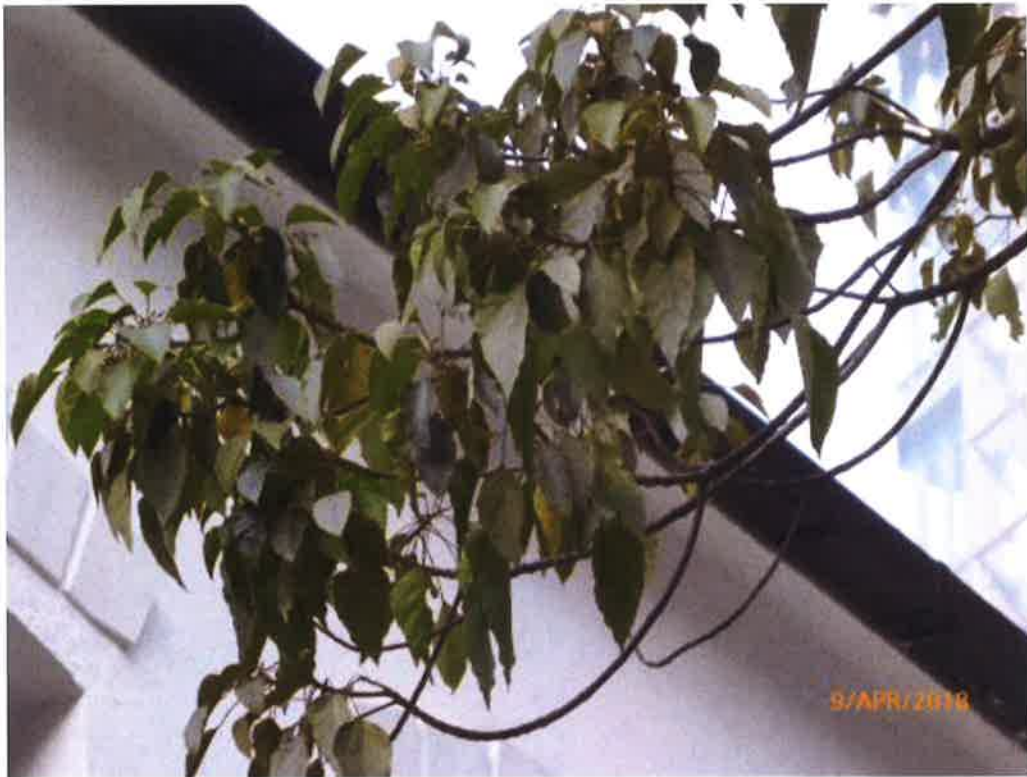
Fig. 8 Leaves on the lower branches are normal.

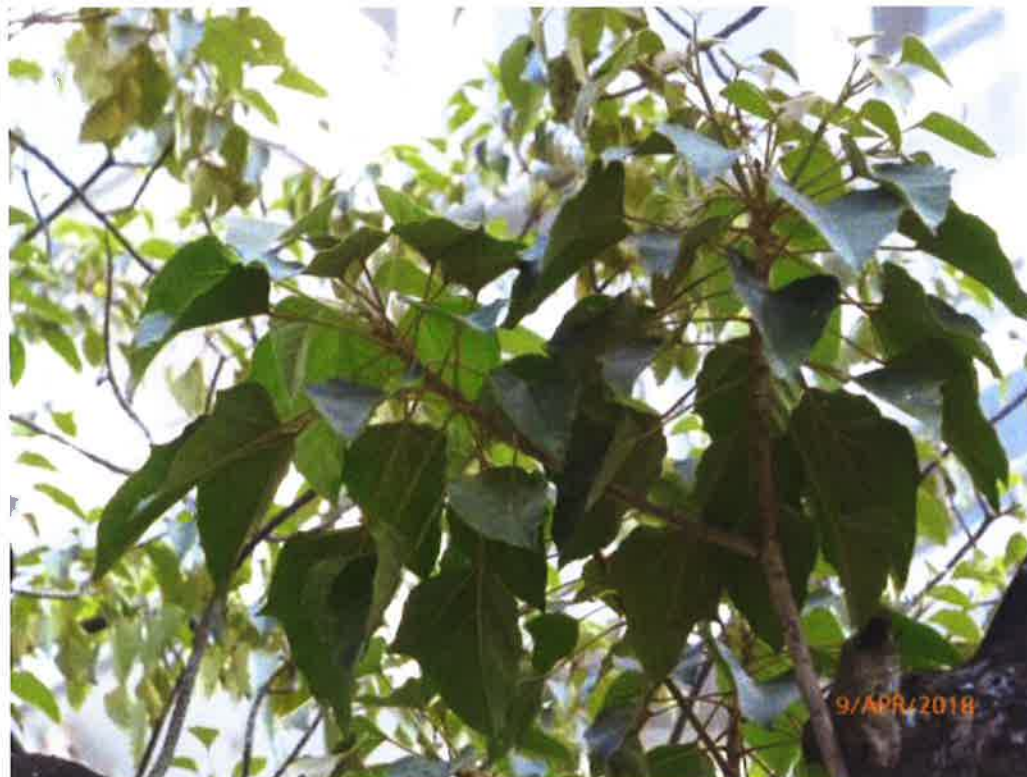
Fig. 9 Some young and green leaves appear on the tree.

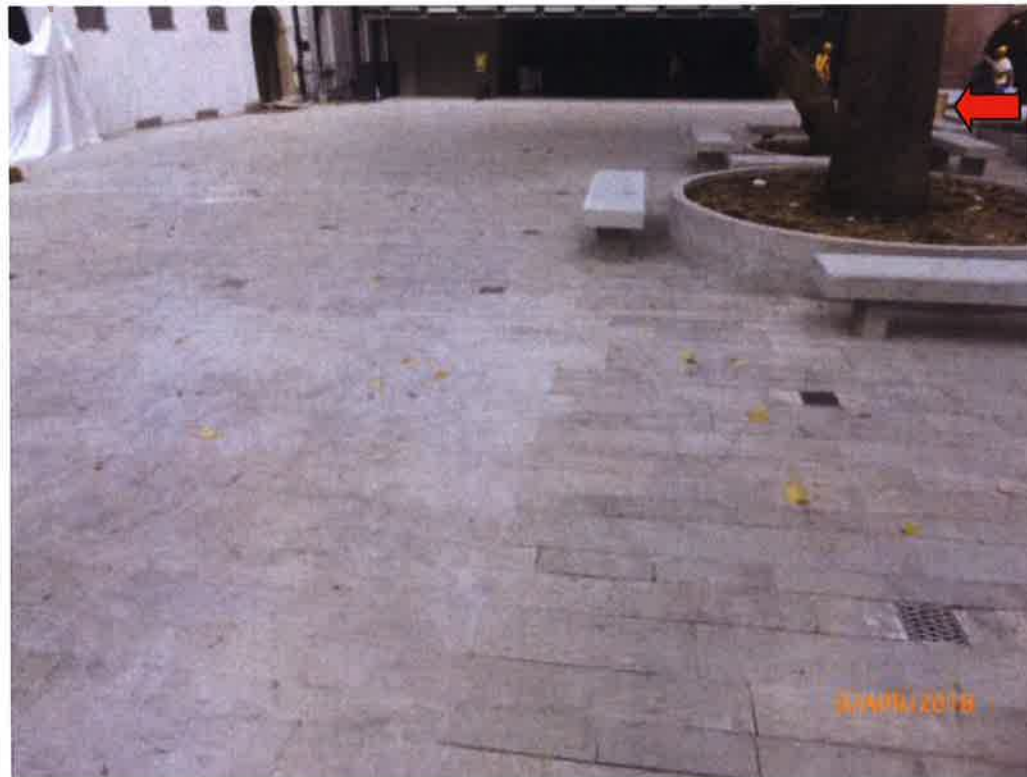
Fig. 11 The site near Tree-7 is clean and tidy.

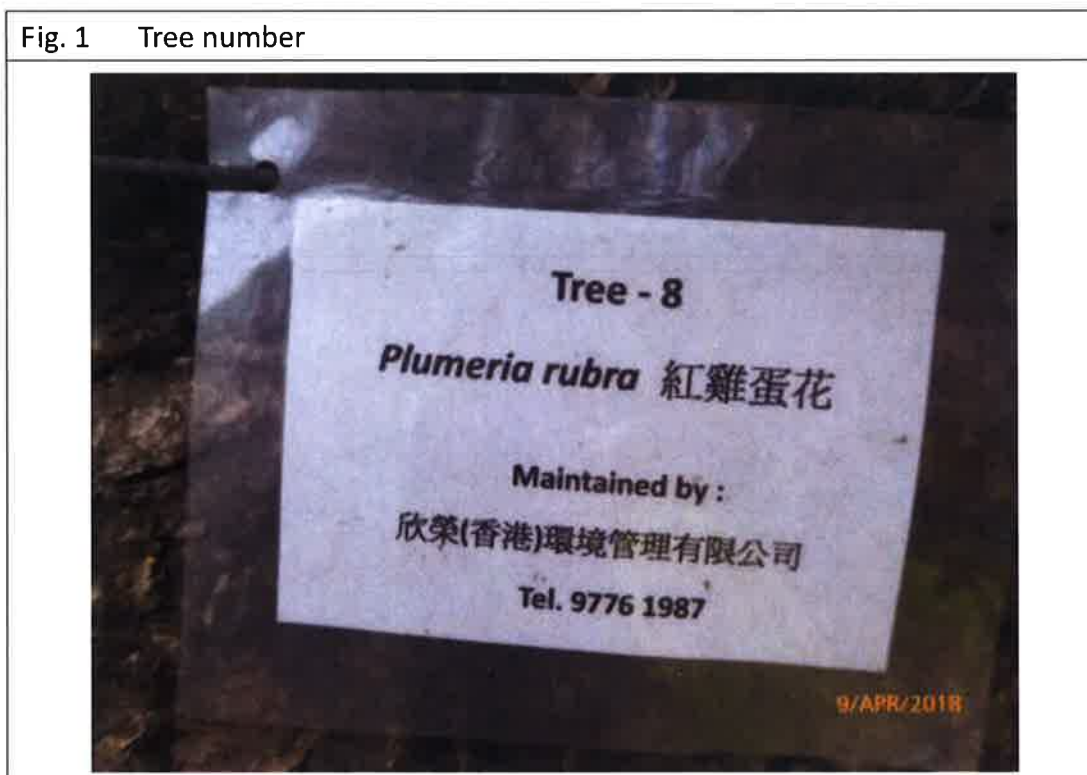
Fig. 2 Root collar is normal.

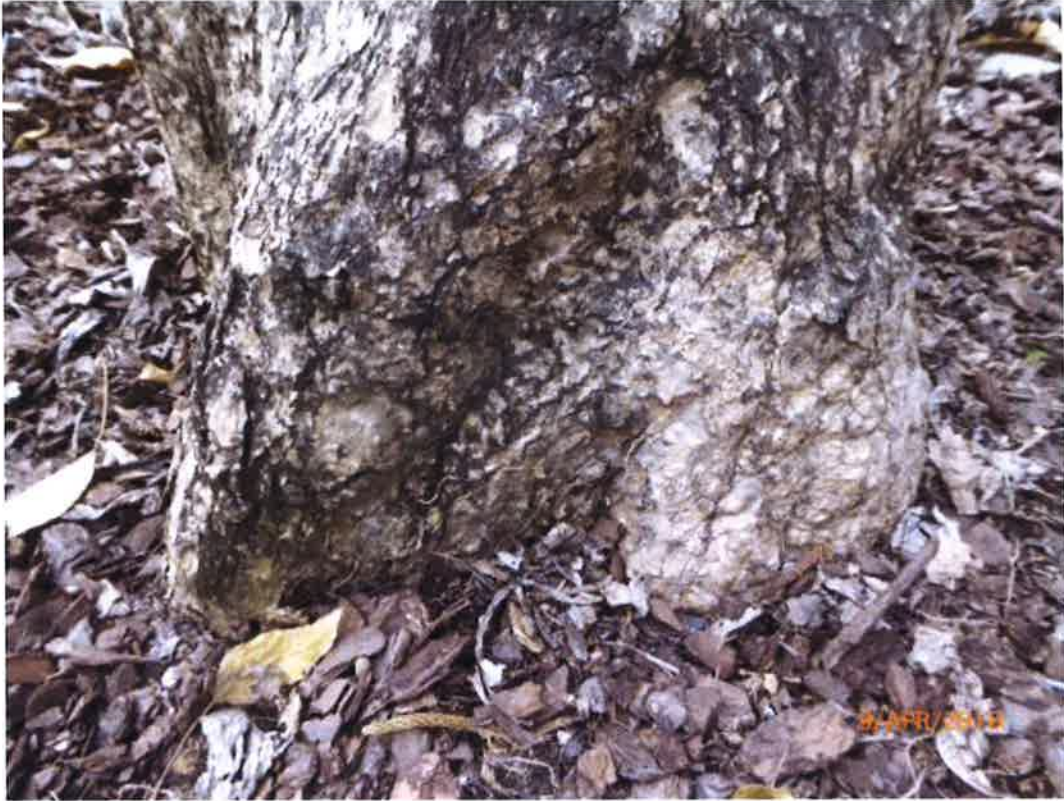
Fig. 3 The planter is covered with mulch and dry leaves.

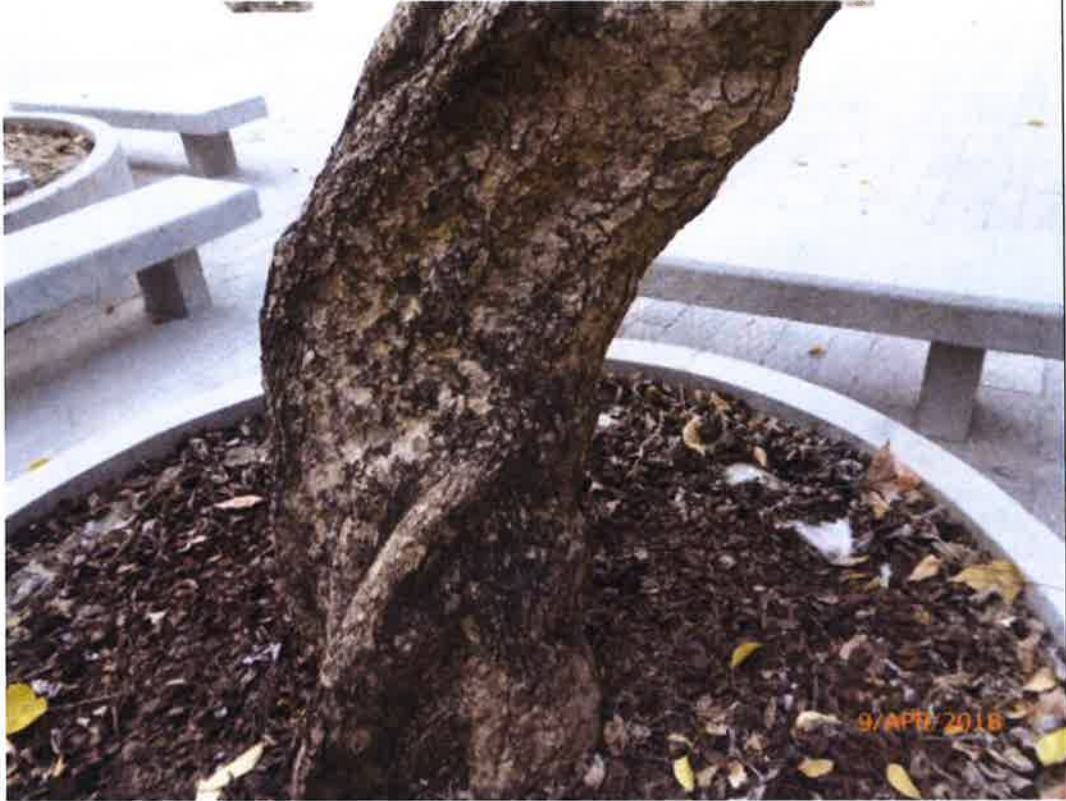
Fig. 5 Health condition of the mid trunk is fair.
