Central Police Station Conservation
and Revitalisation Project:
78th Monthly EM&A Report
(1 April to 30 April 2018)

Issue Date: May 2018

Environmental Resources Management

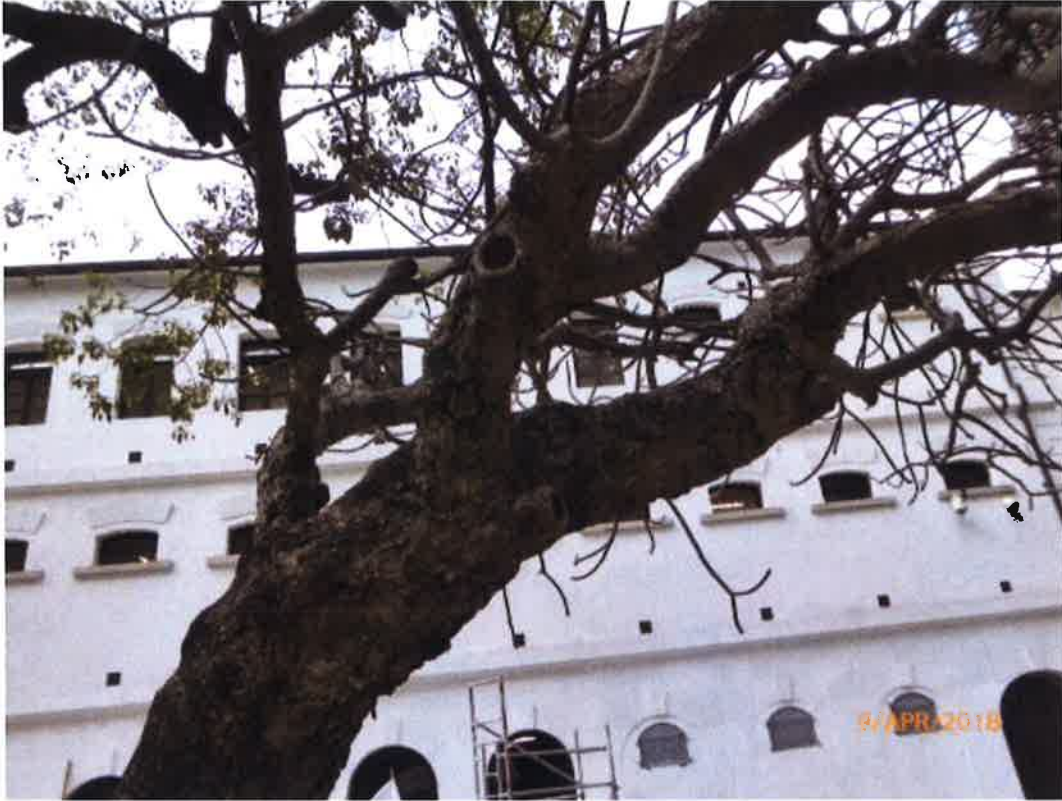
Fig. 7 As dry season has come, leaves on the crown are sparse.

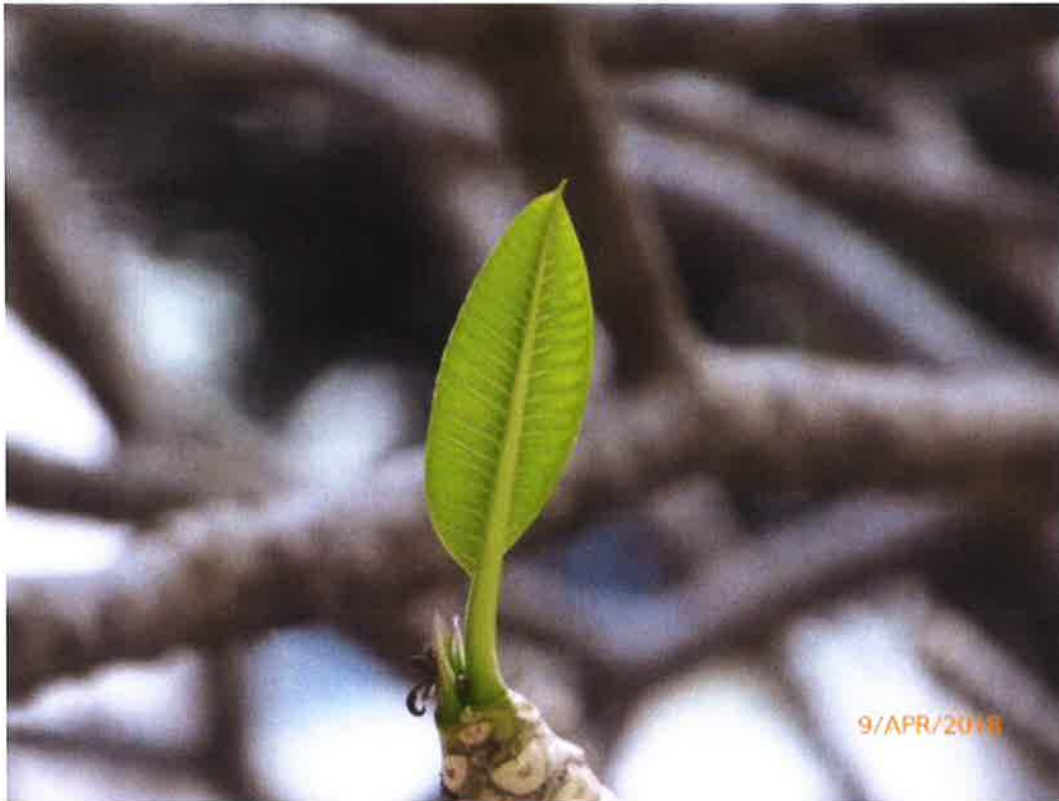
Fig. 9 Young buds also appear on the upper branches.

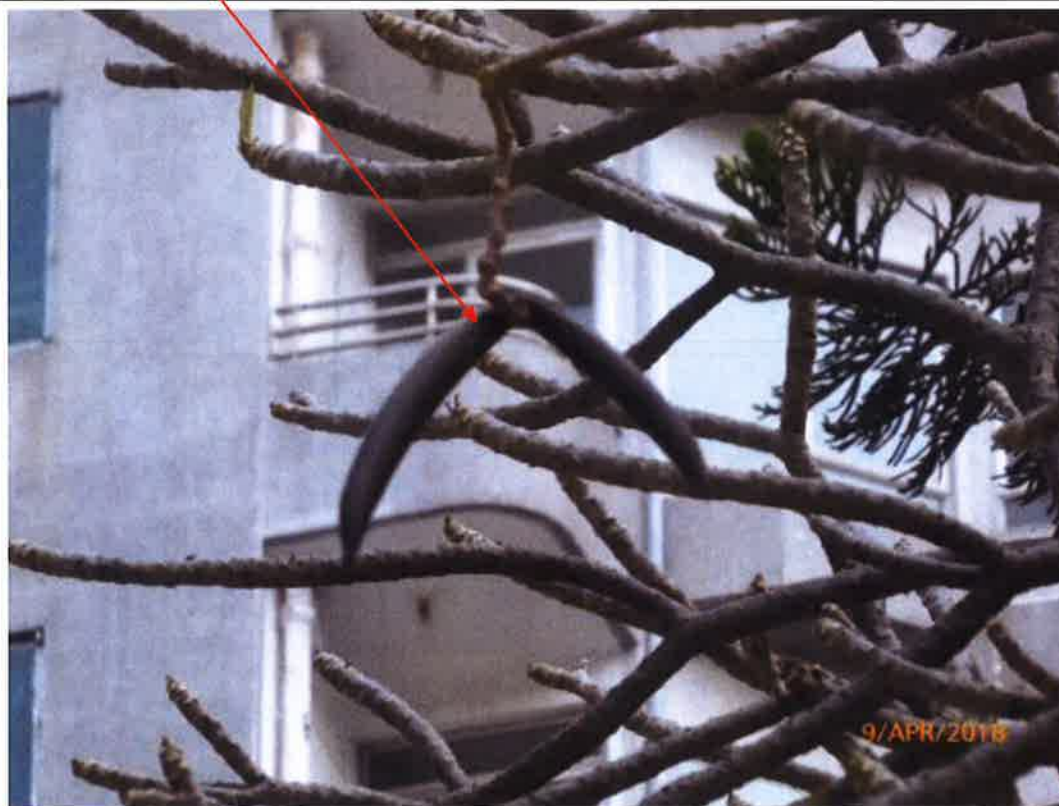
Fig. 10 A few dead branches remain on the tree.

1. Remove the dead branches away from the tree.

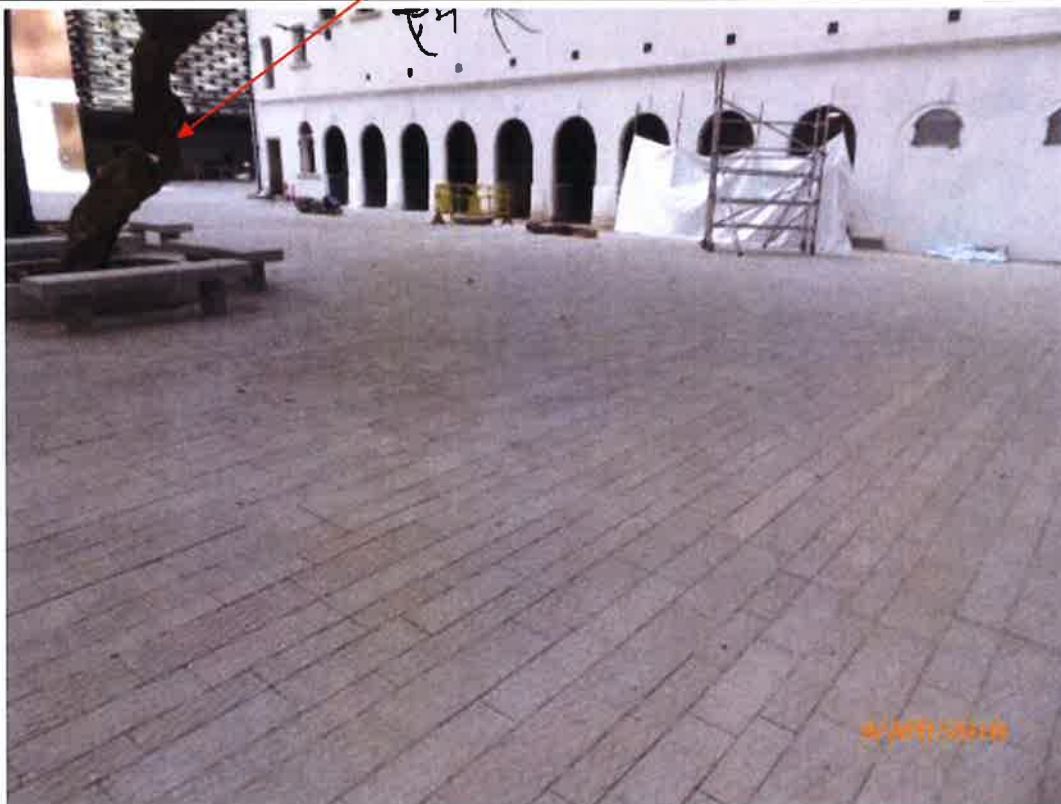
Fig. 12 Overall view of Tree-8 during inspection on 9th April 2018.

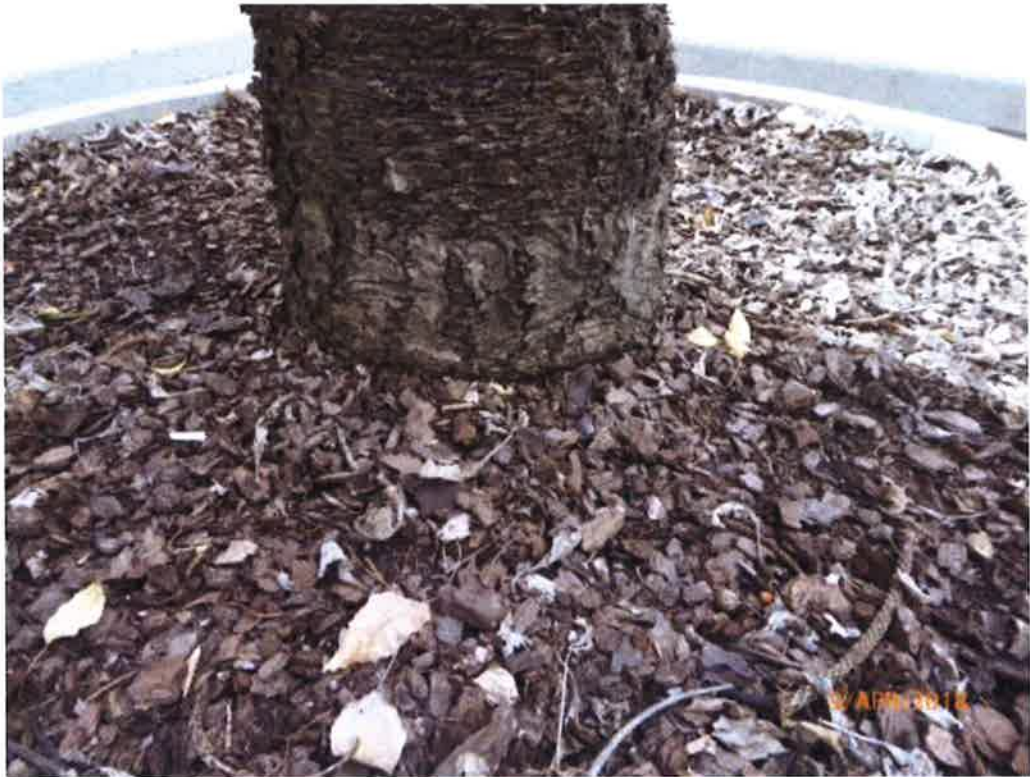
Fig. 3 The planter is covered with mulch and dry leaves.

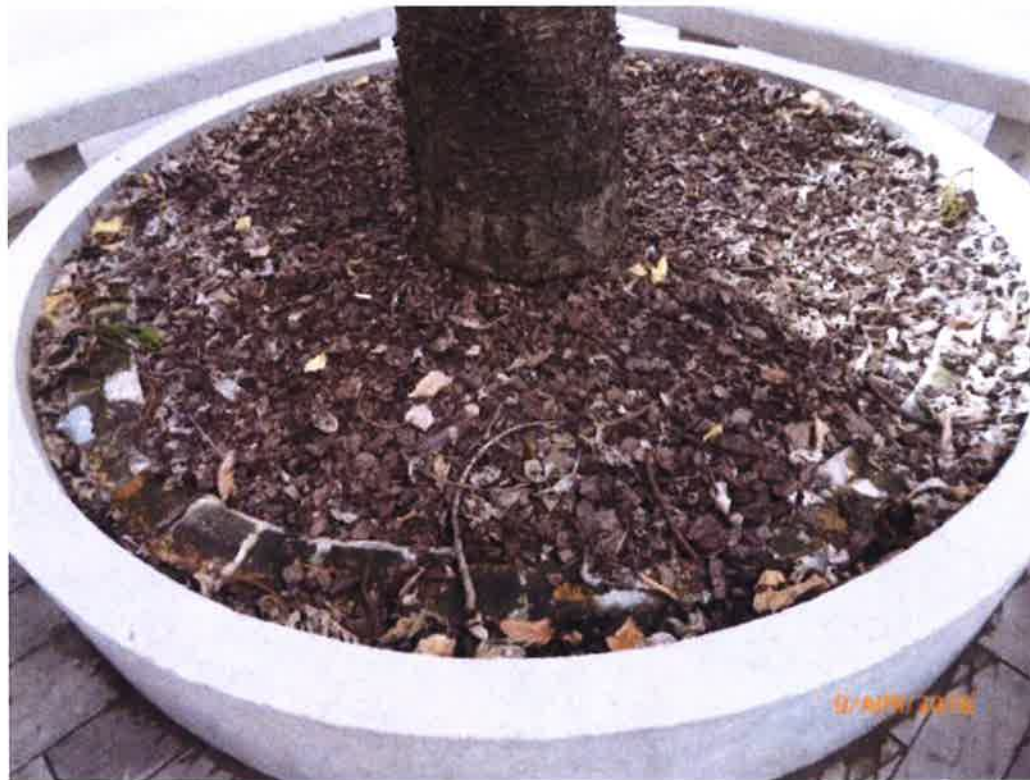
Fig. 4 Health condition of the lower trunk is fair.

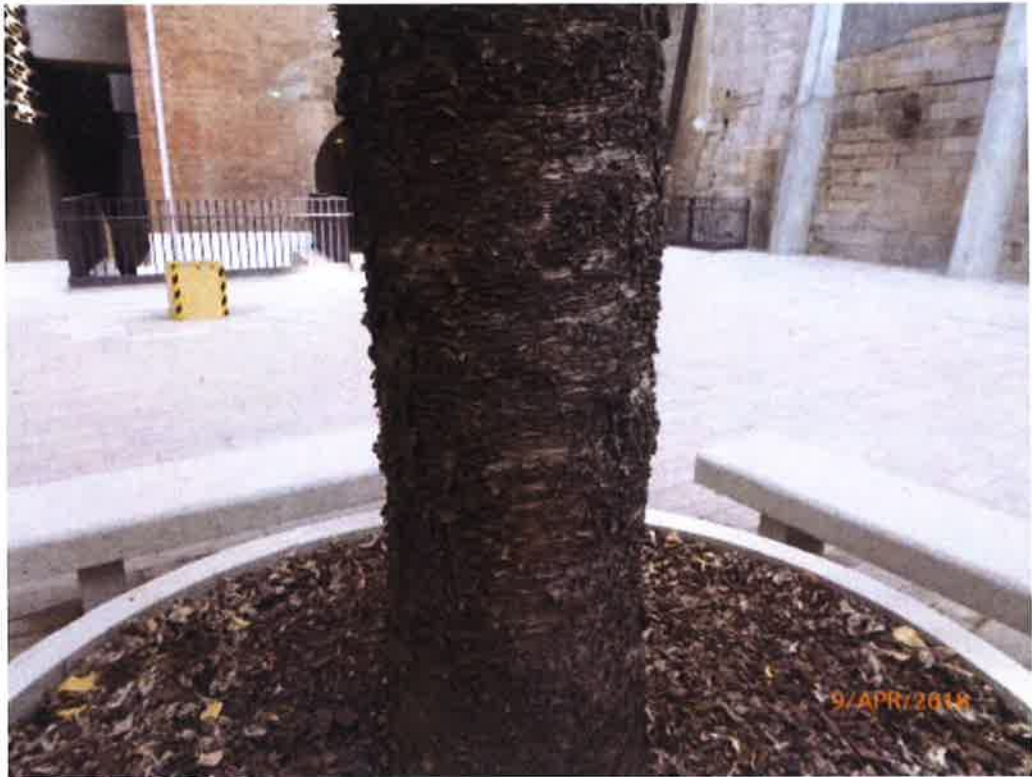
Fig. 5 Health condition of the mid trunk is fair.

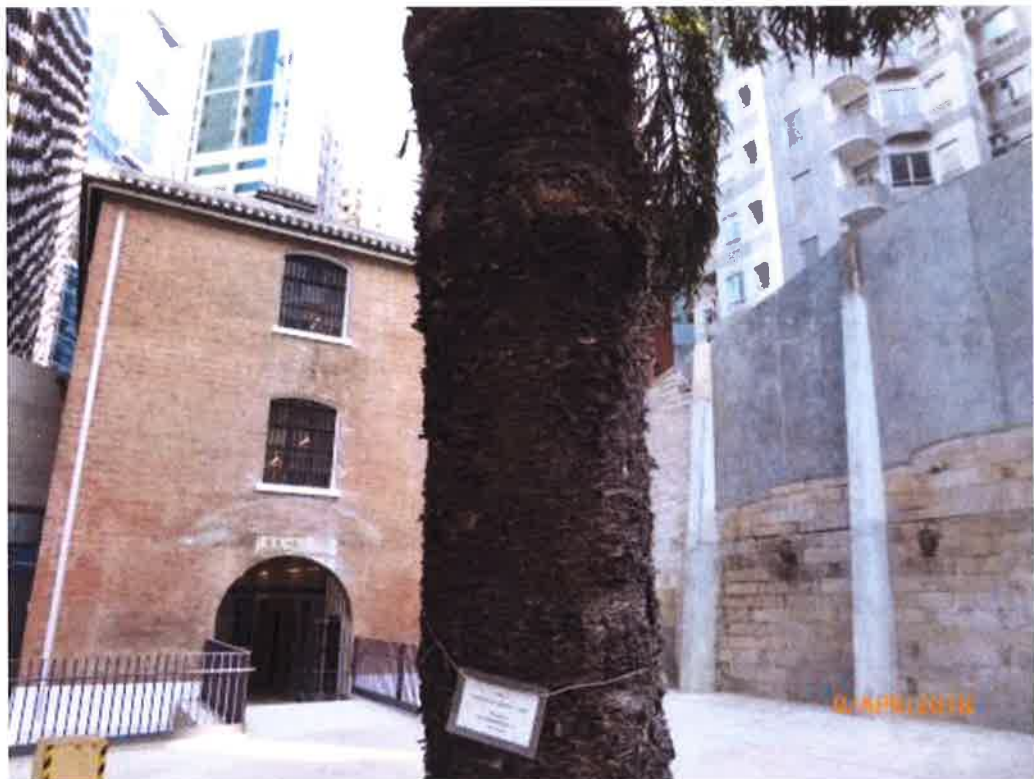
Fig. 6 Health condition of the upper trunk also is fair.

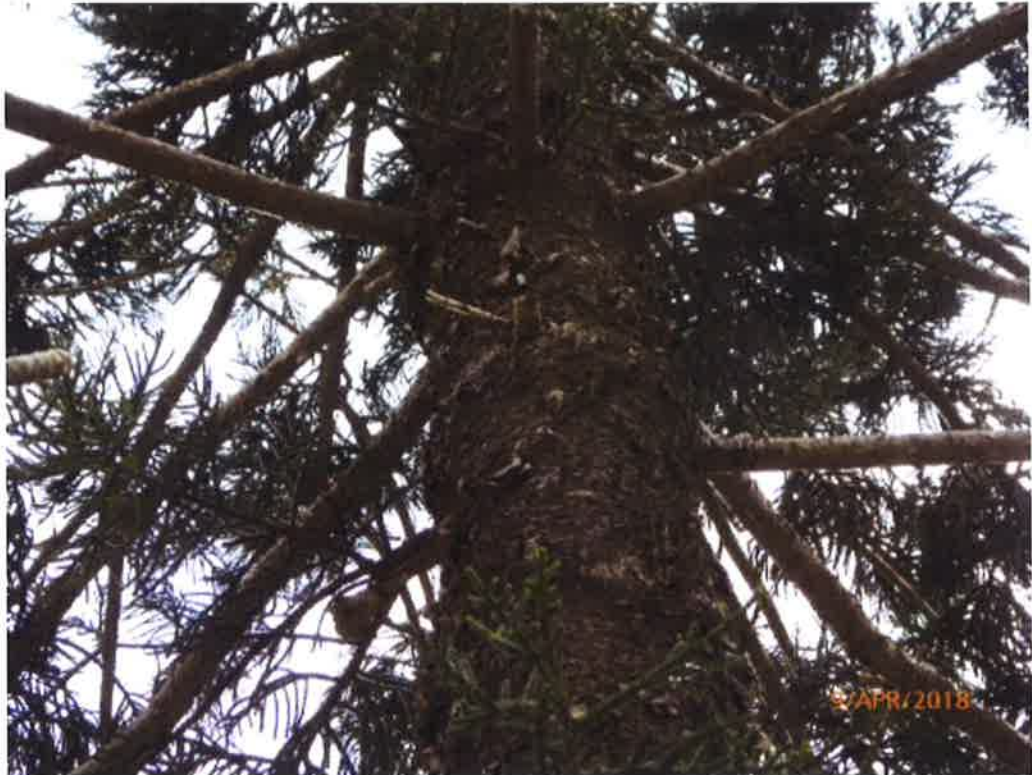
Fig. 7 The crown is full of vigorous and green leaves.

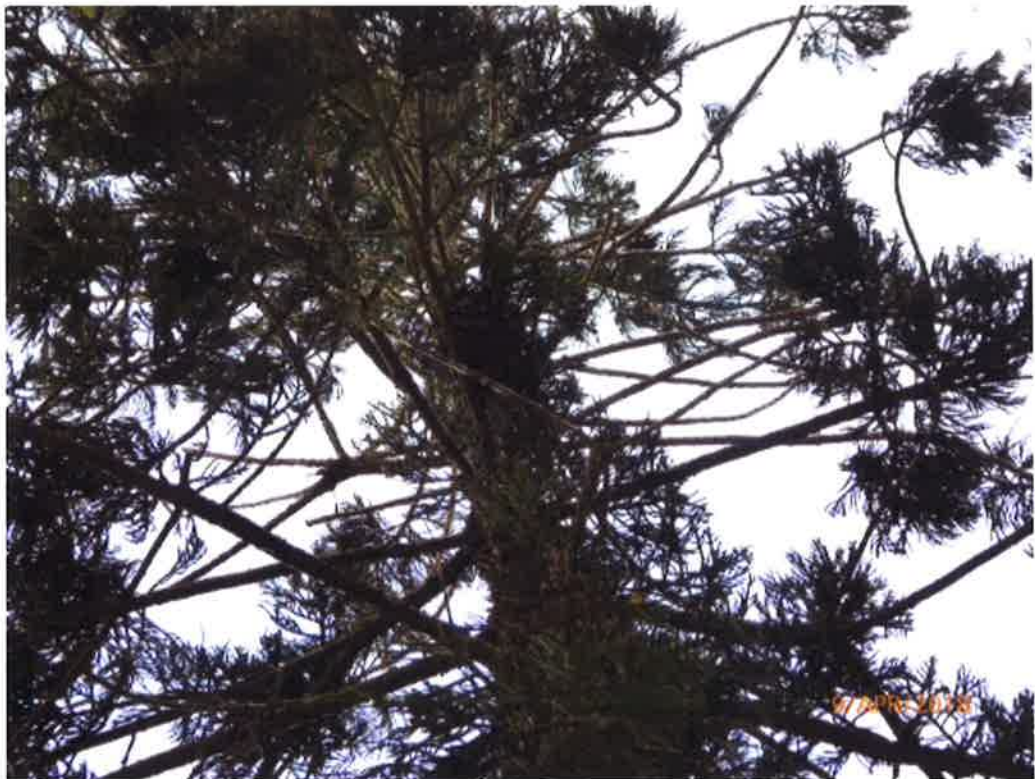
Fig. 8 Vigorous and green leaves also are growing on the lower branches.

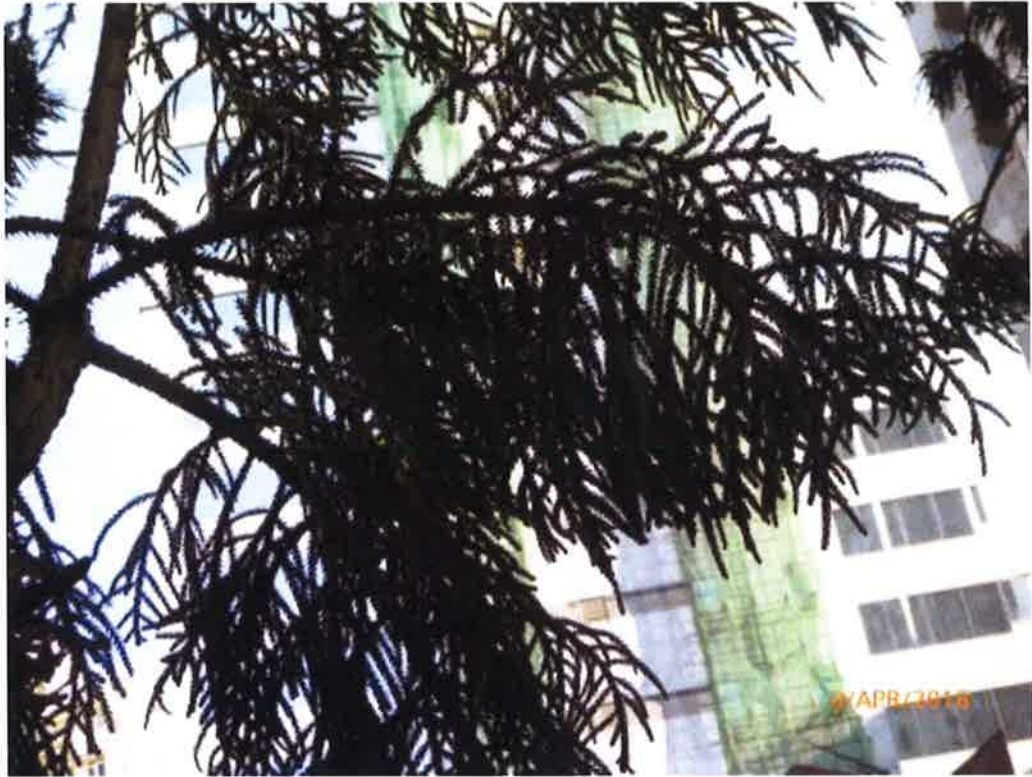
Fig. 9 Some young and green leaves appear on the mid trunk.

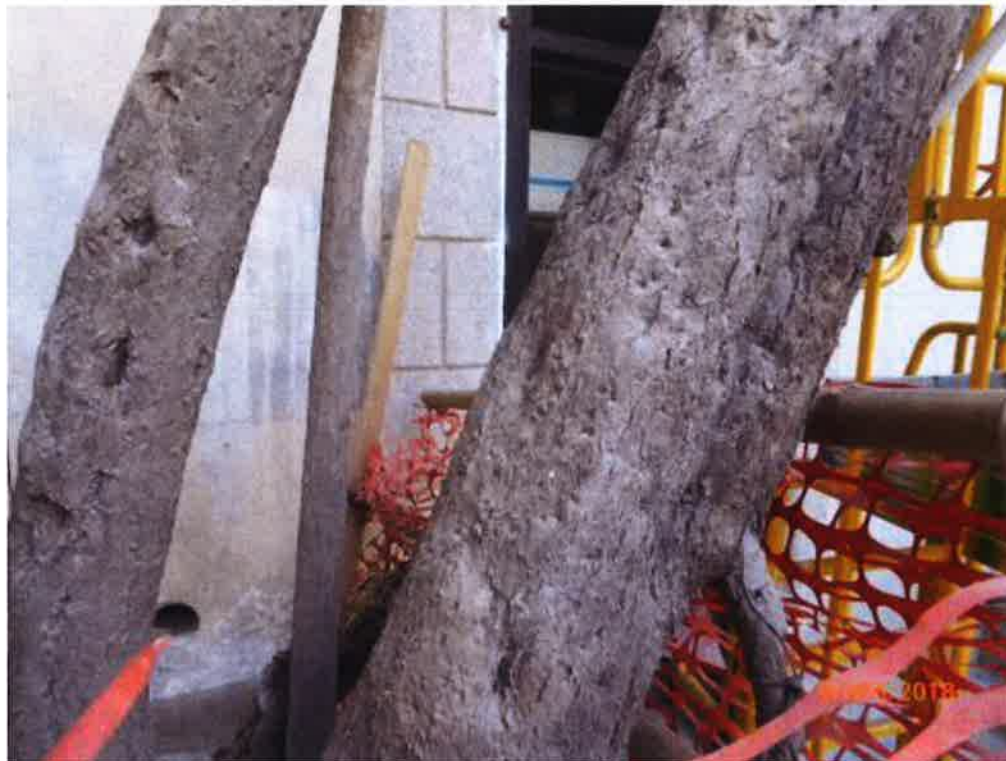
Fig. 4 Health condition of the mid trunk is fair.

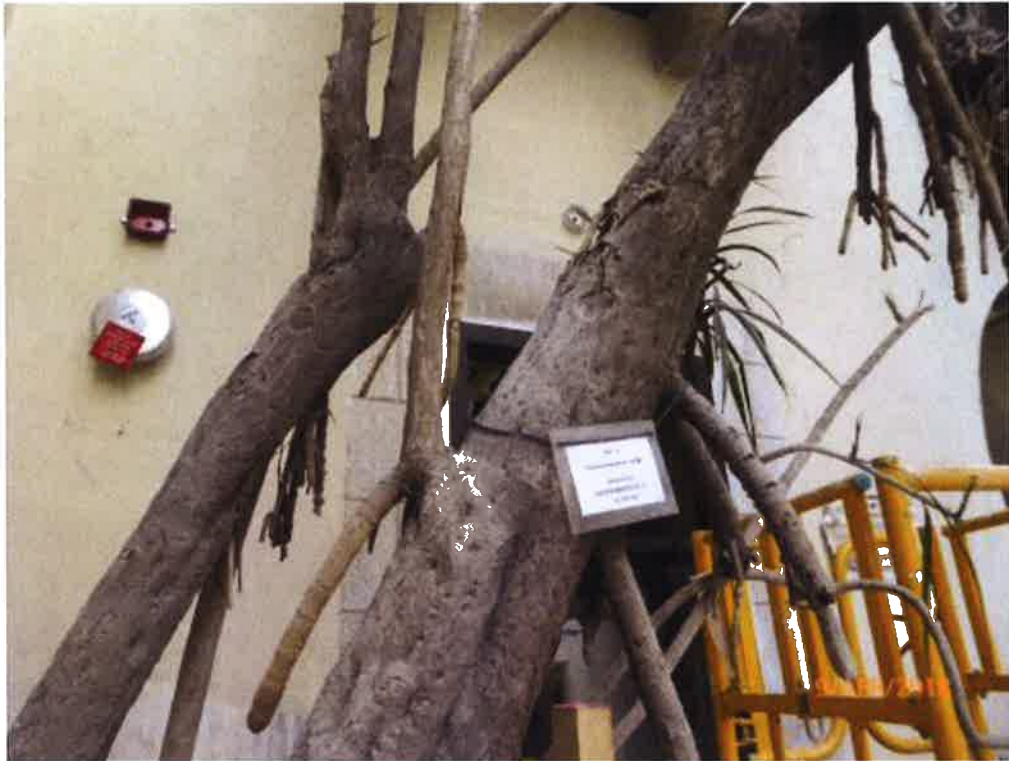
Fig. 5 Health condition of the upper trunk also is fair.

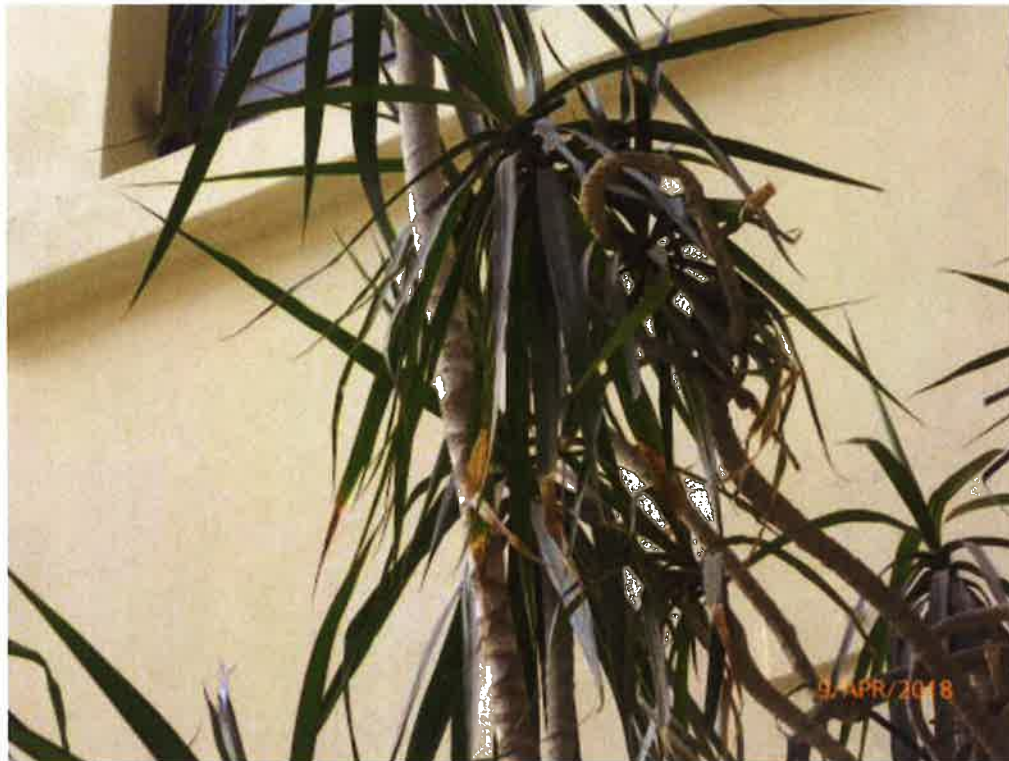
Fig. 7 Some withered leaves also appear on the lower branches.

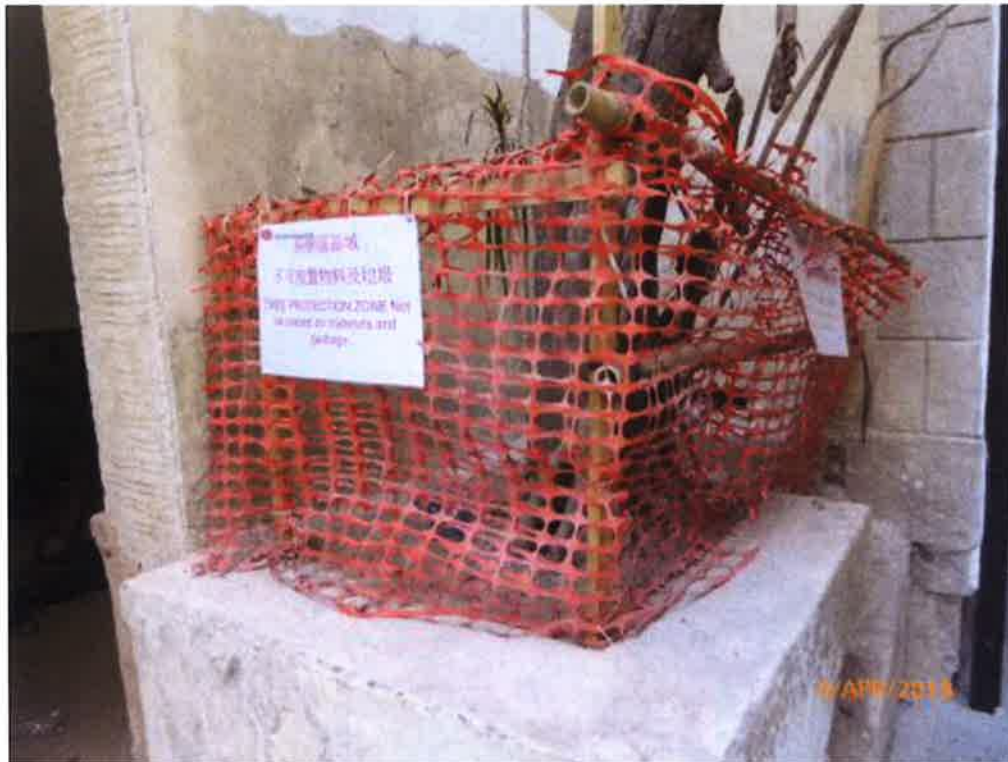
Fig. 11 The site near Tree-11 appears clean and tidy.

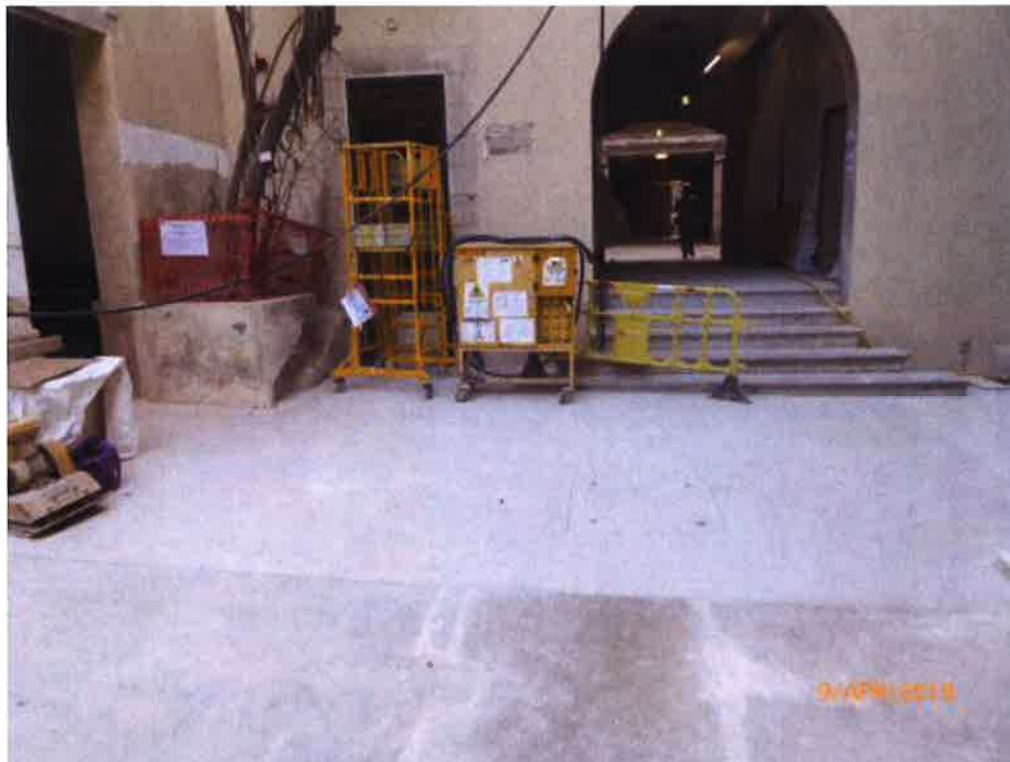
Fig. 12 Overall view of Tree-11 during inspection on 9th April 2018.
