Central Police Station Conservation
and Revitalisation Project:
74th Monthly EM&A Report
(1 December to 31 December 2017)

Issue Date: January 2018

Environmental Resources Management

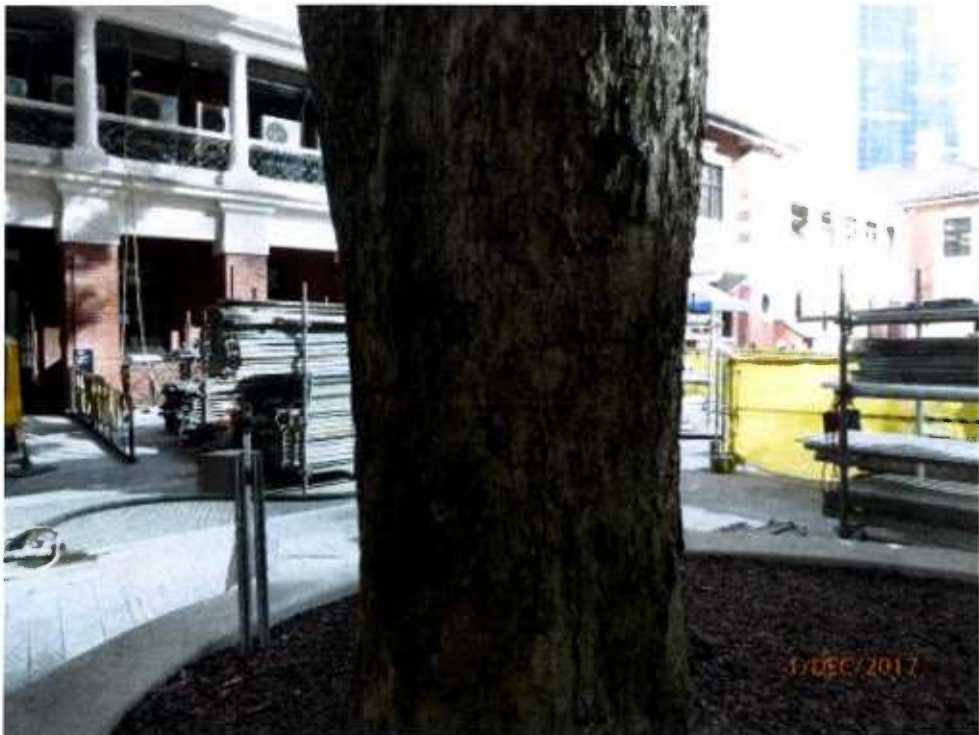
Fig. 4 Health condition of the mid trunk is fair.

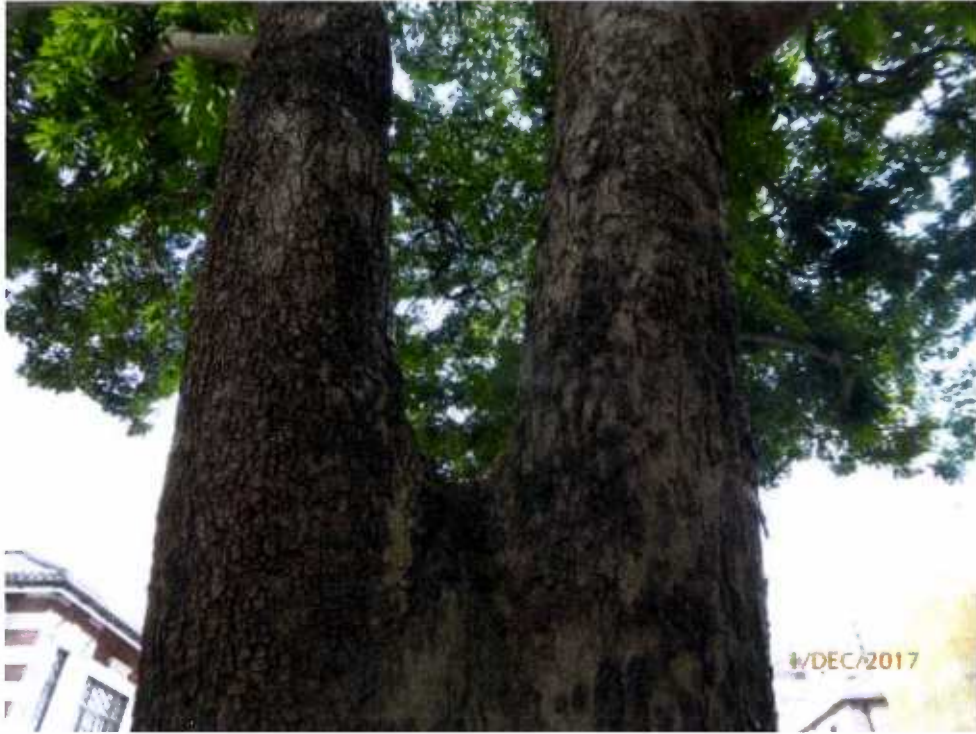
Fig. 5 Health condition of the upper trunk also is fair.

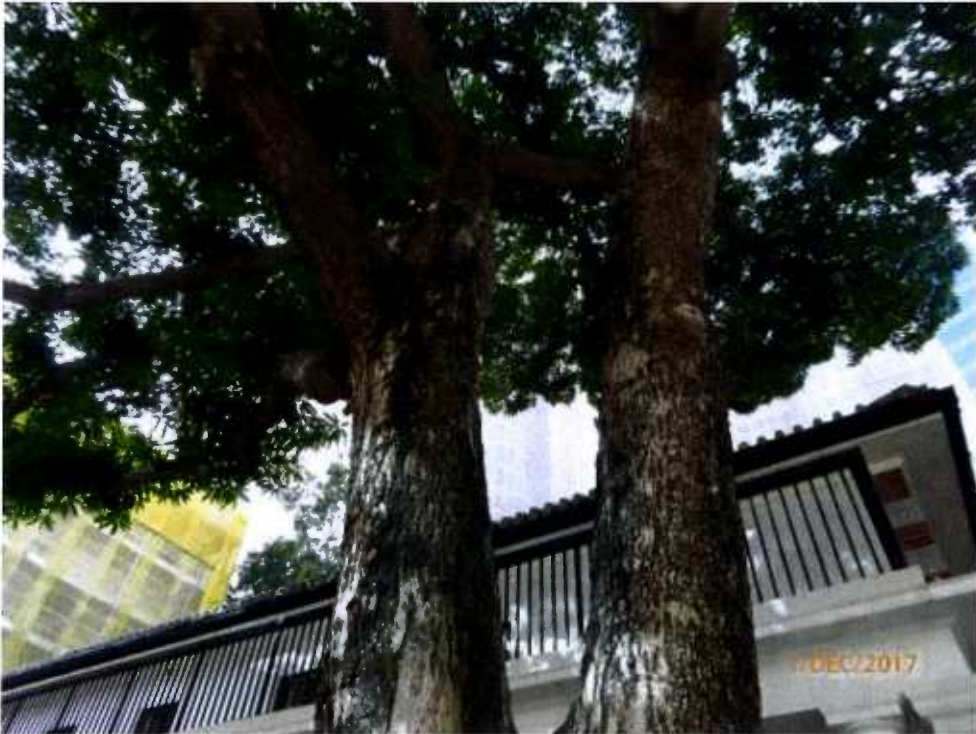
Fig. 6 The crown is full of vigorous and green leaves.

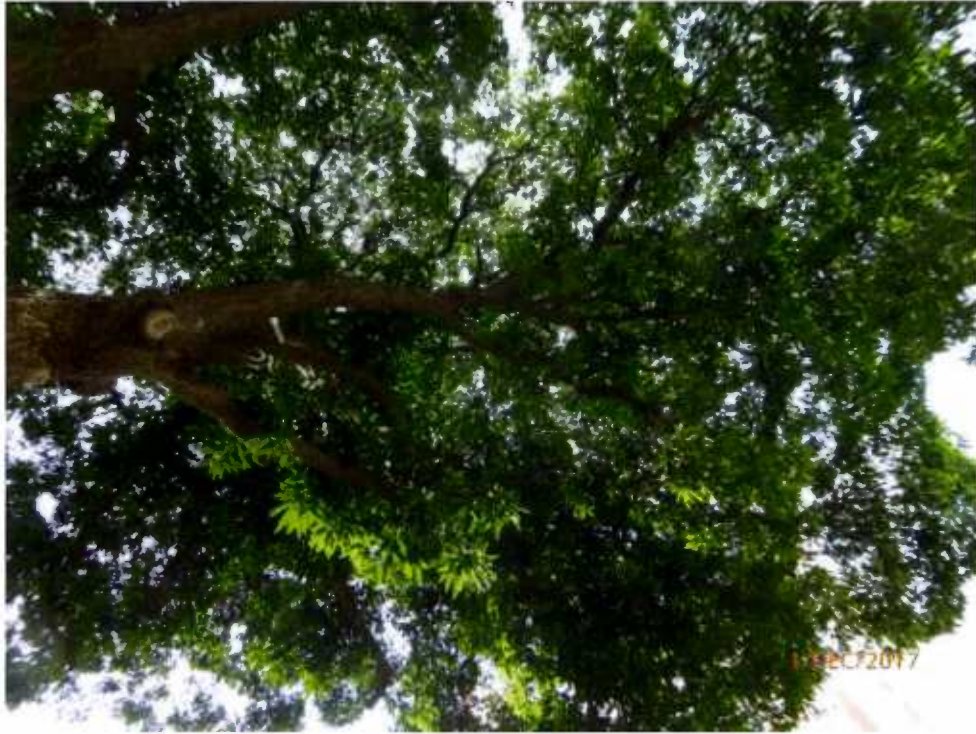
Fig. 7 Vigorous and green leaves also are growing on the lower branches.

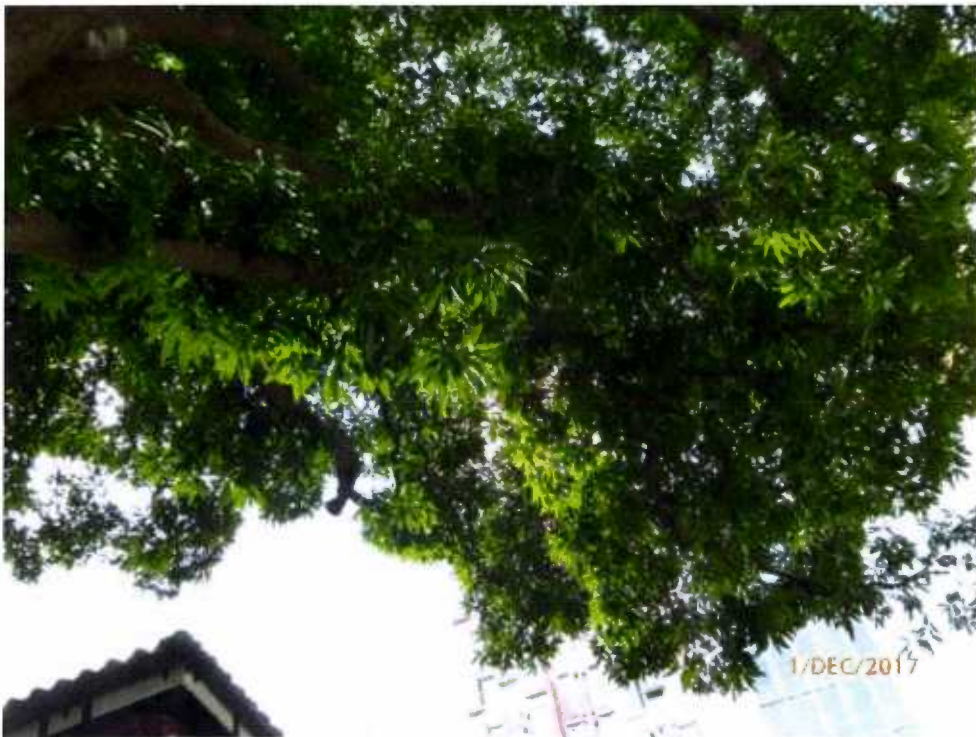
Fig. 8 Many young and green leaves appear on the tree.

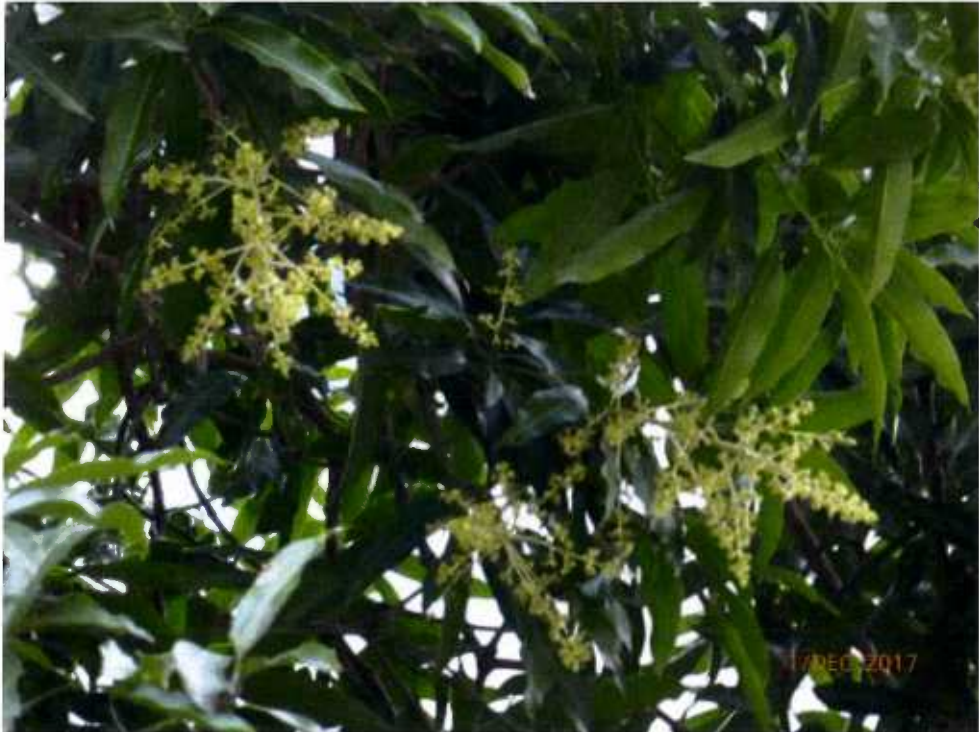
Fig. 10 Mango fruits also appear on Tree-5.

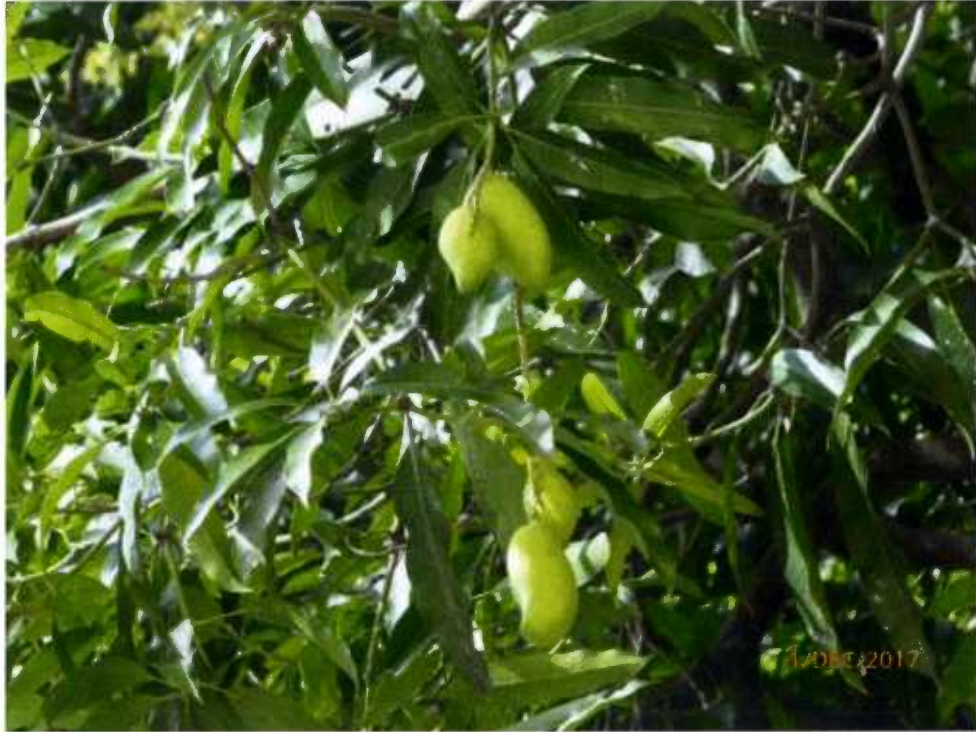
Fig. 11 The site near Tree-5 is clean and tidy.

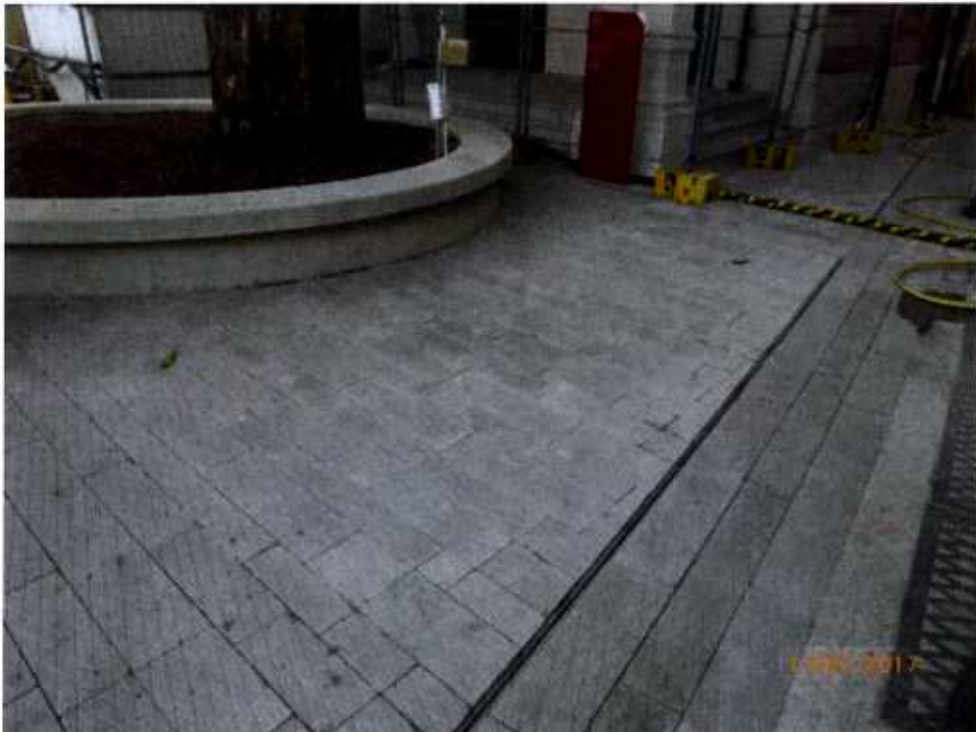
Fig. 12 Overall view of Tree-5 during inspection on 1st December 2017.

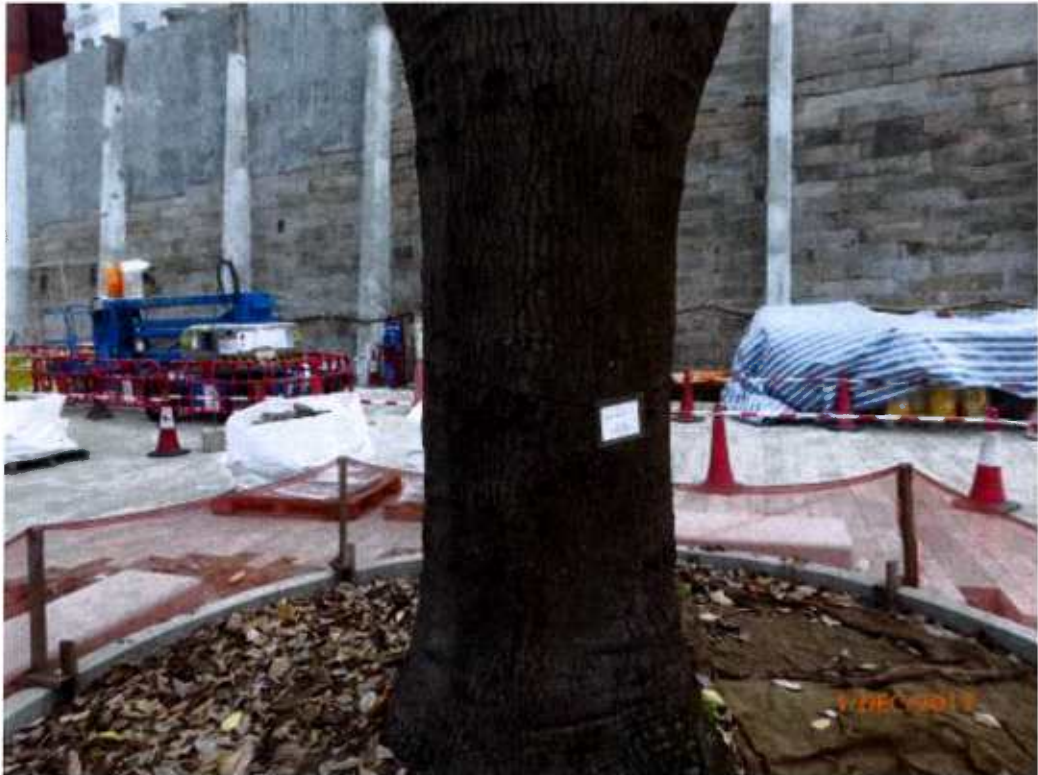
Fig. 4 Health condition of the mid trunk is fair.

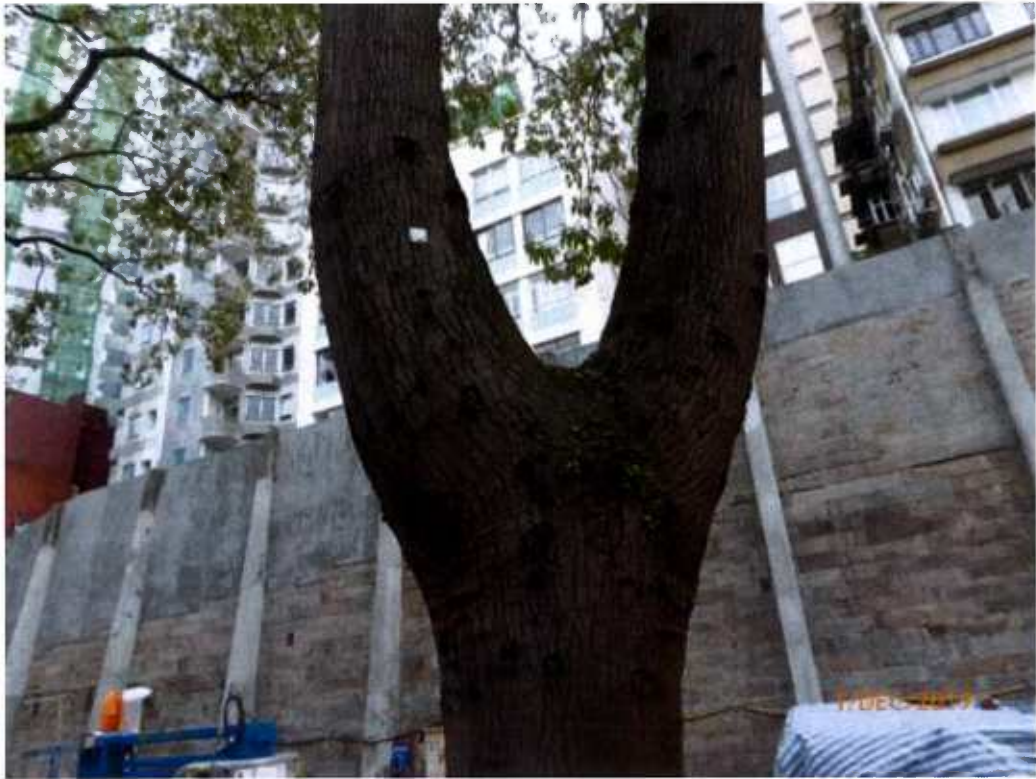
Fig. 5 Health condition of the upper trunk also is fair.

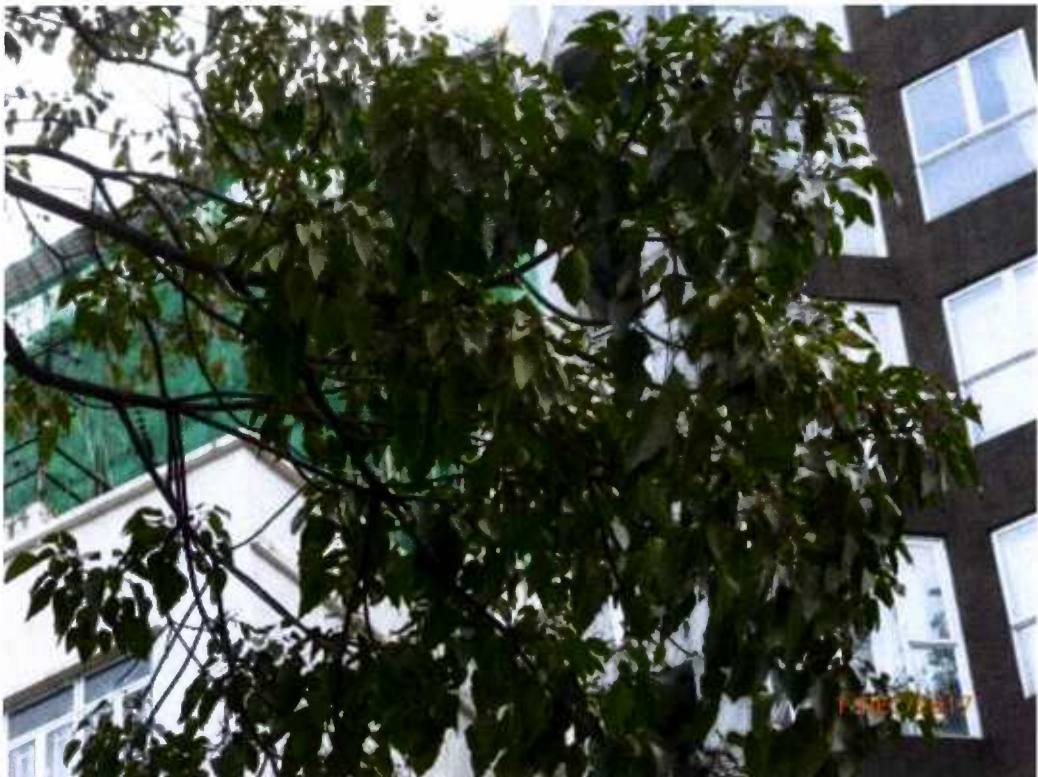
Fig. 8 Flowers still appear on the tree.

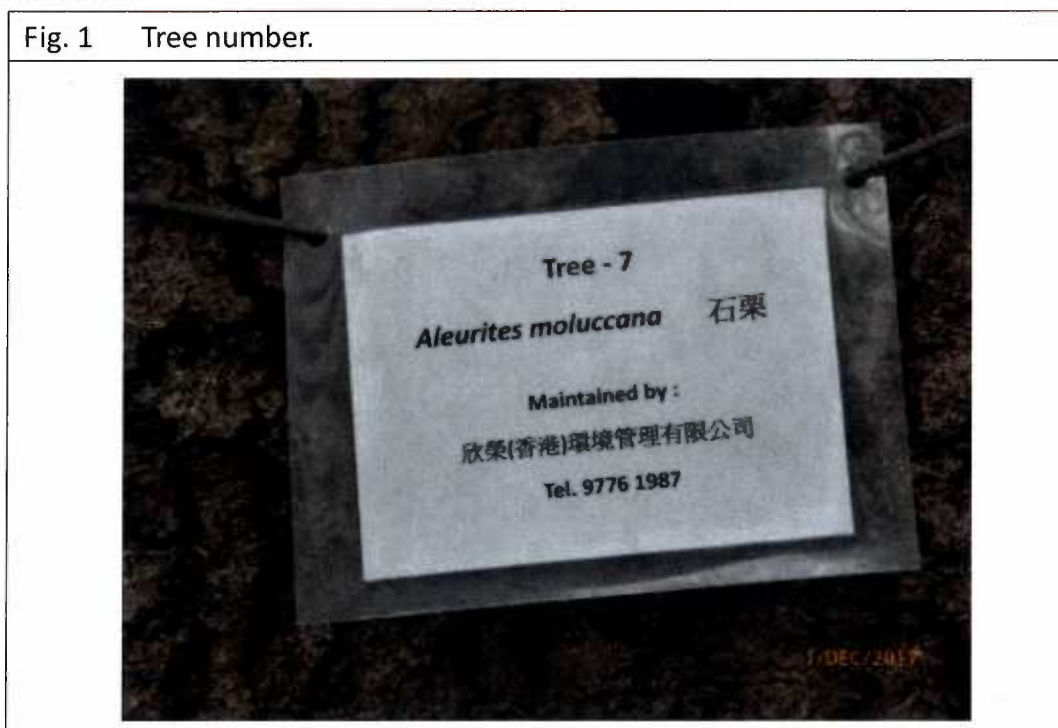
Fig. 2 Root collar is normal. The planter is covered with wet hessian clothes.

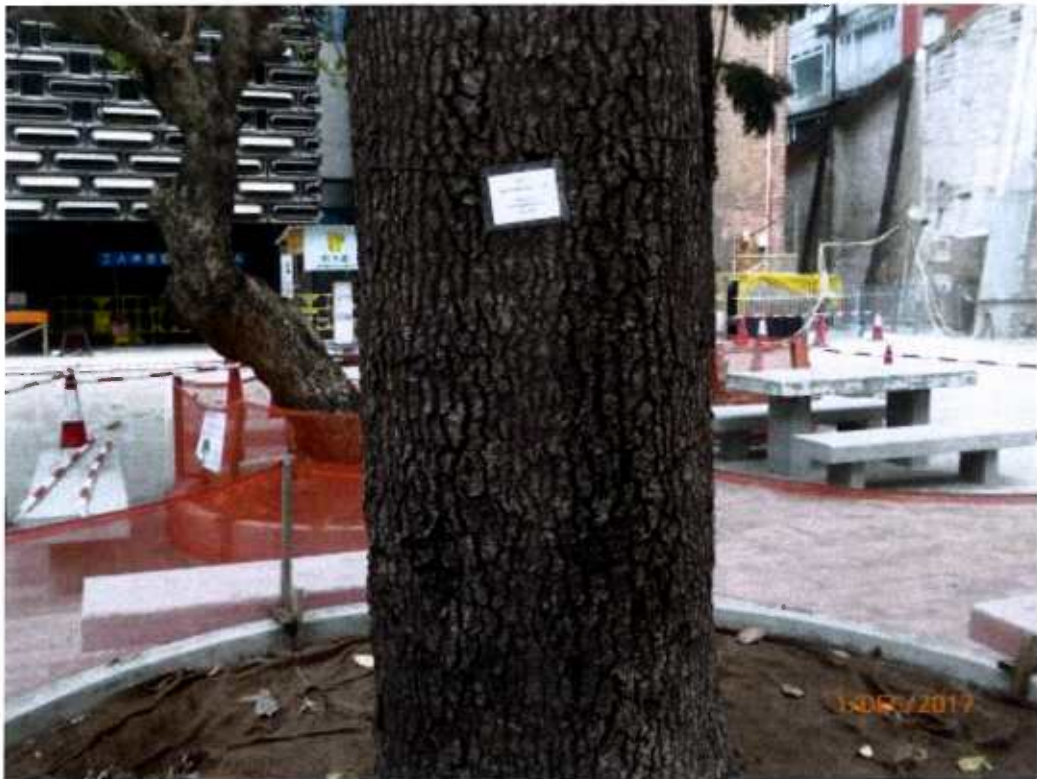
Fig. 4 Health condition of the mid trunk is fair.

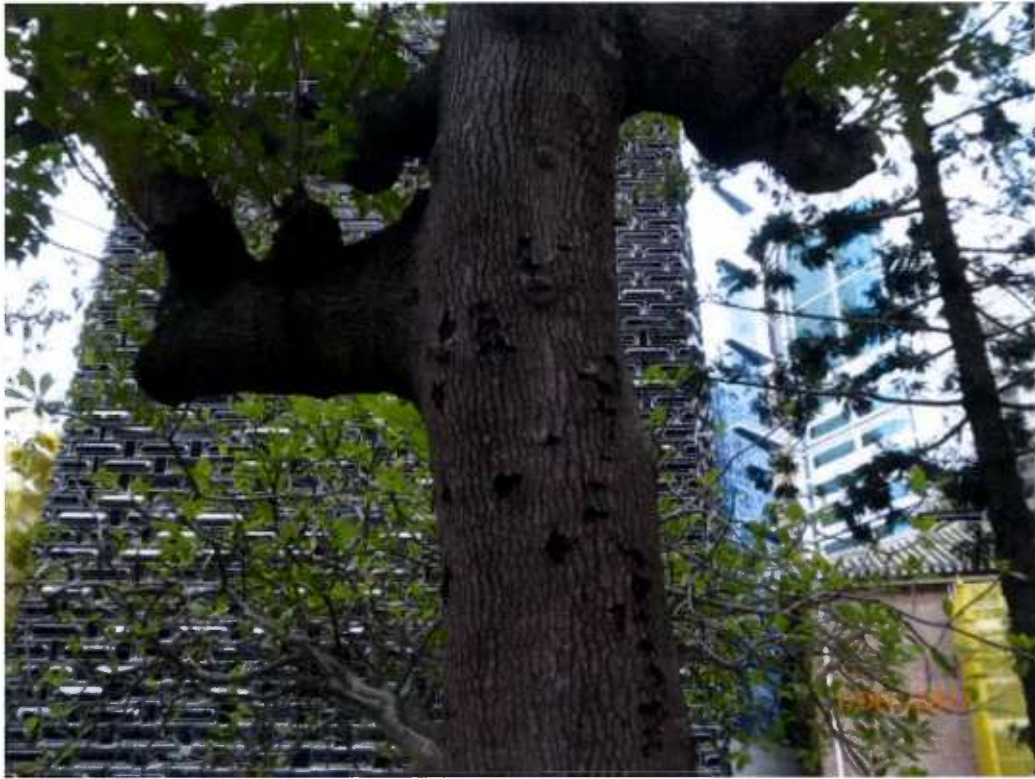
Fig. 5 Health condition of the upper trunk also is fair.

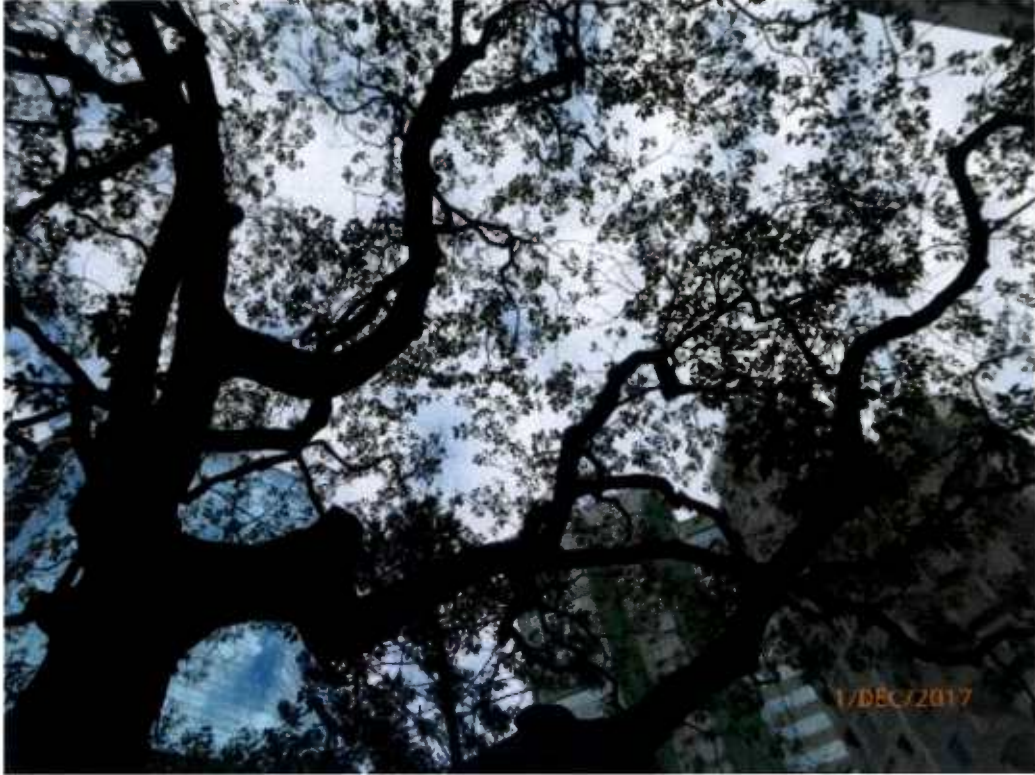
Fig. 7 Leaves on the lower branches are normal.

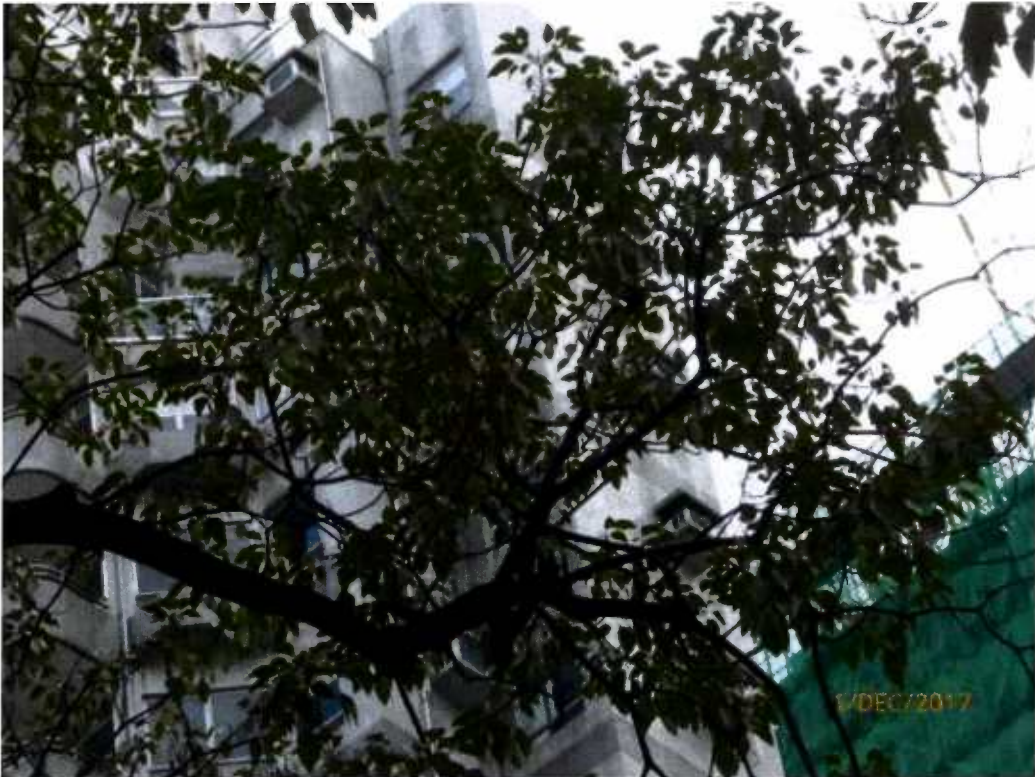
Fig. 8 Some young and green leaves appear on the tree.

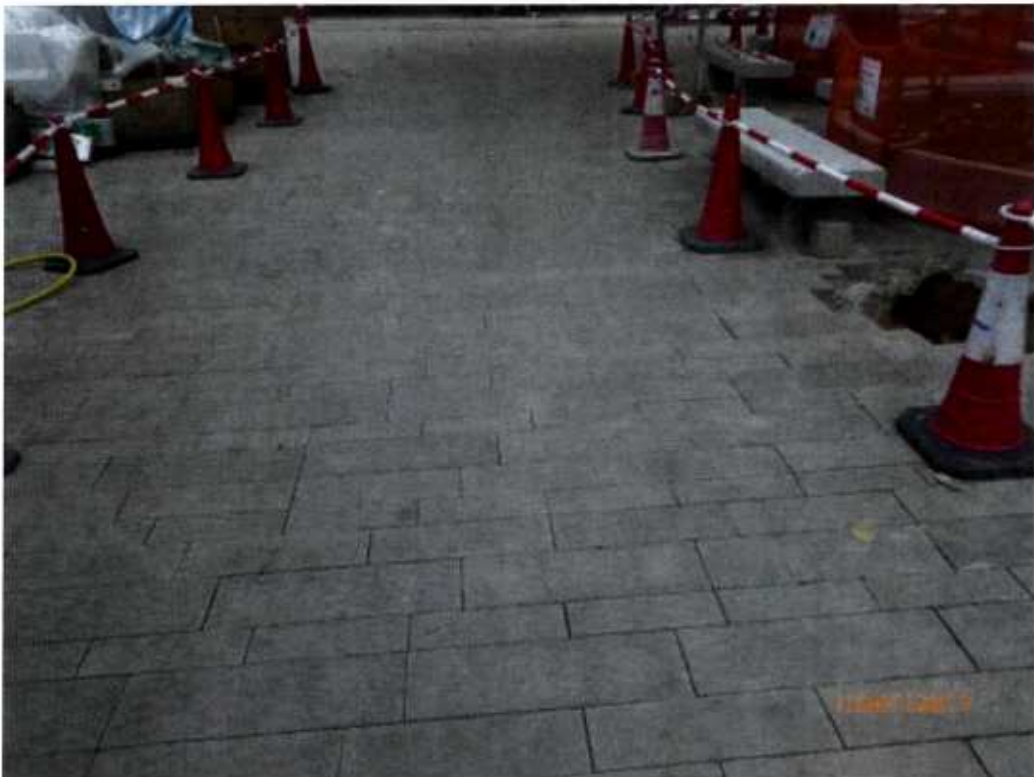
Fig. 12 Overall view of Tree-7 during inspection on 1st December 2017.

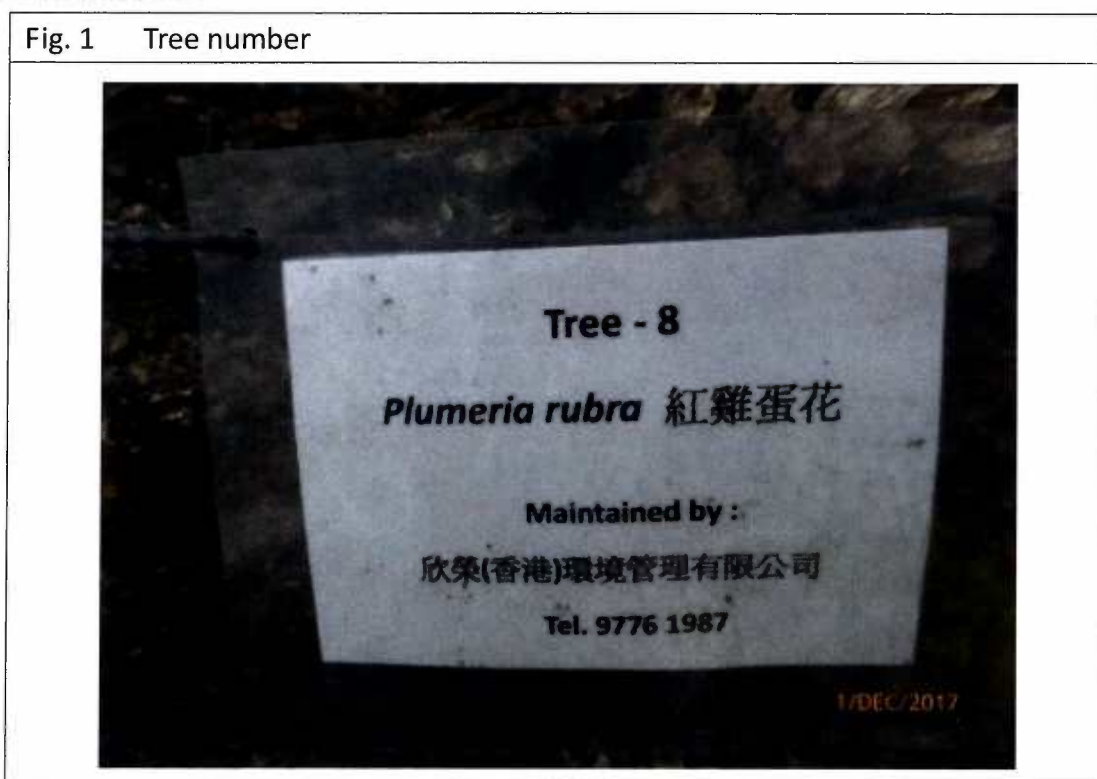
Fig. 2 Root collar is normal. The planter is covered with mulch and dry leaves.

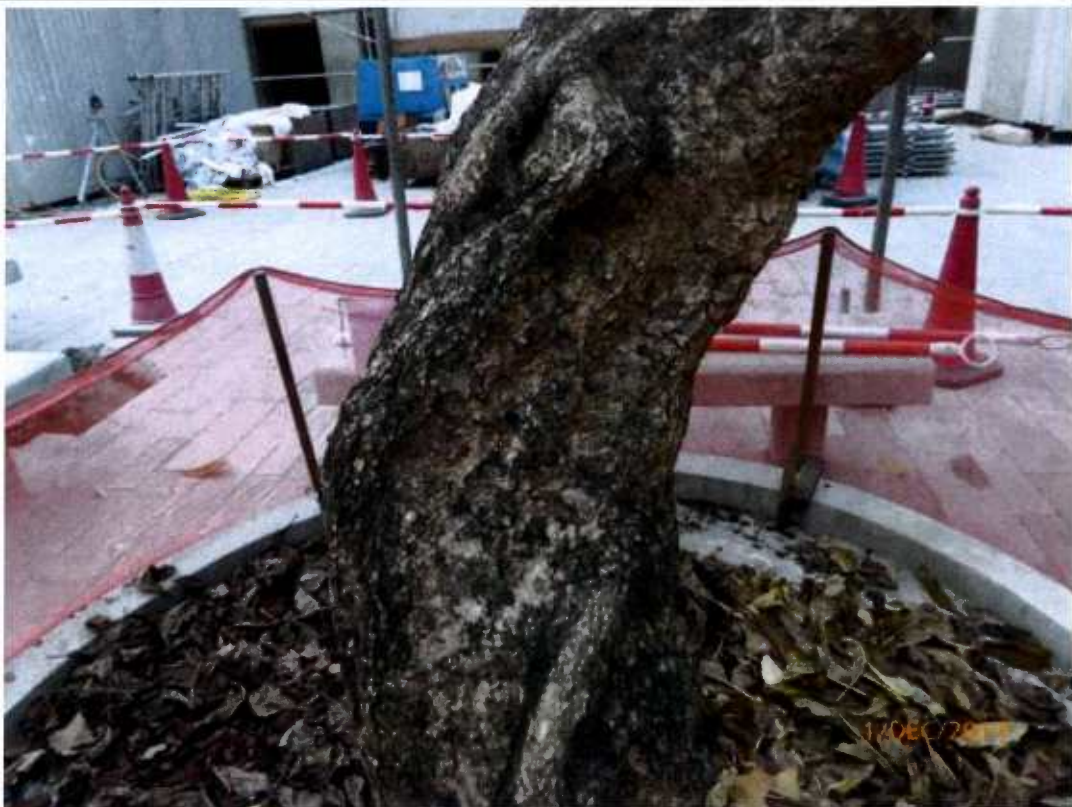
Fig. 4 Health condition of the mid trunk is fair.

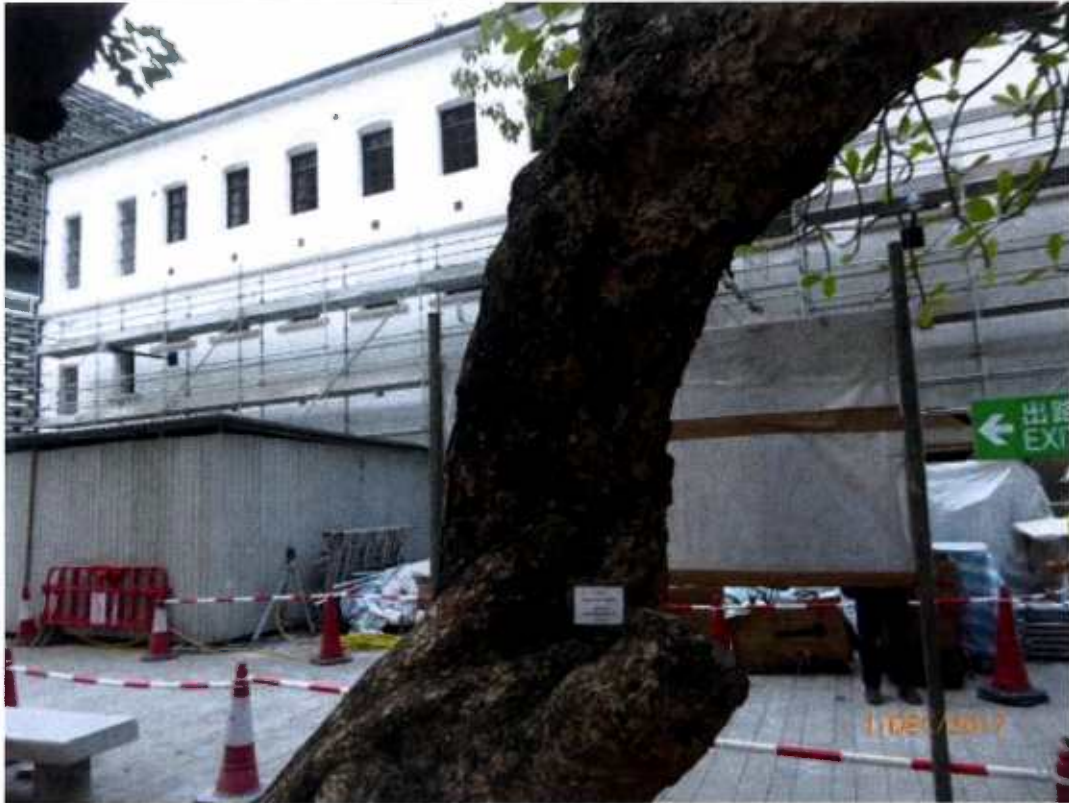
Fig. 5 Health condition of the upper trunk also is fair.

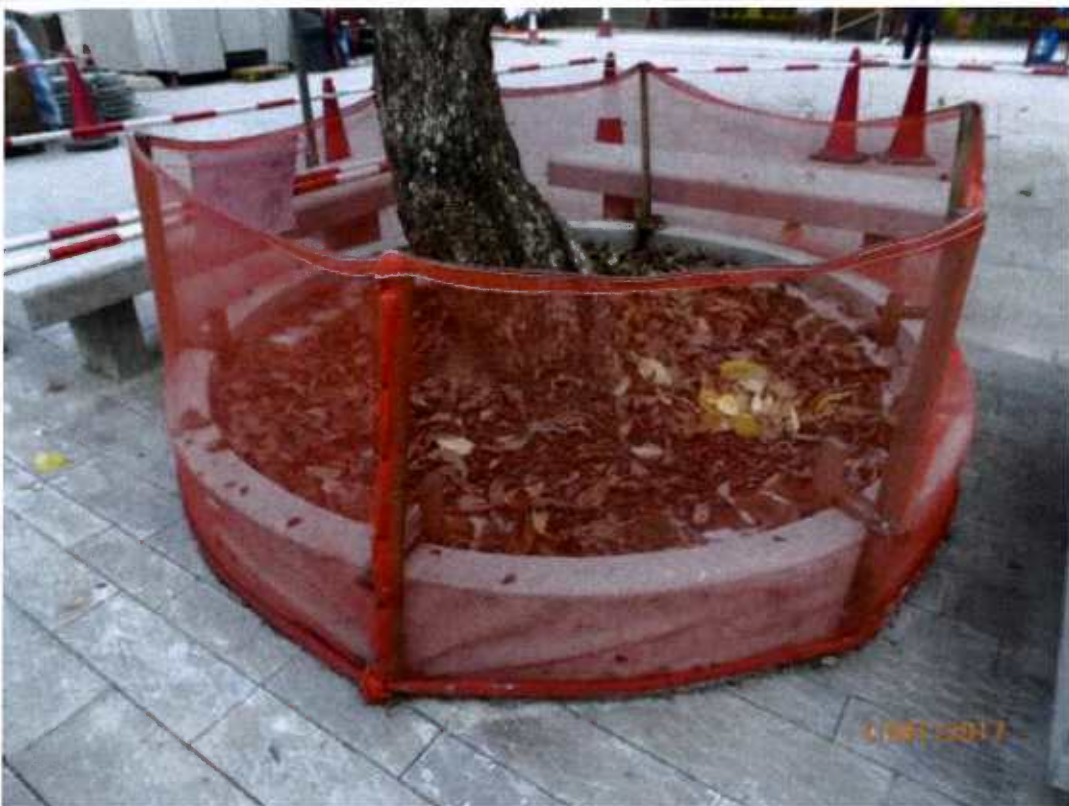
Fig. 10 The site near the planter is clean and tidy.

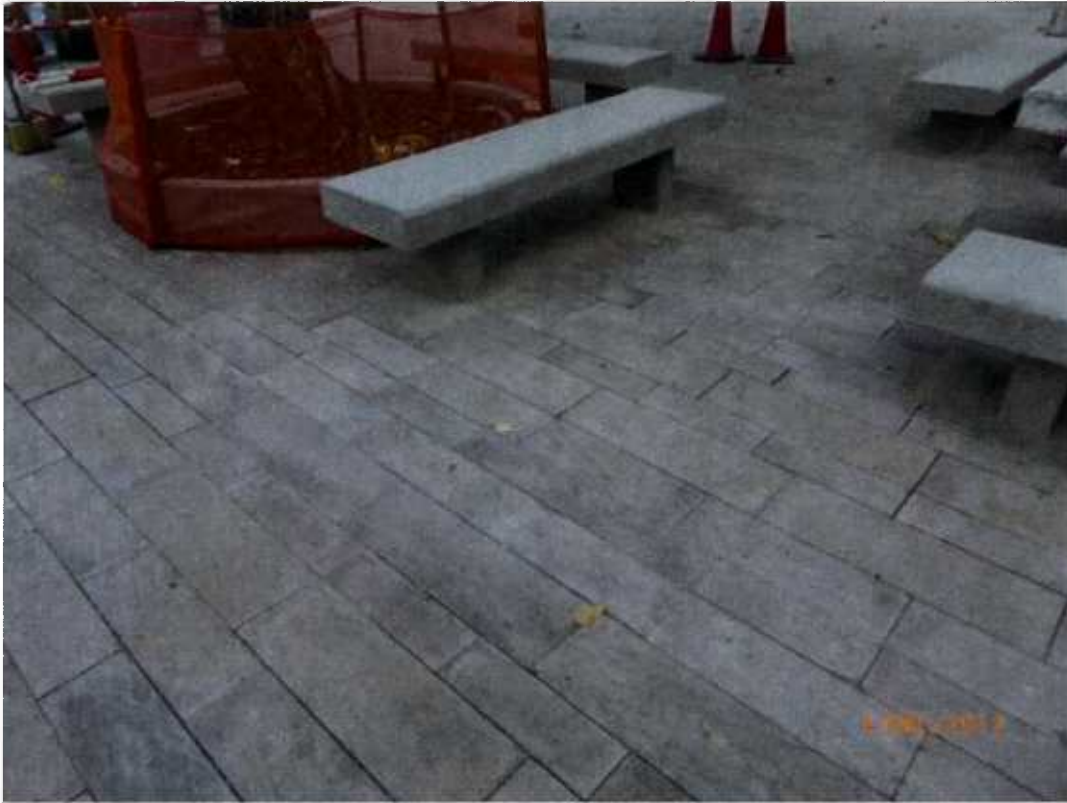
Fig. 11 The access near Tree-8 also is clean and tidy.

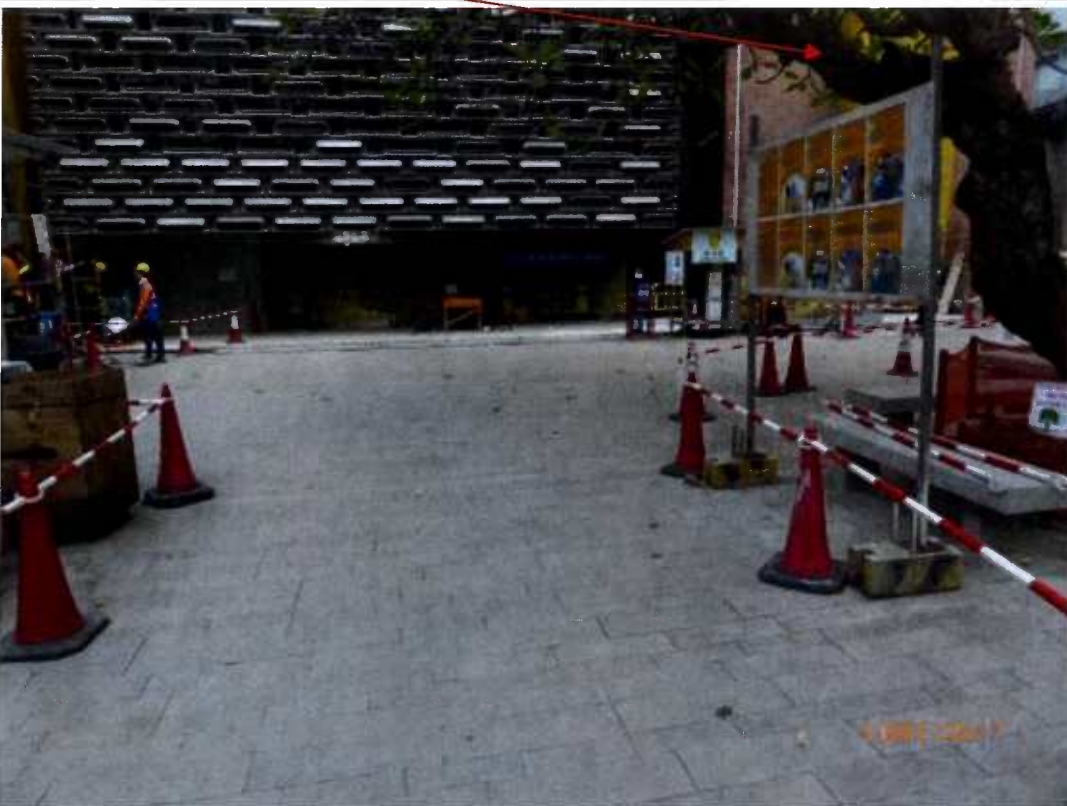
Fig. 12 Overall view of Tree-8 during inspection on 1st December 2017.

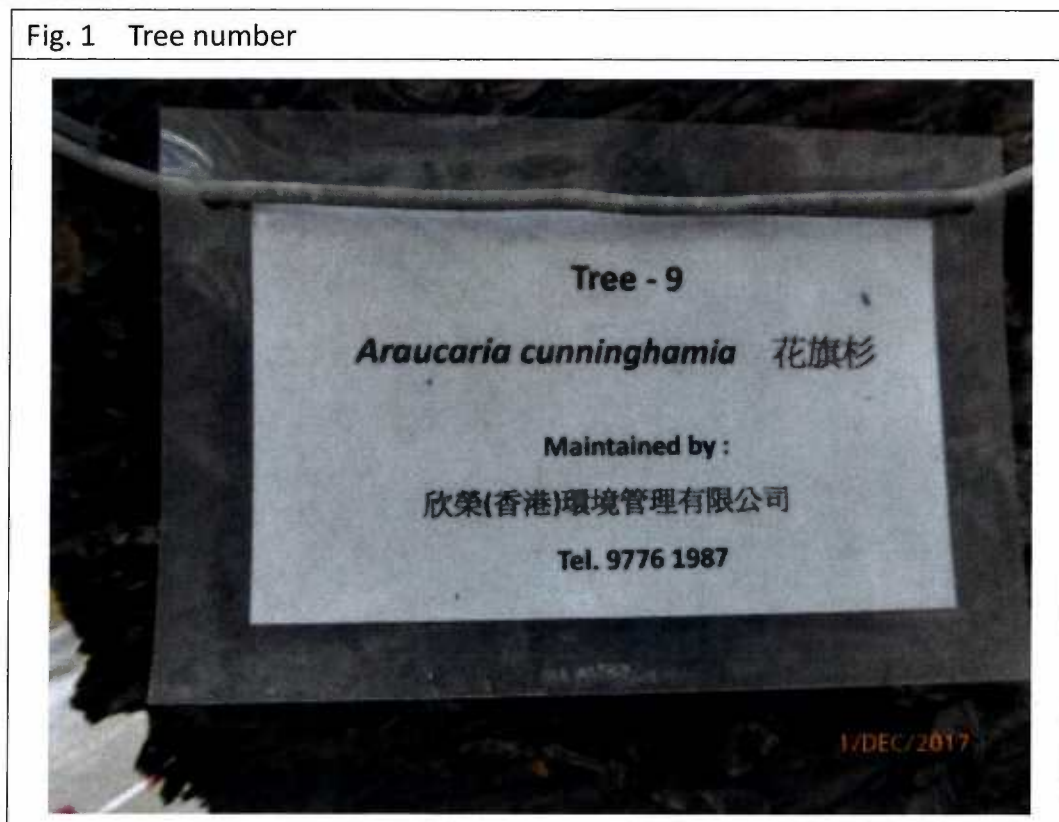
Fig. 2 Root collar is normal. The planter is covered with mulch and dry leaves.

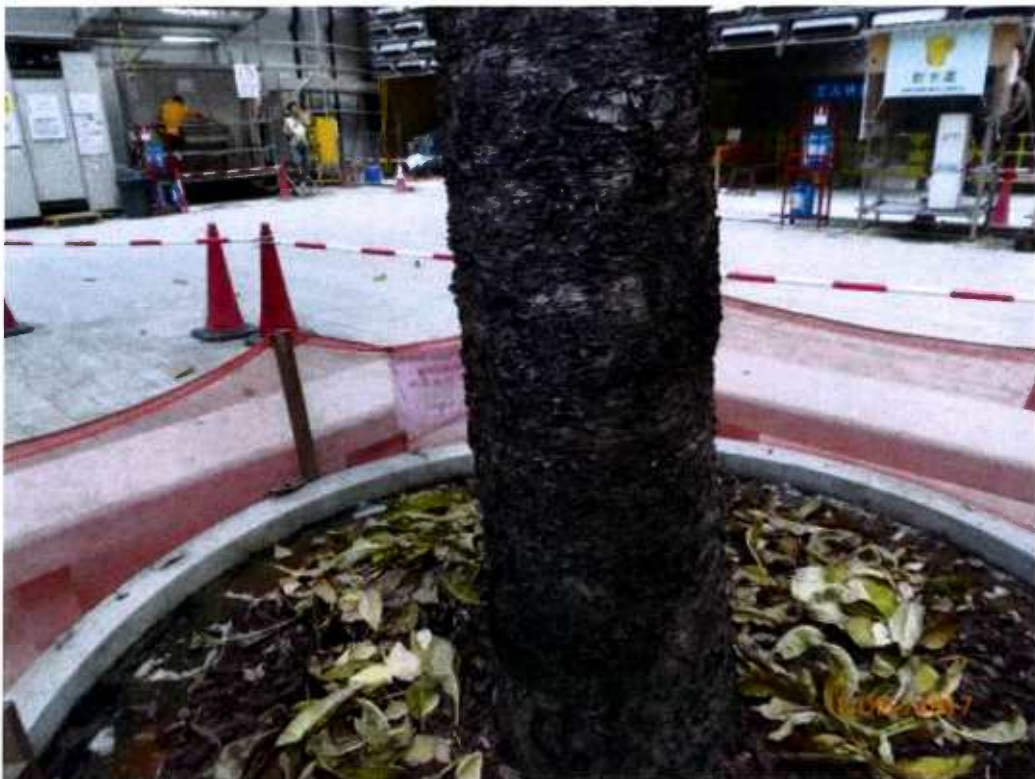
Fig. 4 Health condition of the mid trunk is fair.

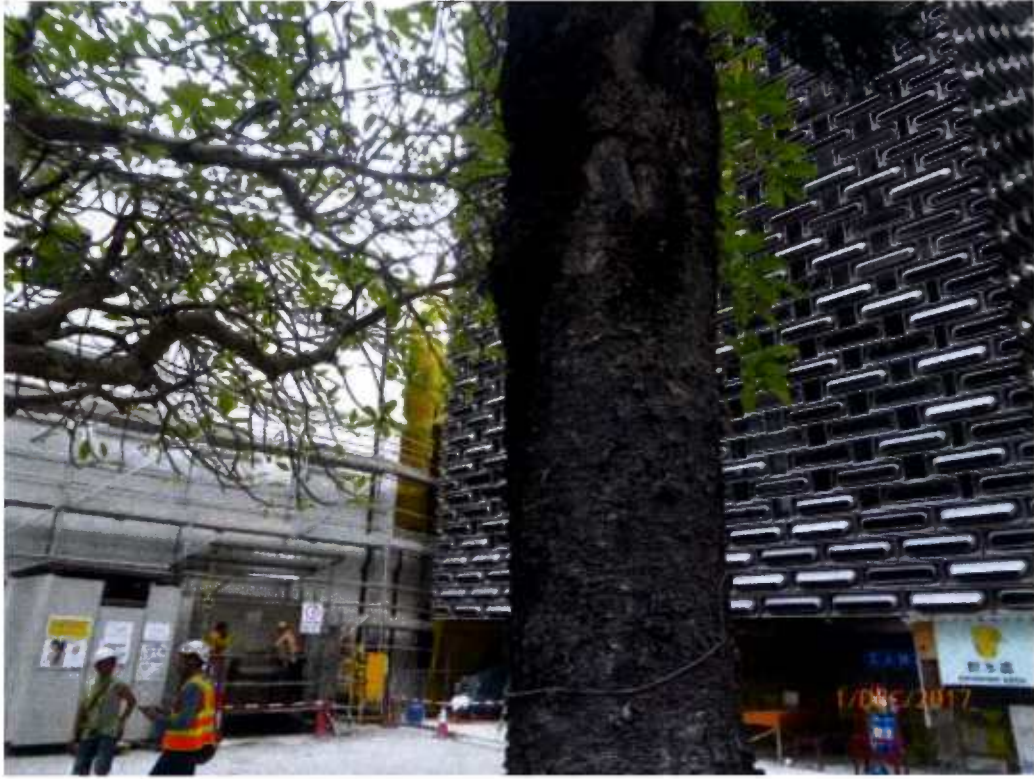
Fig. 5 Health condition of the upper trunk also is fair.

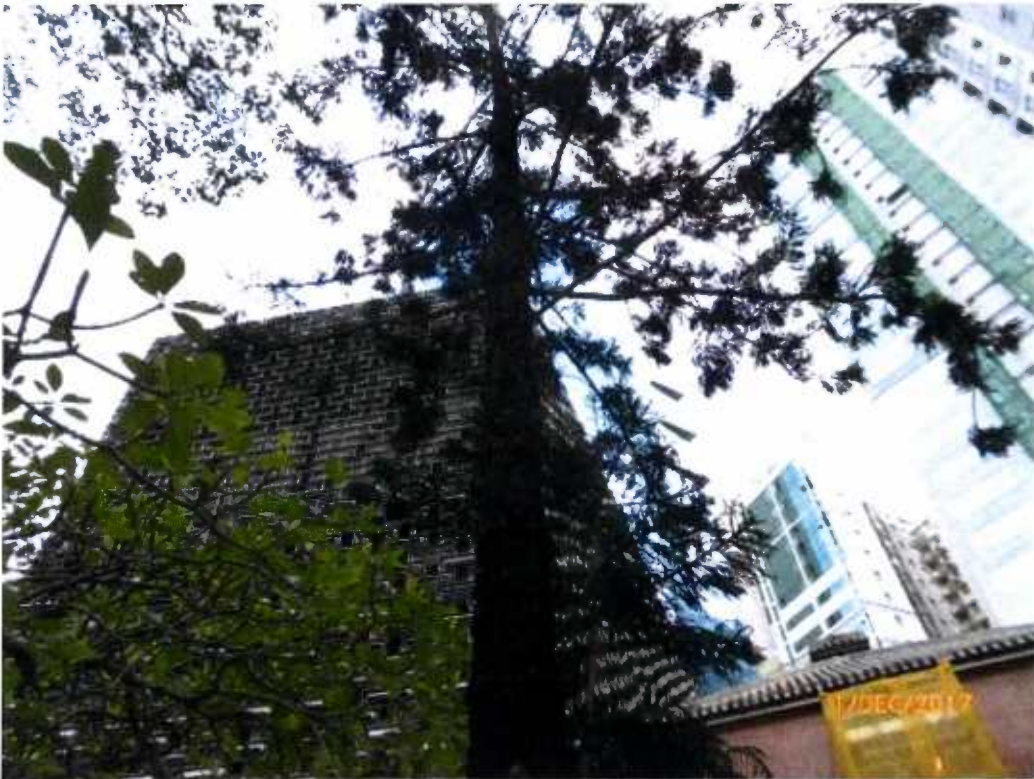
Fig. 6 The crown is full of vigorous and green leaves.

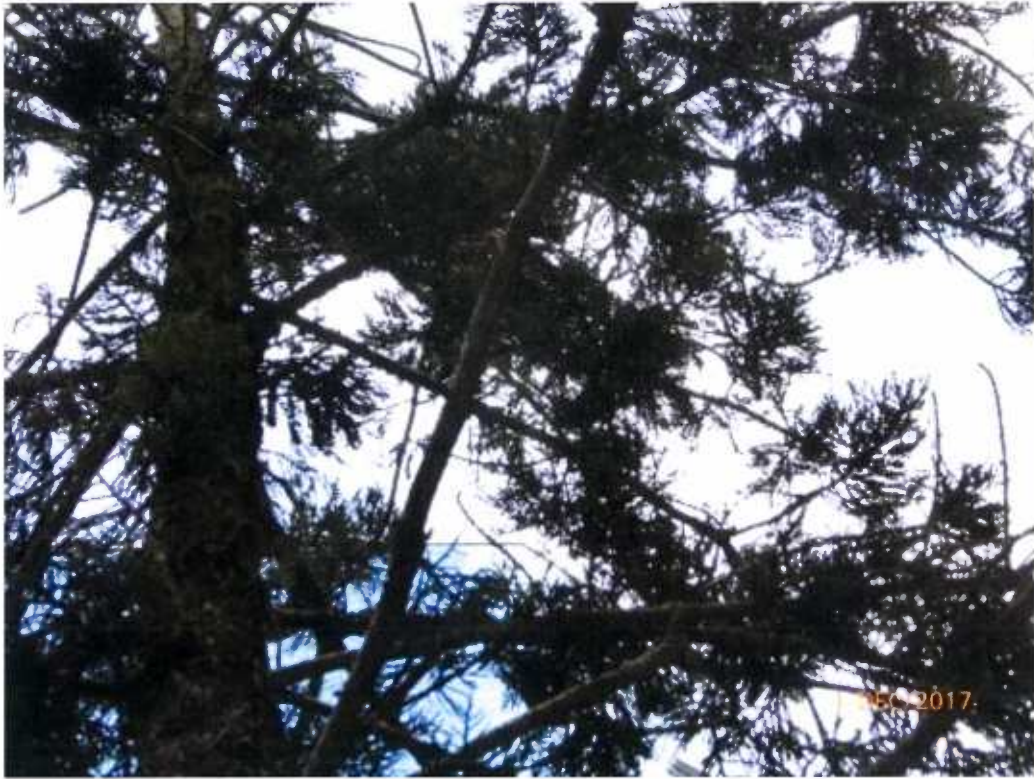
Fig. 7 Vigorous and green leaves also are growing on the lower branches.
