Central Police Station Conservation
and Revitalisation Project:
74th Monthly EM&A Report
(1 December to 31 December 2017)

Issue Date: January 2018

Environmental Resources Management

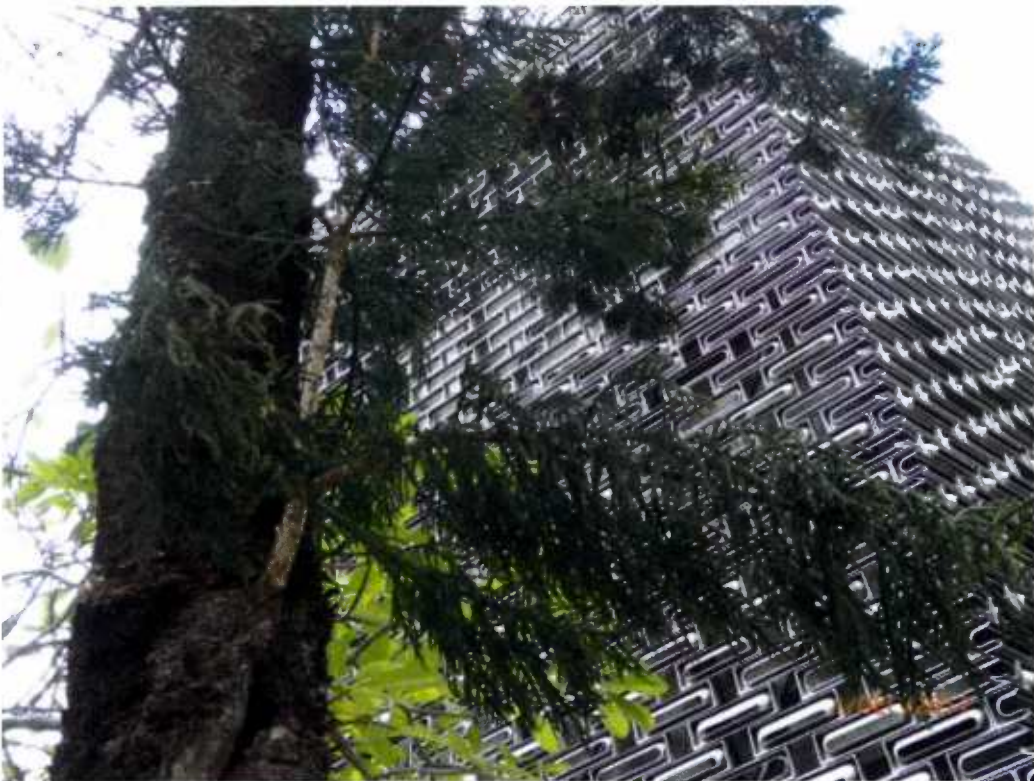
Fig. 8 Some young and green leaves appear on the mid trunk.

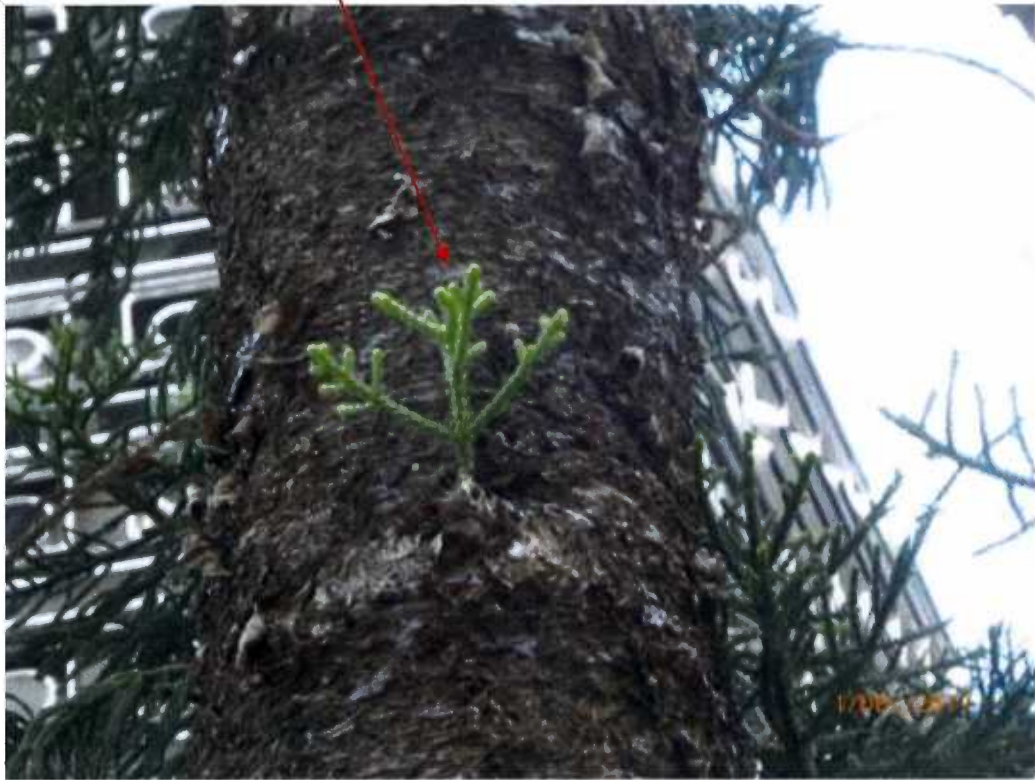
Fig. 9 Young and green leaves also appear on the lower branches.

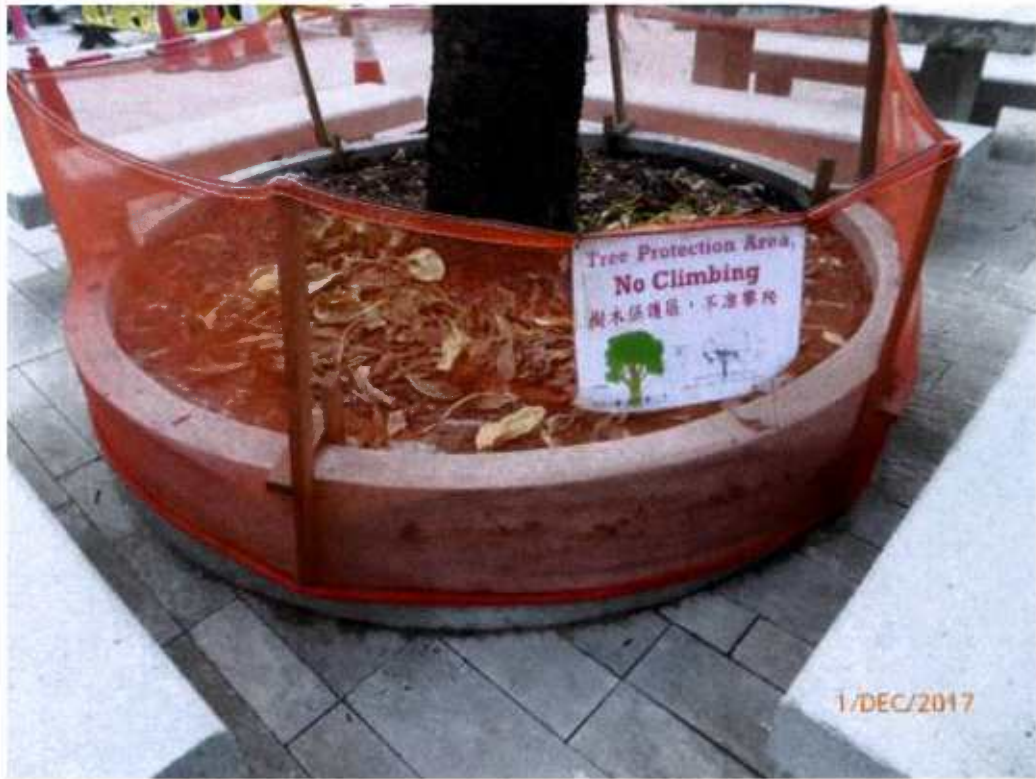
Fig. 11 The site near Tree-9 is clean and tidy.

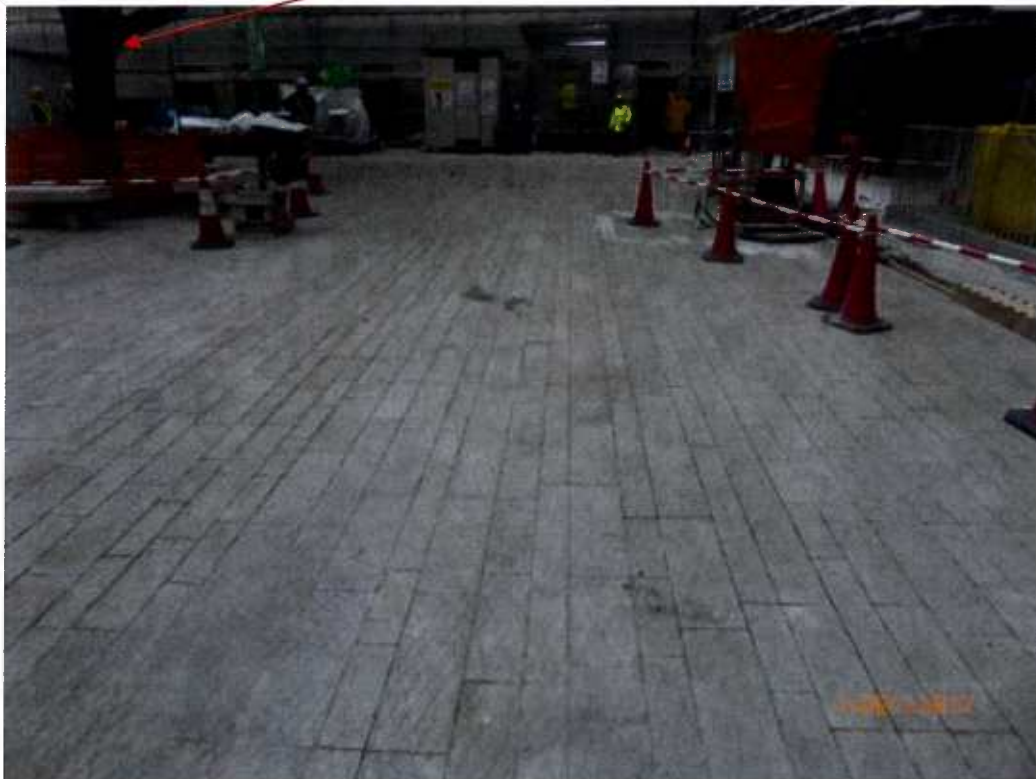
Fig. 12 Overall view of Tree-9 during inspection on 1st December 2017.

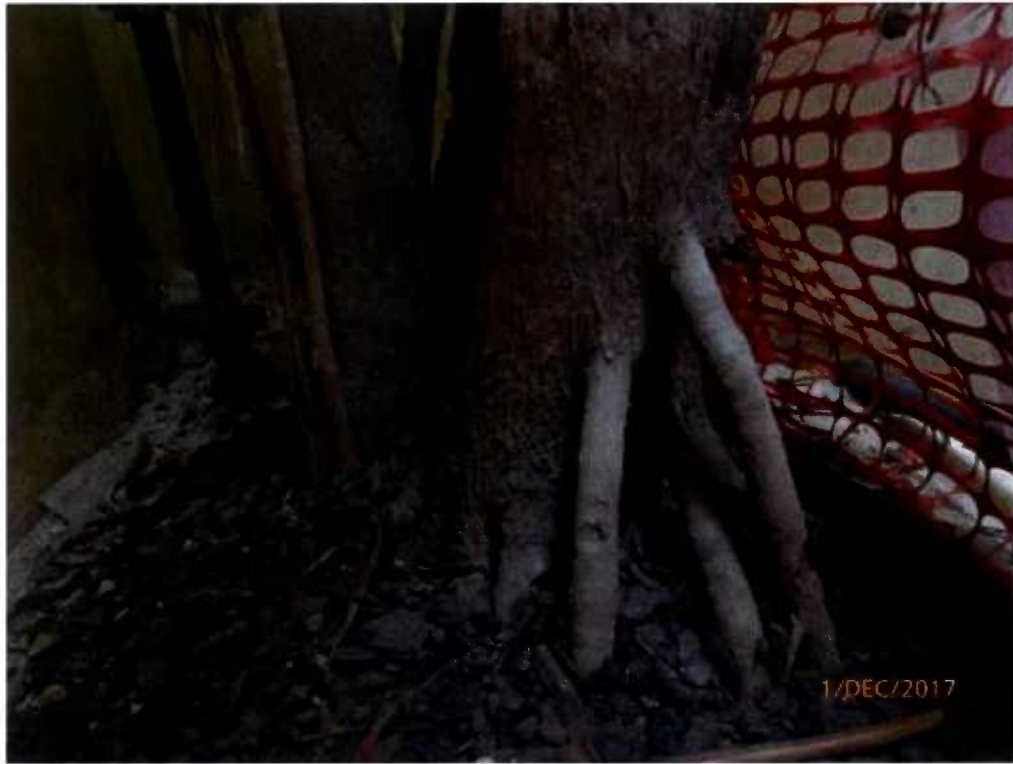
1. Health condition of the tree is fair.
2. Withered leaves still appear on the tree.
3. A few litter remain at the planter.
4. Renovation works near the tree are in progress.

Fig. 3 A few litter remain at the edge of the planter.

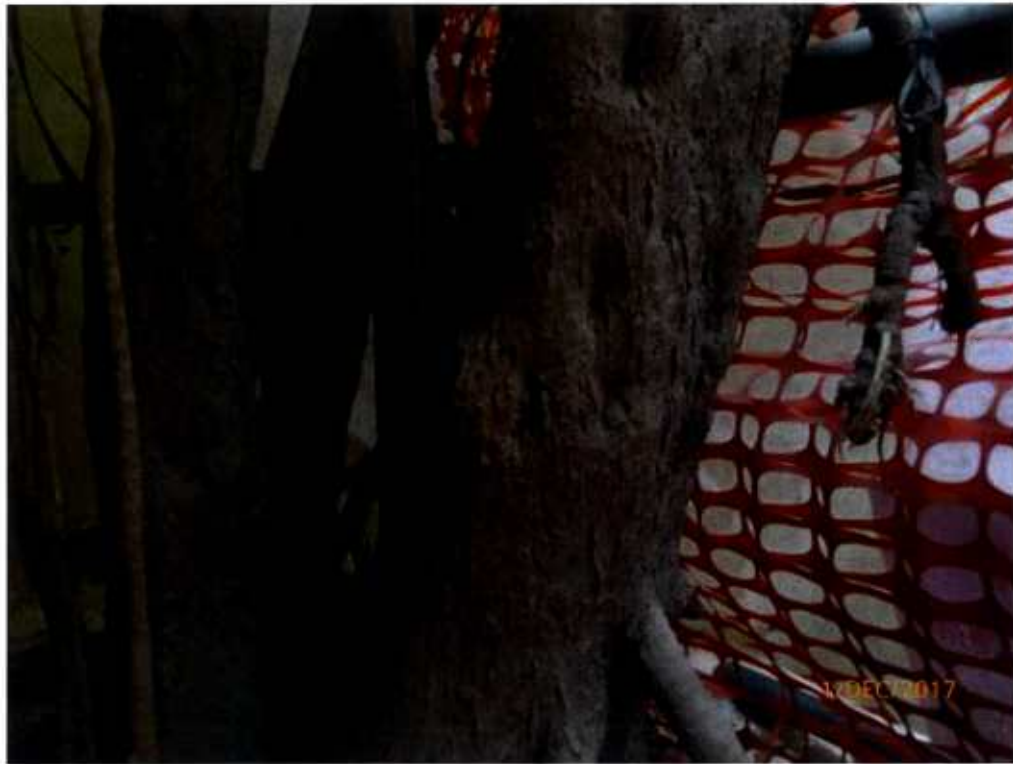
Fig. 5 Health condition of the mid trunk is fair.

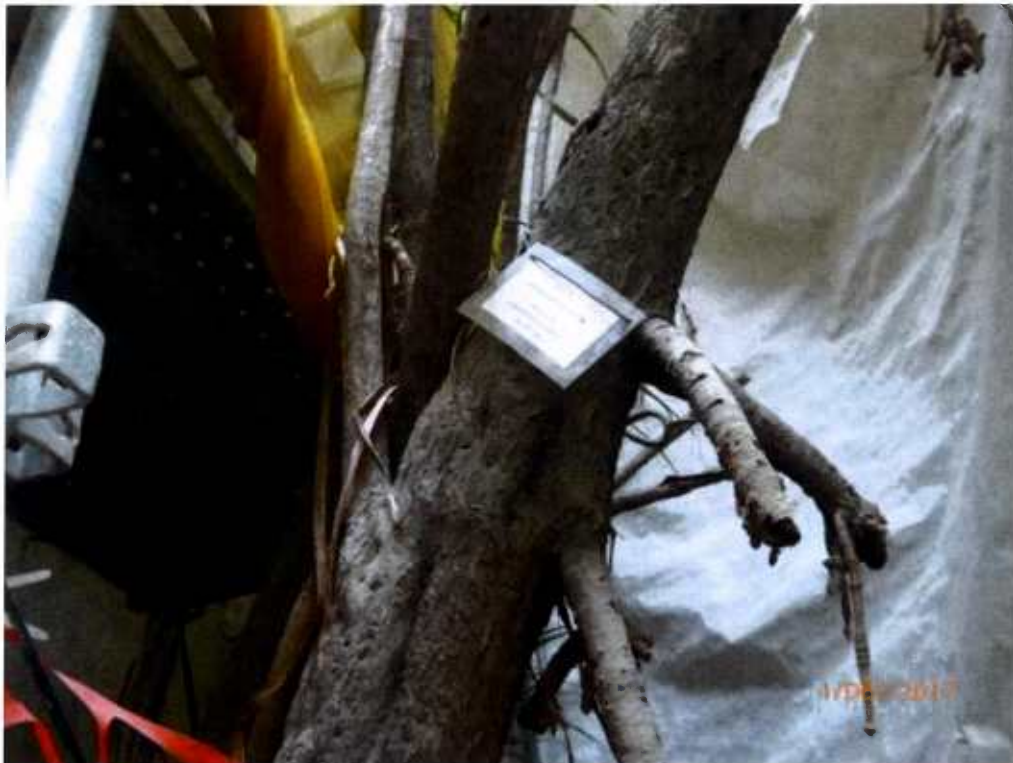
Fig. 6 Health condition of the upper trunk also is fair.

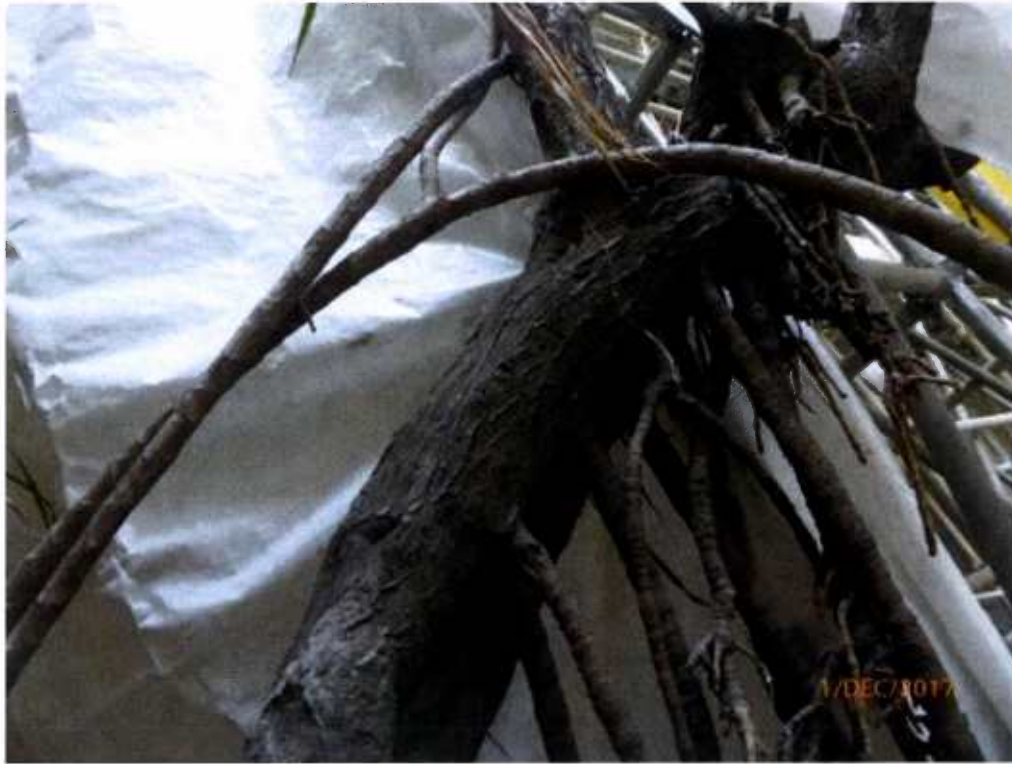
Fig. 7 Withered leaves still appear on the tree.

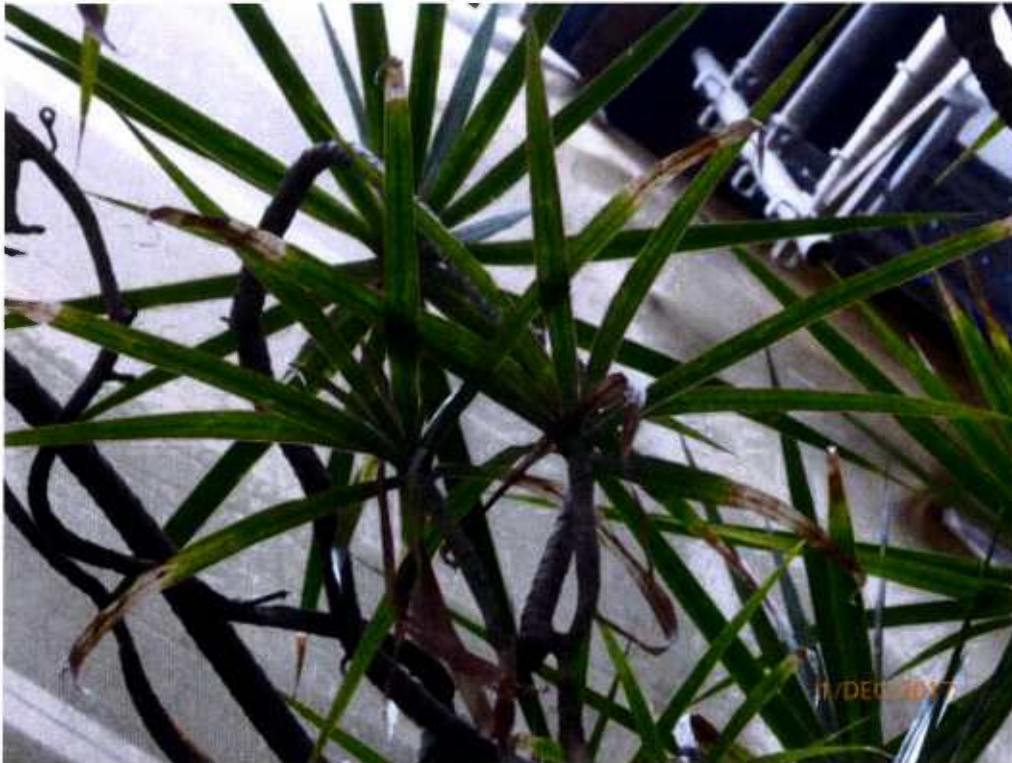
Fig. 8 Withered leaves also appear on the lower branches.

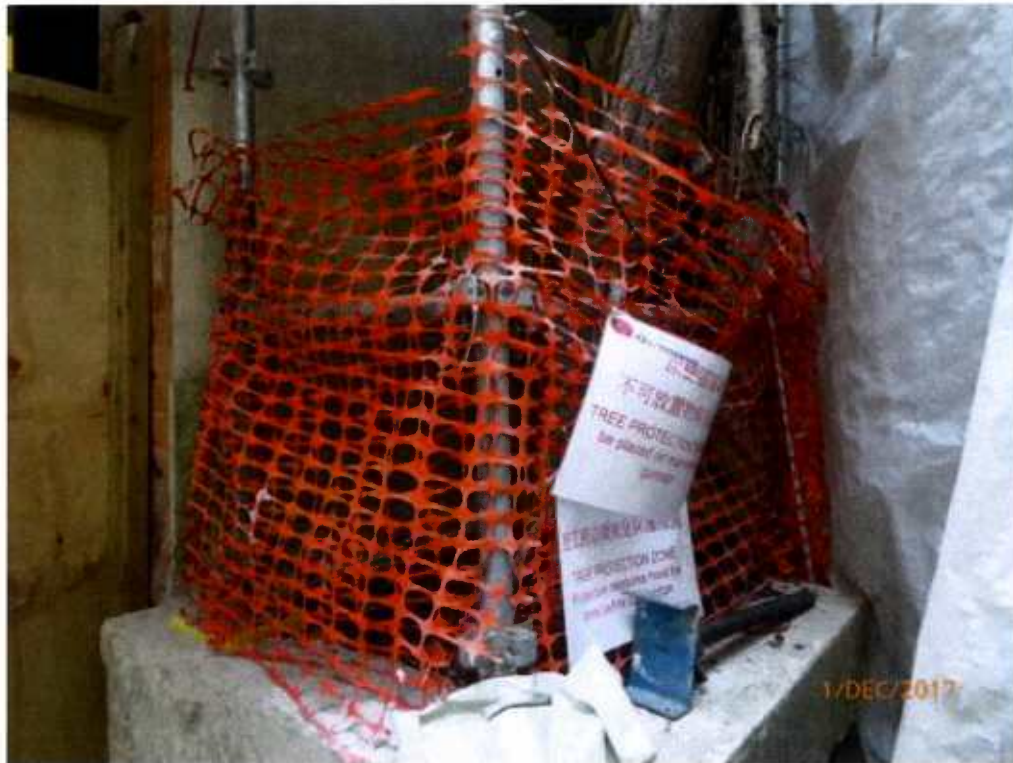
Fig. 11 Renovation works are in progress near Tree 11
